State of Oregon
Department of
Environmental
Quality

LANDFILL INSPECTION CHECKLIST

FACILITY:	Riverbend Landfill		
COUNTY:	Yamhill	PERMIT NO:	345
INSPECTOR(S):	Bob Schwarz	INSPECTION DATE:	Feb 22, 2017
	Start time:	10 am	End time: 1:30 pm
Site Weather Conditions: intermittent rain, 40s F			
Facility Representatives:	Nick Godfrey, Sarah Anunsen		
Inspection type:	Unannounced		
Facility Type:	MSW Landfill

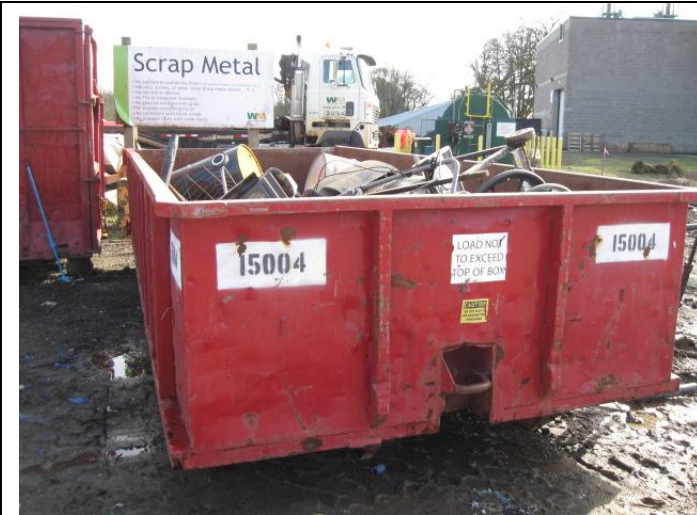
Scrap metal recycling container

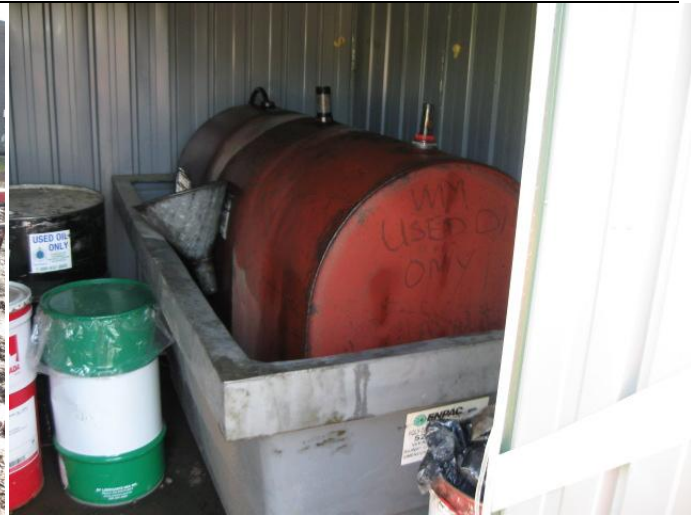
Used oil container. This is used by the facility. When customers bring in used oil, which is rare, it is placed in this tank.

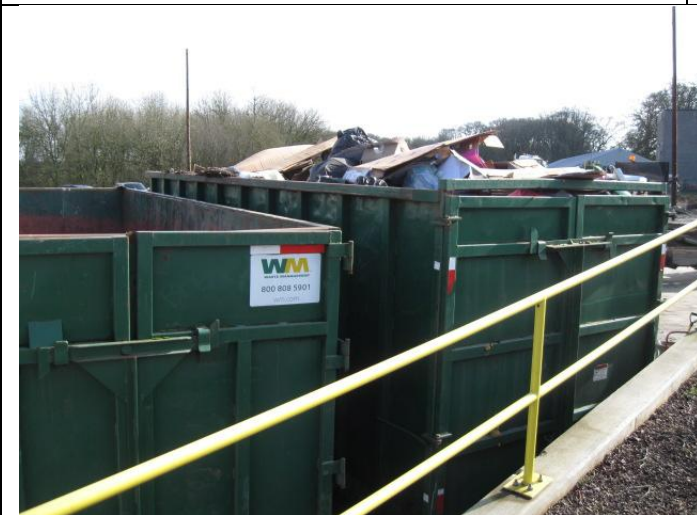
Container for recycled paper and cardboard.

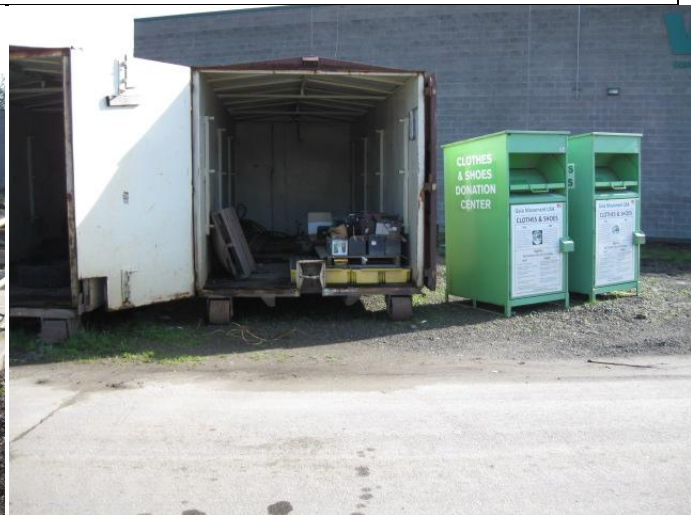
Battery recycling

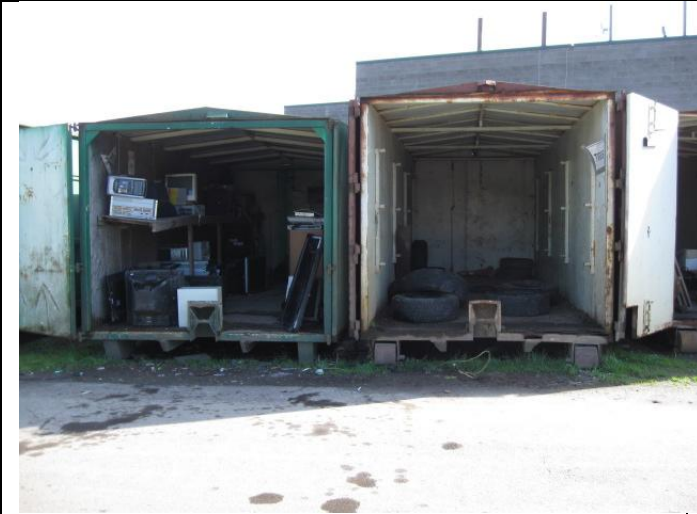
Containers for recycled tires and electronics.

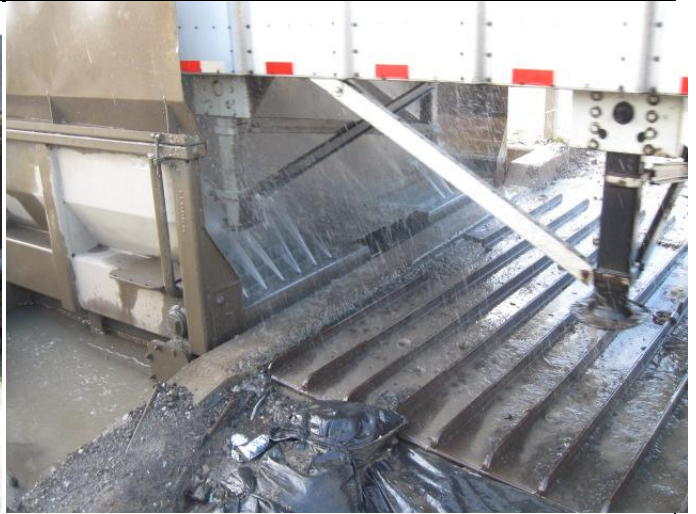
Road conditions, efforts to control trackout of mud. I did not observe significant mud on roads on the landfill property or on Highway 18. A road sweeper was working on site roads during my inspection. As noted in the report for the November 2016 inspection, the wheel wash was spraying muddy water at the time. This problem appears to have been corrected. Photos below show clear water being sprayed by the wheel wash facility. An additional tank has been added to increase settling capacity so that solids are removed from the water that is recycled to the sprayers.

Water at wheel wash facility.

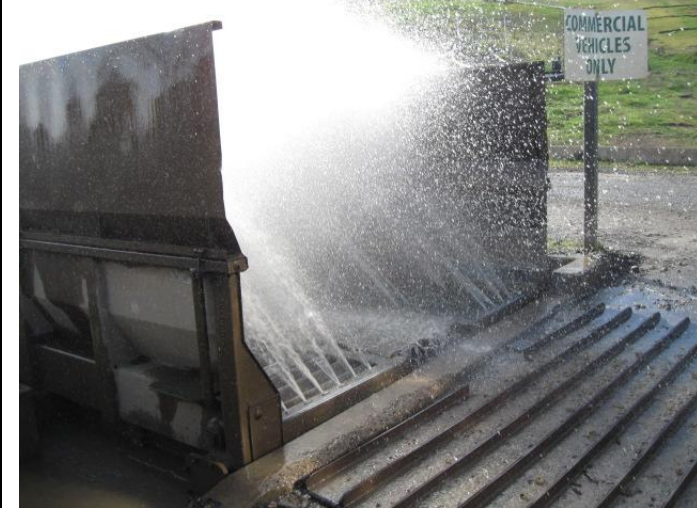
Water at wheel wash facility. The problem of dirty water noted in the Nov. 2016 inspection report appears to have been corrected.

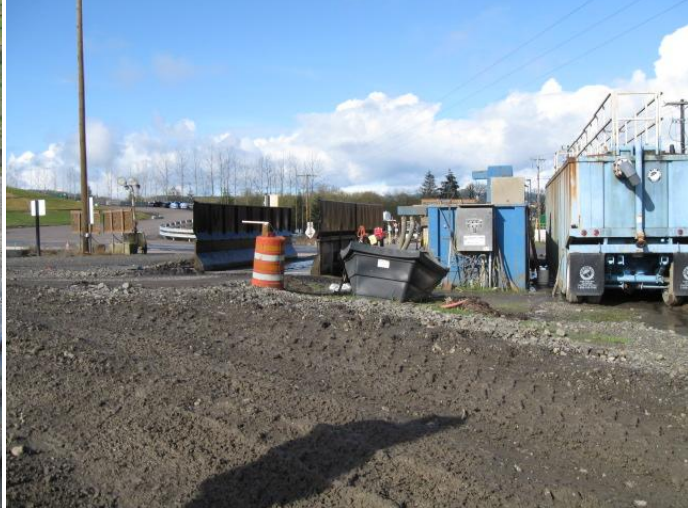
From left to right: wheel wash, old settling tank, recently added additional settling tank.

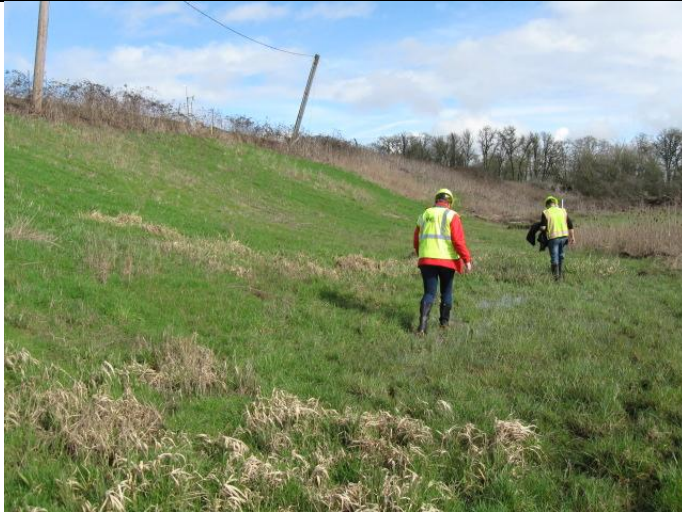
Southern perimeter berm (1 of 4). Following recent flooding of the area south of the landfill, the berm was inspected for signs of scouring or erosion. The berm appears to be in good condition.
