**DEBRIS FLOW ASSESSMENT
EILERTSEN CREEK/WOODSON
December 2007 Storm
T 7N, R 5W, Sections 5, 8, & 17**

April 10, 2008

This report presents the results of a geologic/geotechnical assessment of the causes and slope movement mechanisms that led to the railroad fill failure which occurred on the morning of December 11, 2007 in the Eilertsen Creek drainage (T 7N, R 5W, Sections 5, 8, and 17, Figure 1). The failure sent a debris flow through the hamlet of Woodson, across Highway 30, and into Westport Slough, destroying several residential structures and covering the highway with mud and large woody debris. Due to warning of the impending failure by ODF personnel prior to the event, the effects were limited to property damage. This report was completed at the request of the Oregon Department of Forestry's Policy Unit. The assessment was completed in its entirety by Gunnar Schlieder, Ph.D., an Oregon Certified Engineering Geologist.

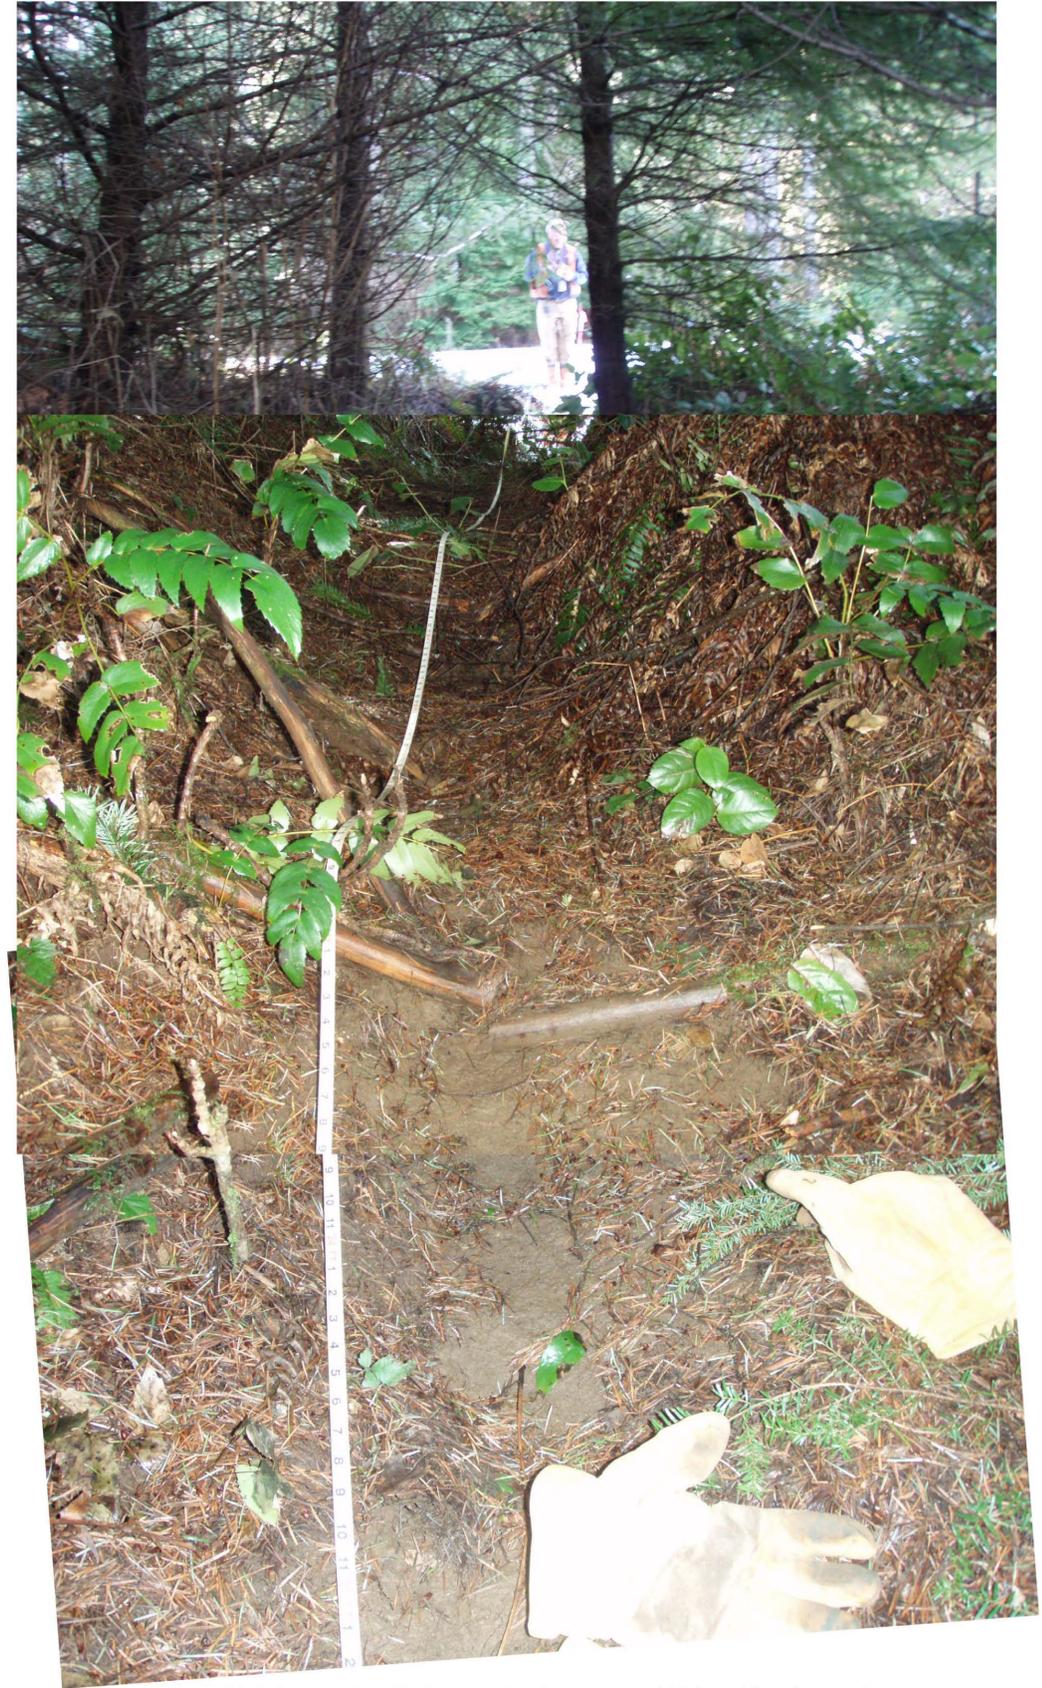
Discharge point of ditch from road to N. Slide 1 deposit below. View NE. →

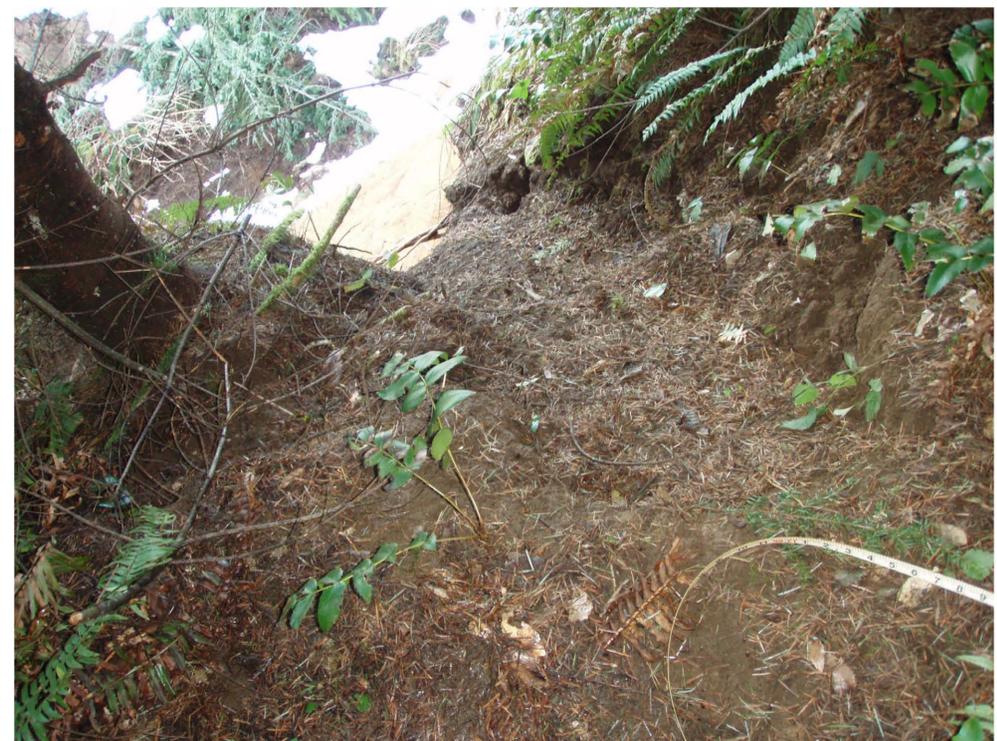
Ditch from road to discharge point above scarp of Slide 1. View S to road. Note organic debris in channel and lack of scouring.

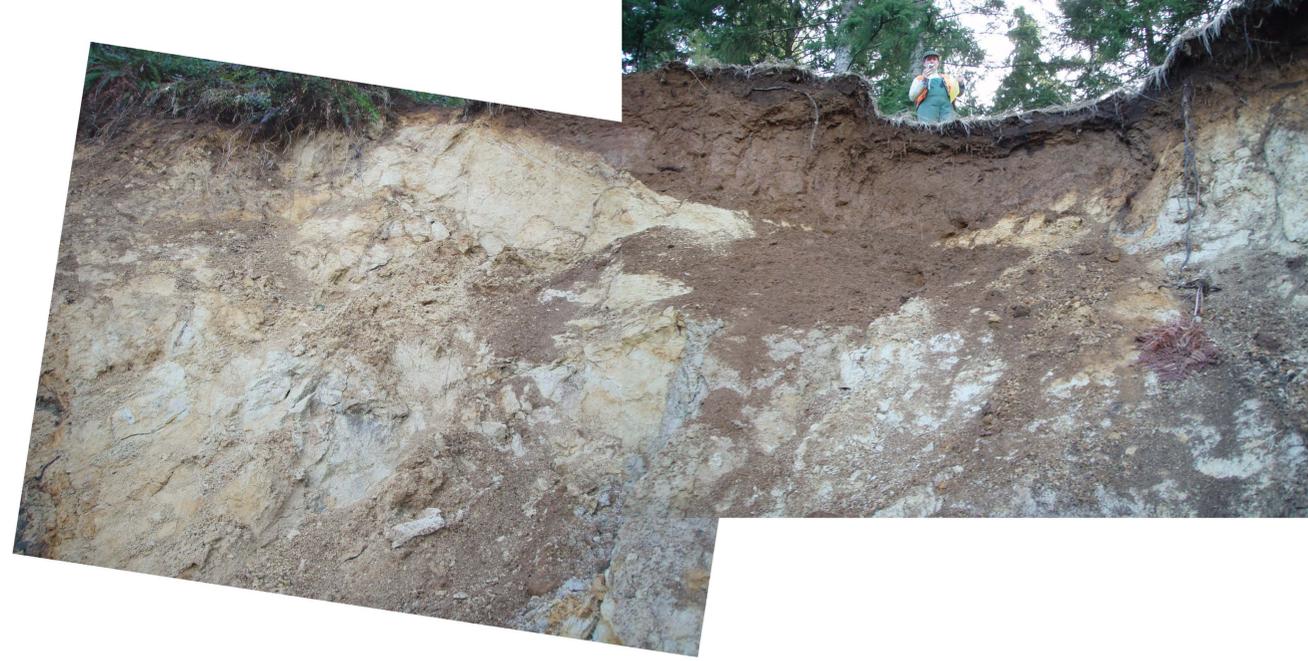
View SE to S at point "B". Darker brown transported soil over in-place completely decomposed sandstone (remolds to sand w/silt (SW).

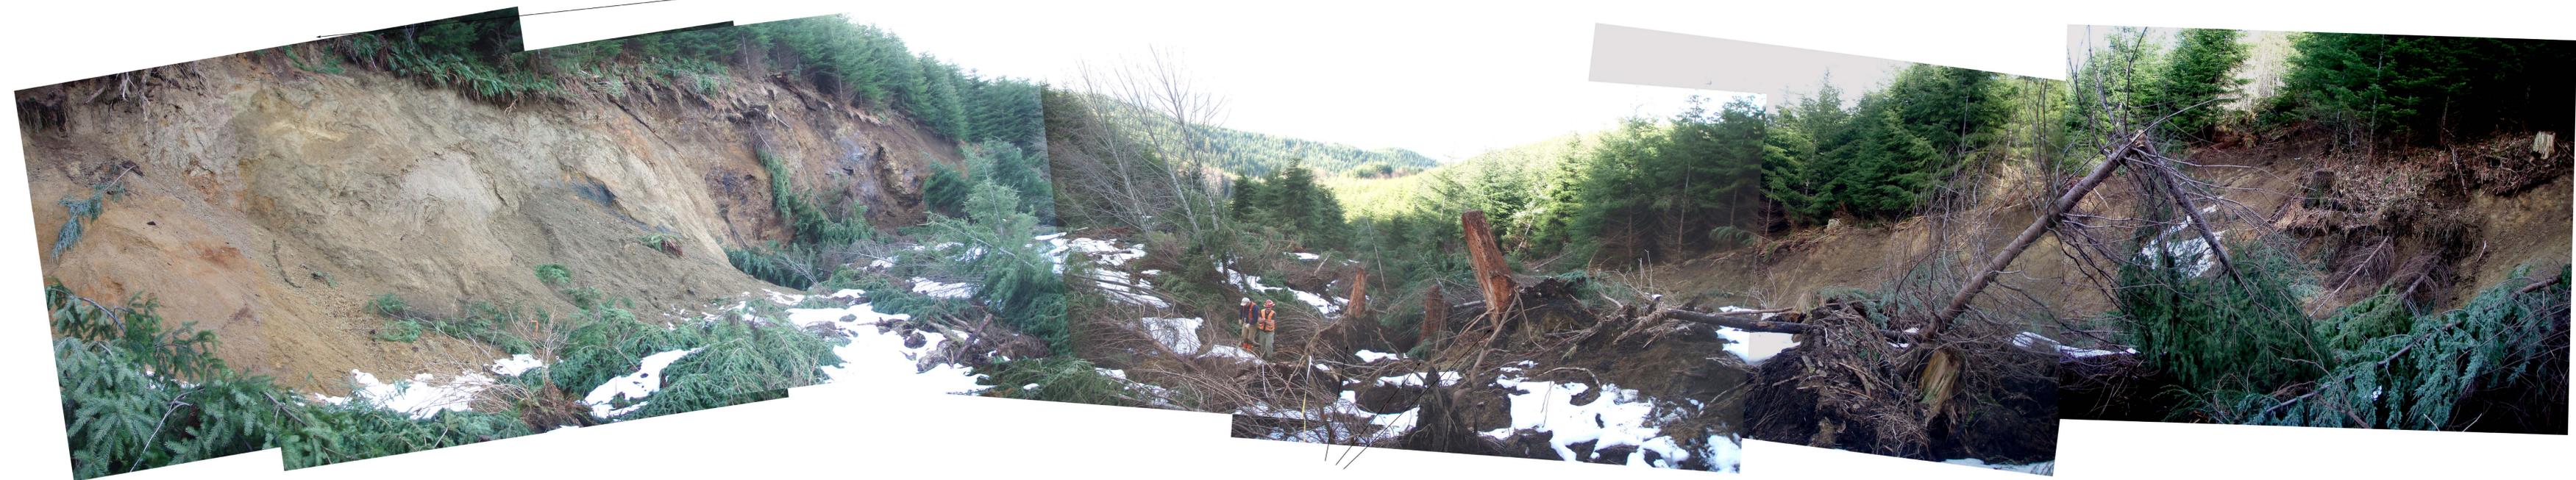
Single stump has been torn into three pieces by movement.

View of Slide 1 from near Point "B" on Figure 5. SW on Left and NE on right. Note back-rotated trees in central portion of photo. Cliff on left is between 40 and 60 feet high and exposes completely decomposed to stained-state sedimentary rock. Scarp on right ranges from 15 to 25 feet high and expose completely decomposed rock.

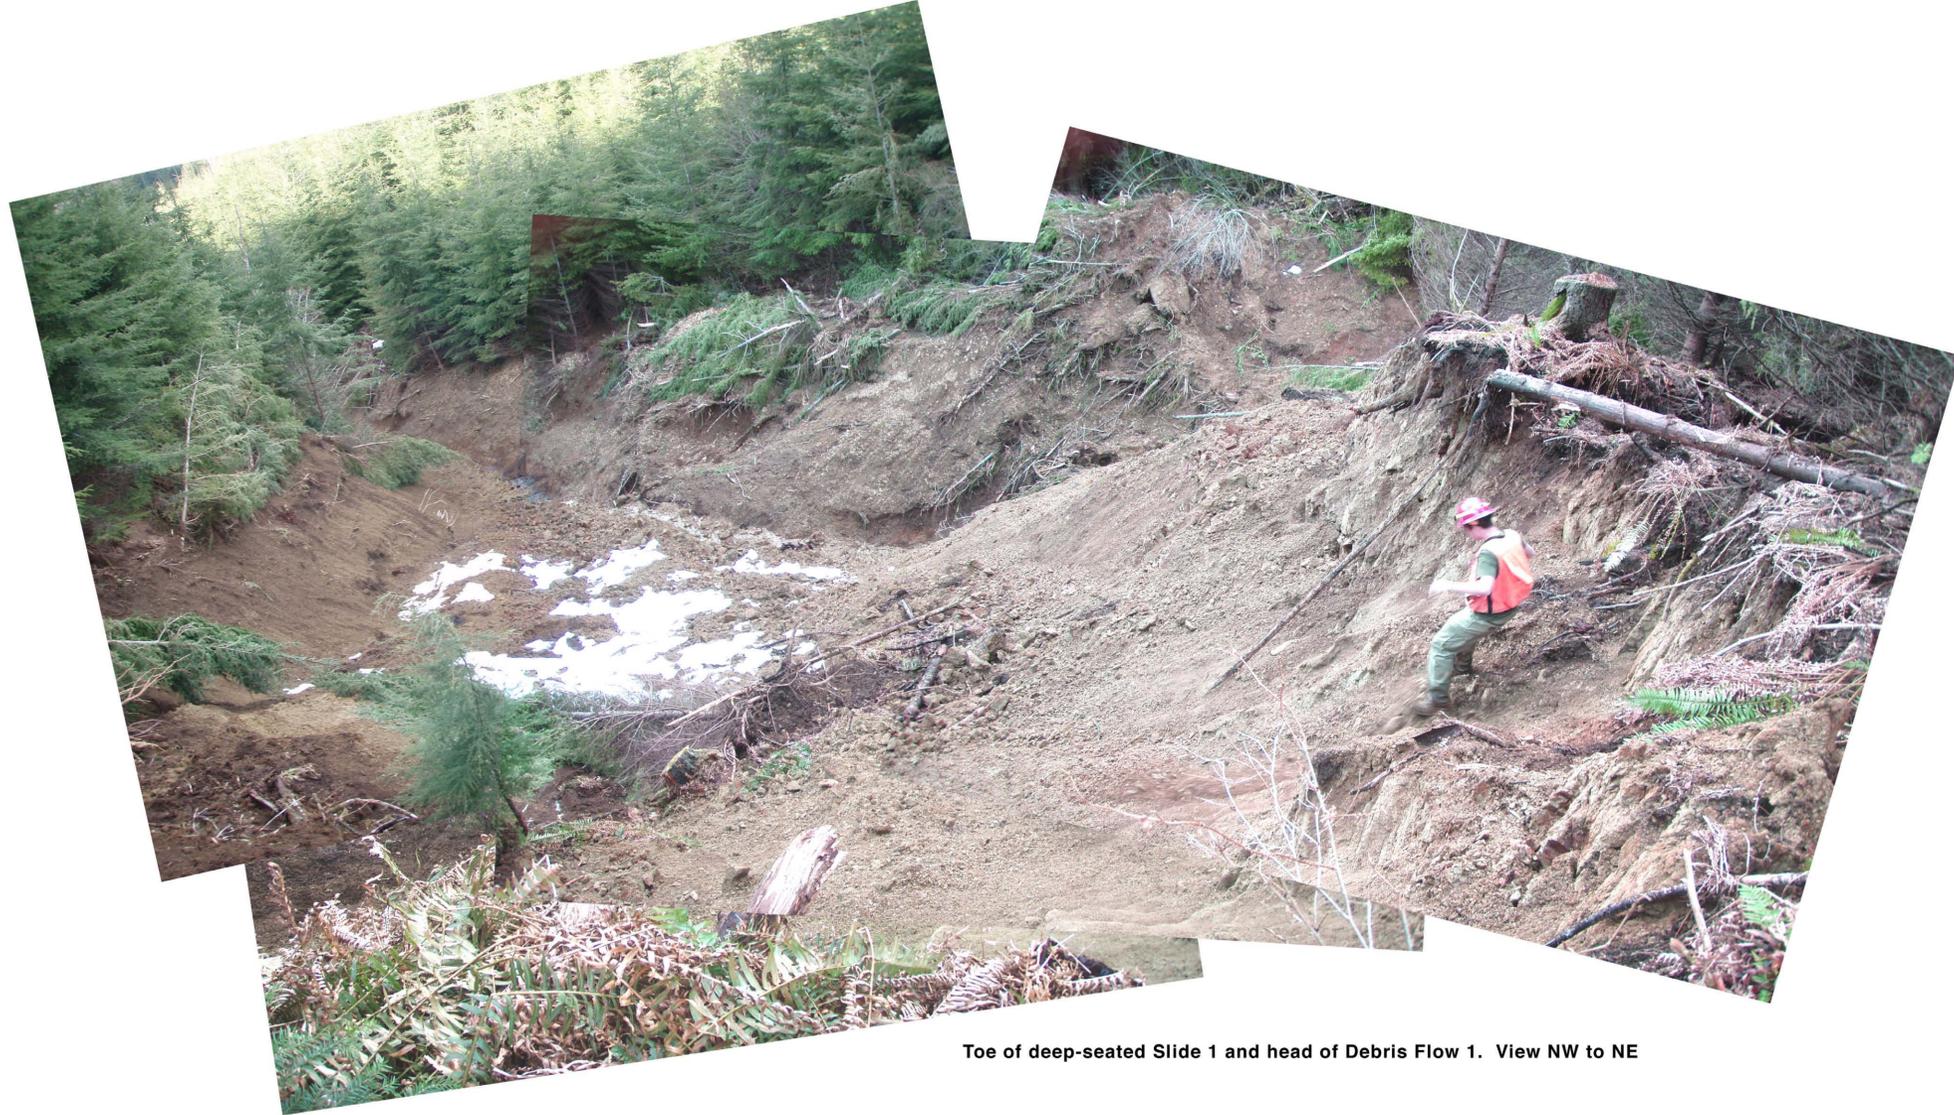
Toe of deep-seated Slide 1 and head of Debris Flow 1. View NW to NE

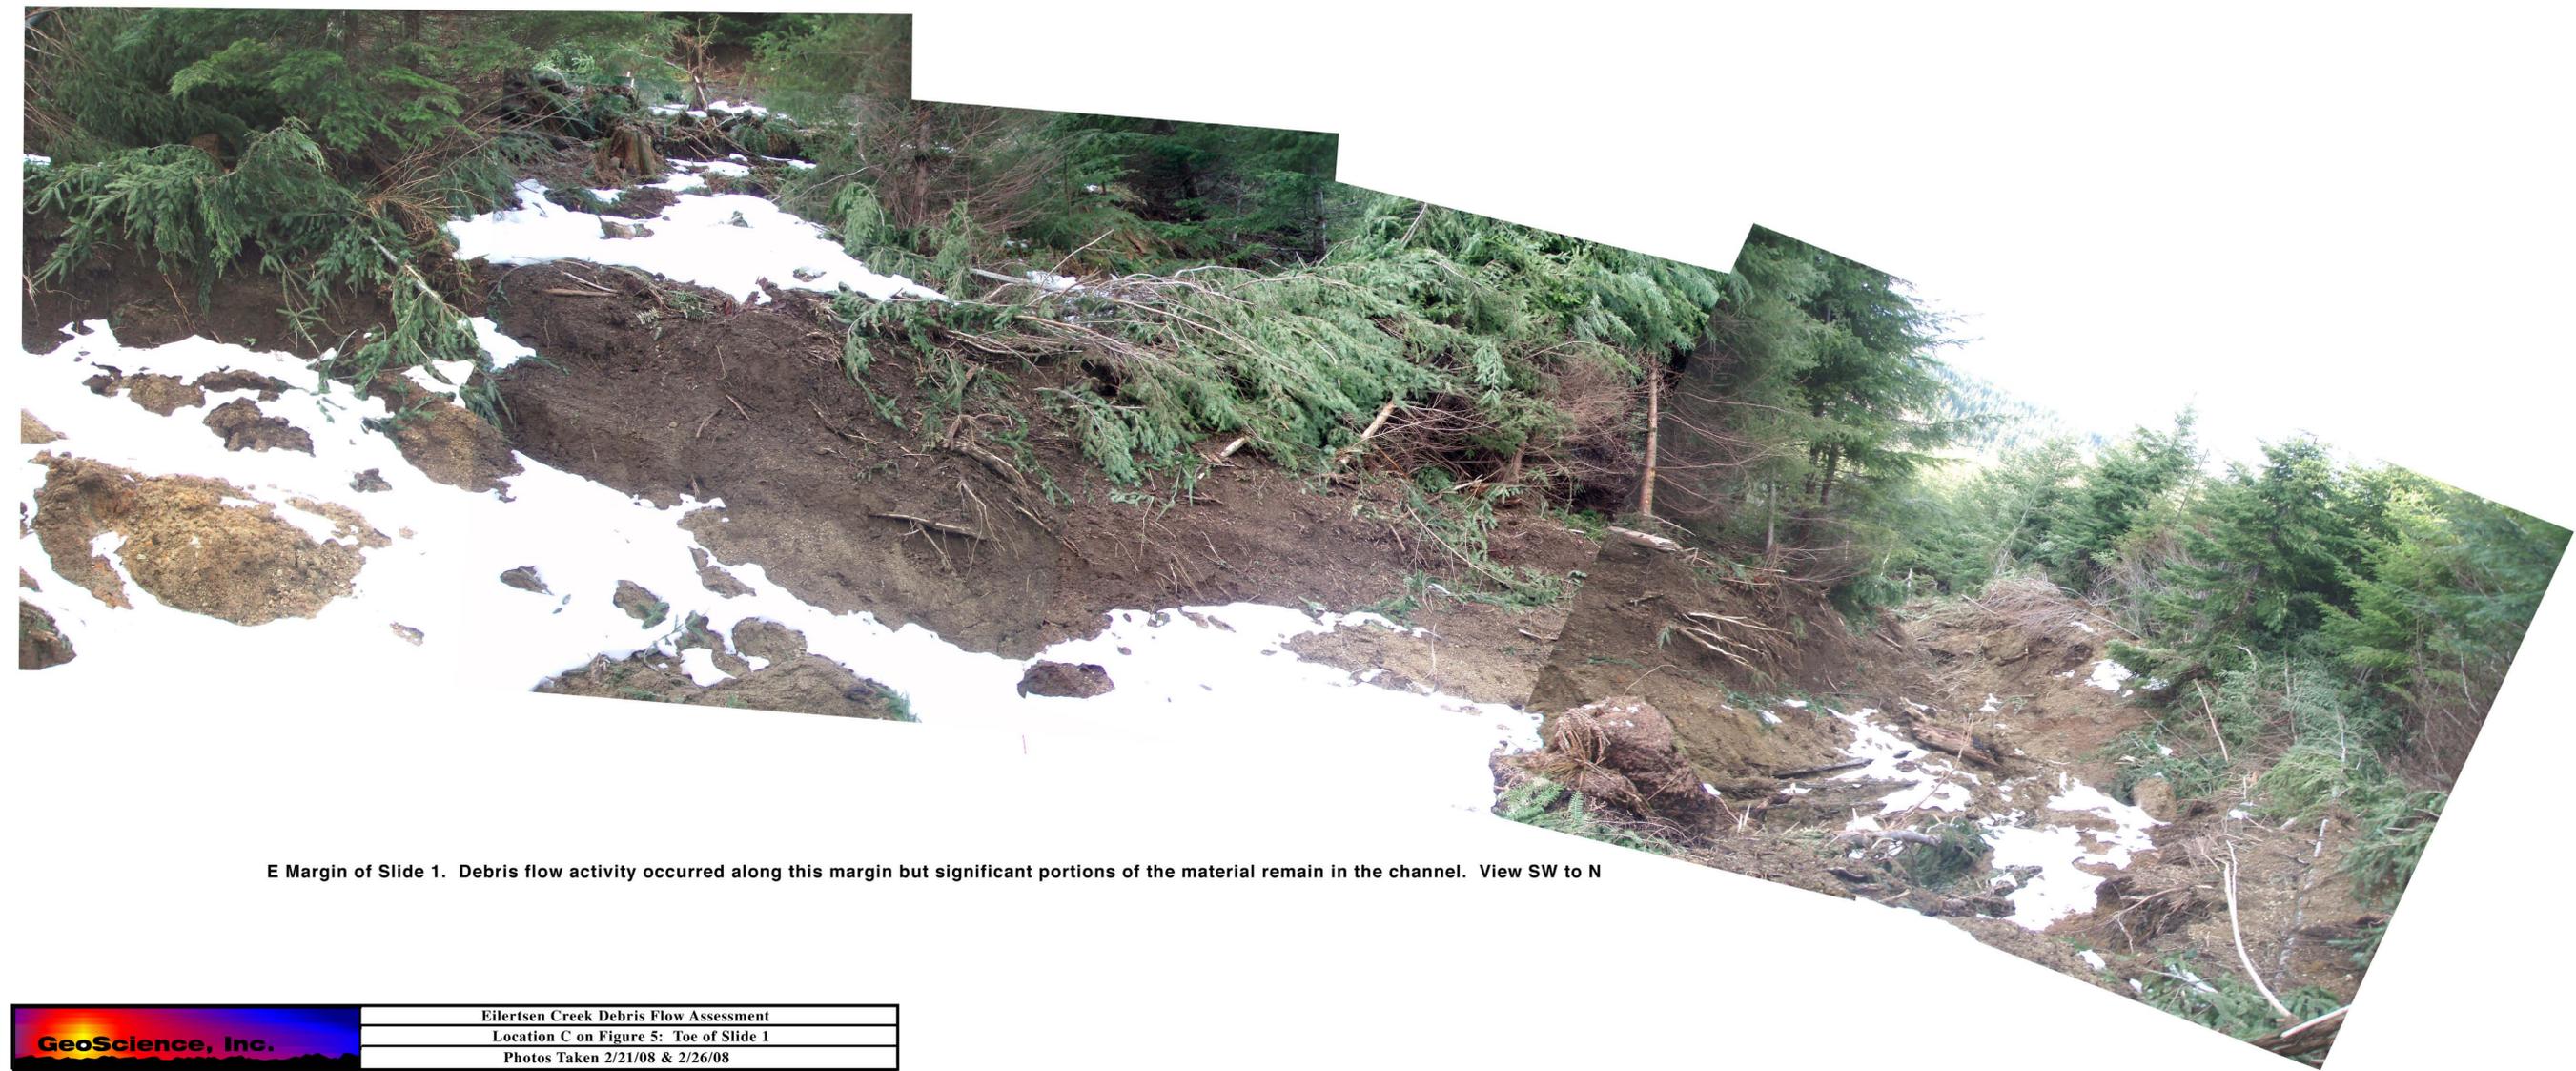
E Margin of Slide 1. Debris flow activity occurred along this margin but significant portions of the material remain in the channel. View SW to N

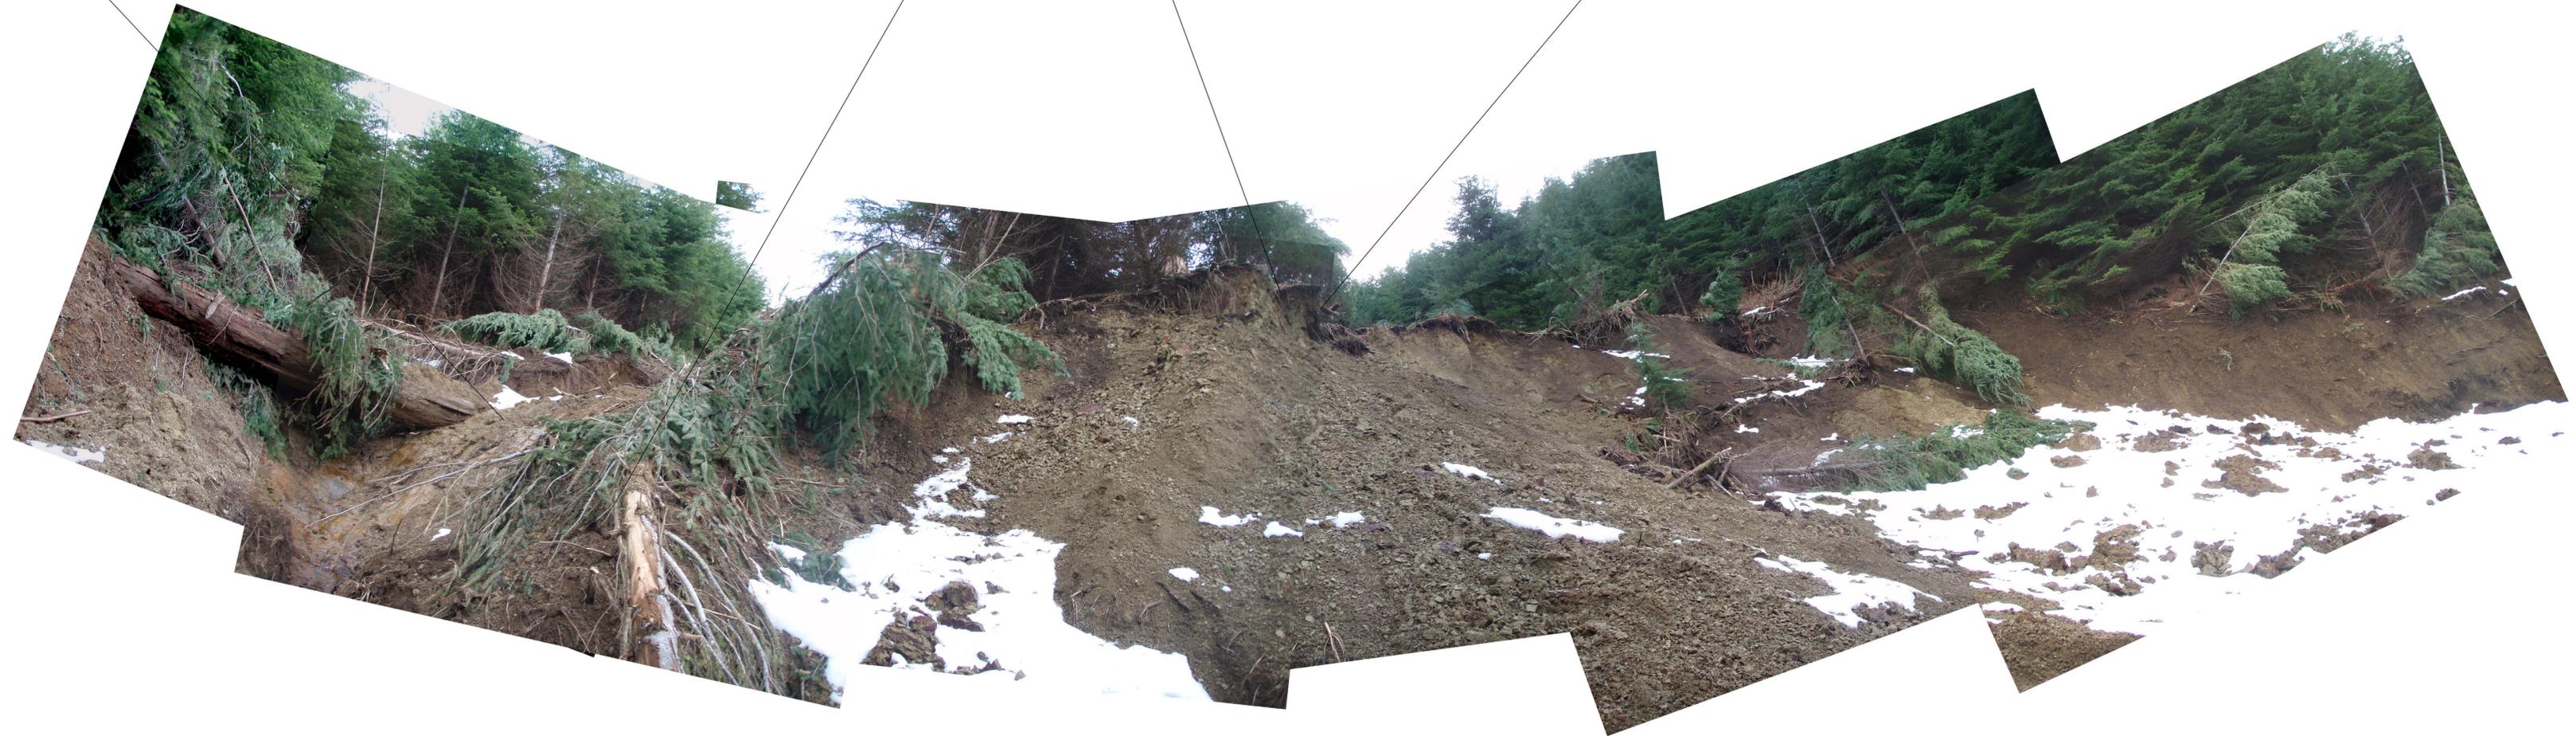
Location E to F: Toe of deep-seated Slide 1 with smaller debris flow at left. Confluence of creeks 1b and 1c. Creek 1c enters picture from far left (log across creek). Toe of Slide 1 in central portion of panorama is covering former channel of creek 1b. Head of larger Debris Flow 1 scour area on right. View SE (left) to W (right)

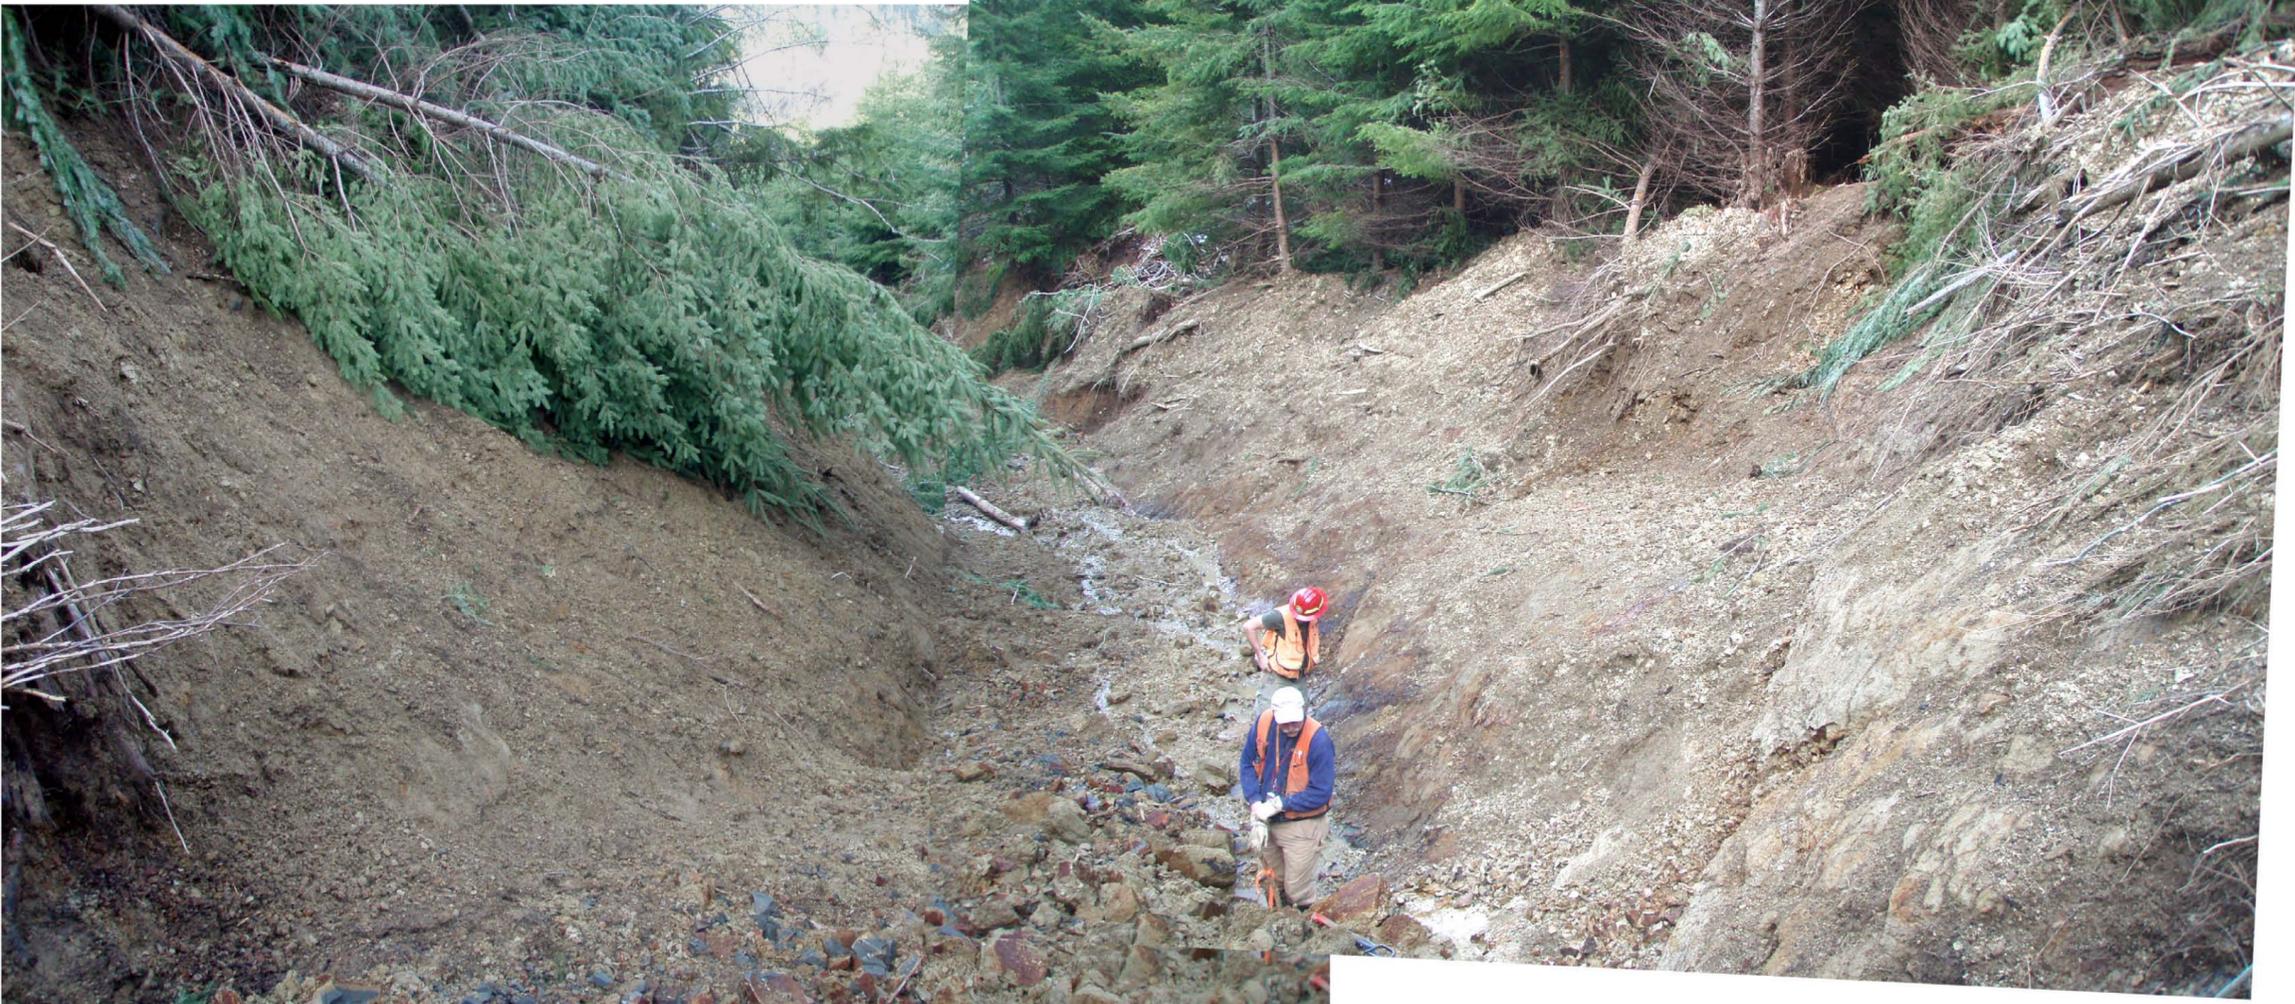
Head of Debris Flow 1, at Location "F" on Figure 5. View NW. Note partly decomposed rock rubble lag. Depth of flow on right bank is 17 feet.

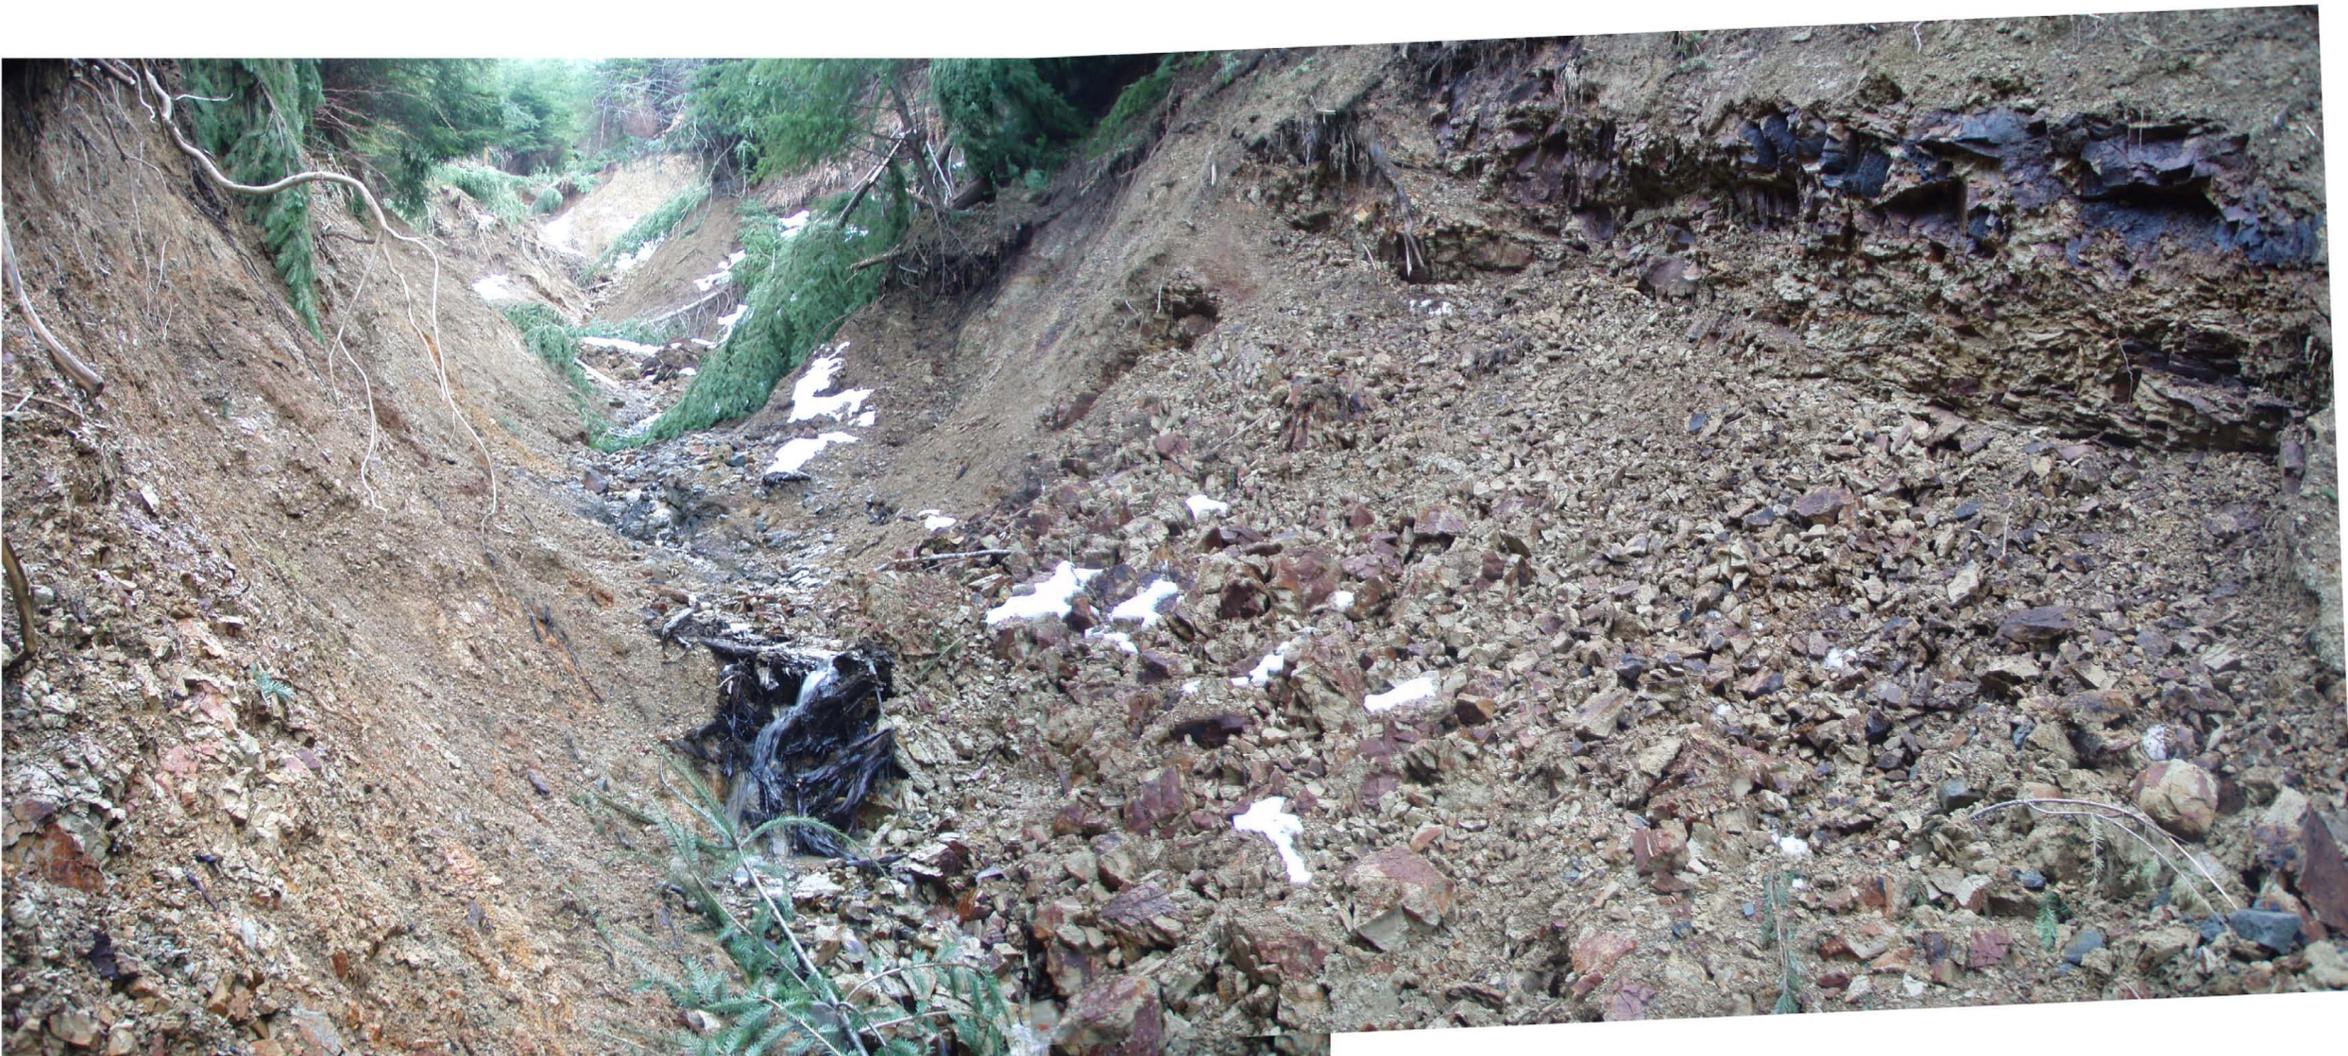
Upper reach of Debris Flow 1 near location "G" on Figure 5. View SE. Toe of Slide 1 is visible in background. Note scoured, in-place rock along channel sides.

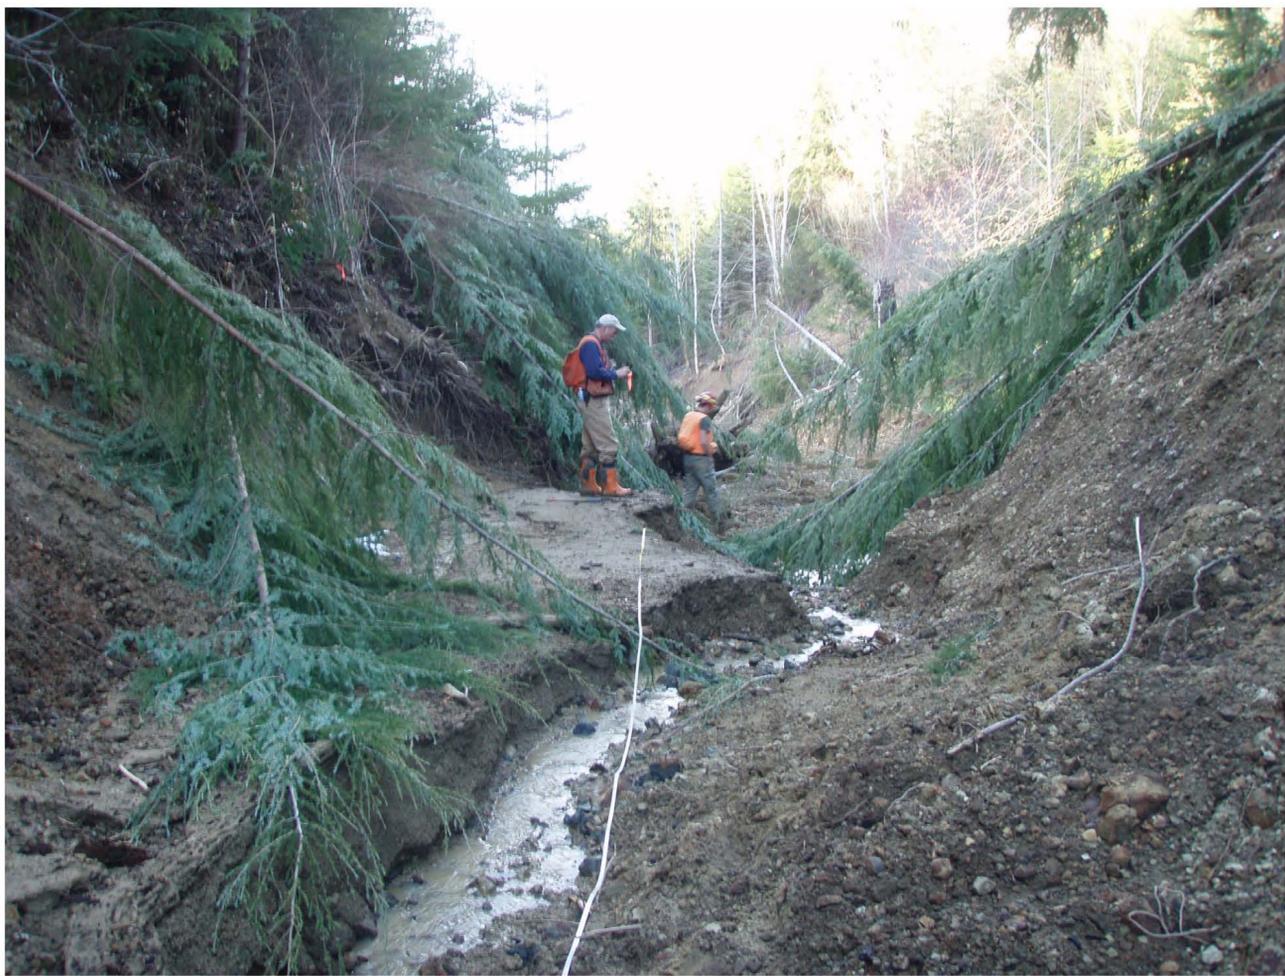
Delta deposit formed where creek 1 entered pond impounded by railroad embankment. View NW. Railroad fill failure visible above red hard hat.

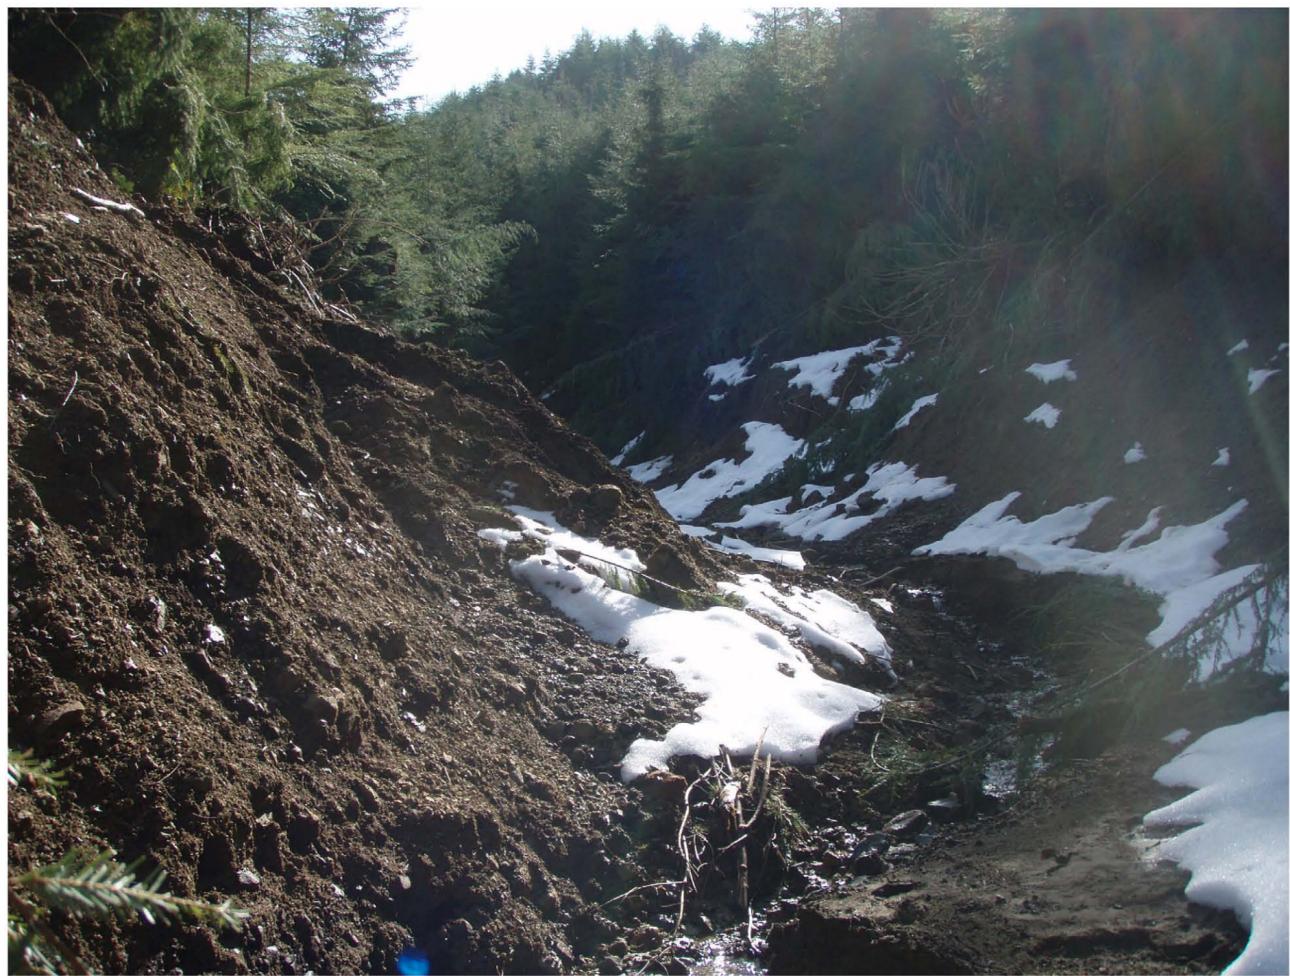
Delta deposit in creek 1, view upstream. Deposit located at right. Elevation of deposit indicates high water level of pond.

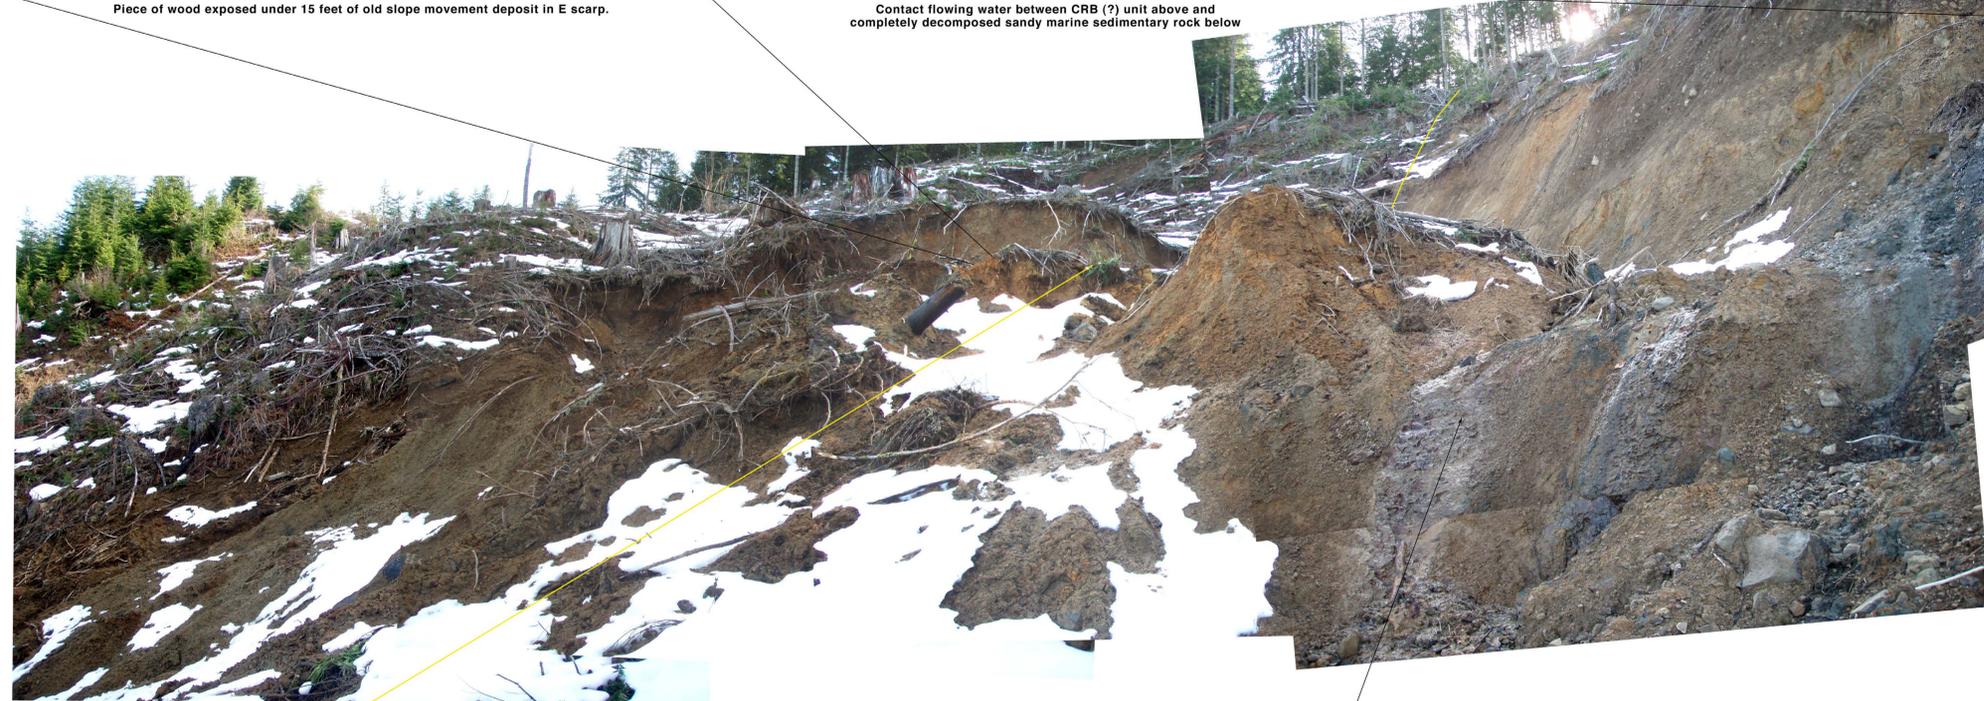
View of Slide 2 from NW. NNE is to left and SW is to right. Note in-place rock (siltstone?) in bench in right foreground. Deep-seated rotational sliding slope movement spills over this bench and turns into viscous flow type failure. Section B - C indicated in yellow.

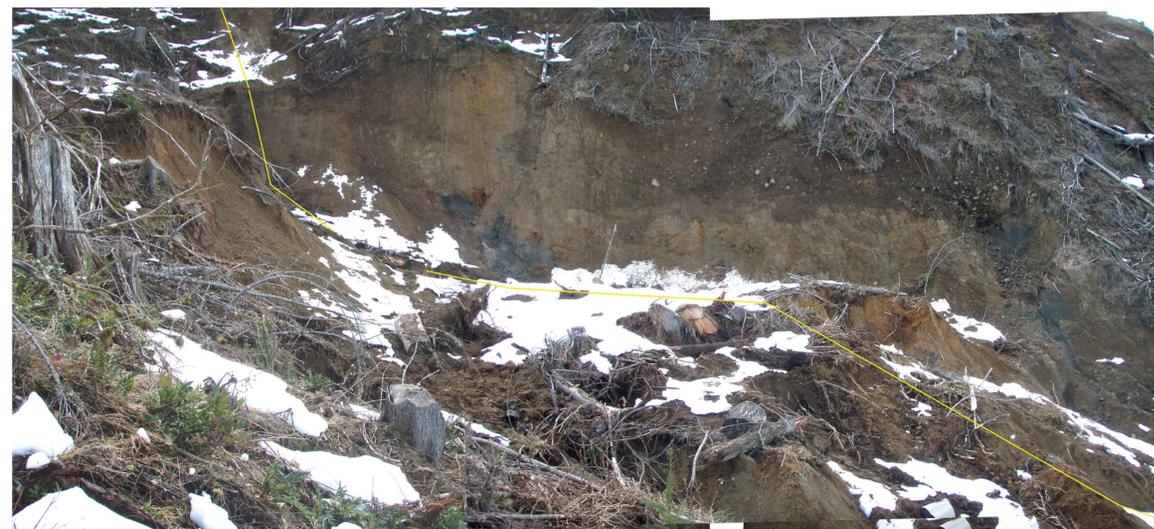
View of Slide 2 from NE. S is on left and NW is to right. Approximate section line indicated in yellow. Siltstone bench is located near center of section at break in slope. Note lobate form of viscous flow movement in right portion.
