**DEBRIS FLOW ASSESSMENT
EILERTSEN CREEK/WOODSON
December 2007 Storm
T 7N, R 5W, Sections 5, 8, & 17**

April 10, 2008

This report presents the results of a geologic/geotechnical assessment of the causes and slope movement mechanisms that led to the railroad fill failure which occurred on the morning of December 11, 2007 in the Eilertsen Creek drainage (T 7N, R 5W, Sections 5, 8, and 17, Figure 1). The failure sent a debris flow through the hamlet of Woodson, across Highway 30, and into Westport Slough, destroying several residential structures and covering the highway with mud and large woody debris. Due to warning of the impending failure by ODF personnel prior to the event, the effects were limited to property damage. This report was completed at the request of the Oregon Department of Forestry's Policy Unit. The assessment was completed in its entirety by Gunnar Schlieder, Ph.D., an Oregon Certified Engineering Geologist.

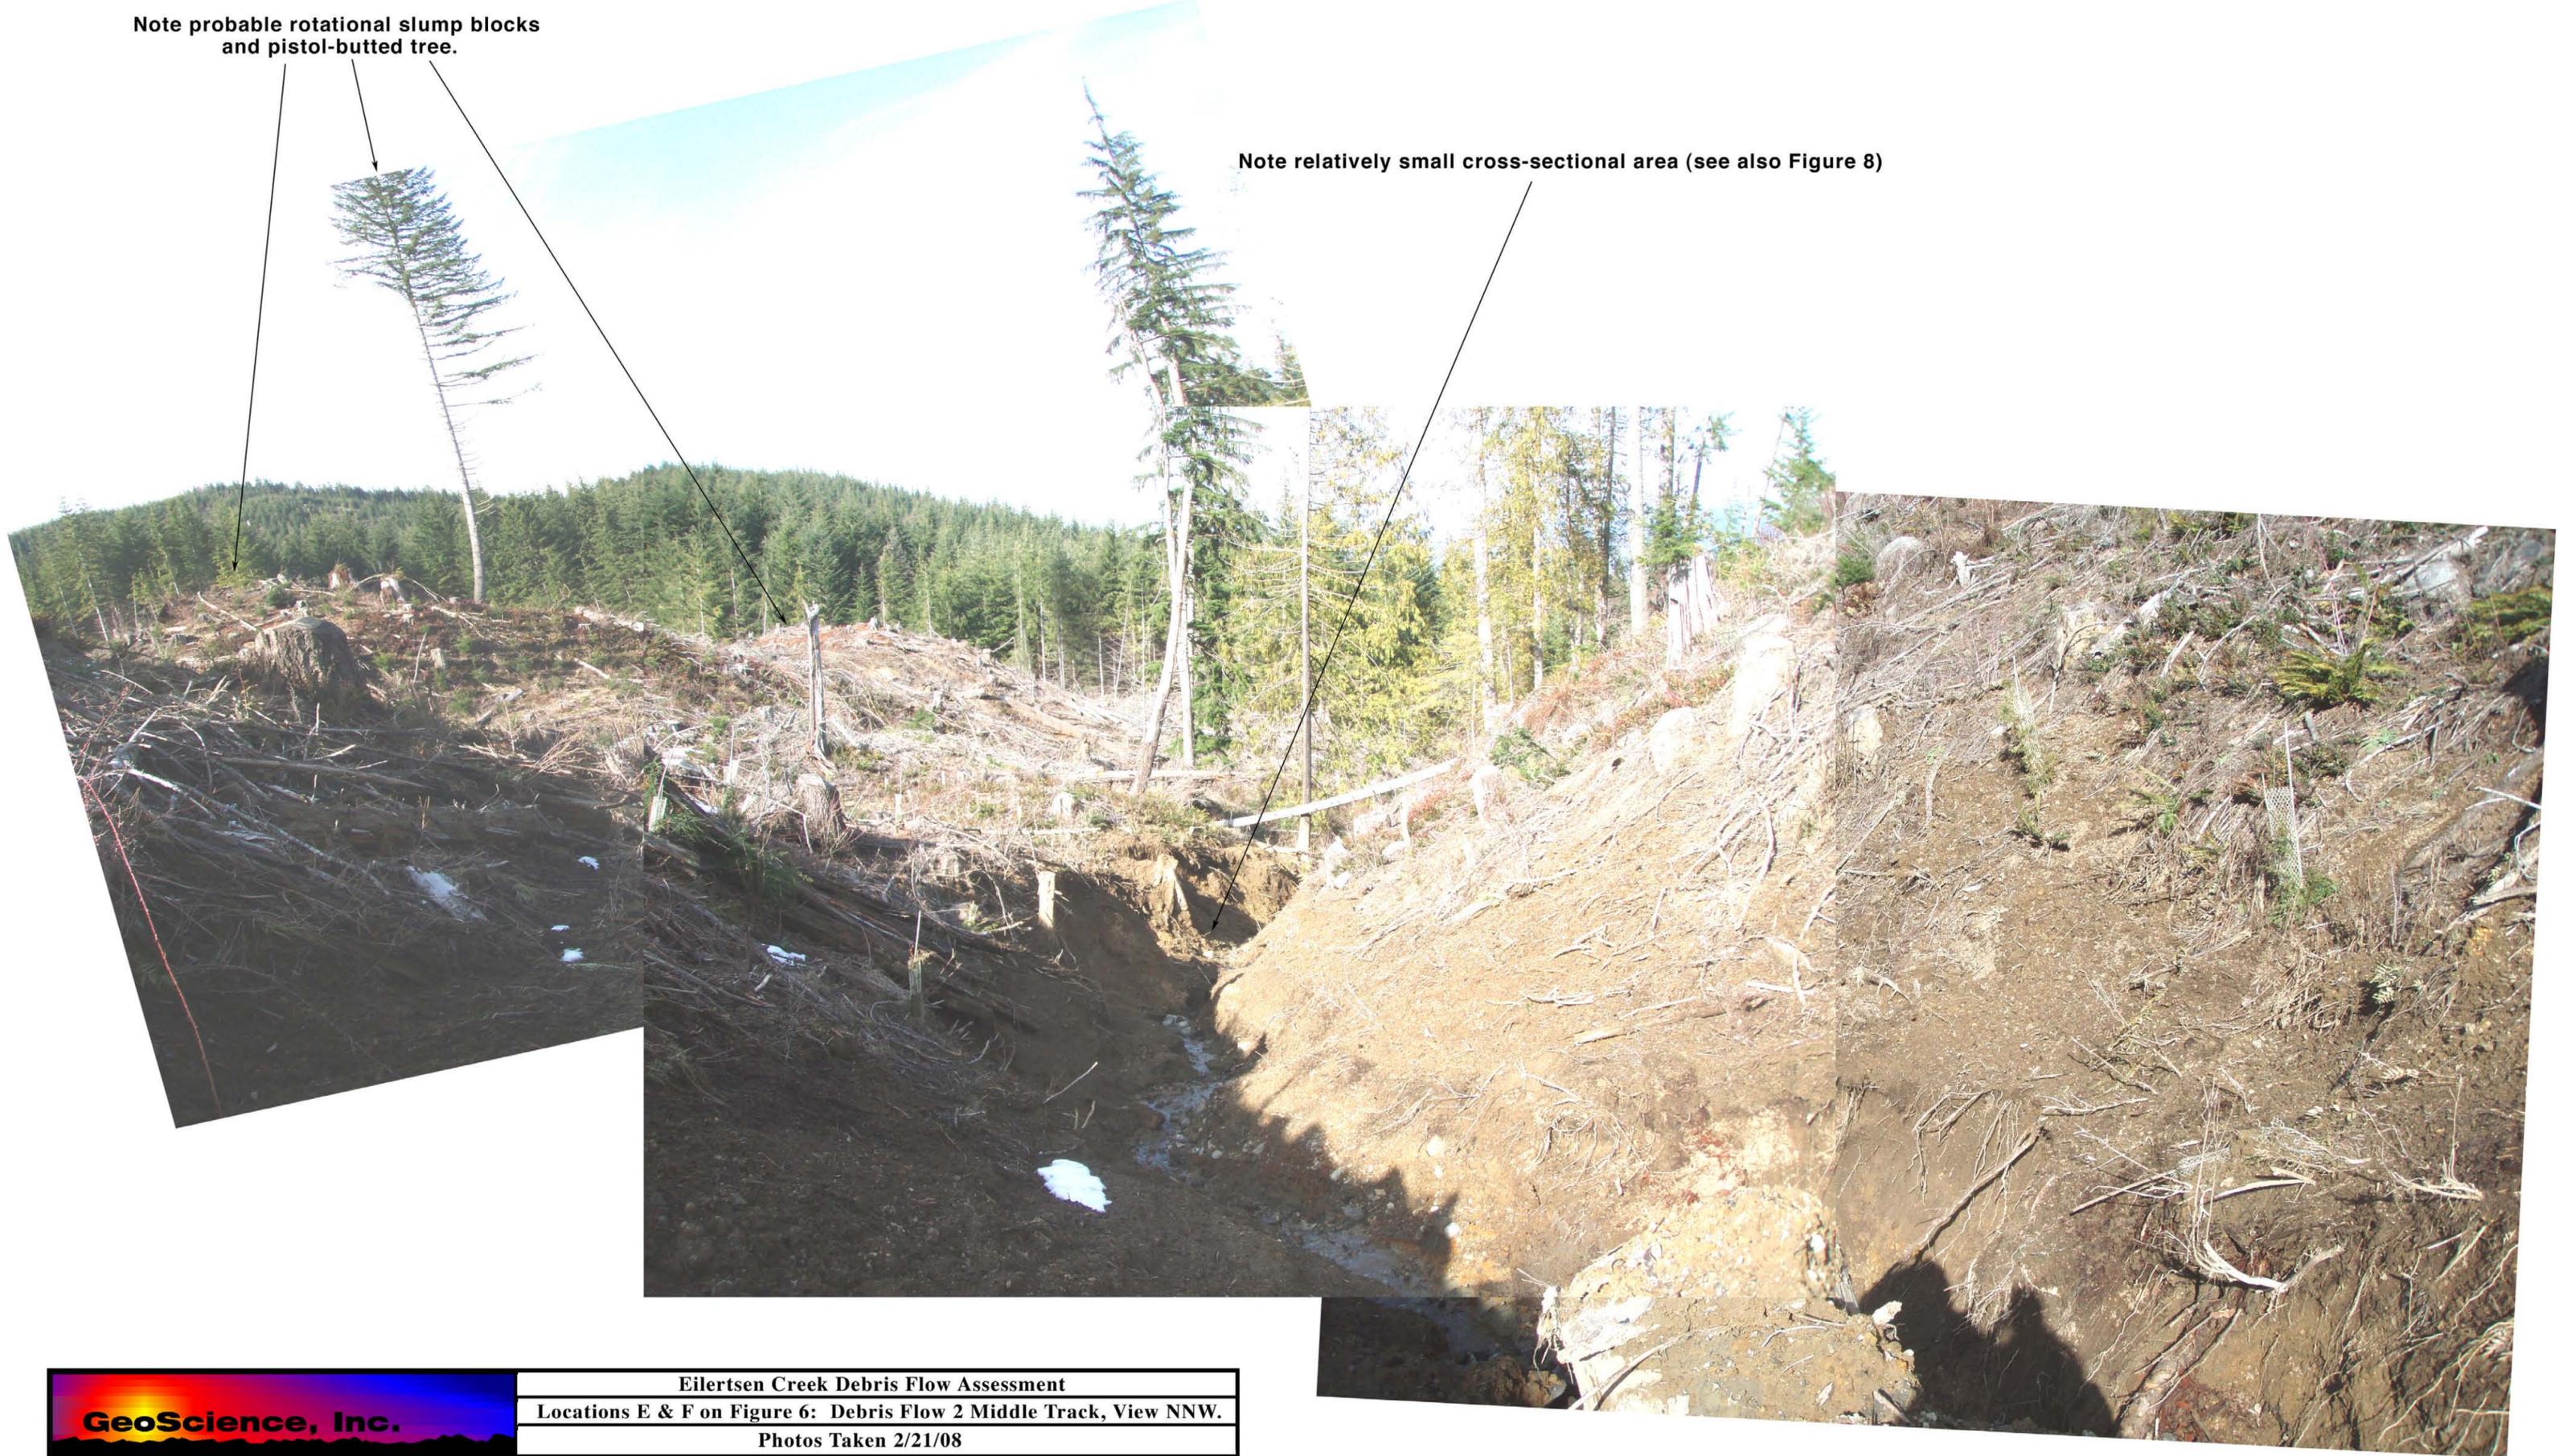
Debris Flow 2 path between "F" and "G" on Figure 6. Note small cross-sectional area.

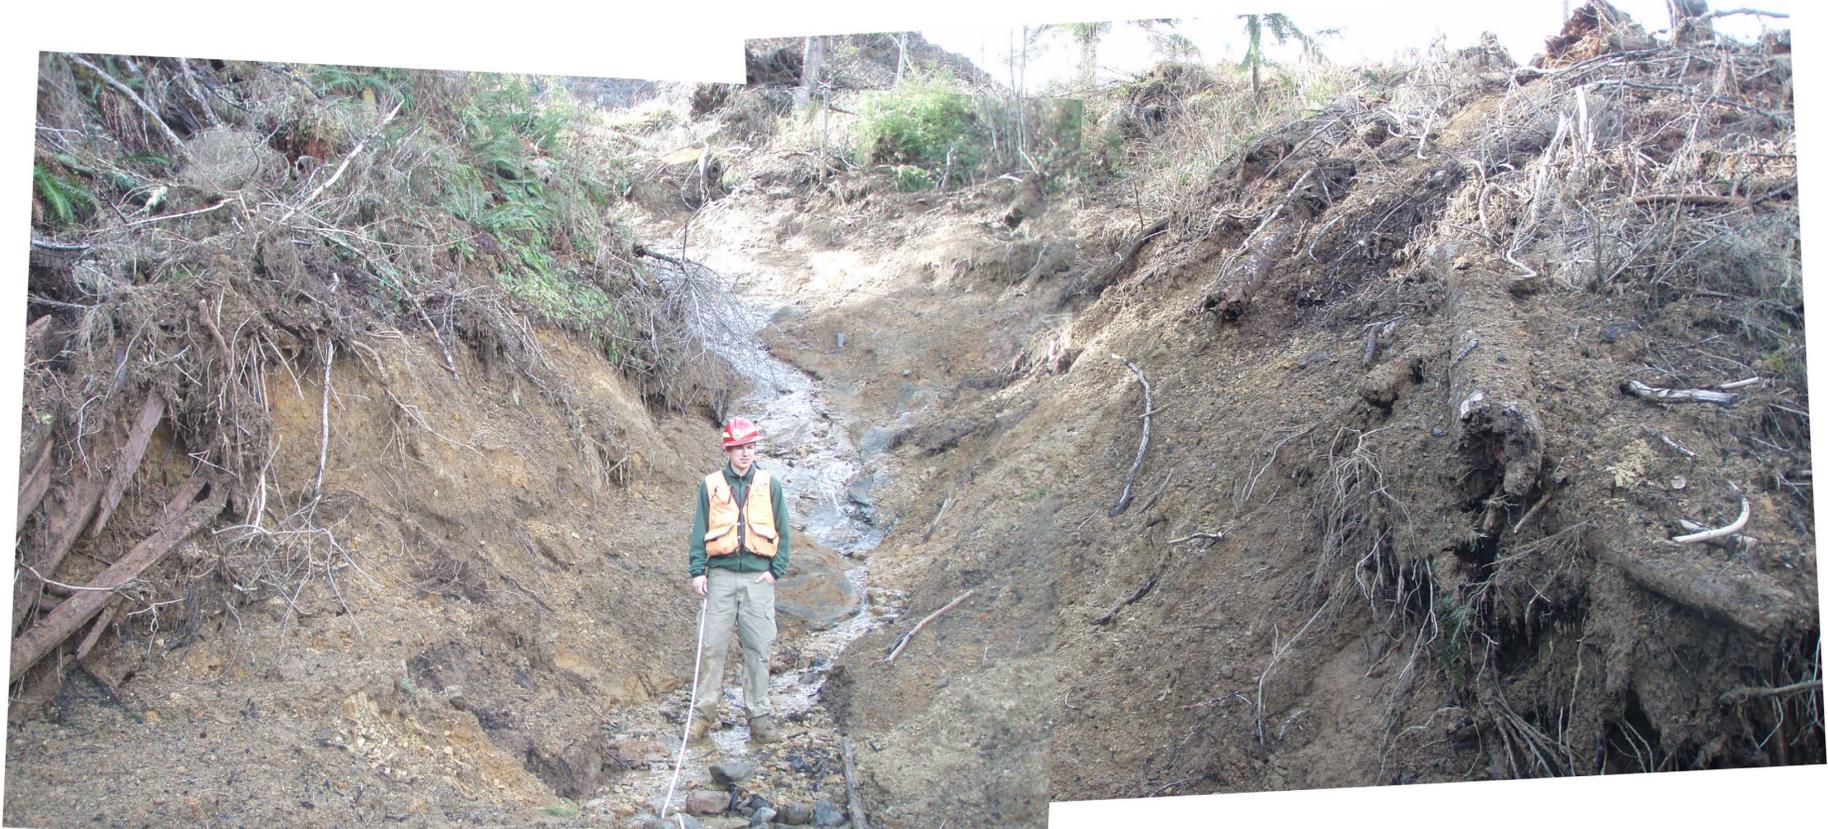
Upstream end of depositional area of Debris Flow 2 (Location "G"). View SSW.

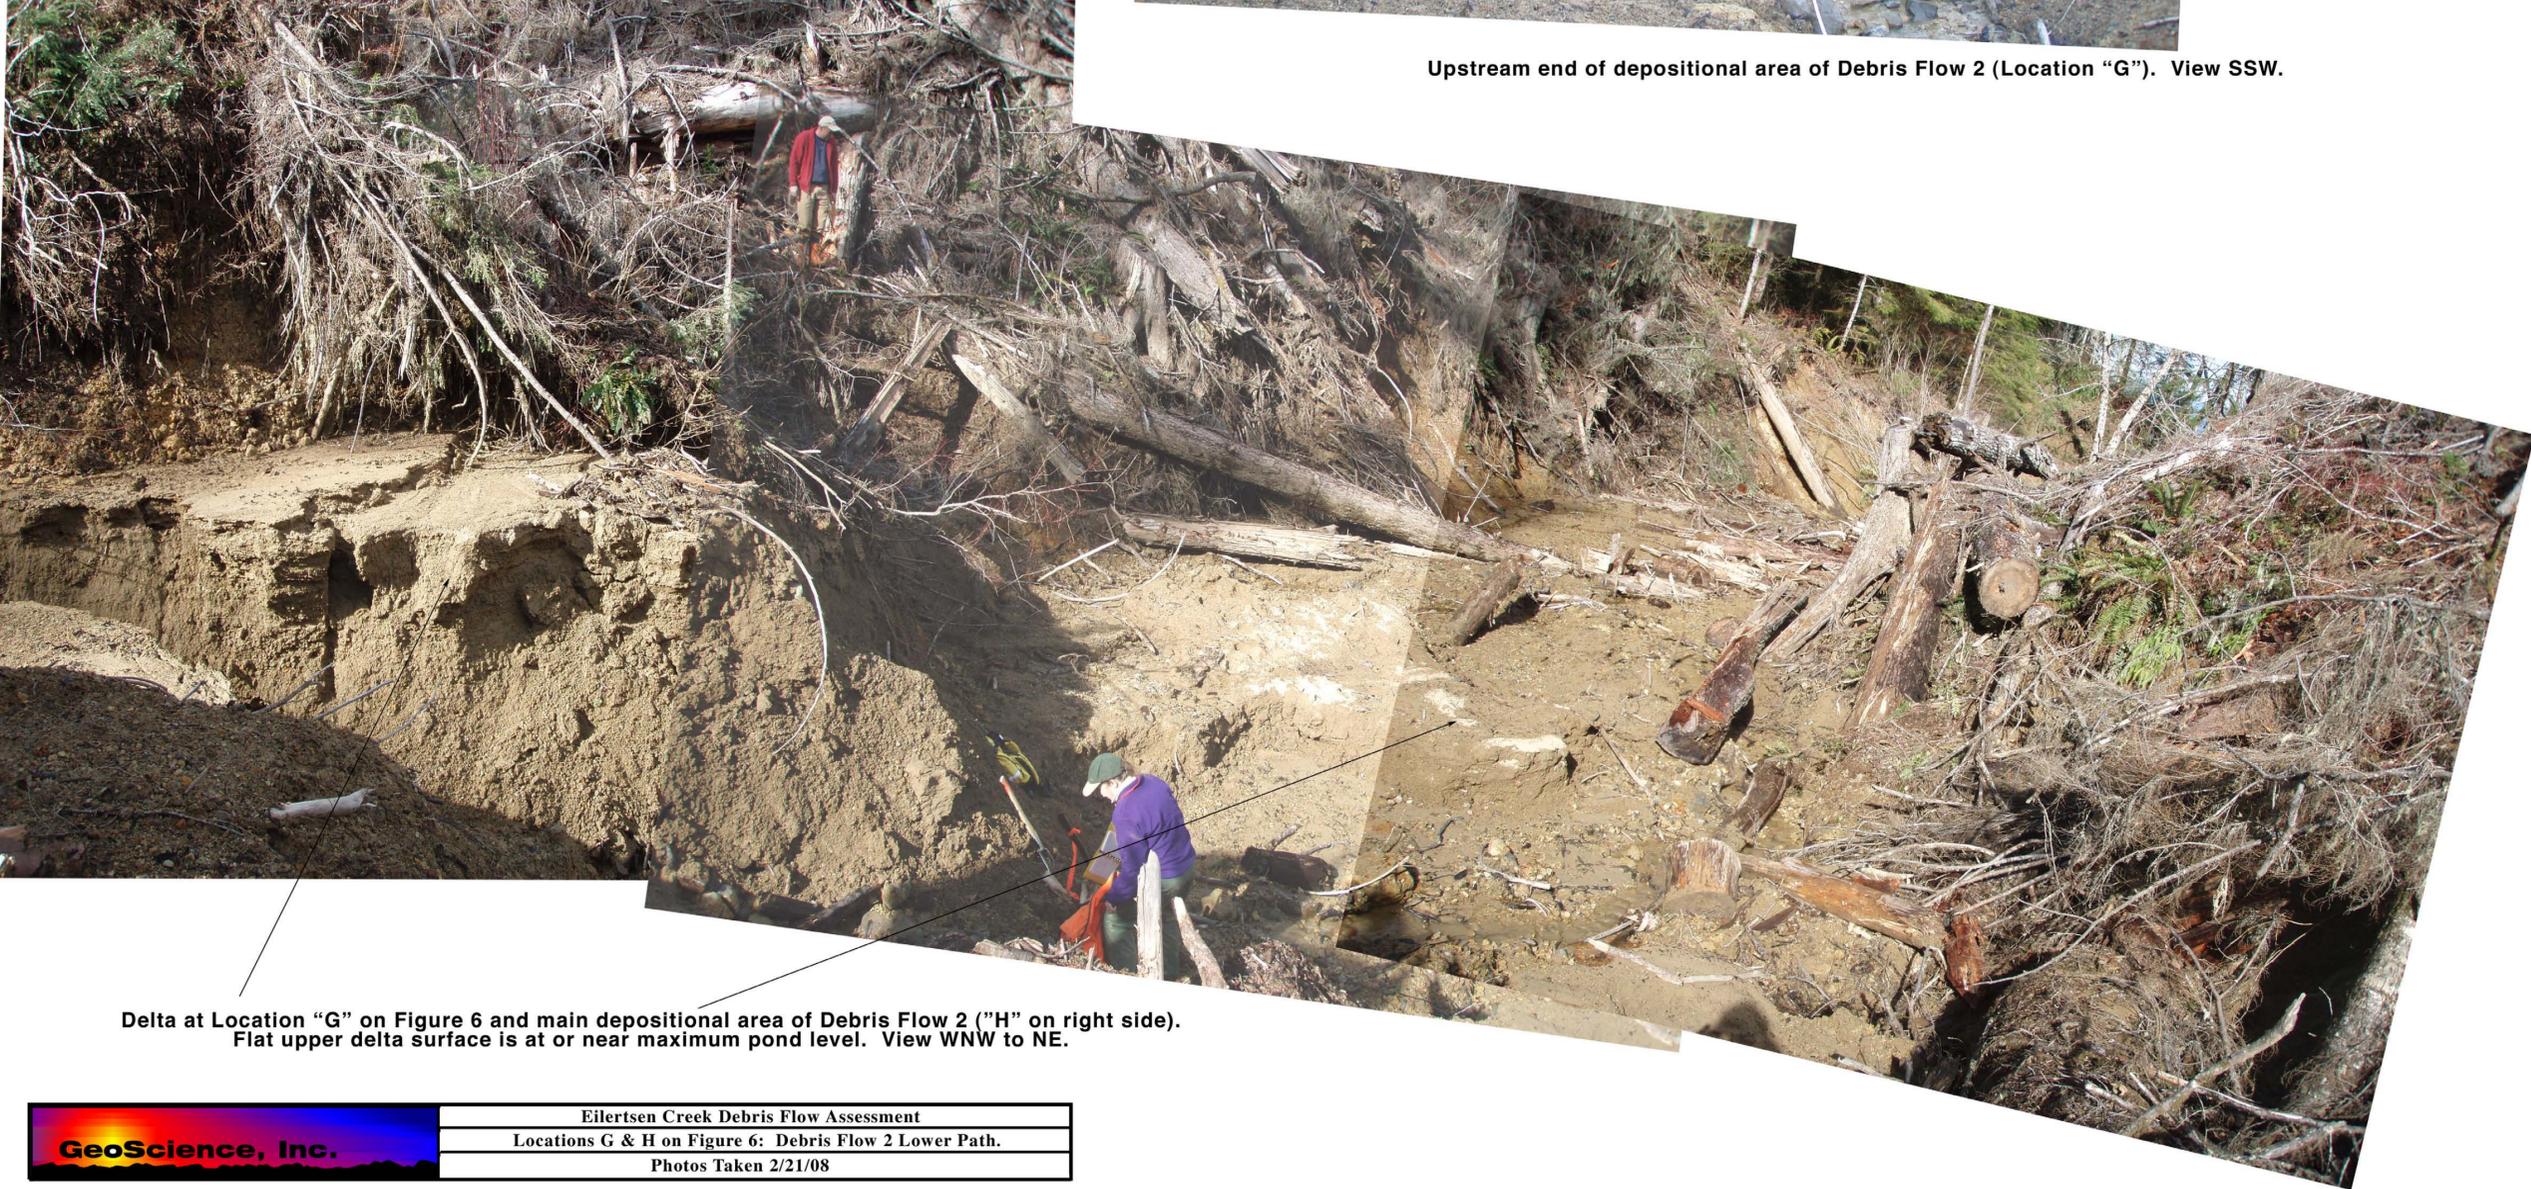
Delta at Location "G" on Figure 6 and main depositional area of Debris Flow 2 ("H" on right side). Flat upper delta surface is at or near maximum pond level. View WNW to NE.

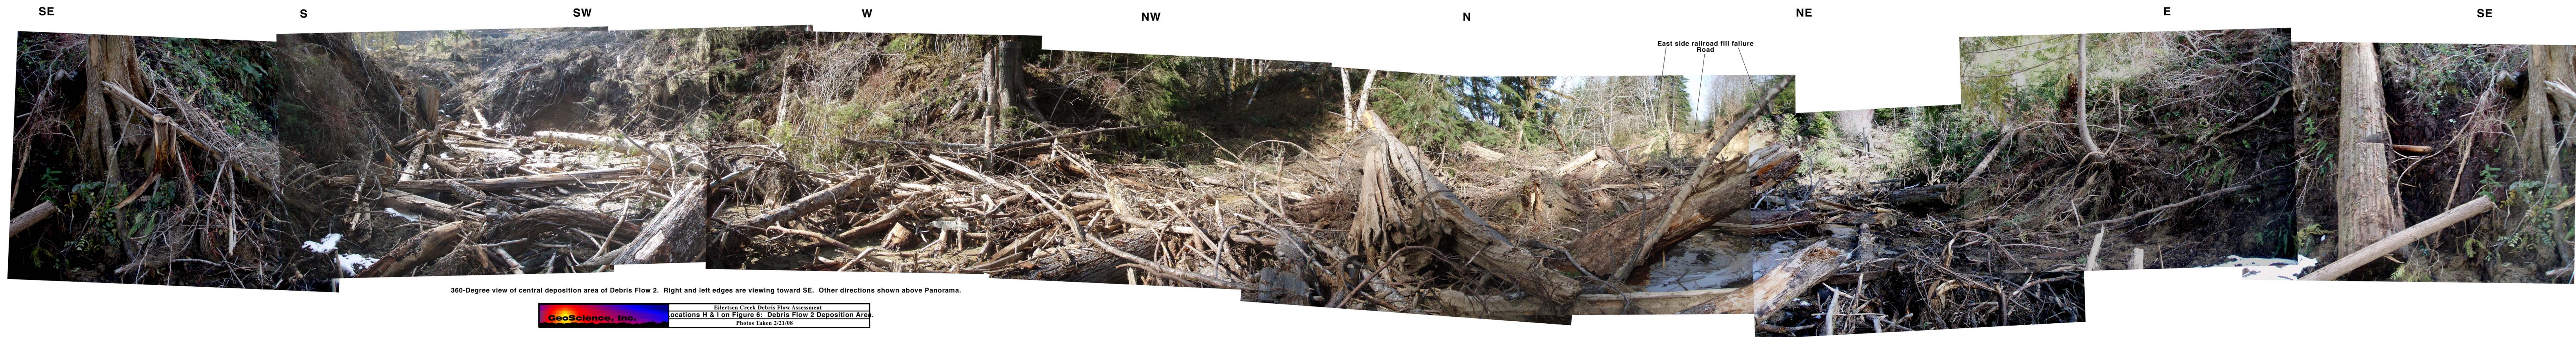
360-Degree view of central deposition area of Debris Flow 2. Right and left edges are viewing toward SE. Other directions shown above Panorama.

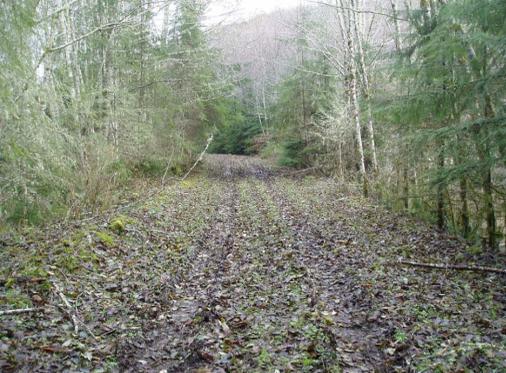
Railroad Fill View E, 12/07/07. Photo Jason Hinkle ODF

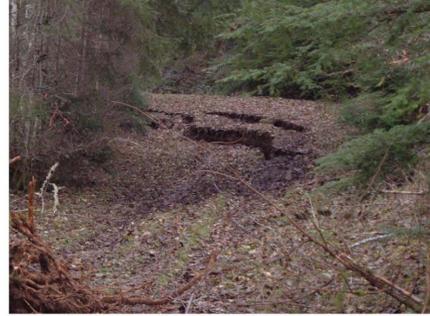
Railroad Fill Shortly Prior to Failure, 12/11/07; Photo Jason Hinkle, ODF

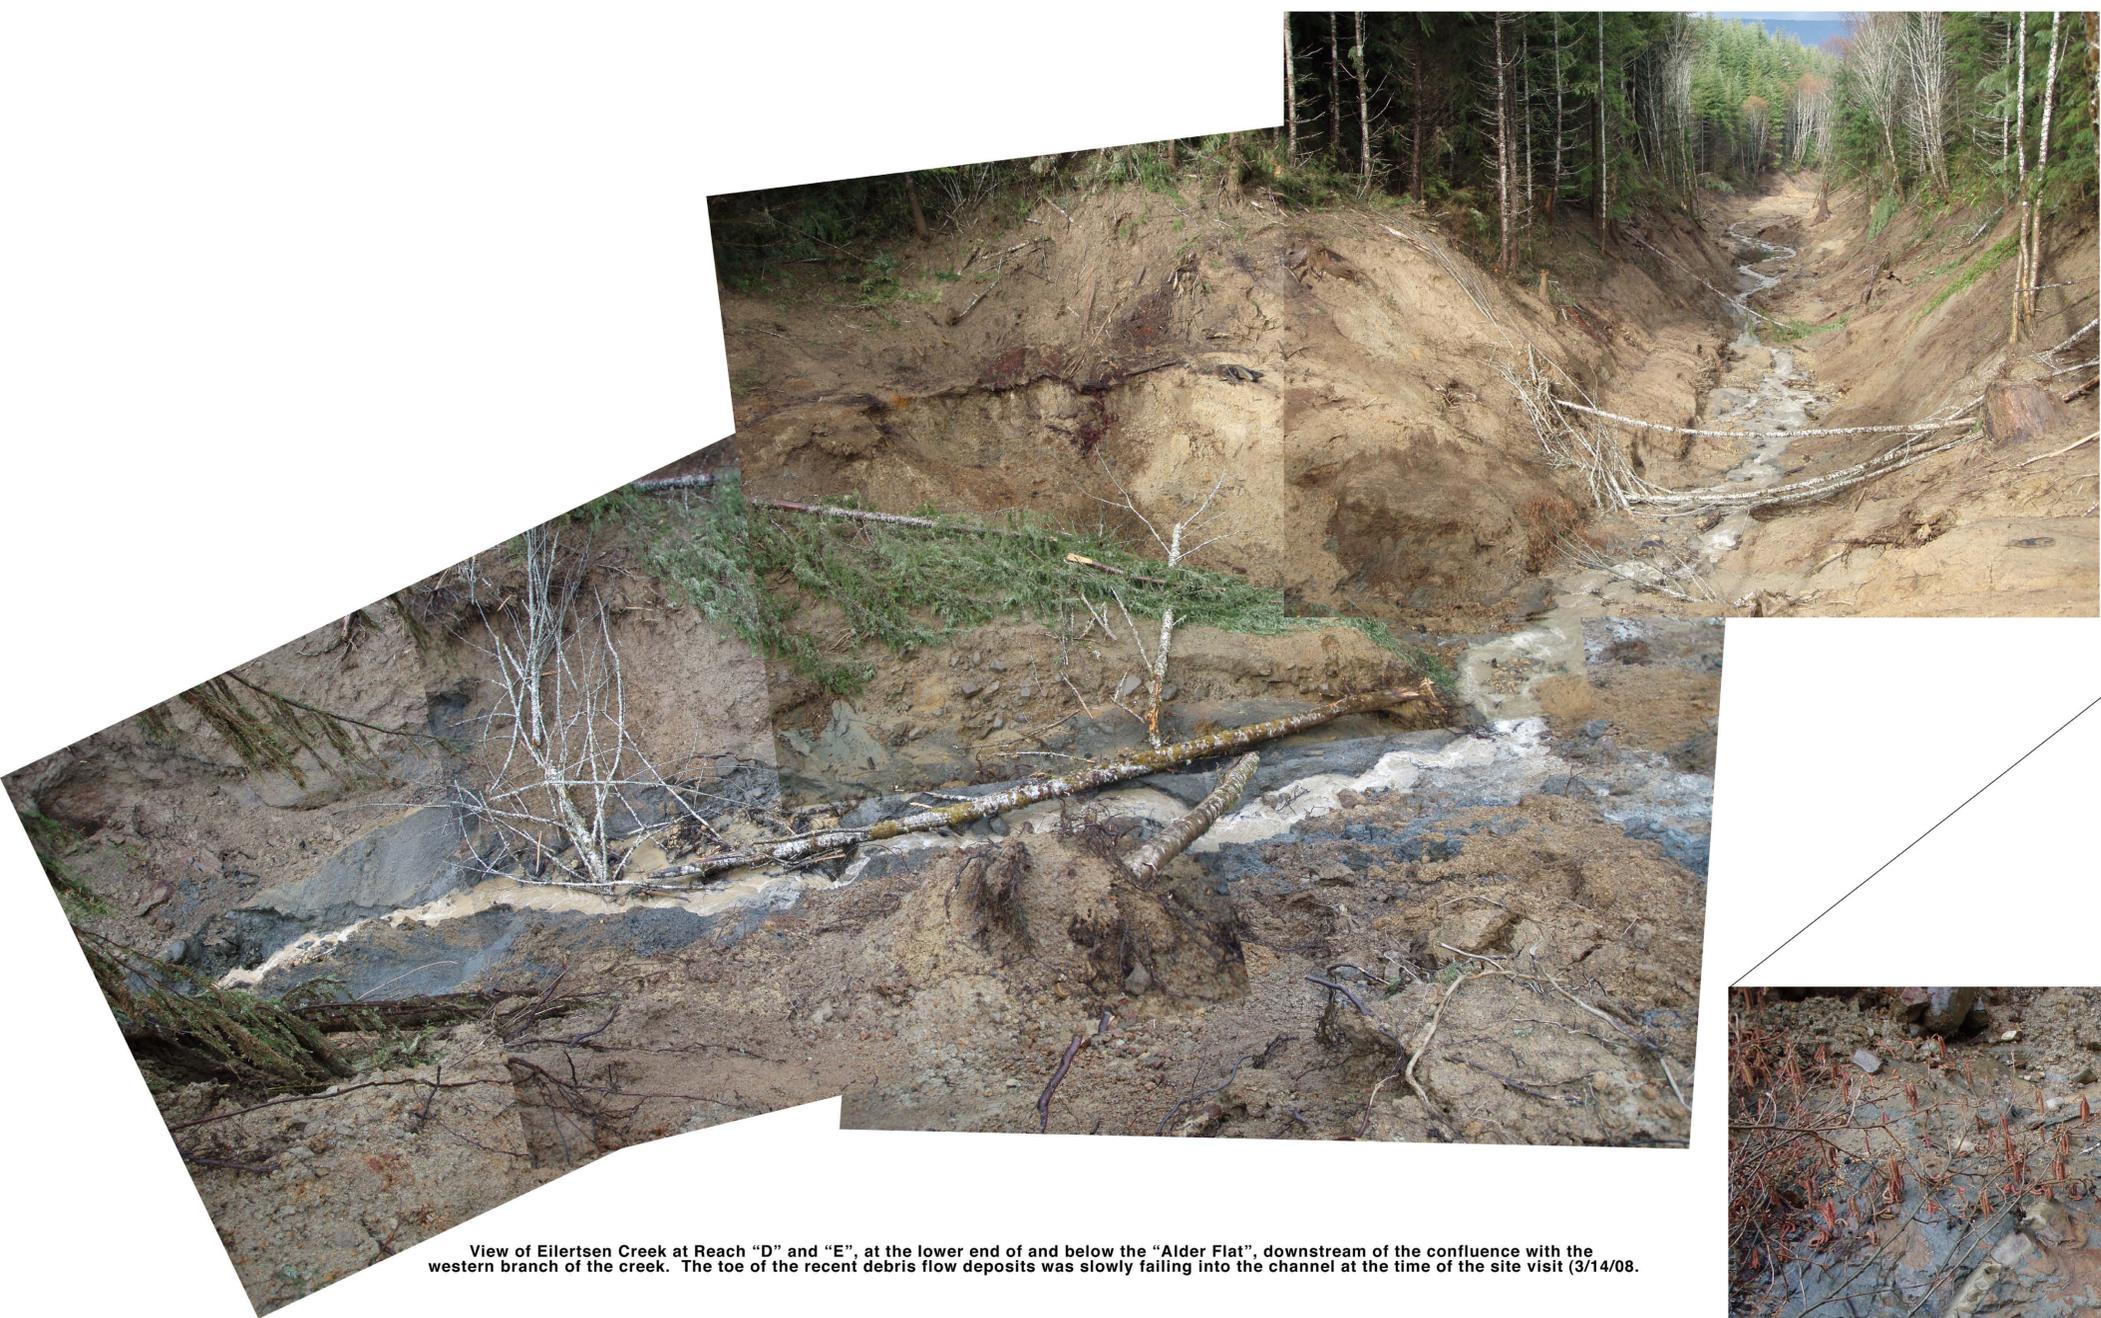
View of Eilertsen Creek at Reach "D" and "E", at the lower end of and below the "Alder Flat", downstream of the confluence with the western branch of the creek. The toe of the recent debris flow deposits was slowly failing into the channel at the time of the site visit (3/14/08).

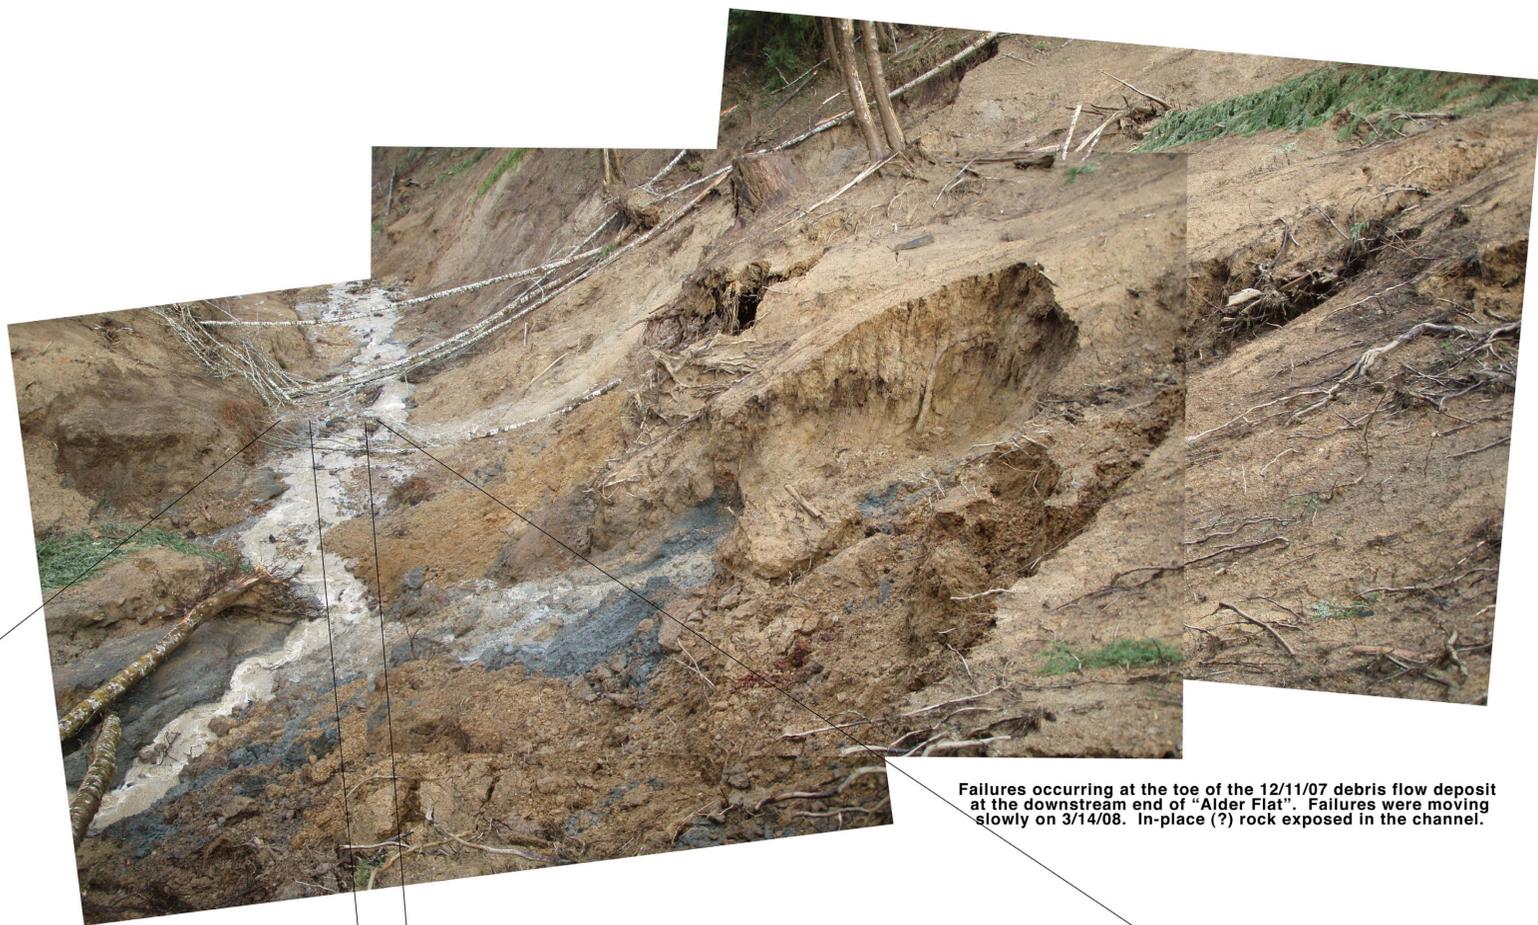
Failures occurring at the toe of the 12/11/07 debris flow deposit at the downstream end of "Alder Flat". Failures were moving slowly on 3/14/08. In-place (?) rock exposed in the channel.

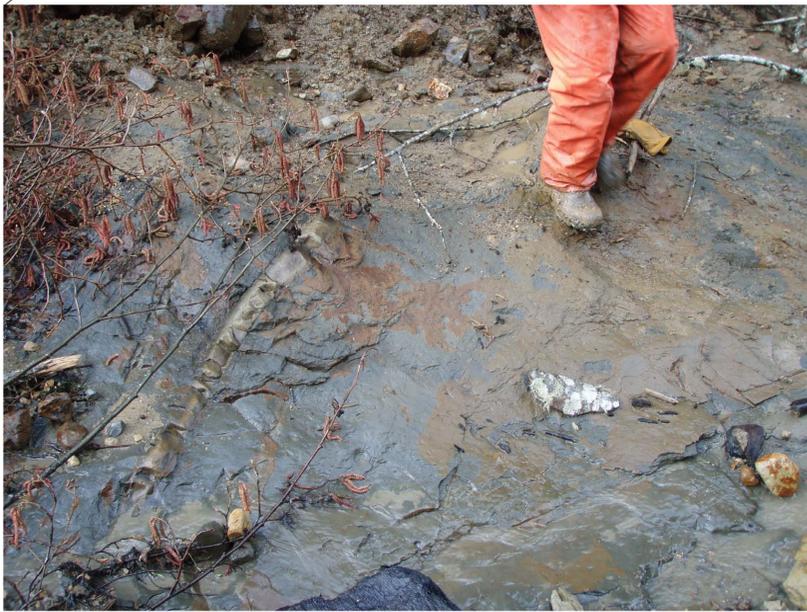
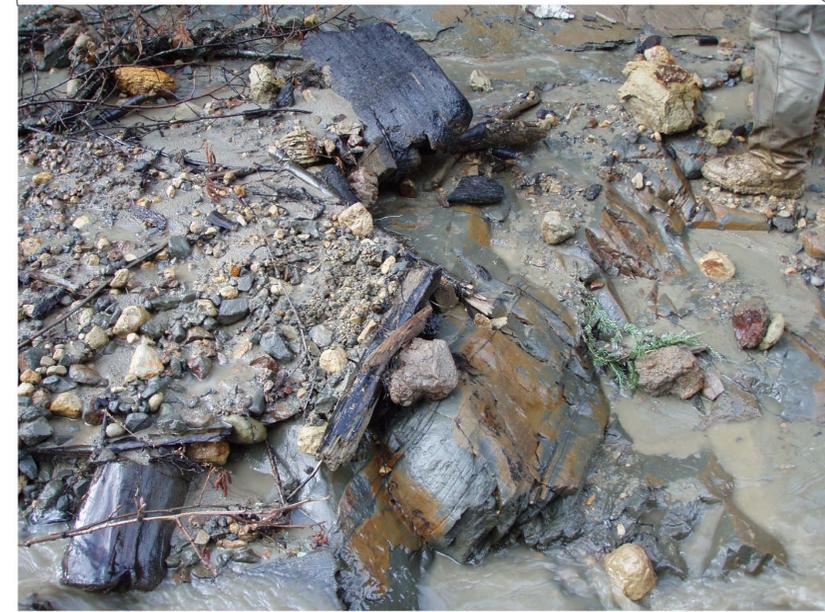
Two views of in-place (?) rock in the channel. Bedding is dipping 60 degrees to the SW, striking approximately NW. It is not known whether this attitude is structural or is the result of large-scale rotational slope movement.

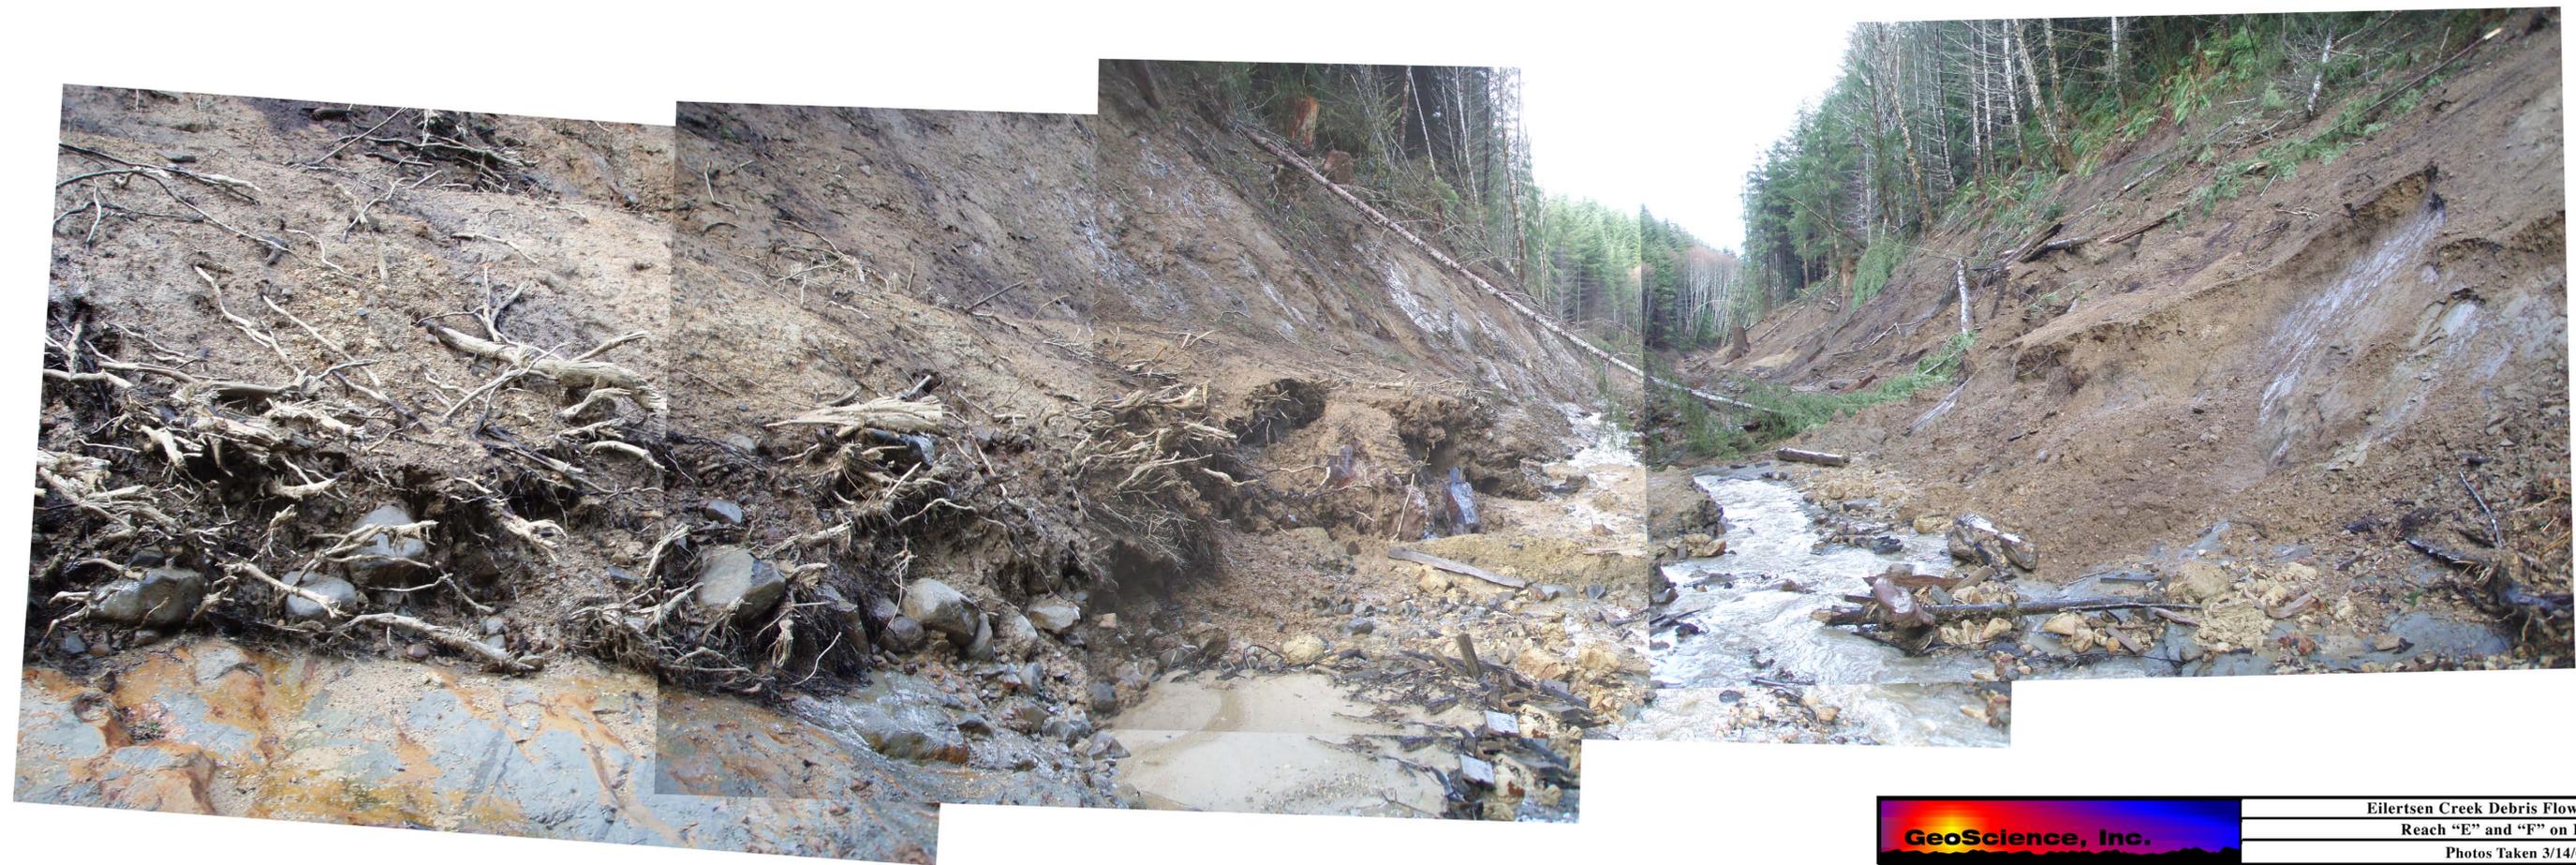
Downstream view of Reach "E" (Fig. 2). Note older debris flow deposit on west bank (left), with mature tree roots preserved (trees removed by recent event). Only a thin veneer of sandy 12/11/07 deposits is on top of the older deposit, which contains larger angular rock fragments.

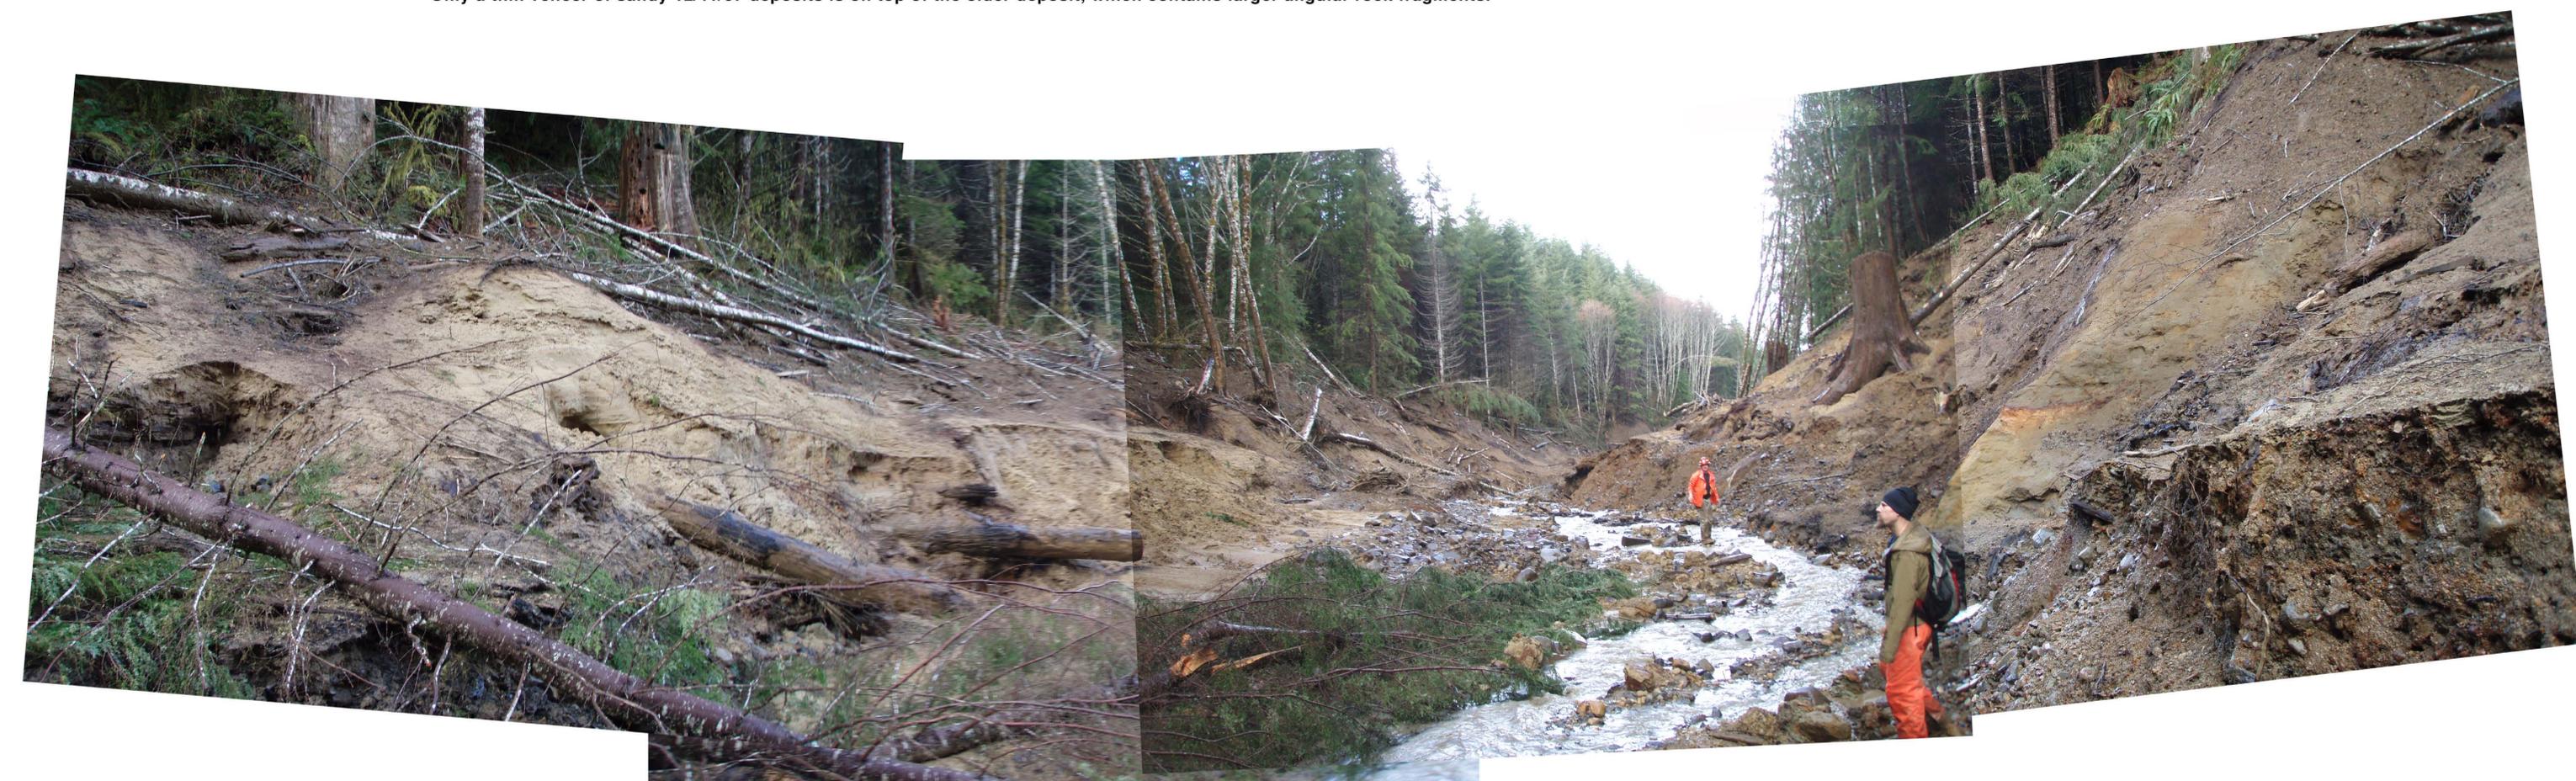
View downstream of Reach "F" (Fig. 2). Greater thickness of sandy, (recent ?) deposits over older woody debris flow deposit (lower left). Age of more rocky deposit on right is indeterminate. Stump on east bank (right) is in place.

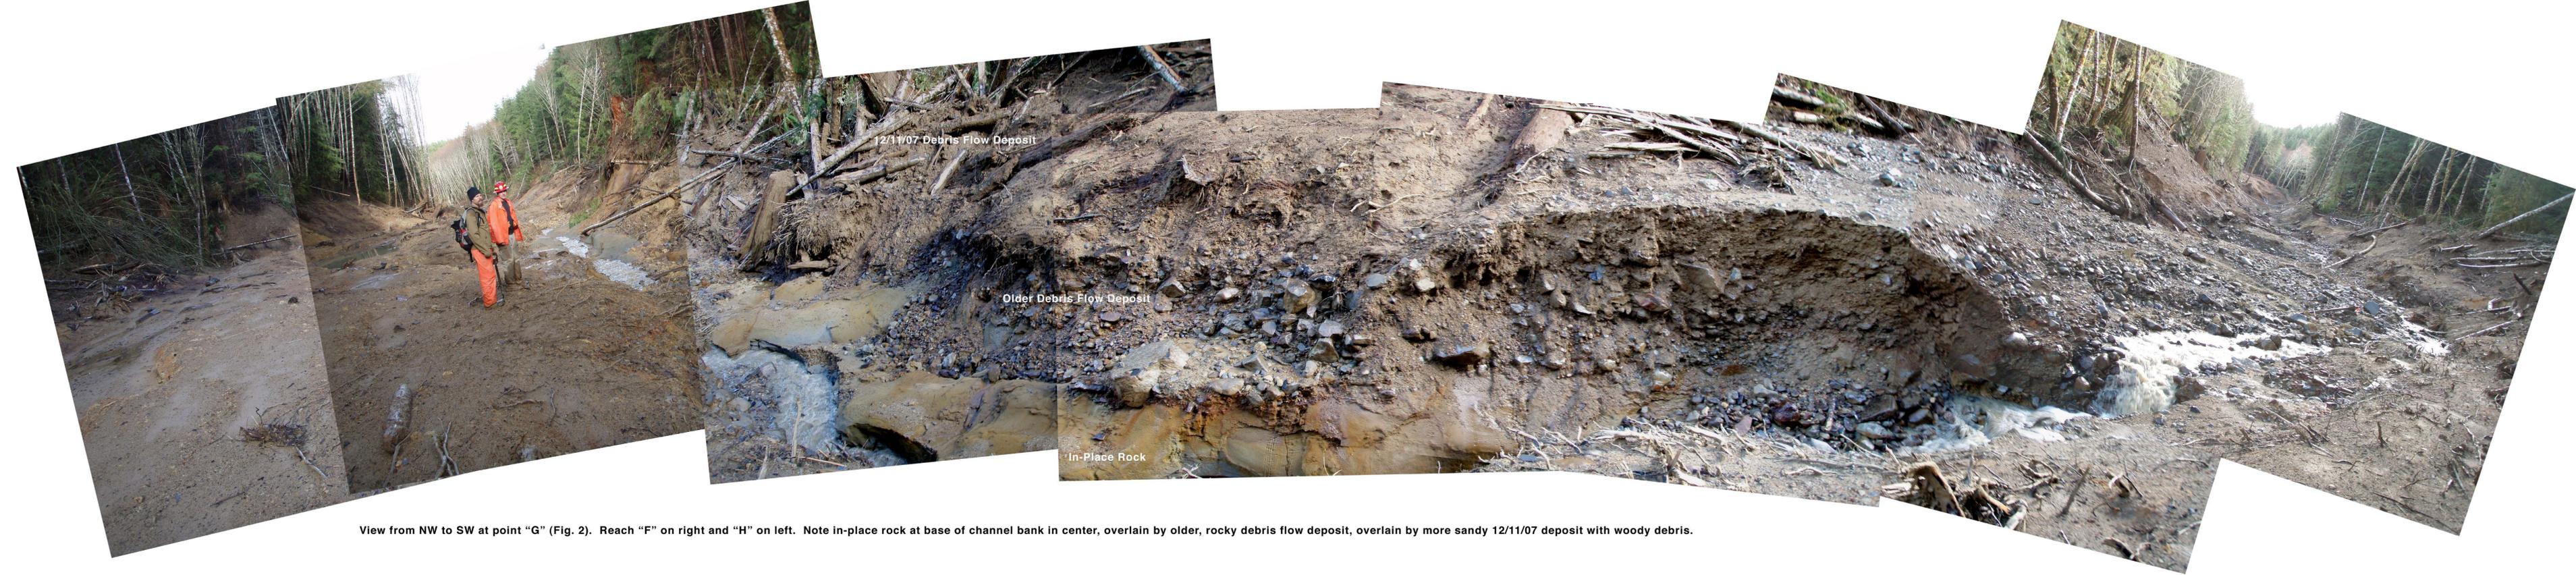
View from NW to SW at point "G" (Fig. 2). Reach "F" on right and "H" on left. Note in-place rock at base of channel bank in center, overlain by older, rocky debris flow deposit, overlain by more sandy 12/11/07 deposit with woody debris.
