**DEBRIS FLOW ASSESSMENT
EILERTSEN CREEK/WOODSON
December 2007 Storm
T 7N, R 5W, Sections 5, 8, & 17**

April 10, 2008

This report presents the results of a geologic/geotechnical assessment of the causes and slope movement mechanisms that led to the railroad fill failure which occurred on the morning of December 11, 2007 in the Eilertsen Creek drainage (T 7N, R 5W, Sections 5, 8, and 17, Figure 1). The failure sent a debris flow through the hamlet of Woodson, across Highway 30, and into Westport Slough, destroying several residential structures and covering the highway with mud and large woody debris. Due to warning of the impending failure by ODF personnel prior to the event, the effects were limited to property damage. This report was completed at the request of the Oregon Department of Forestry's Policy Unit. The assessment was completed in its entirety by Gunnar Schlieder, Ph.D., an Oregon Certified Engineering Geologist.

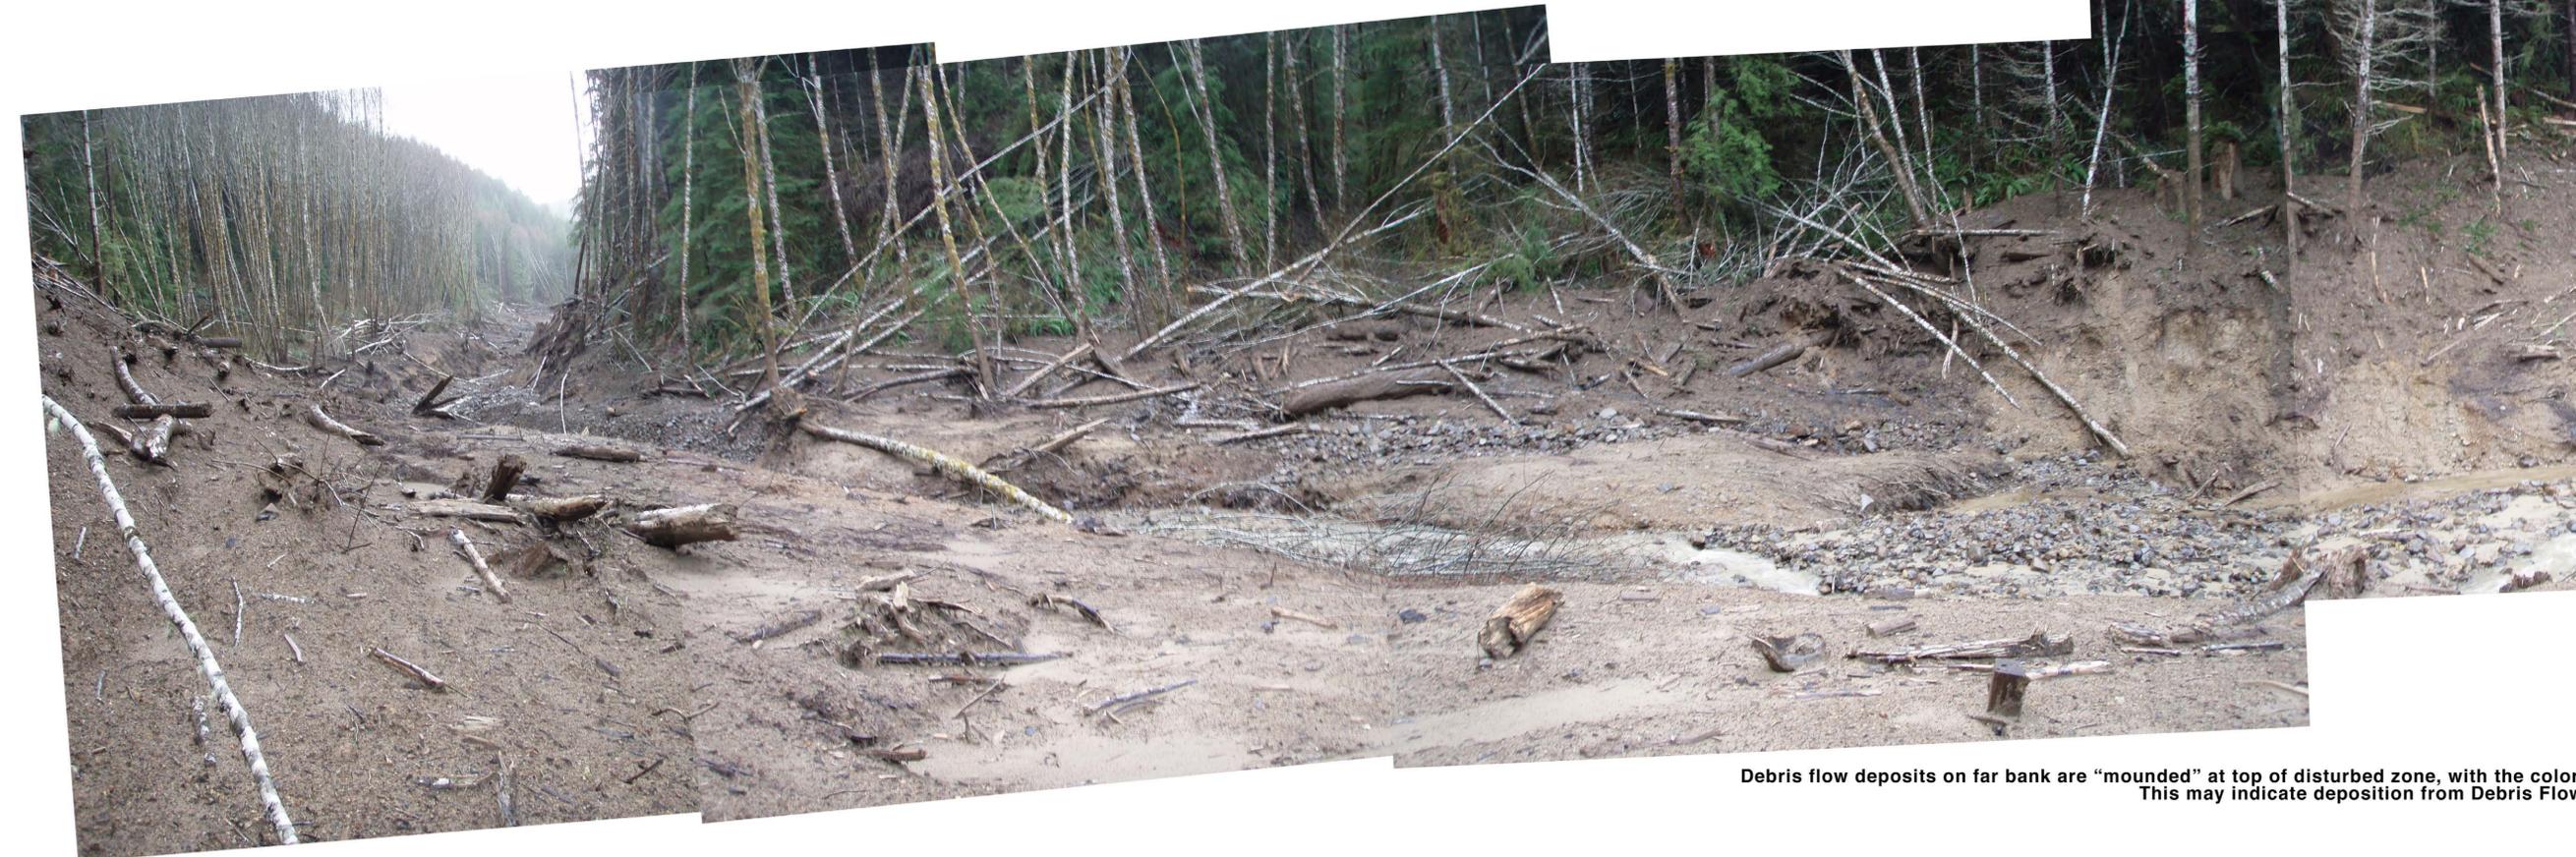
Debris flow deposits on far bank are "mounded" at top of disturbed zone, with the color darker than typical sandy 12/11/07 deposits. This may indicate deposition from Debris Flow 7.

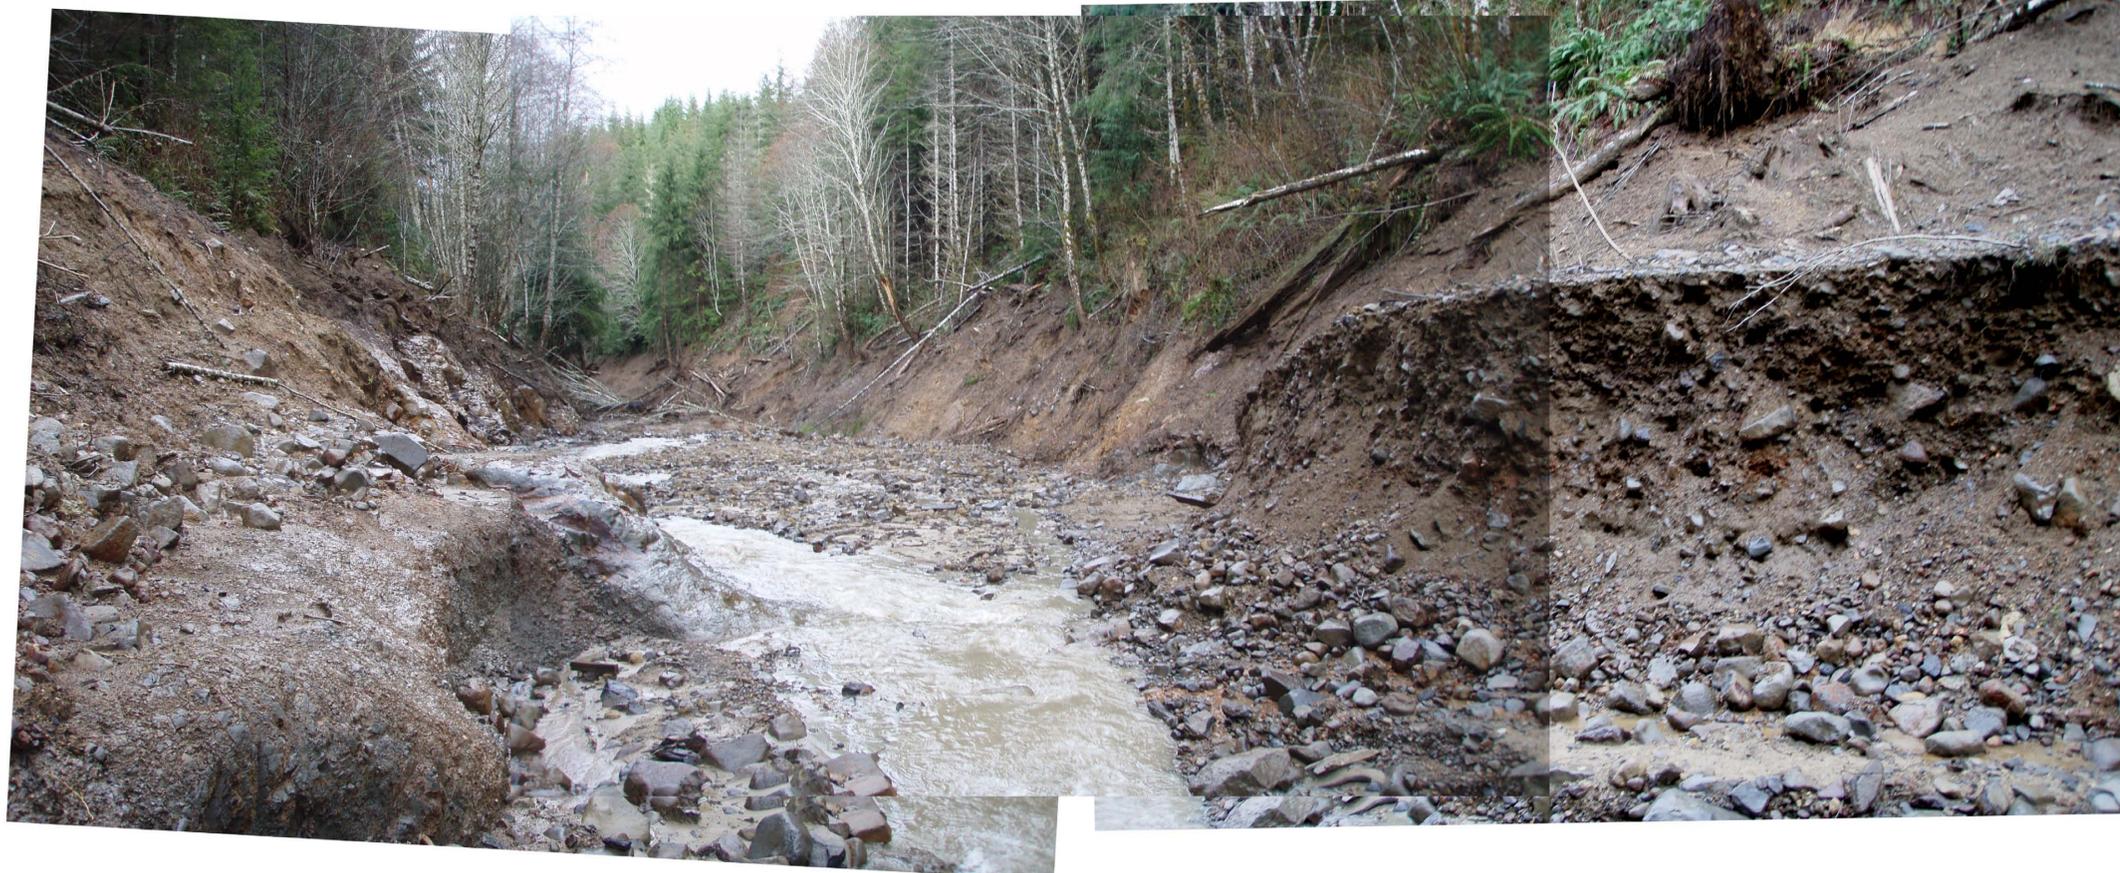
Reach "K", view NNE. An increase in gradient has resulted in more scouring by the 12/11/07 debris flow. In-place rock exposed at base of left bank and older debris flow deposits in right bank.

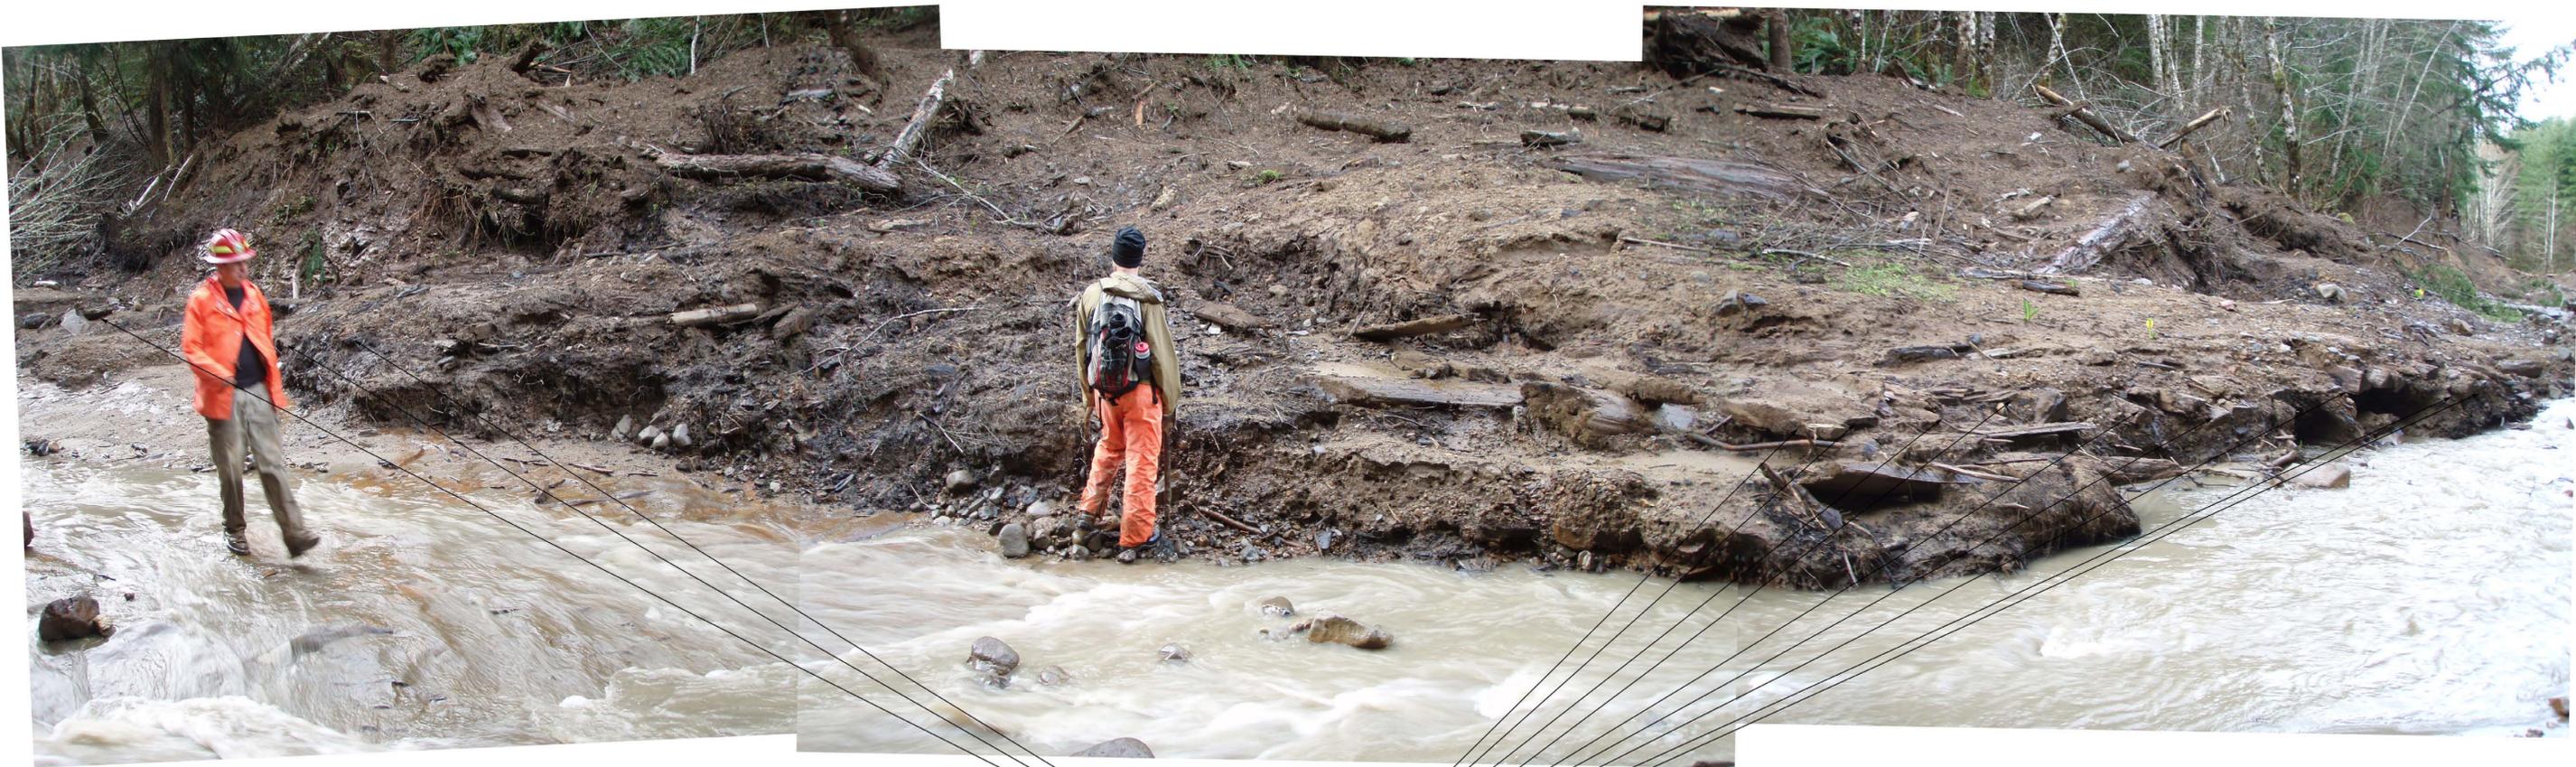
Reach "L". View from SW (left) to NW (right). Along this stretch an old road bed made of hewn planks is exposed in the left bank. Arrows point at boards identifiable on the photos.

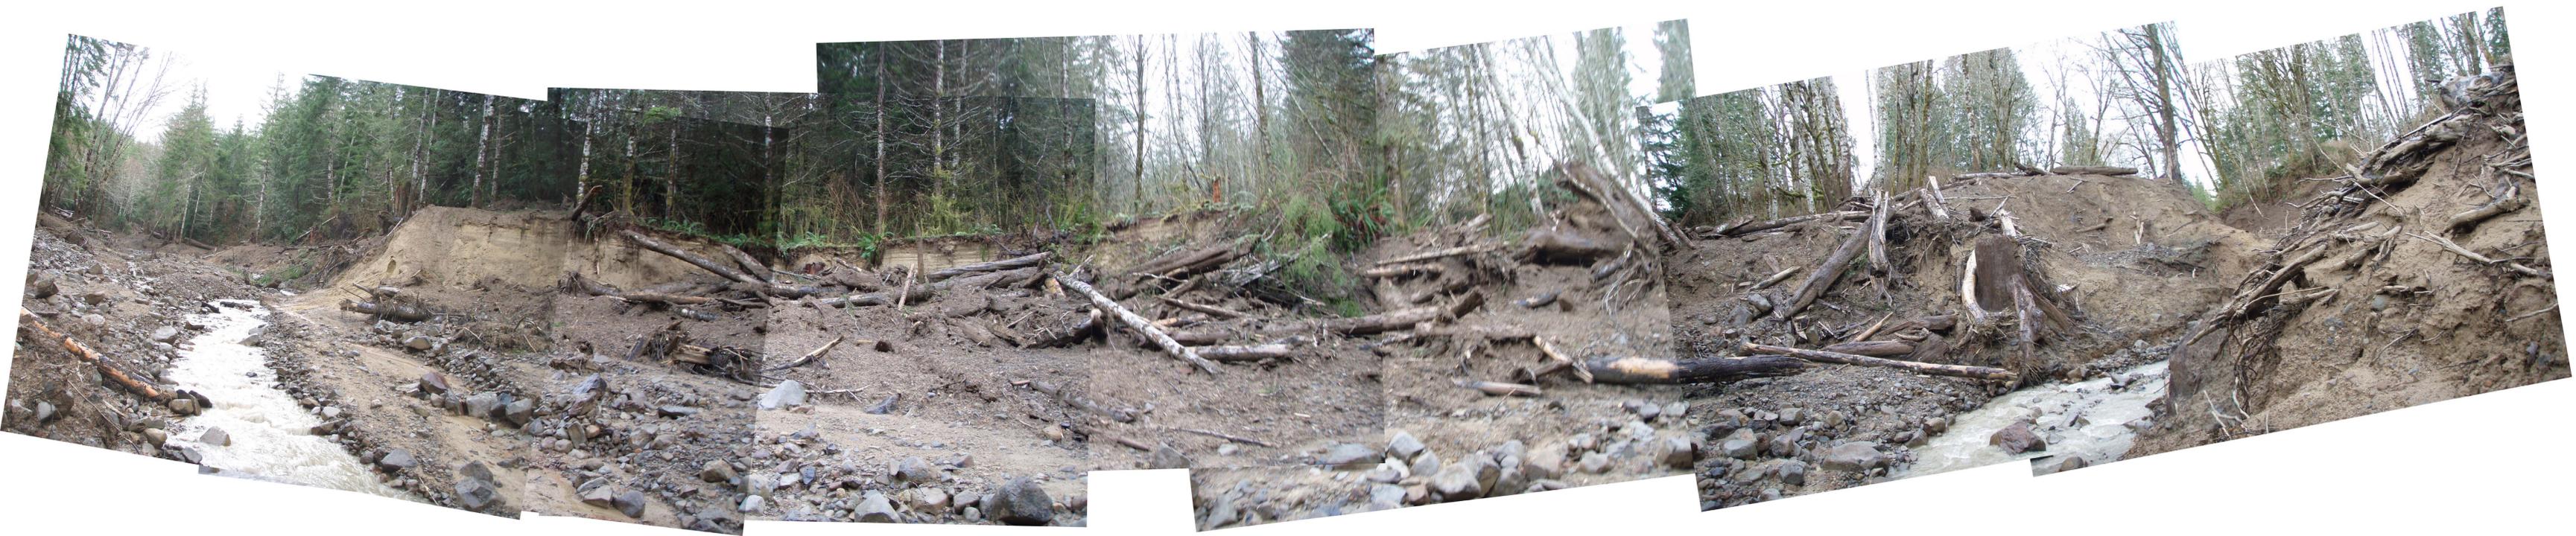
Upstream side of old railroad crossing at point "M". View S (left) to N (right). Light-colored, thinly bedded deposits are sandy, and appear to have formed behind the old railroad crossing, possibly during construction of embankment at crossing that failed 12/11/07. Woody debris and darker mud is from 12/11/07 event.

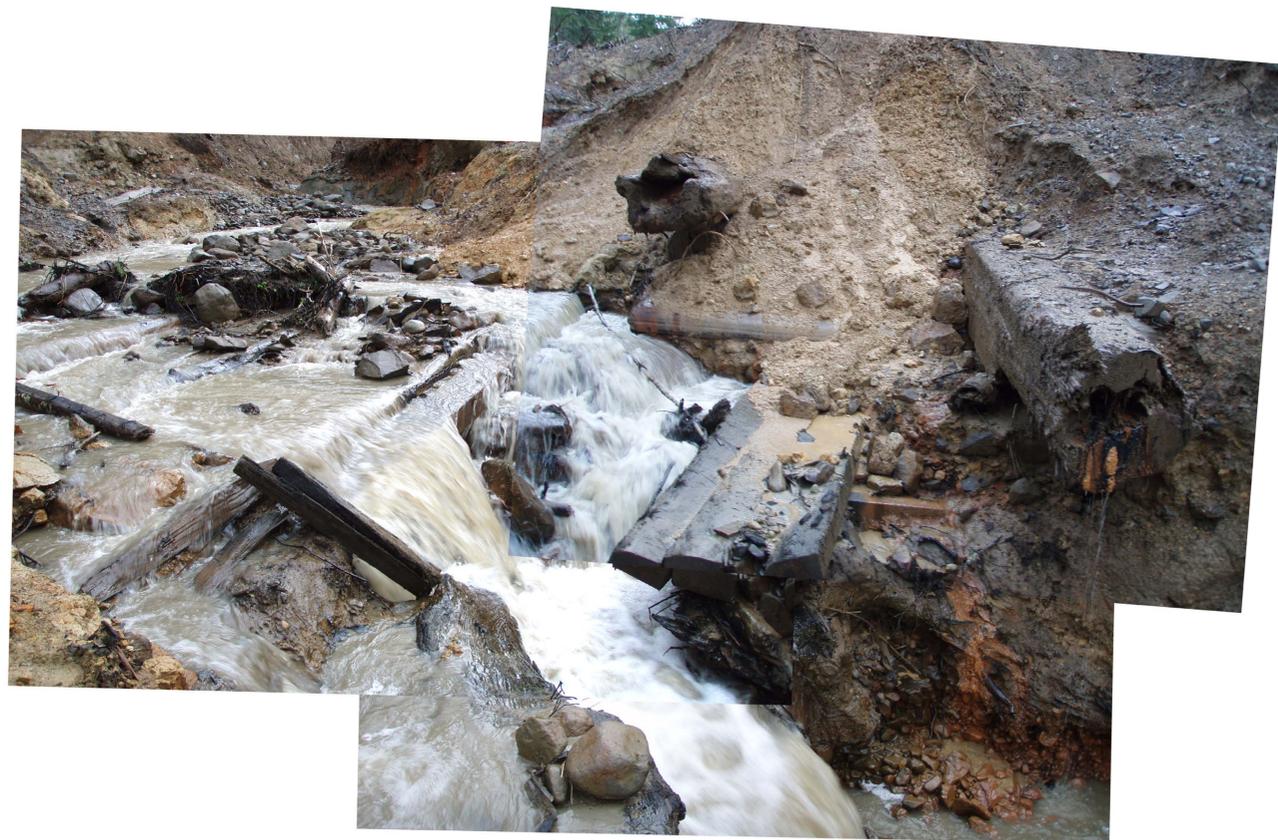
Remainder of old railroad trestle at point "M" which may have been buried in similar fashion as the crossing that failed 12/11/07. View S.

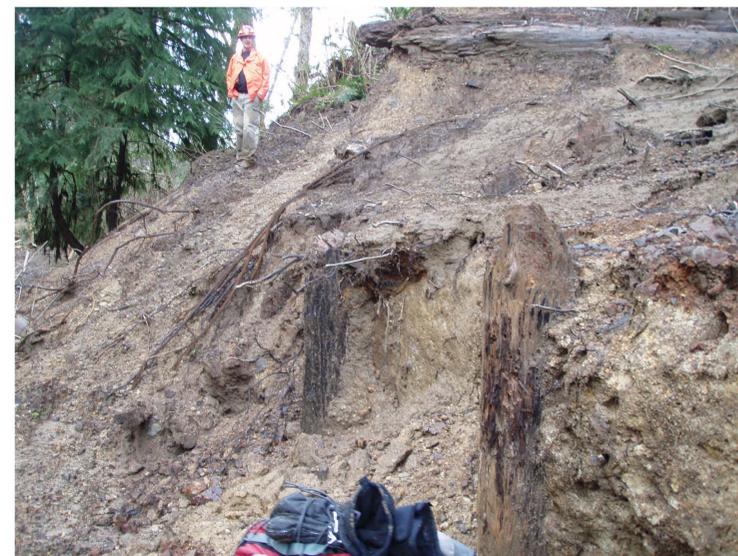
Buried trestle bents or piles on downstream side of point "M".

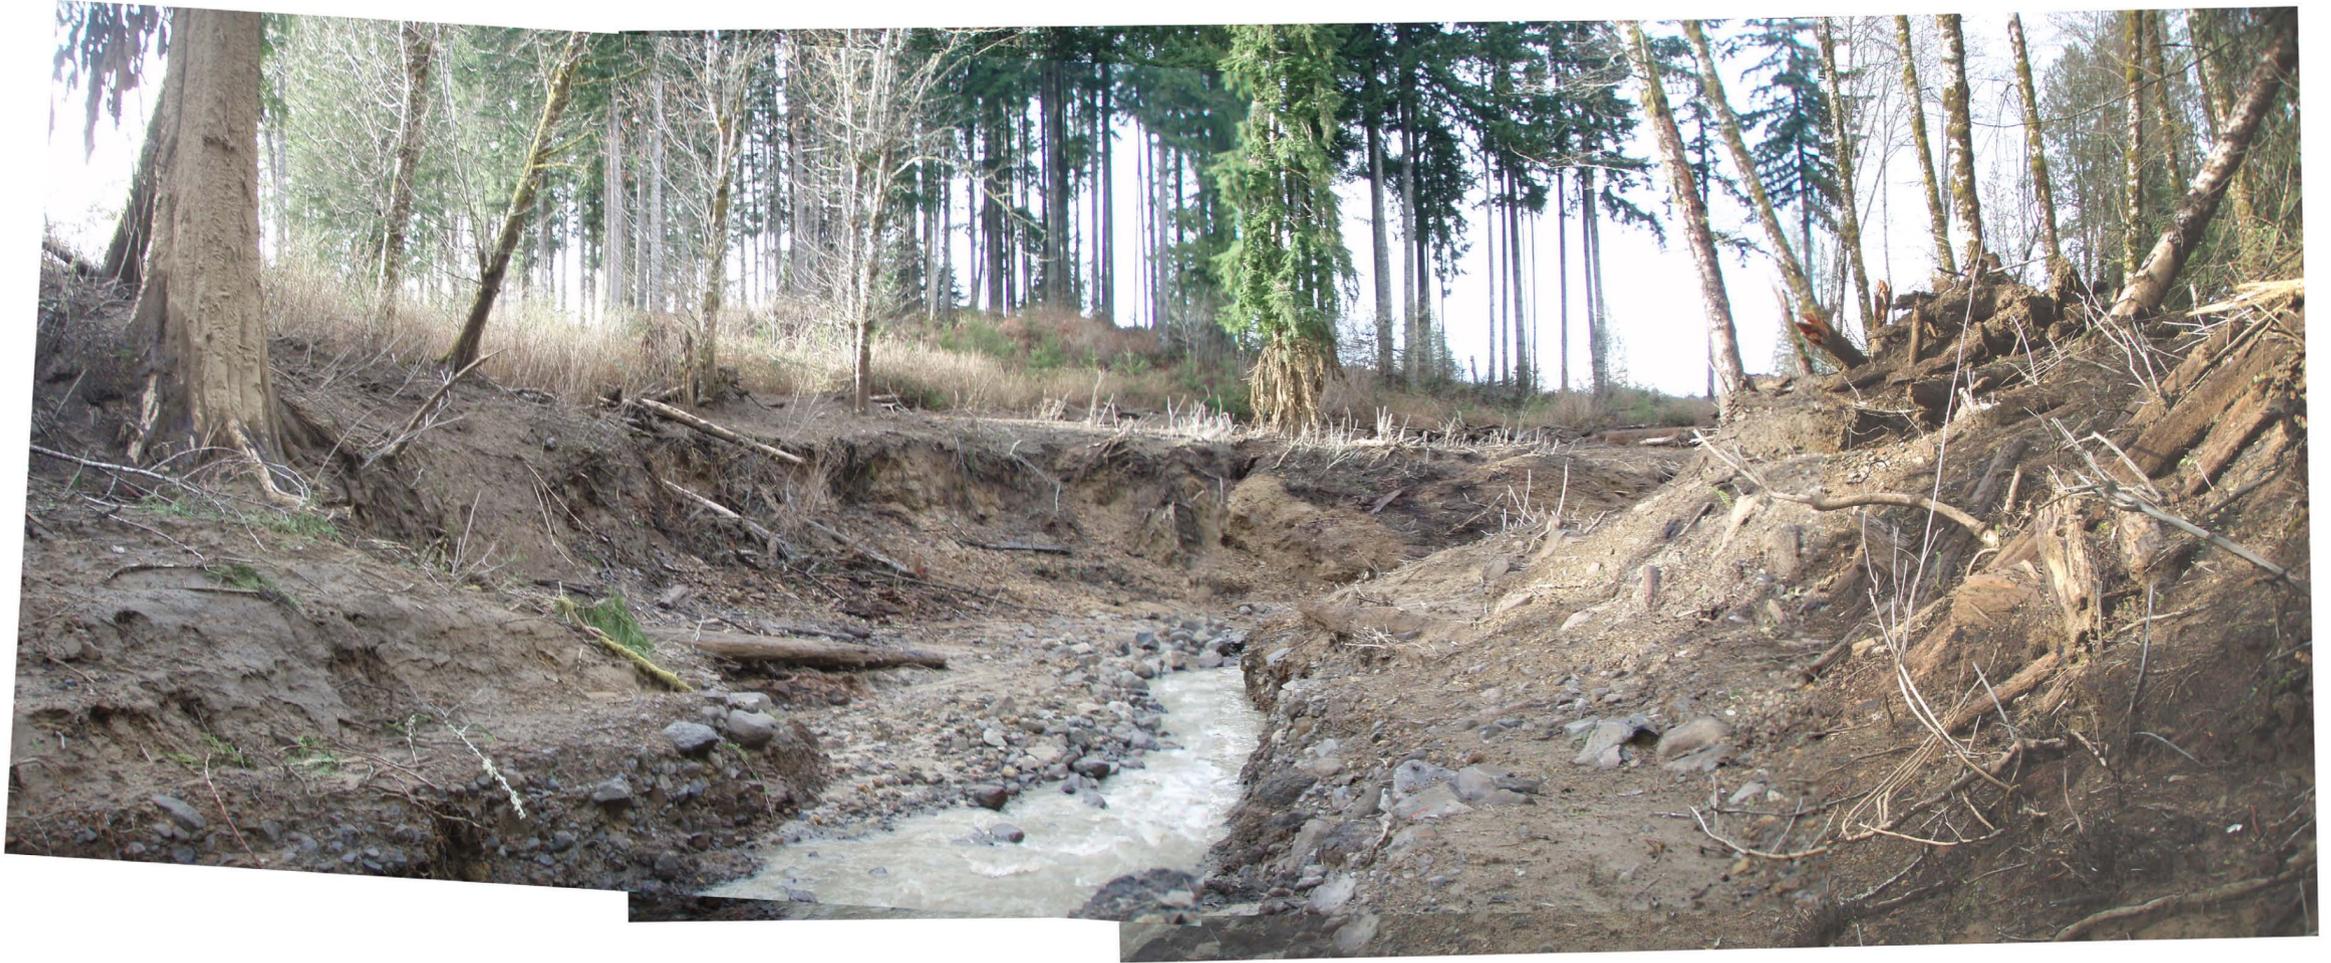
Upstream of right channel curve at "N" (Fig.2). View NW. Note relatively low height of flow through this section downstream from narrows at old railroad crossing ("M").

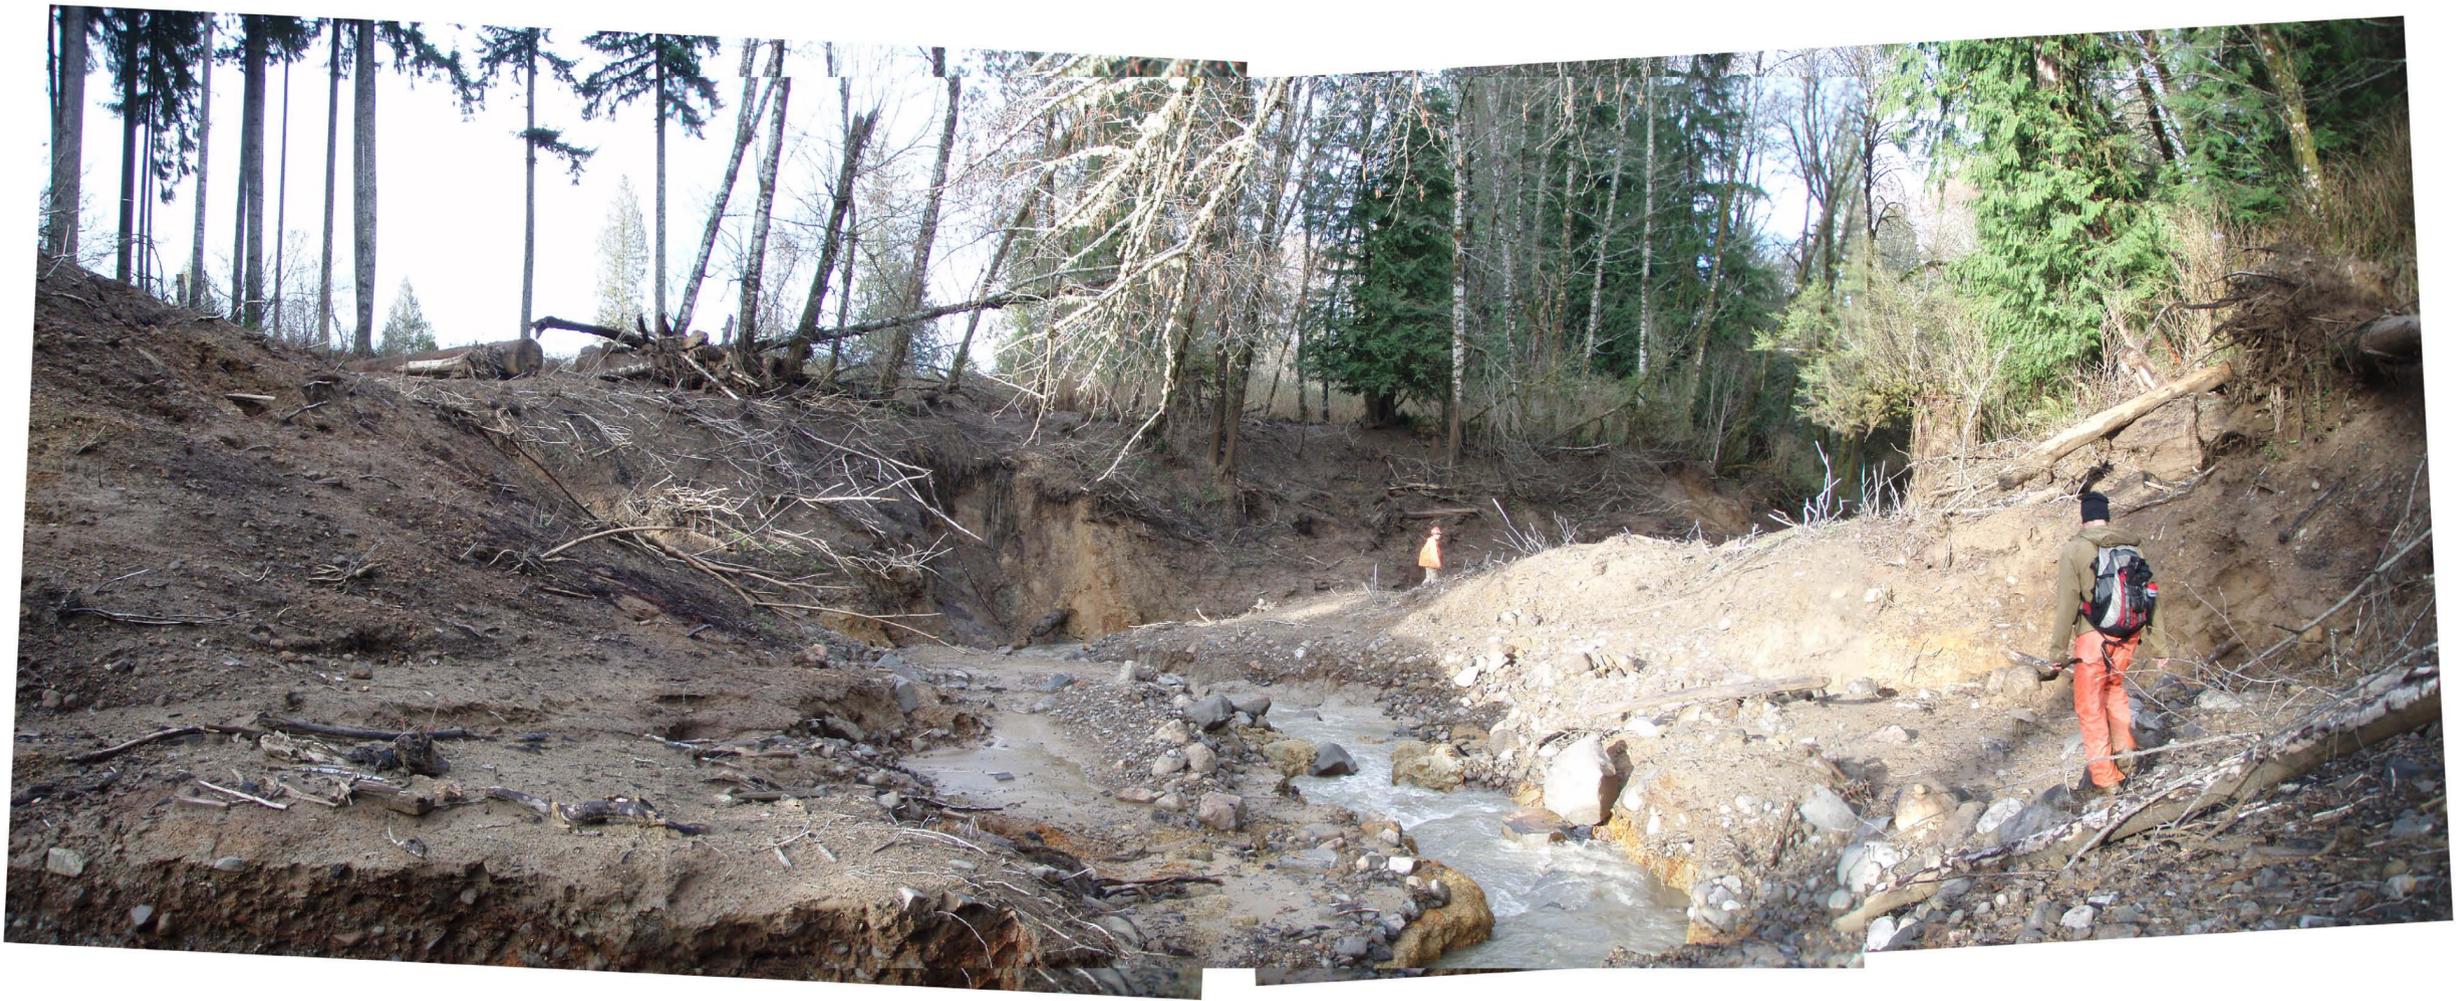
Right channel curve at "N". View N. Note deposits on left bank of curve. Also note increase in channel gradient at curve. At and immediately below this curve, channel is cut through CRB, which forms a knick point.

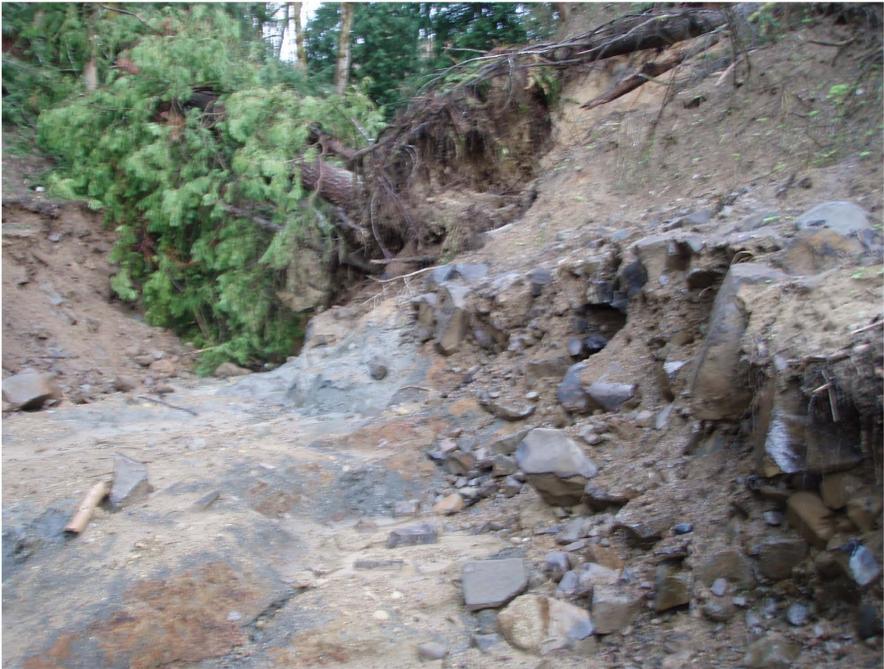
Failure of W bank into channel at "O" as a result of downcutting during the 12/11/07 event.

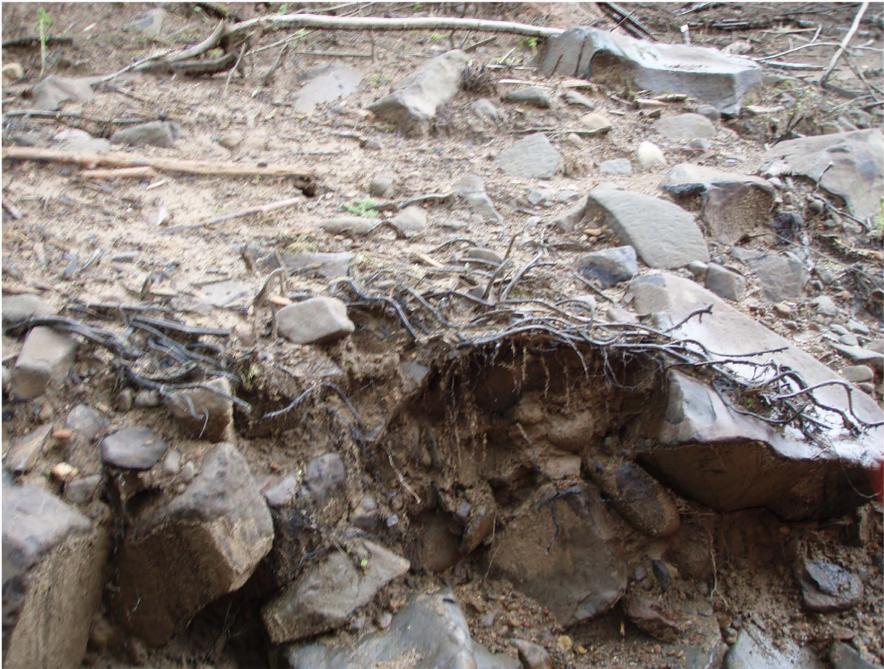
Older debris flow deposit below "O". Note presence of roots.

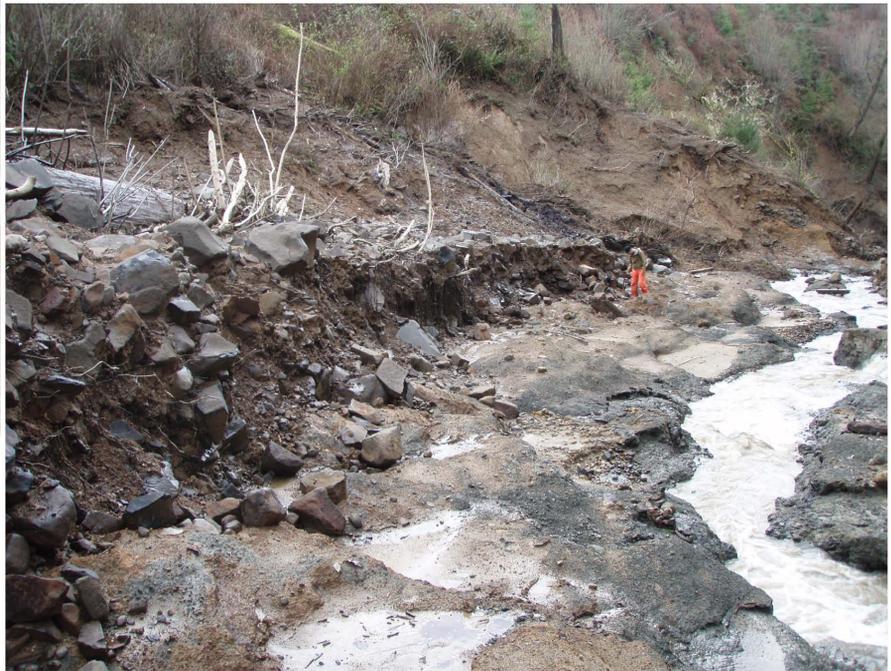
Older debris flow "terrace" deposit extending from "O" to "P". Note stripped, in-place vegetation.

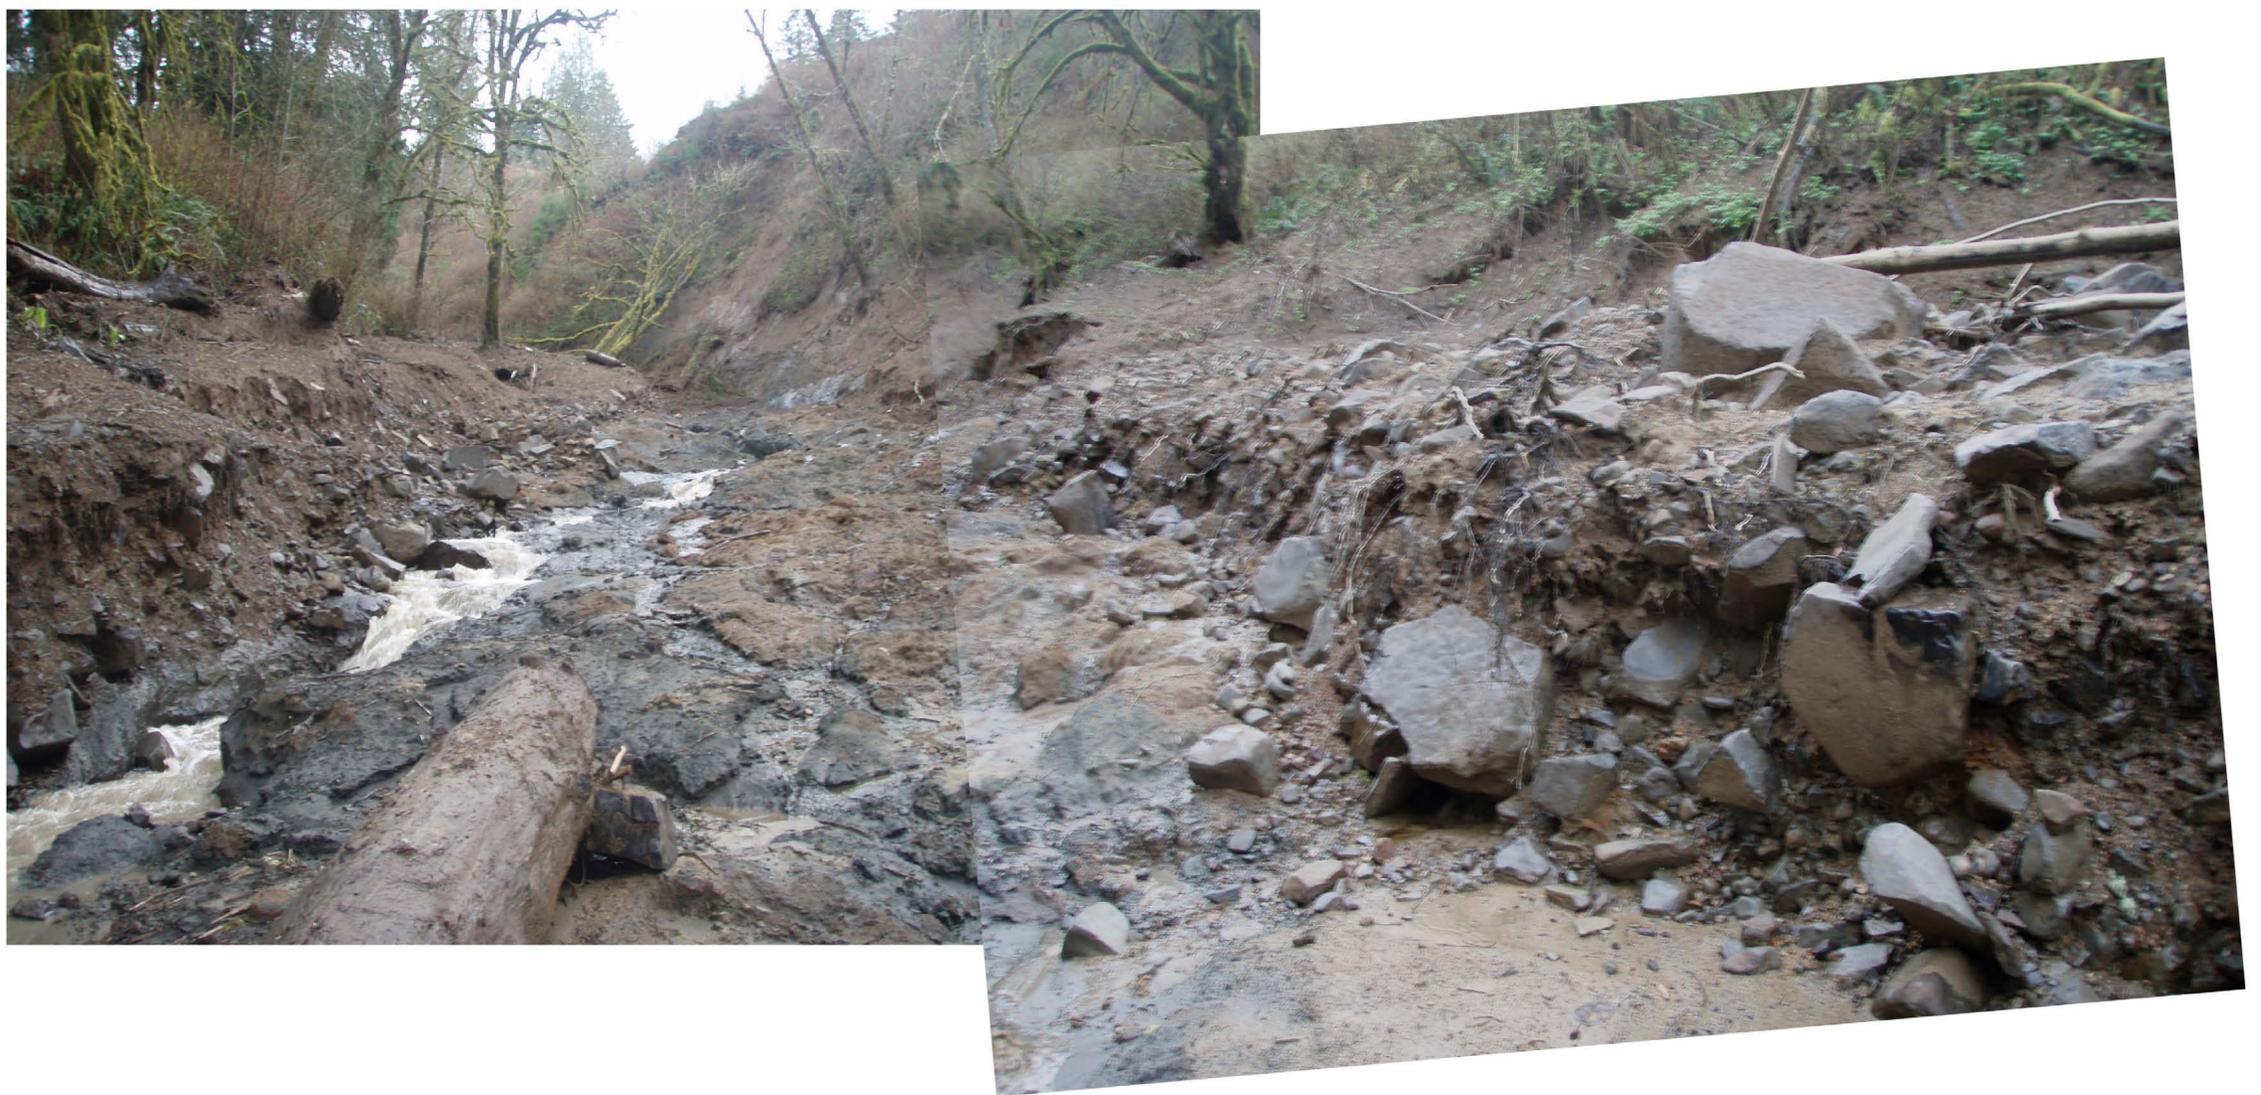
Older debris flow "terraces" on both sides of channel between "P" and "Q". View upstream (S).

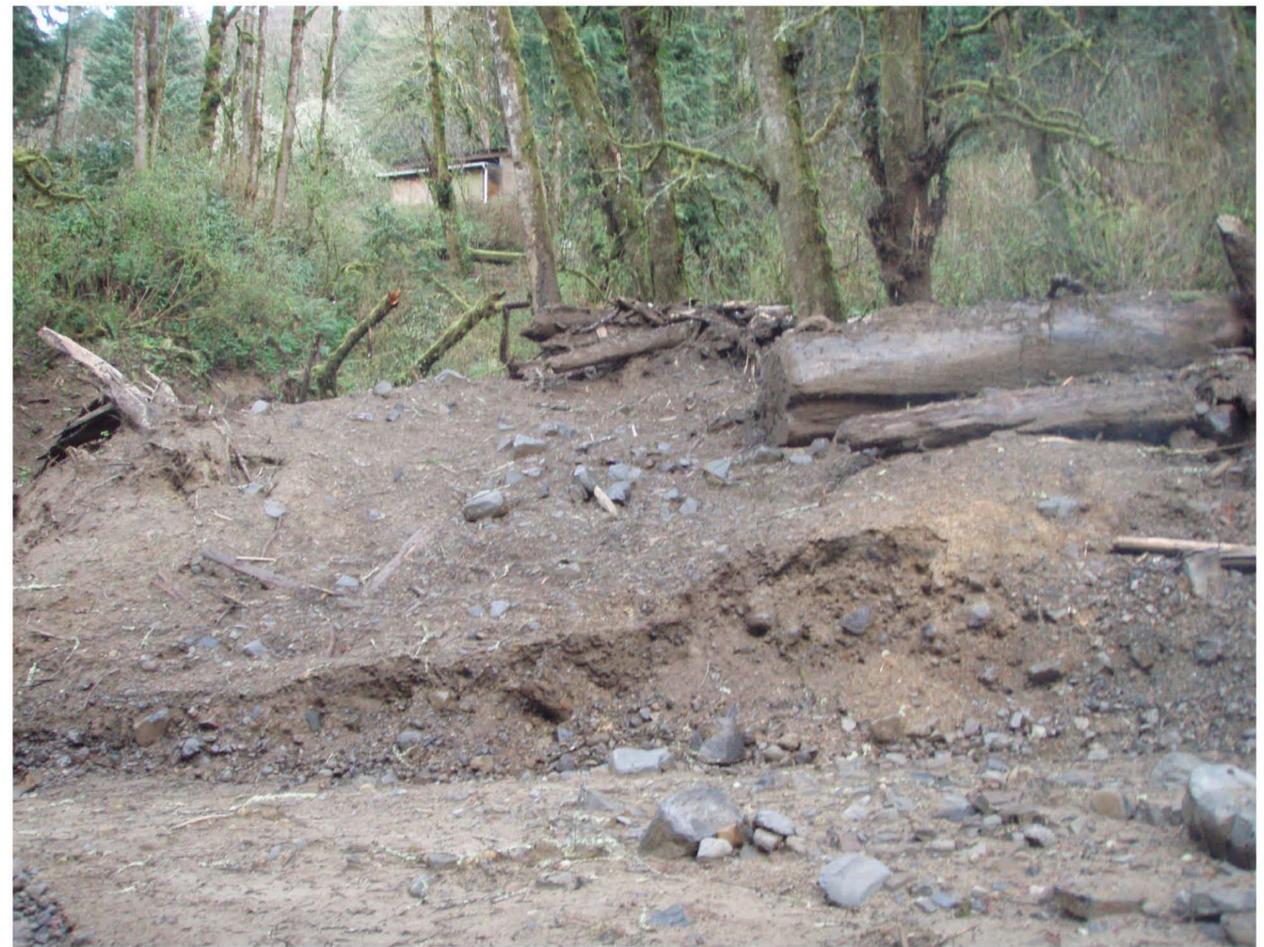
12/11/07 debris piled at outside of curve at "R". A small side-draw failure is visible on L.
