Columbia River Highway

Guide for Maintenance

Columbia River Highway Project 1981

ASSESSMENT AND
MAINTENANCE GUIDELINES
PREFACE

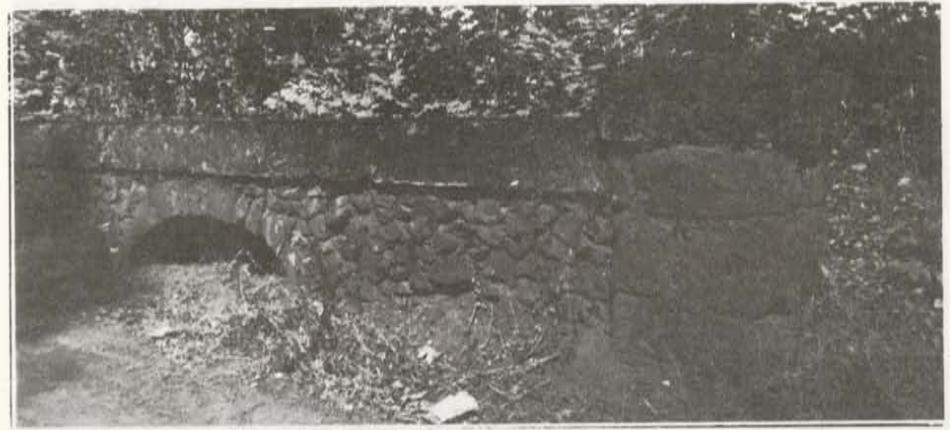
This photograph shows a section of guardrail just east of the Vista House. The mortar is powdery and falling out of the joints. The particular guardrail was laid with a very weak mortar and the outer surface has eroded away causing some stones to be lost.

Urgent. Recommendation. Remove deteriorated mortar and repoint joints. Mortar should match the original (see specifications).

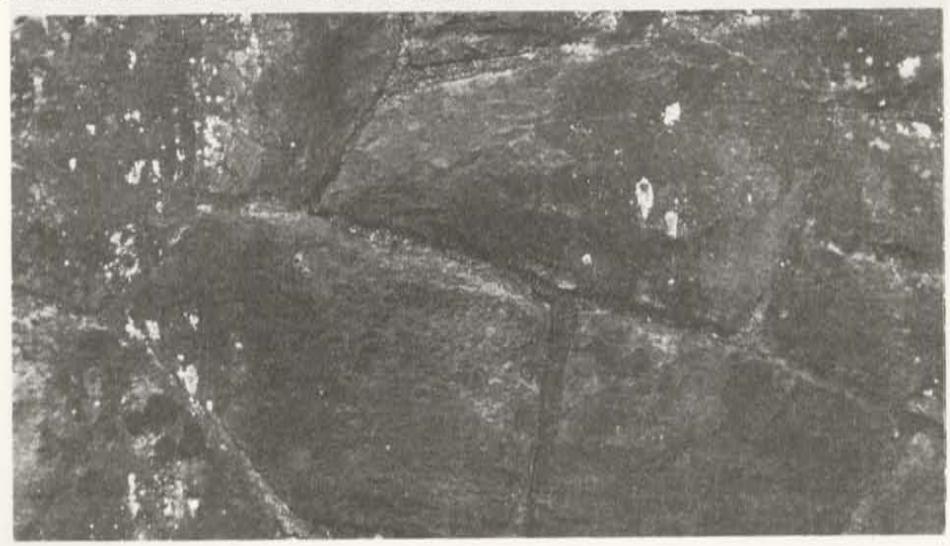
In this photograph of stonework, the mortar is missing in areas and loose in some sections.

Essential. Recommendation. Missing areas and loose mortar should be removed and joints repointed. Mortar should match the original (see specifications).

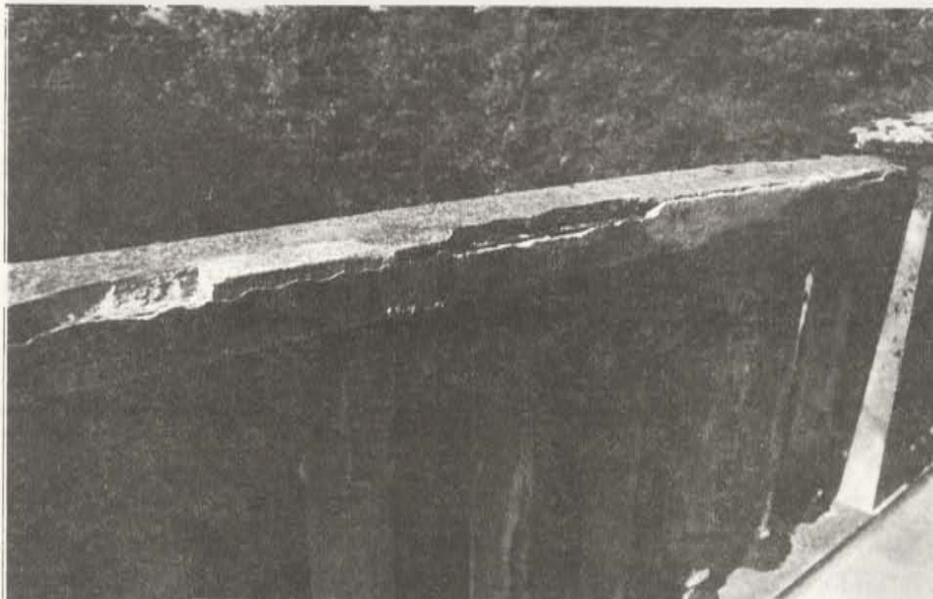
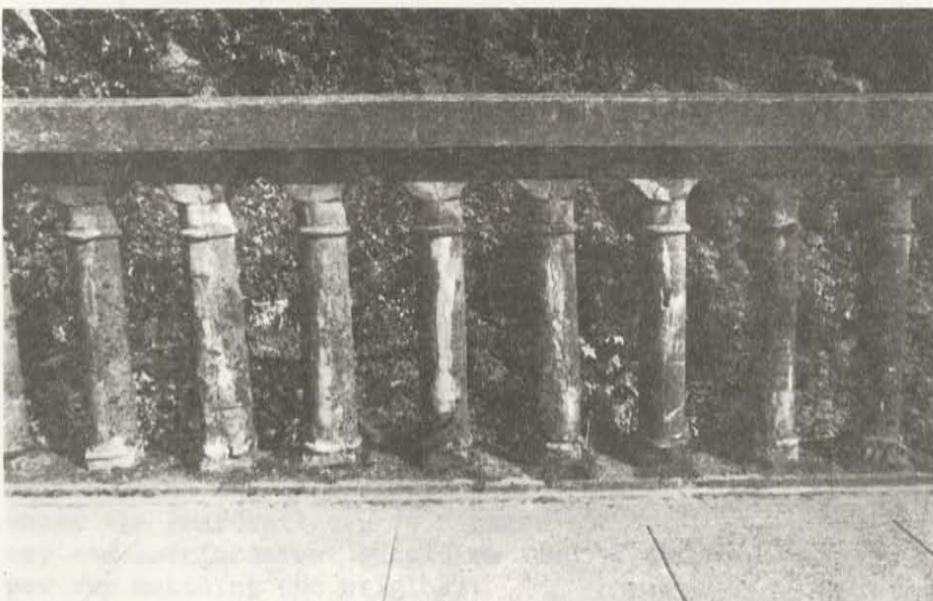
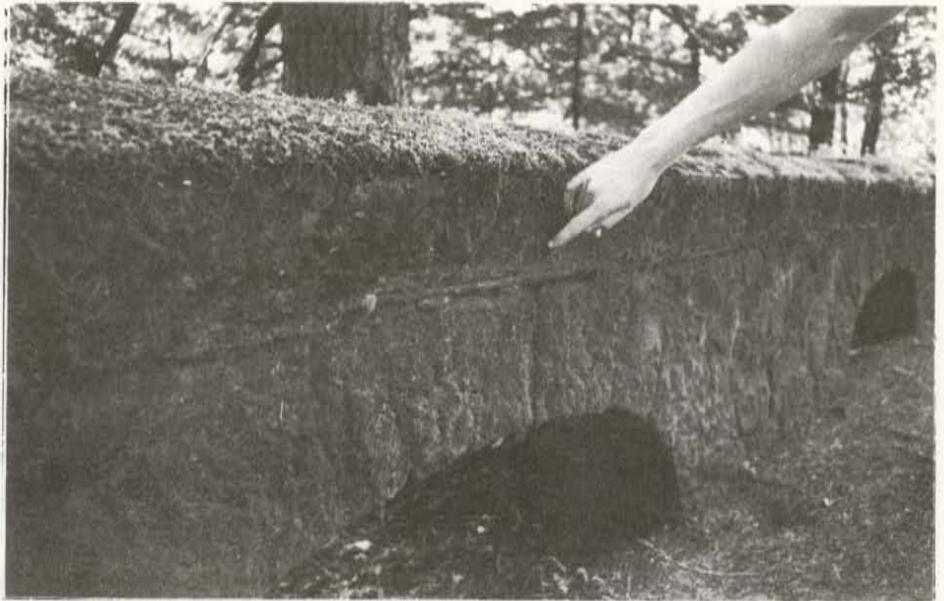
Exfoliation of metal. In many locations the reinforcing bars are exposed to the weather and have started to rust. A very minimal amount of metal exfoliation causes the concrete to crack, allowing water to penetrate. The bridge railing has very thin members with exposed metal reinforcing. This condition is a very serious problem. As shown in these photographs, metal reinforcing is exposed on most guardrail sections and on the underside of the caps.

Urgent. Recommendation. In the area where elements can be replaced, such as the balusters of the bridge railing, they should be removed and replaced with balusters which match the originals. Where deteriorated elements on the bridges cannot be removed and replaced, exposed areas of reinforcement should be cleaned by sandblasting the metal free of rust, and the missing concrete replaced with concrete matching the original.

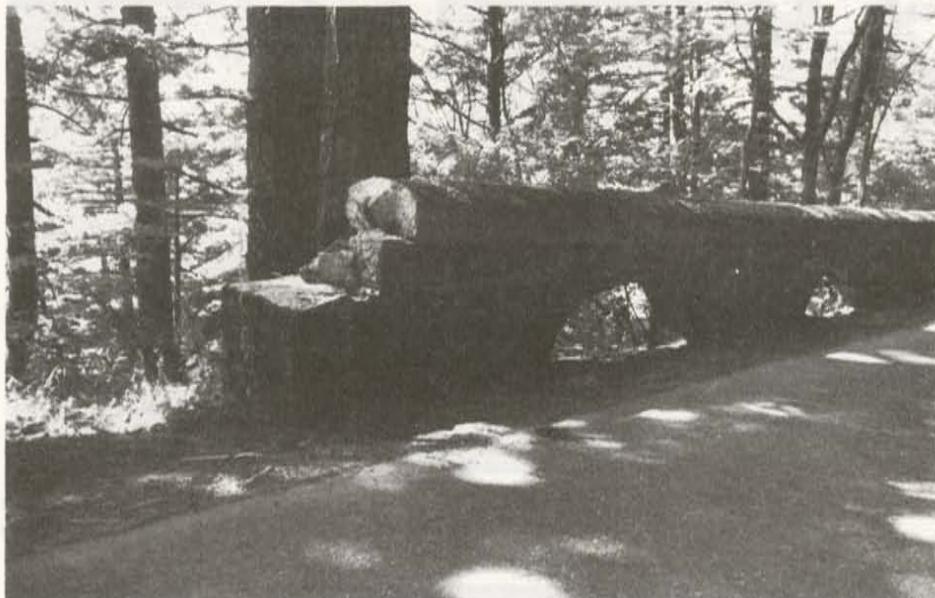
Missing post guardrail, one-half mile west of Vista House.

Recommendation. Although nothing can be done to stop vehicles from damaging these features, periodic inspections should be made to assess damage and repairs needed. All repairs should follow the guidelines set forth in this guide.

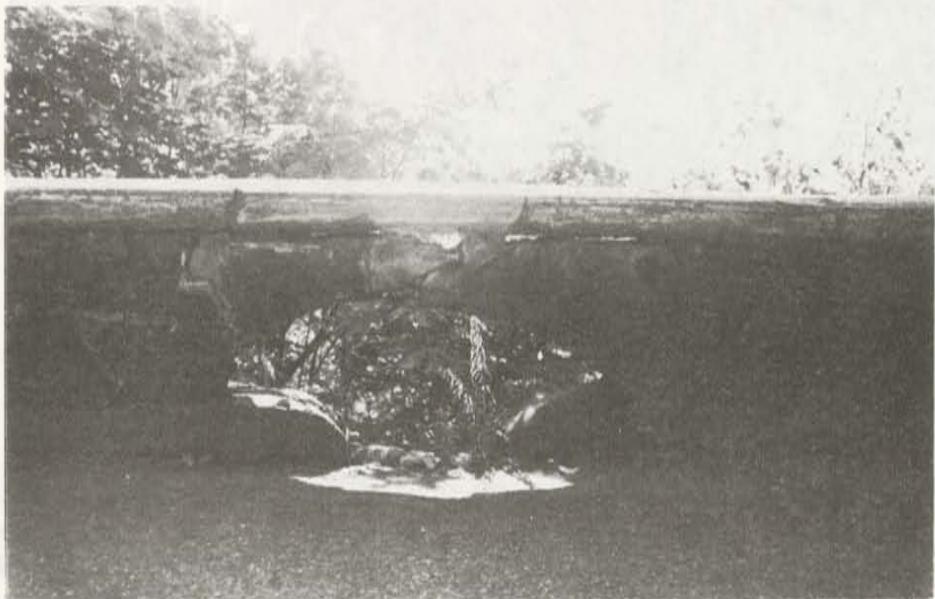
Guardrail arch structurally unsound and cap beam out of alignment, east of Vista House.

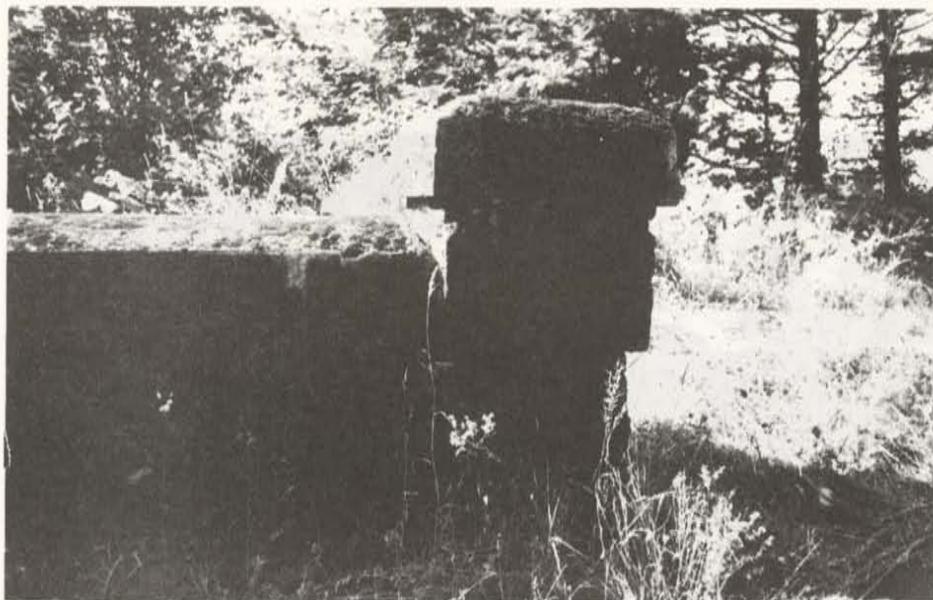
Guardrail post out of alignment, one-quarter mile west of Vista House.

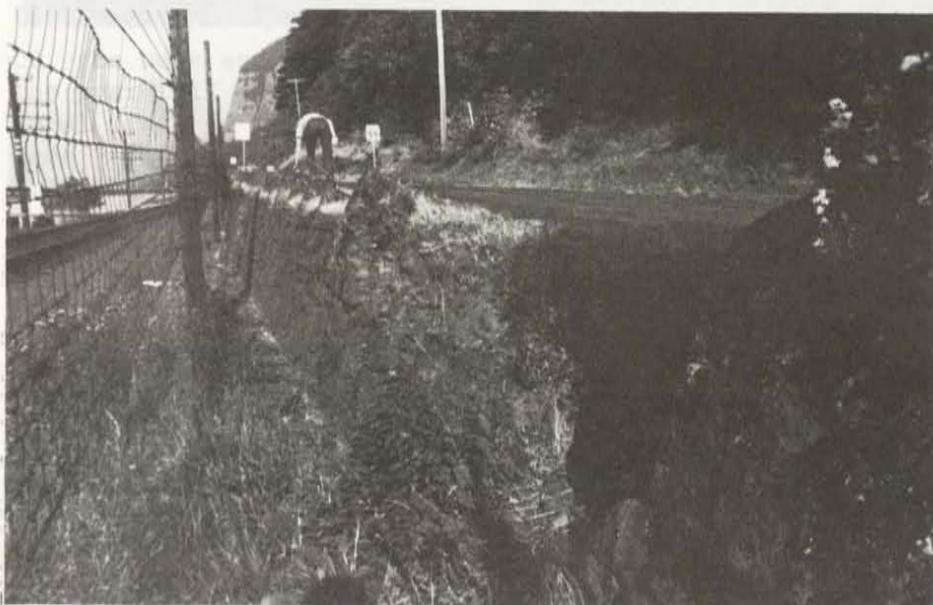
Missing area of guardstones and retaining wall, east of Multnomah Falls.

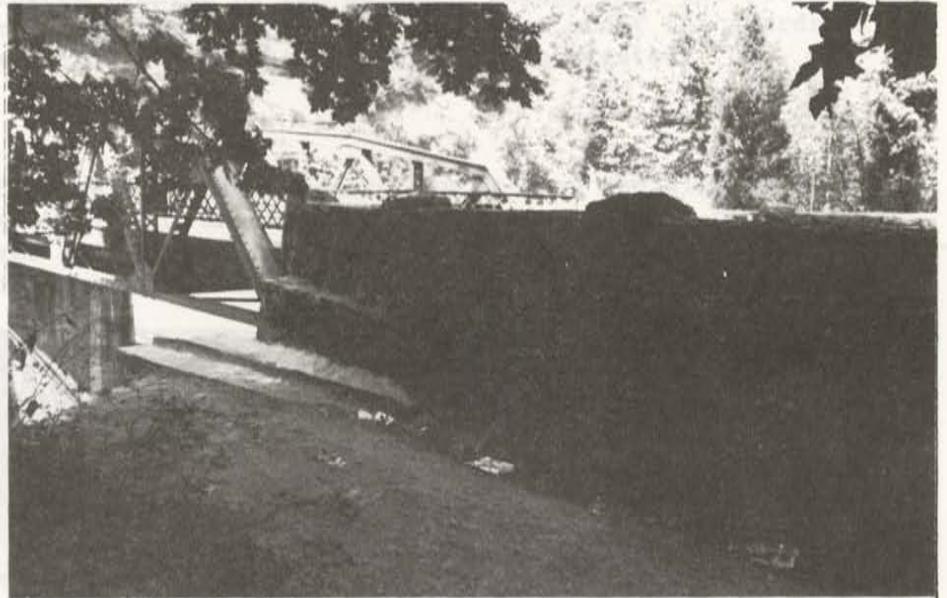
Although most structural cracking in the stonework of the guardrails was caused by vehicles, some areas have cracks caused by uneven settlement of the guardrails.

On the west end of the Sandy River-Stark Street Bridge, the guardrail adjacent to the bridge has a major structural crack at midspan. This is an old crack which has been repaired by grouting the crack with Portland cement. But, although the wall has been repaired, it has continued to move and the crack has reopened.

Recommendation. Periodic inspection should be made to cracks, and as they reopen cracks should be grouted with a mortar matching the original mortar used in the stonework. The forces created by the adjacent bridge onto the river embankment may have caused the settlement under the guardrail, and this possibility should be investigated.

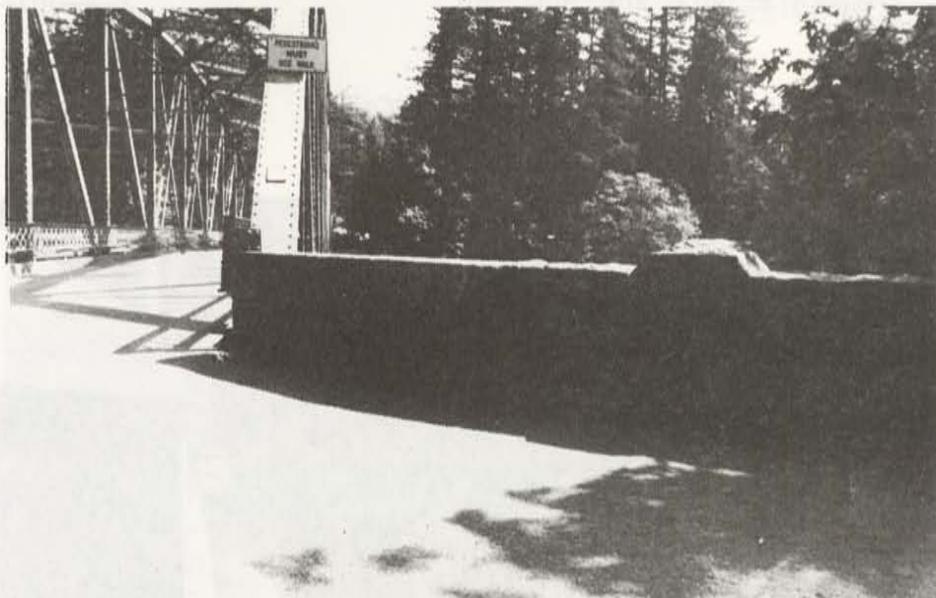
Repairs have been made to features on the highway that are visually and materially inappropriate to the original. At the east end of the Sandy River-Stark Street Bridge, a missing section of the guardrail was replaced with concrete.

This photograph shows how the replacement has destroyed the appearance of the original guardrail.

Recommendation. Missing areas should be replaced in stone matching the historic stonework in size, color, texture, and quality. The replacement of the missing areas of guardrail can be accomplished by either rebuilding the wall as a solid stone wall or as a concrete wall faced with stone to match the historic appearance of the original.

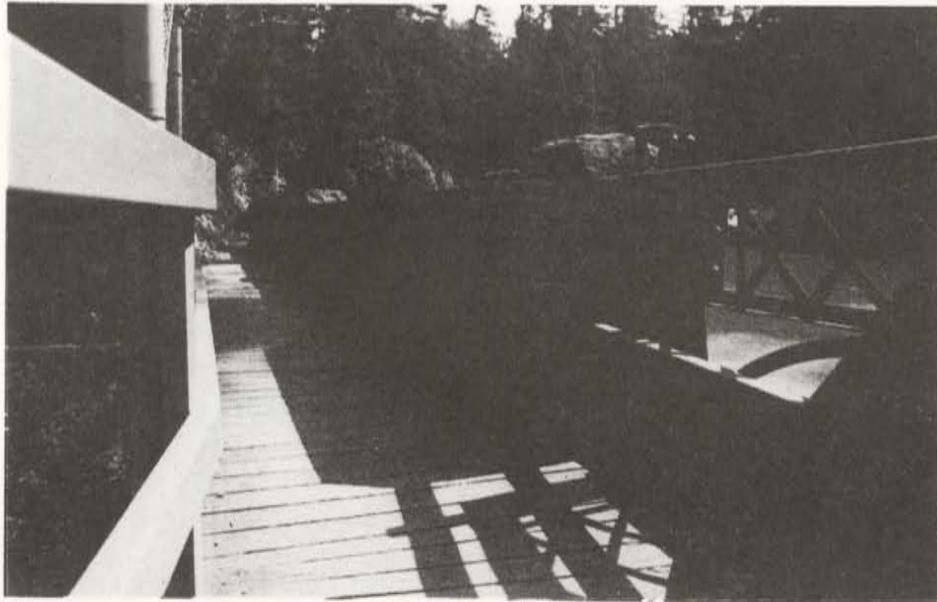
Along the walkway at the west end of the Sandy River-Stark Street Bridge, concrete reinforcement was added to the guardrail. It cannot be seen from the road which is good, but it is visible to pedestrians from the sidewalk. This kind of reinforcement should only be considered where it is visually and physically concealed.

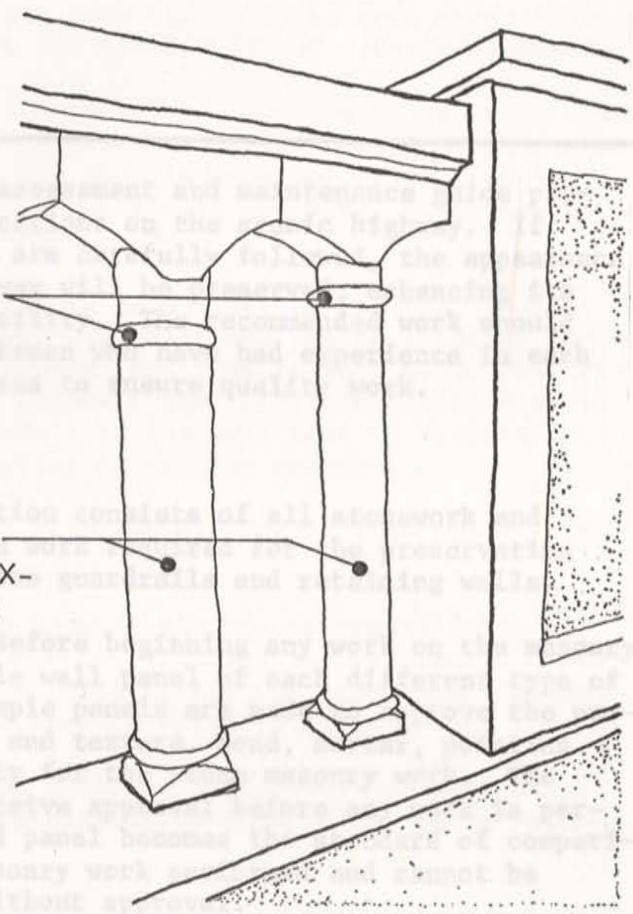
DIFFERENT LOCATION OF THE ASTRAGALS

SIZE DIFFERENCE IN BALUSTERS IS APPROXIMATELY 1 1/2 INCHES IN DIAMETER.

Recommendation. On the bridge at Bridal Veil Falls, the rhythm of the balusters is interrupted by a change in size (see drawing on following page). It is not yet determined which balusters are original although it appears to be the thinner members. Investigation should be made into which size baluster is historically correct and any further replacements should be made to that size.

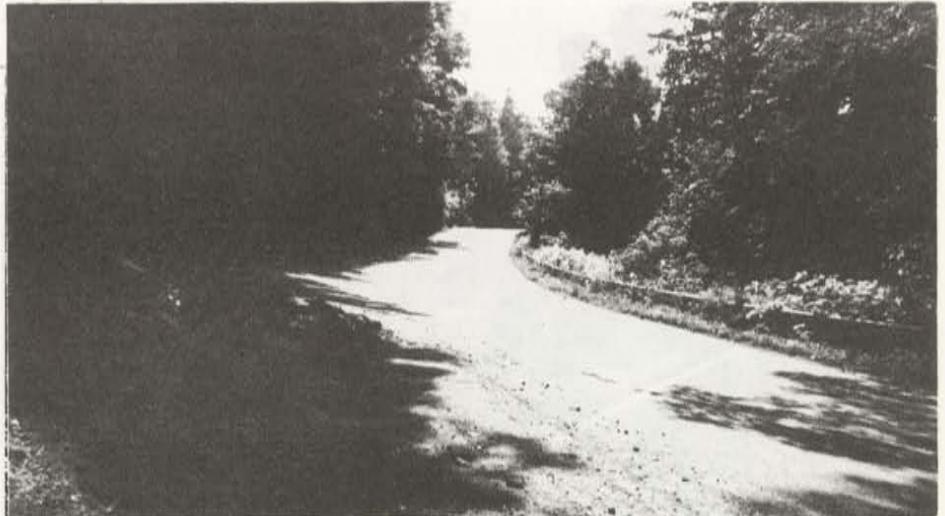
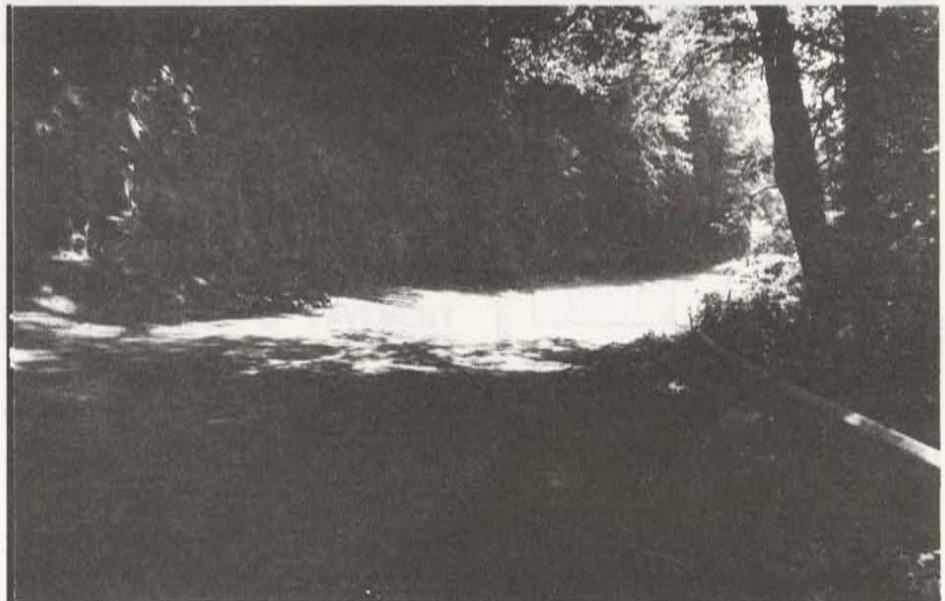
Subsidence of roadway.

About one mile west of the Crown Point Vista House is a section of the highway that is settling. This section is approximately fifty yards long. Information from the state landscape architect indicates that the road is sinking six inches a year in this area. The hillside in the area is settling to its slope of repose and, until this is reached, the roadway will keep sinking.

Urgent. Recommendation. For years the state has been resurfacing this area of the road to build up the level of the roadway. This is the best short-term solution for this problem. However, at some time, a slide could force the closure of this section of highway. This section has more associated structures than any other segment, and it would be a great loss to the highway. The state highway department should investigate this area for a long-term solution to the settlement problem.

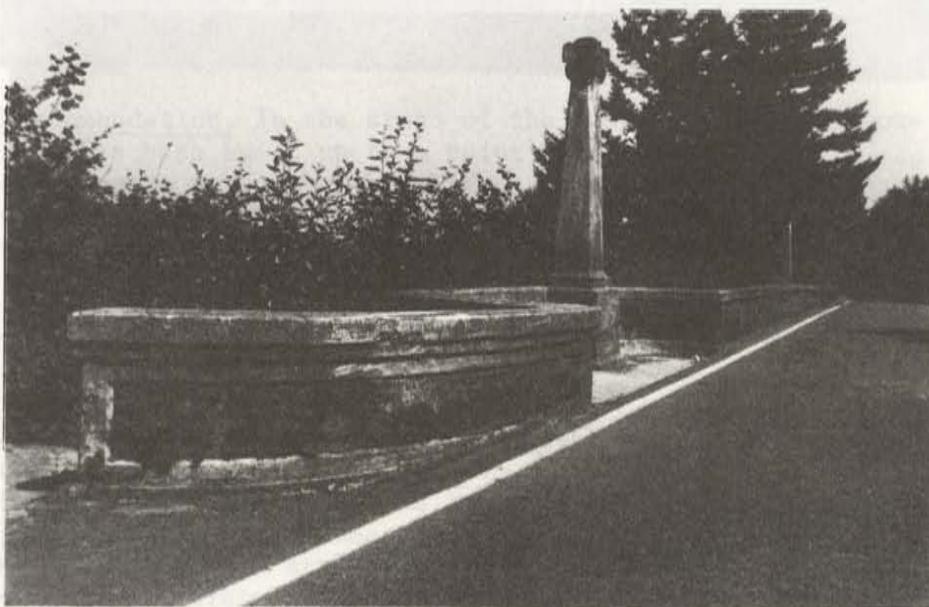
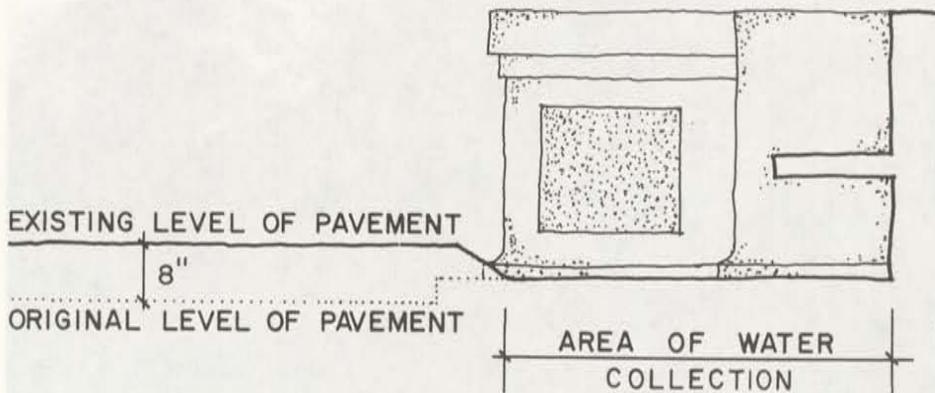
EXEDRA - STARK STREET

Paving material buildup. Drainage from road surface has changed since the historic surface was first laid. As seen at this exedra on a bridge near Troutdale, the road surface has been raised approximately eight inches.

Recommendation. In the areas of the roadway where the surface has been built up to a point where standing water could cause damage to the highway's historical features, the grade should be lowered to the original level, and original drainage re-established.

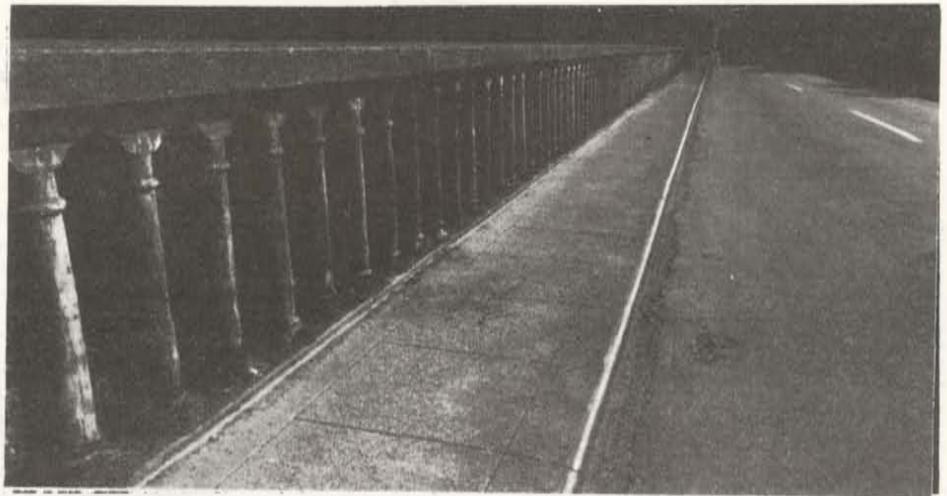
Another example of paving buildup is Shepperd's Dell Bridge where the road surface has been raised to a level almost equal to the sidewalks on the bridge.

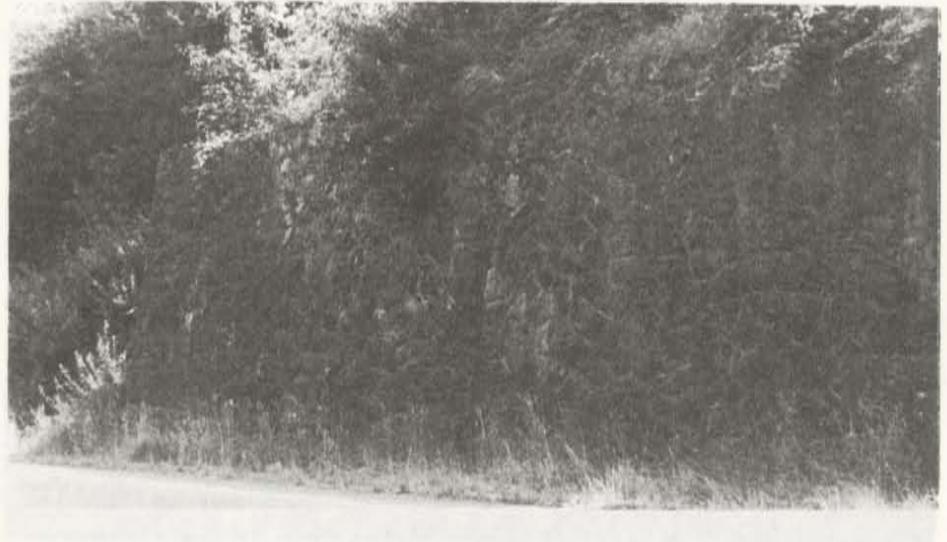
Just outside of Troutdale is a large retaining wall about ten to twelve feet in height. On the east end of the wall the earth is eroding behind and around the retaining wall. If the erosion continues the wall will lose its support which could cause structural cracks and collapse at the end of the retaining wall.
