Shellrock Mountain

Lindsey Creek

Starvation Creek

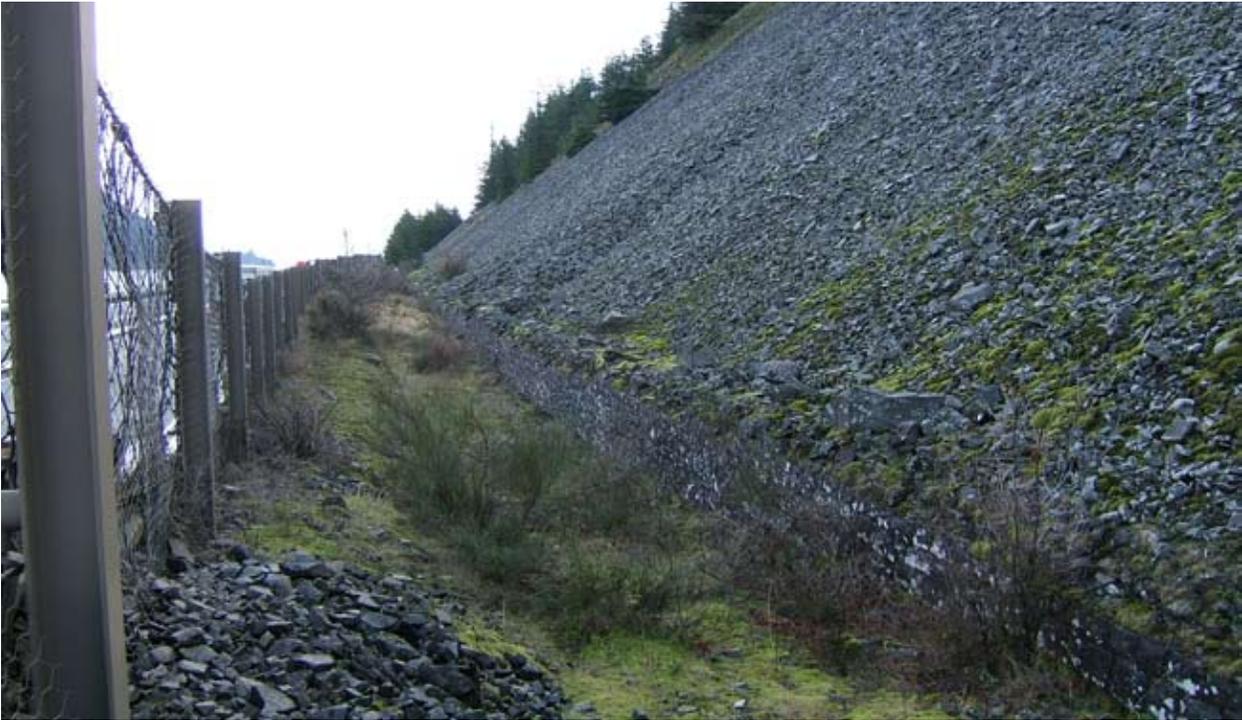
Two fragments of retaining wall remain. The first is about 400 feet long near the west end of the section, built of large, ashlar and hewn basalt or diorite stone. This is about 6 feet tall, but the top of it is broken in many places. The stones vary from coursed in some areas to random in others. Fragments of wall, concrete, and of mortared rubble

masonry parapet are piled along the top of the wall, and talus has accumulated there as well. These wall fragments reveal how thick this retaining wall is, and the size of the stones used in it. The second retaining wall, located about two thousand feet east of the first, is about 150 feet long and 10 feet high, but like the first the top is broken or missing in places. The stones are hewn basalt, laid in a random arrangement with some mortar at least at the top. This second wall is buried in vegetation and overgrown with trees. It is in poor condition, but impressive nevertheless.

Retaining wall and rock catchment, Shellrock Mountain

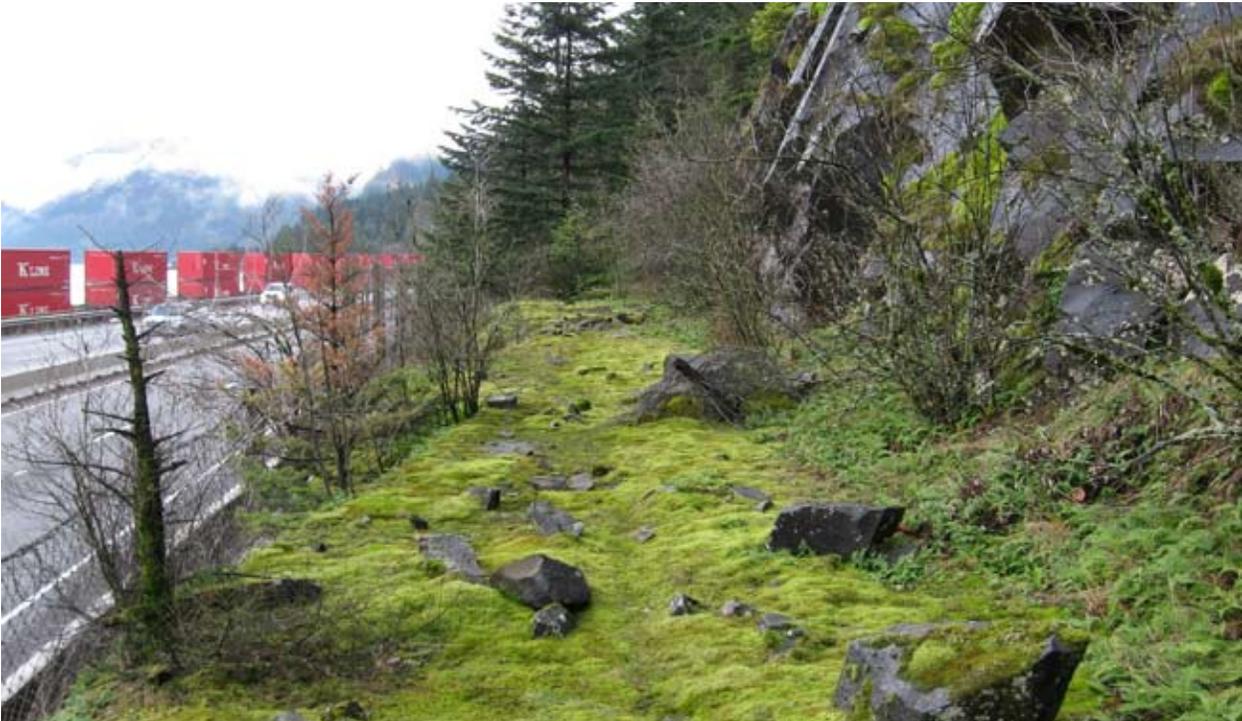
The overall topography of this portion of the HCRH is characterized by an even grade around the toe of the mountain, below the talus slopes. There are two rock cuts that remain, each about 100 feet long and 70-90 feet high.

HCRH roadbed and rock cut, Shellrock Mountain

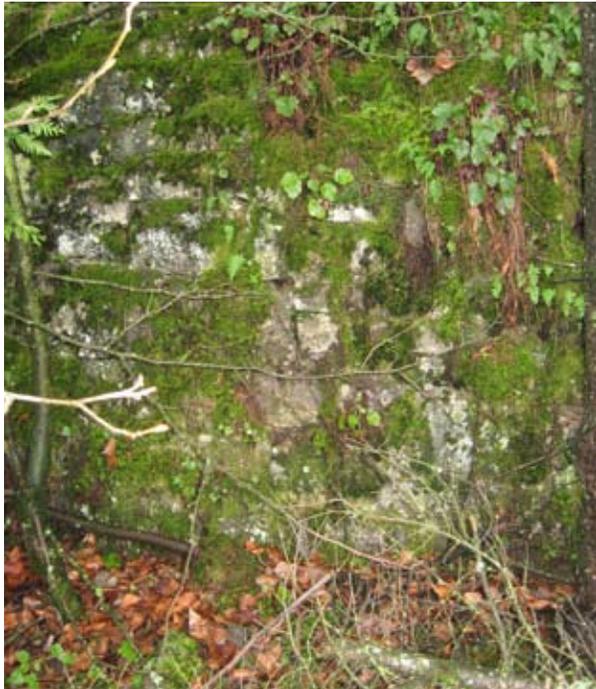
Retaining wall, Shellrock Mountain

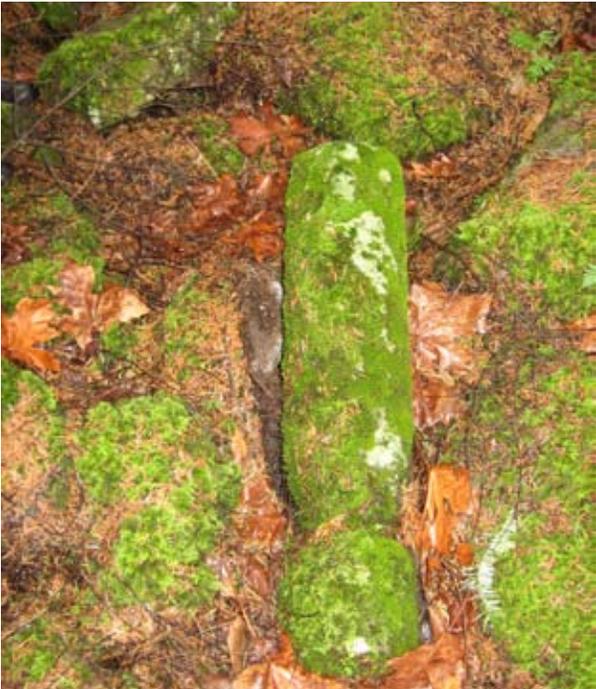
Archaeological features identified by the inventory survey include remains of concrete guard rail from the 1940s and concrete rubble by the side of the road, the original location of the plaque commemorating the “honor men” who built the road replaced by the HCRH.

Concrete guard post, Shellrock Mountain

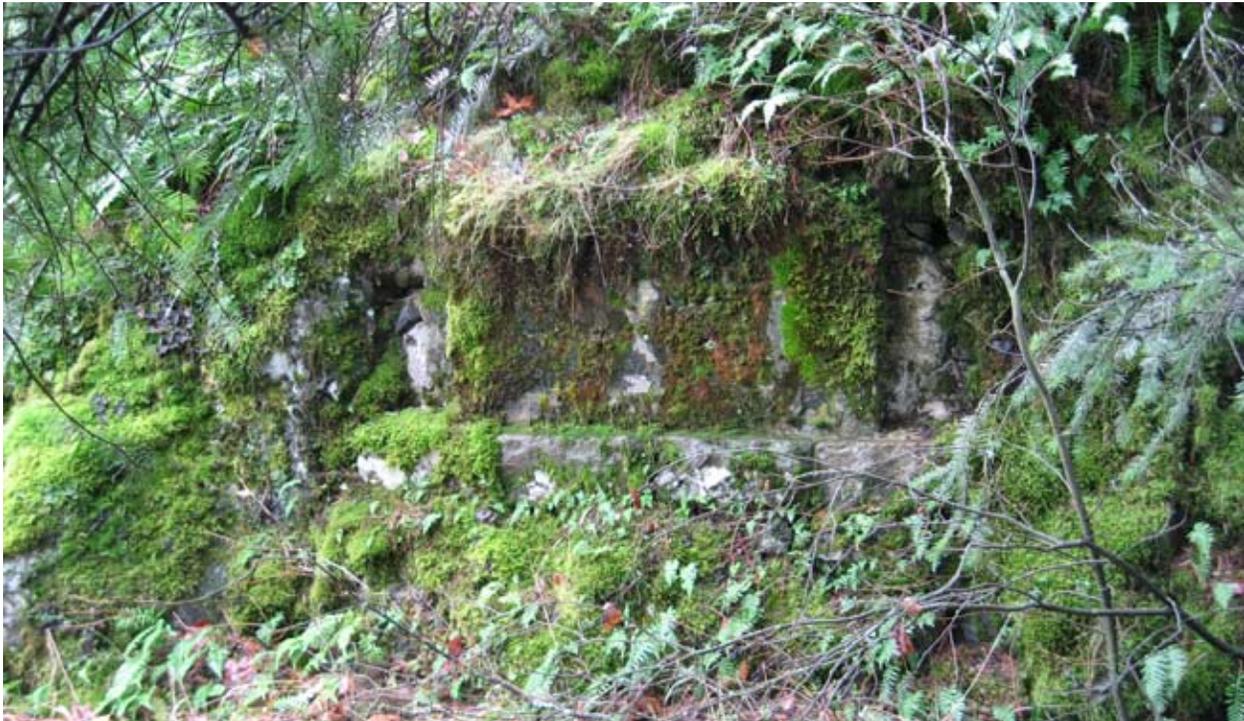
Plaque site, Shellrock Mountain

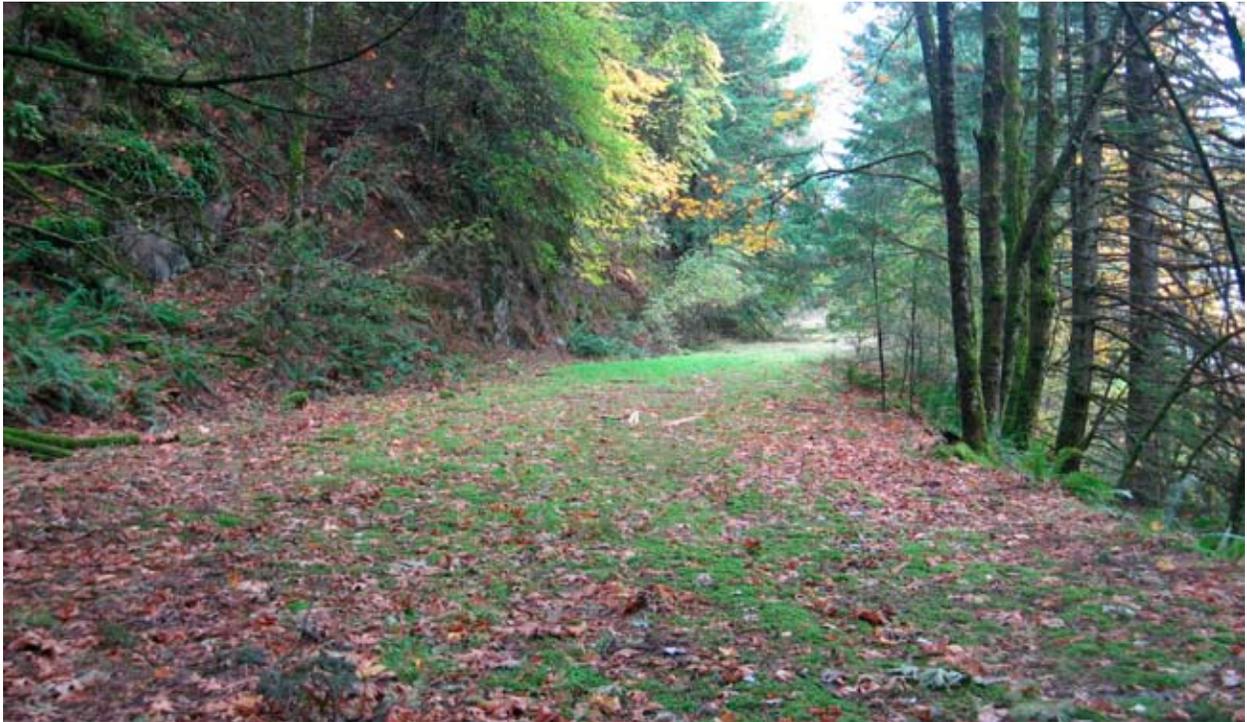
The roadbed of the historic highway is covered in a few inches of duff and moss through out the fragment. Below this layer, the pavement appears to be in good condition, with the centerline still apparent. There are three wye intersections with

Road surface, alignment, rock cut. Lindsey Creek Segment.

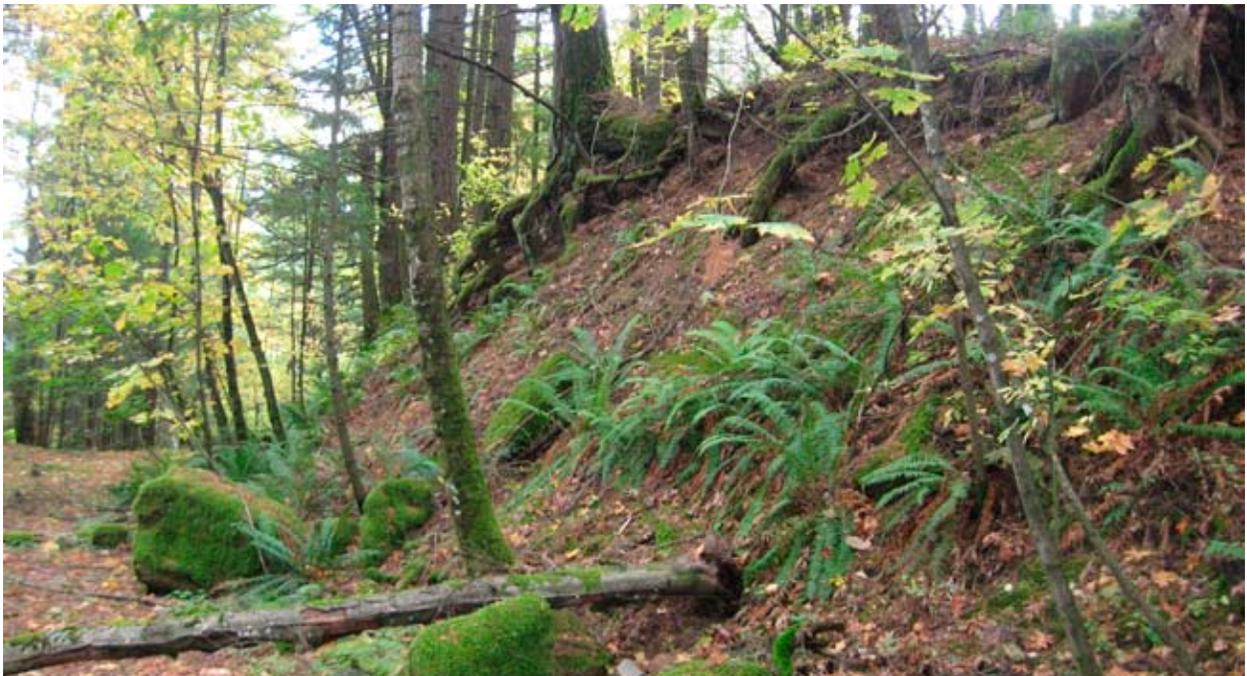
The rock cuts in this section are in fair condition, compromised by some minor rock fall and slides, accumulation of soil in gutters, and small trees and other vegetation along the road edge. The large rock cut at the eastern end was not evaluated as it is past the end of the fragment and inaccessible. There are three fill-throughs. Two are in fair condition, with blocked drainage structures. One is in poor condition, with blocked drainage and overgrown vegetation. The two cut-throughs in the fragment are both in fair condition. They are overgrown with vegetation and sapling trees, and one of them has formed an eyebrow of soil undercutting its top edge, compromising the stability of trees above. Both cut throughs have some slumping or rock fall into the roadbed.

Cut-through, Lindsey Creek Segment. The eyebrow of this cut is compromising the trees and integrity of the slope. Fallen rocks and vegetation are also damaging.

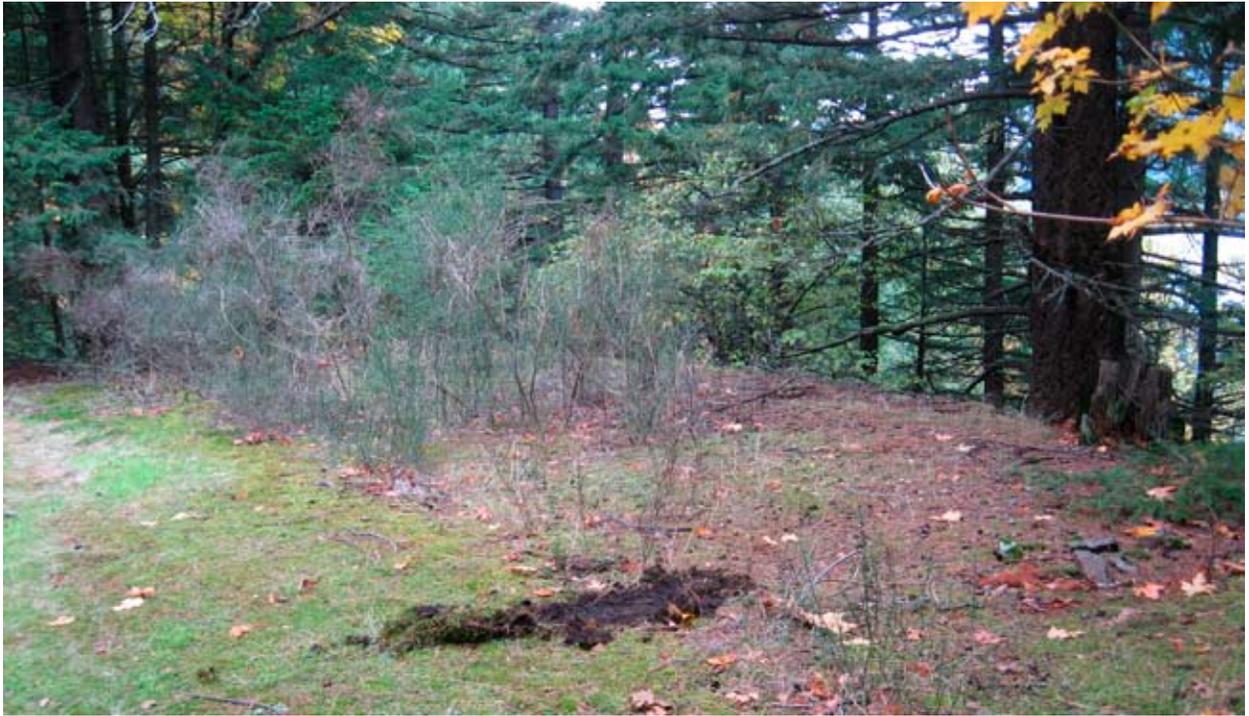
short, unpaved side roads, all of which may be remnants of roads visible on the 1939 aerials. These are all in poor condition, covered in debris, overgrown with vegetation and/or washed out. A currently used graveled access road forms a tee intersection with the Historic highway. A lens shaped turnout associated with a rock cut, masonry wall and road or trail to the north is in poor condition. Its surface is covered in moss, with no evidence of pavement underneath. It is overgrown with Douglas fir and big leaf maple seedlings, and with invasive Scotch broom.

Turn out, Lindsey Creek Segment.

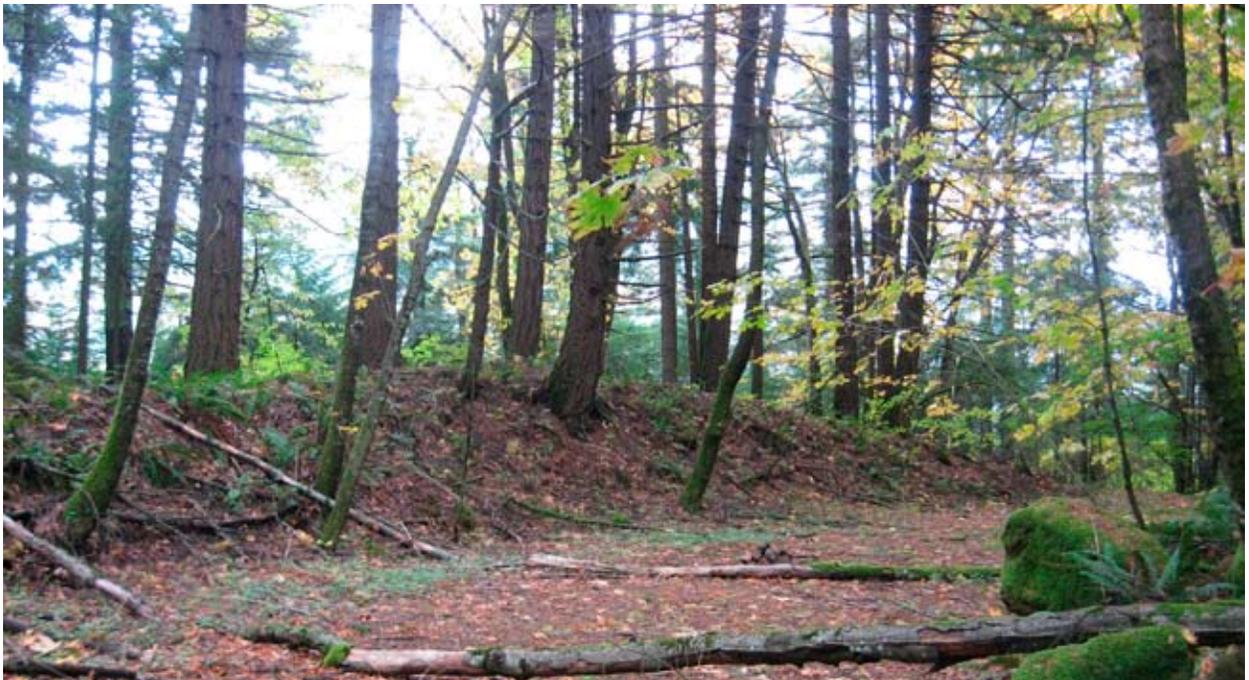
Cut through, Lindsey Creek, overgrown with trees

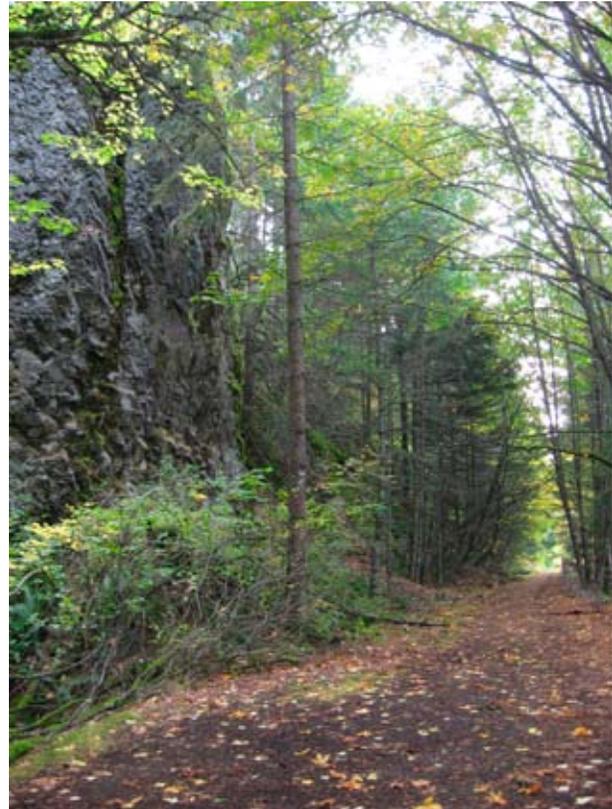
intact, with some crumbled areas and potholes. It is covered in a thin layer of duff and mud. The gutter area along the south edge is buried in debris and overgrown with vegetation. There are two areas where slides have brought rock and mud onto the road. The historic highway pavement terminates at wheel 1207 along the centerline, near the off ramp from I-84.

Cabin Creek area, Starvation Creek Segment. Overgrown vegetation along road edge, slide (right, background), debris and mud build up on edges of the road surface.

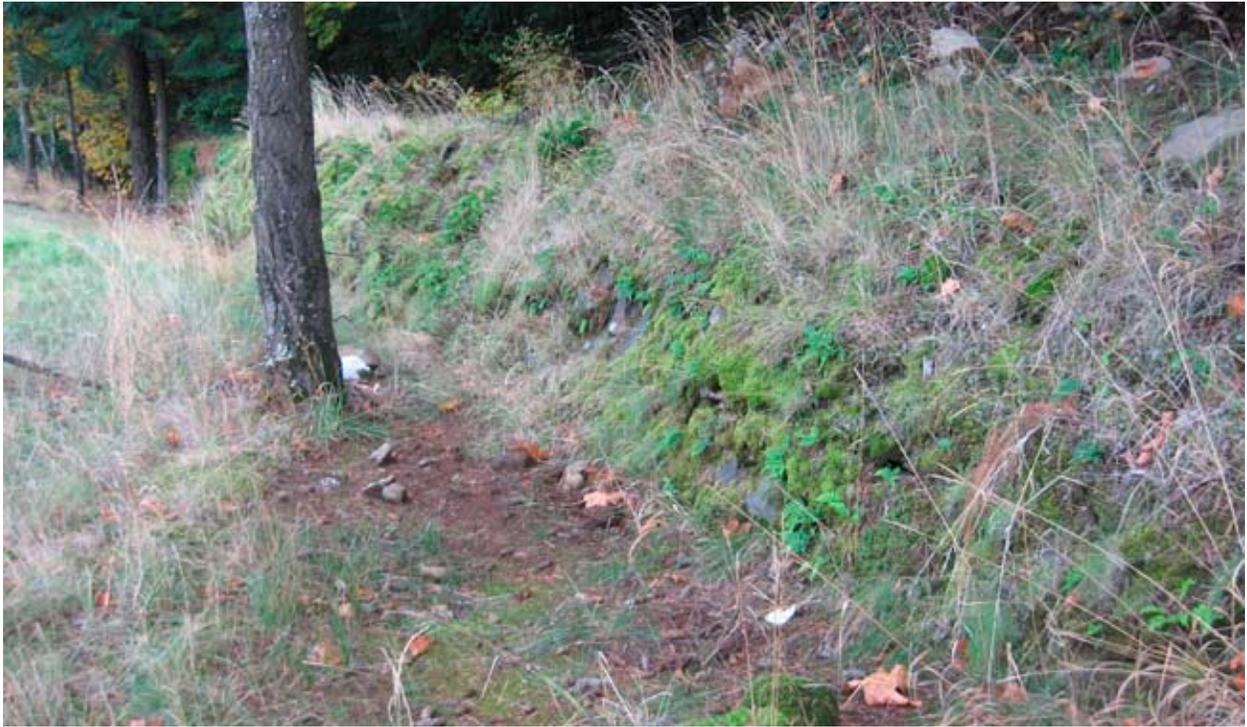
The retaining wall below the road is a portion of the long retaining wall built by Elliot. It is a 267 feet long dry-laid battered basalt stone wall, standing

about five feet tall. The stones are hewn and bossed, and laid in a random to semi-coursed pattern. The top layer of stones has been mortared. Now covered in moss and fern, with many missing chink stones, it is in fair condition. A contemporary wire and steel post fence runs along the top of the historic retaining wall.

Retaining wall north of Historic highway. This may be part of a longer wall. It is damaged by the ferns and other vegetation, missing chink stones.

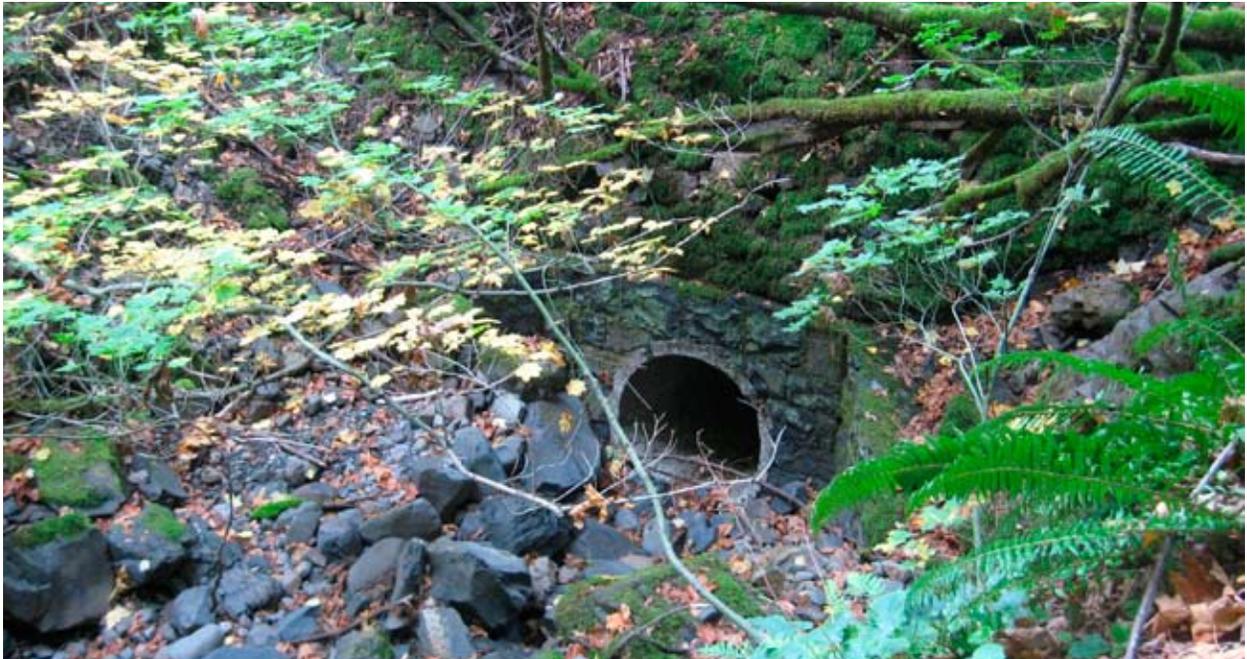
segment. The Cabin Creek culvert was designed to be seen from the trail to the Falls, and consists of 36" concrete culvert set in a six foot wide headwall of coursed basalt stones that have been hewn and bossed, laid with mortar. Above and to the sides of the mortared headwall is a continuation and wing walls of unhewn, dry laid rubble wall. This rubble wall appears to have been repaired or modified at some time. Because of these modifications and some missing stones, the culvert is considered to be in poor condition. A second concrete culvert with basalt stone detailing around the mouth is in poor condition because it is almost entirely buried and clogged.

Cabin Creek culvert. The style of this culvert suggests it was meant to be seen from a path to the fall.

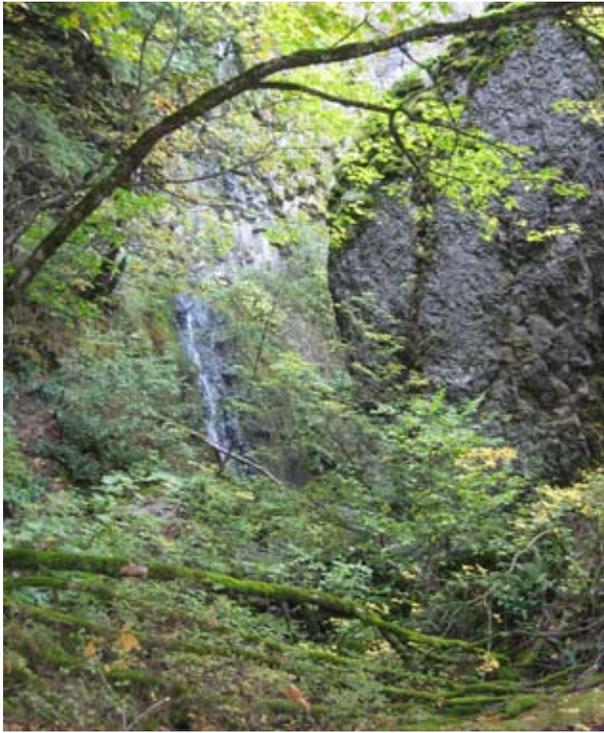
The major view in the segment is a framed vista of Cabin Creek Falls from the road. The view of the falls is framed by a towering boulder or rock outcrop. The 1939 aerial shows this area as more open than it is today; now it is overgrown with trees and vegetation. To the east of the falls is another view of rock columns, also obscured by trees.

Cabin Falls vista, Starvation Creek Segment

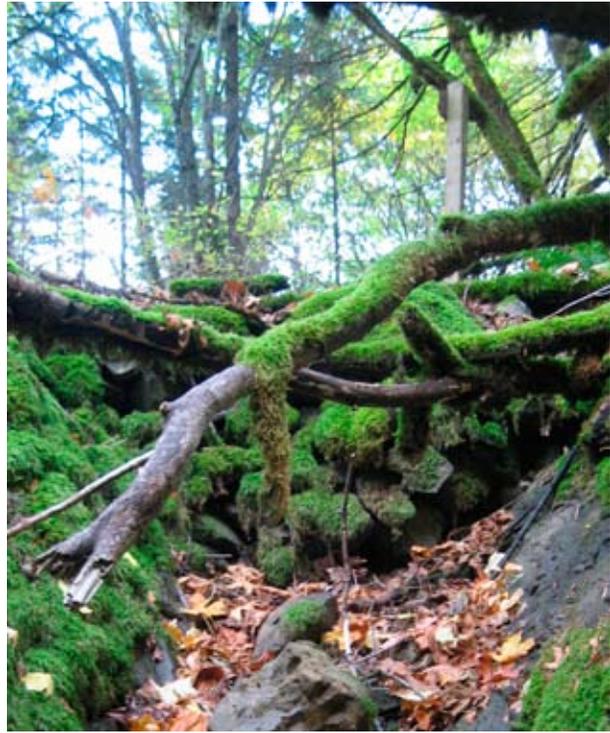
Detail, rubble headwall, Cabin Creek

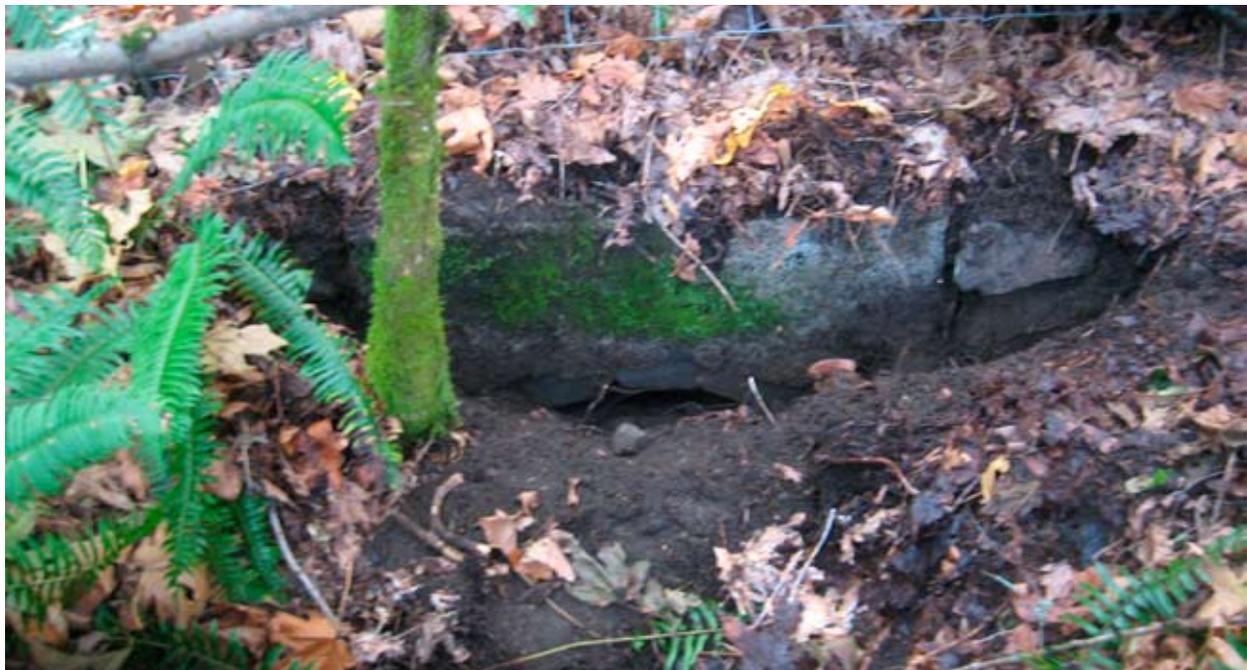
Buried, clogged culvert, Starvation Creek Segment
