## Viento

## Mitchell Point

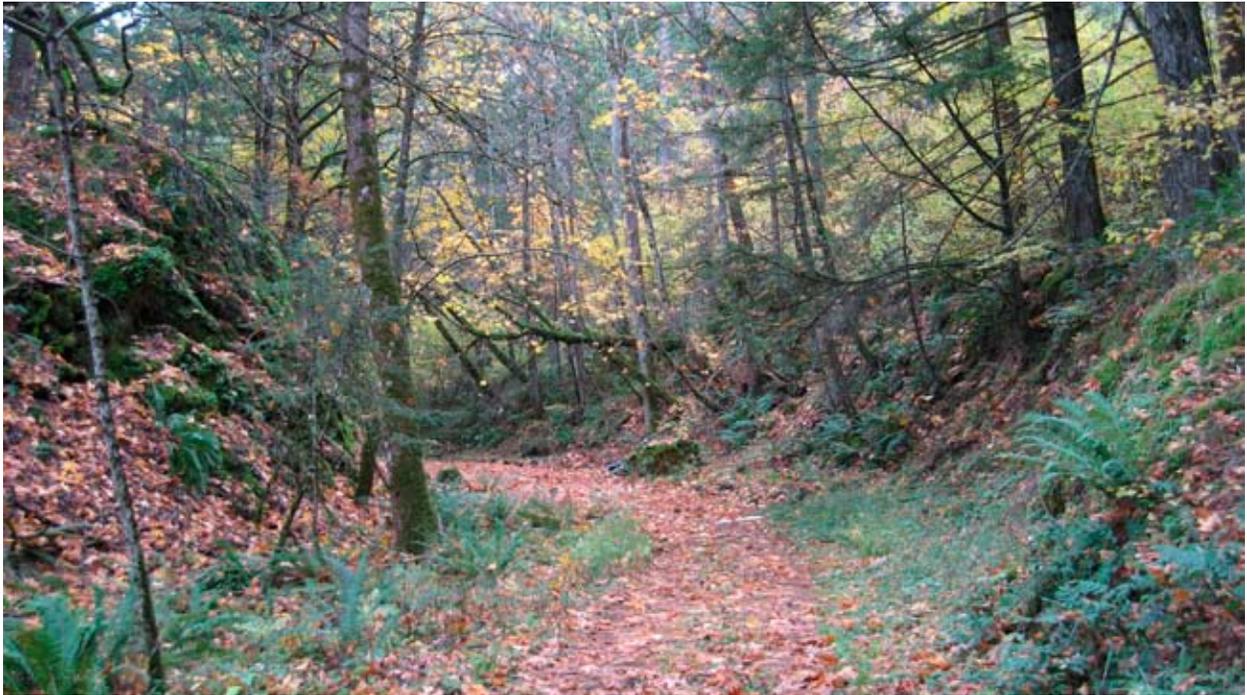
The first segment of road runs through a relatively flat area at the base of the rocky point to the east of Viento Creek. At the start of the segment is a rock cut associated with this point. It is in poor condition, with debris and boulders slumping into the roadway and vegetation filling in the road edges. The rock cut forms the north side of

a cut-through, of which the right edge, a soil bank, is eroded and overgrown. The road then continues on fill just above the toe slope through a broad, shallow draw. The third fragment also begins at its western end with a cut-through and rock cut. This rock cut is on the north side, with a soil cut on the south side. Both are in poor condition and overgrown with vegetation.

*Cut through with rock cut, Viento Segment 1.*

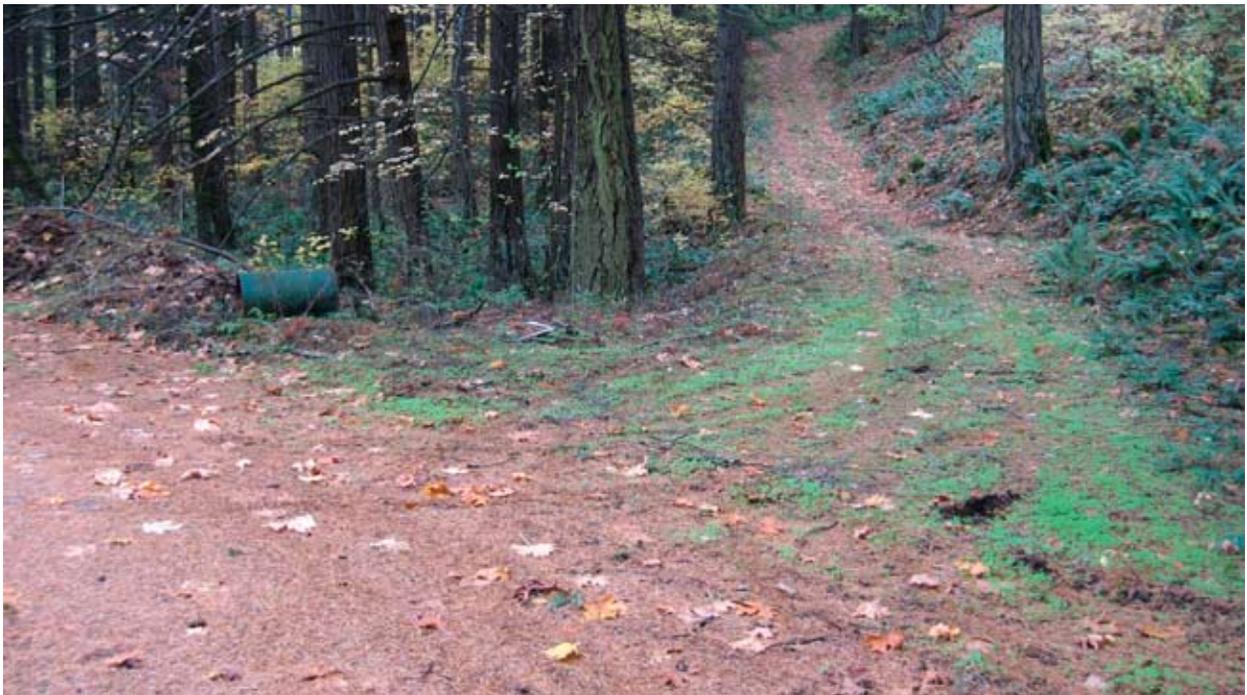
A dirt access or logging road intersects this segment, forming a tee intersection. It connects

to the Viento maintenance yard to the east, and an unknown destination to the southwest.

*Intersection with maintenance road, Viento Segment 1*

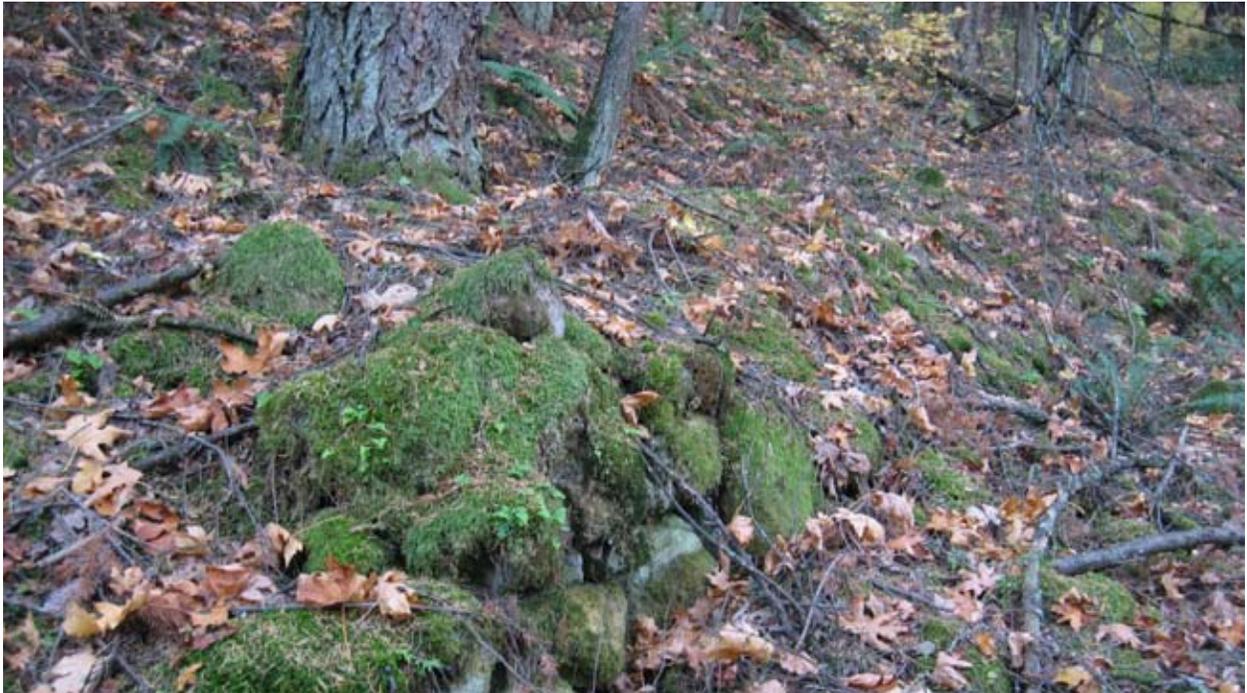
*Stone wall and remnant of trail up draw, Mitchell Point Segment 2*

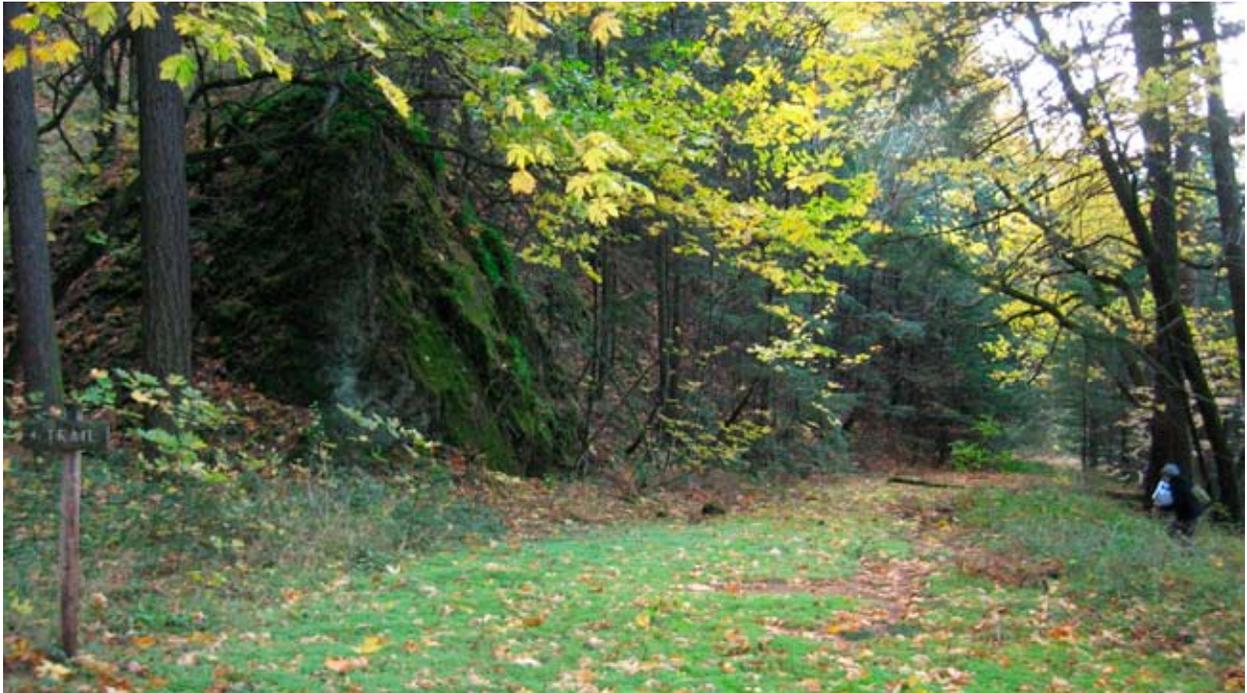
In the middle segment of the HCRH (Mitchell Point 2) the road surface is generally covered in several inches of duff and low vegetation, and the edges of the road are damaged by trees and shrubs filling in the shoulder and gutter areas. There are stretches of intact pavement, some of which may be Warrenite. The pavement in this section has been washed out by Mitchell Creek in one area (wheel 1481 ft.), and taken up and piled on the roadbed during the construction of I 84 in another (wheel 448 – 658 ft.). There was also a lens-shaped turnout or parking area associated with a wide shoulder, which is in poor condition and overgrown with vegetation.

*Mitchell Point Segment 2, Wyzant trail intersection. Overgrown pavement, clogged drainage system.*

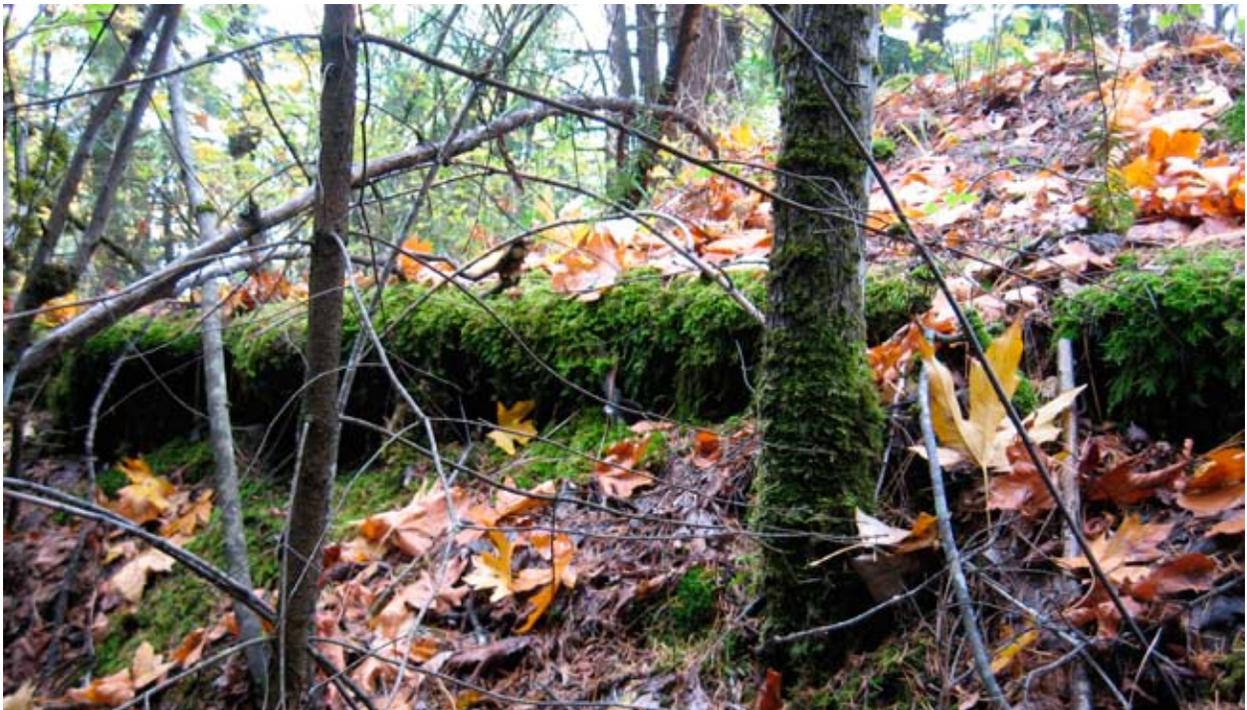
Mitchell Creek itself was diverted at some time, and cut through the remaining fragment of the Highway, leaving a short stretch of pavement and revealing the broken edge of the Warrenite

pavement above the creek. This diversion is apparent from the washout of the highway and earthworks in the area.

*Pavement edge, washout at Mitchell Creek, Mitchell Creek Segment 2*
