Historic Columbia River Highway (HCRH)
Crown Point Viaduct Restoration

Project Overview

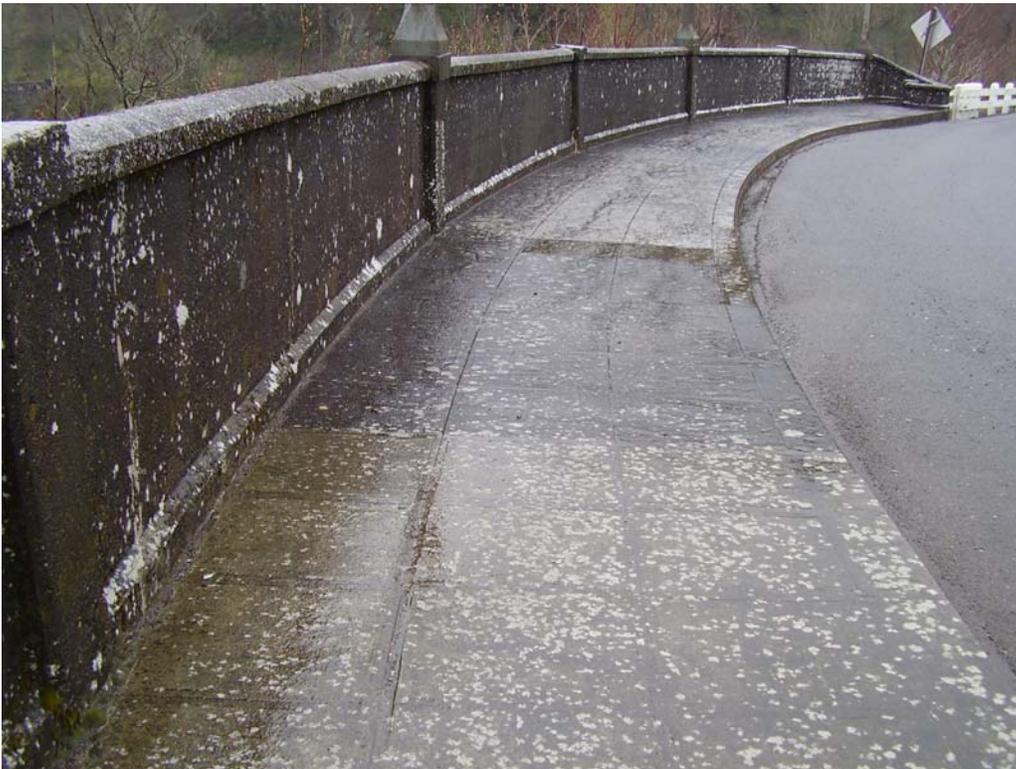
There are several large areas of delamination in the surface area of the deck. There are also sections of the deck that have different appearances from various repairs over the years that don't match. Several generations of deck repair with varying resulting appearances have been conducted in the past. Records of these repairs are unknown.

Existing and previously repaired Top of Deck surface.

- The rehabilitated structure should have a constant color and texture similar to the weathered original existing concrete. All cracks should be repaired and the crack repair blended to match adjoining surface color and texture.

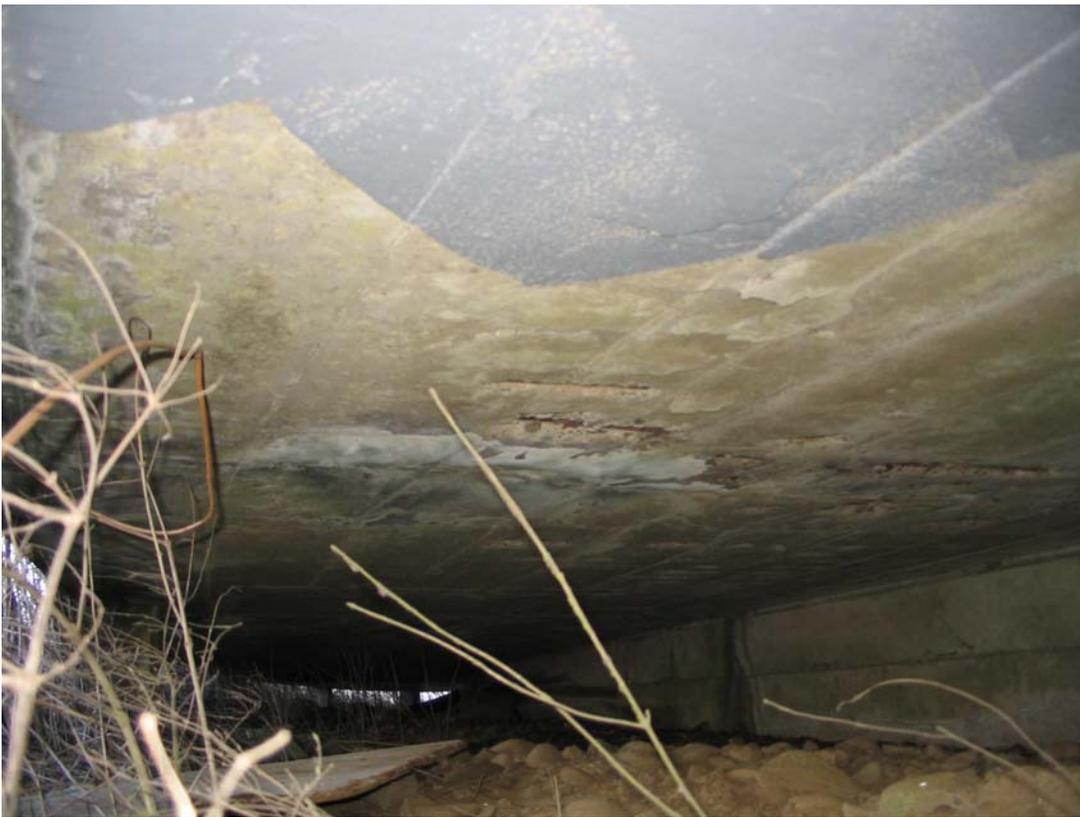
A portion of the bottom surface of deck has been coated with paint. The results of this alternatives analysis are not dependent on the nature of this paint. However, its presence is noted as the need to remove is discussed in the project goals narrative of this report.

Approximately 50% of the bottom surface has deterioration, which can be described as spalling, reinforcement delamination, and deficient past repair.

Bottom of Deck deterioration and paint.

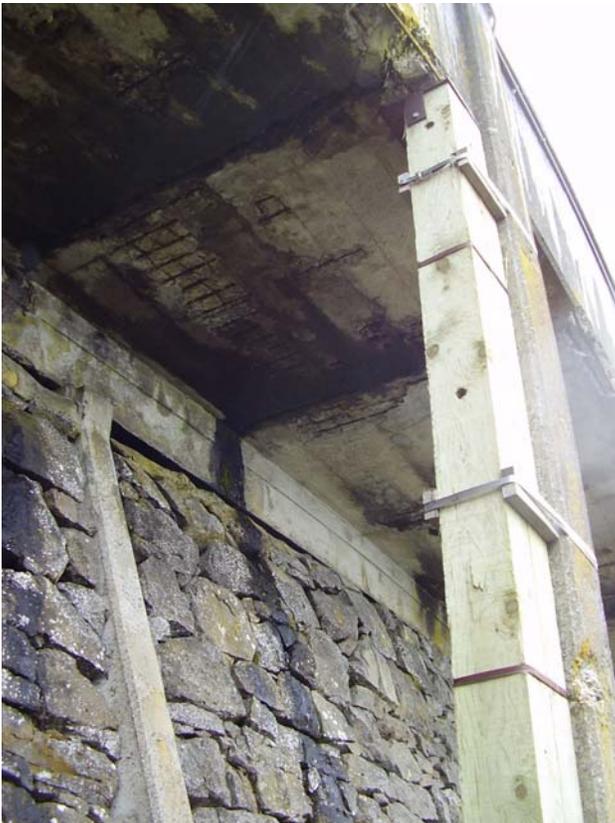
Approximately 50% of the longitudinal beam has deterioration corresponding to that described for the bottom surface of the deck.

These beams have been cracked at a number of locations directly adjacent to supporting columns. In reaction to this cracking, maintenance staff has installed temporary timber posts adjacent to the exterior columns under the parapet at these locations as a precautionary measure to assure that further deterioration will not result in structural collapse.

Deterioration in longitudinal beam under parapet.

Note: Location of longitudinal beam above rock revetment and under roadside curb.

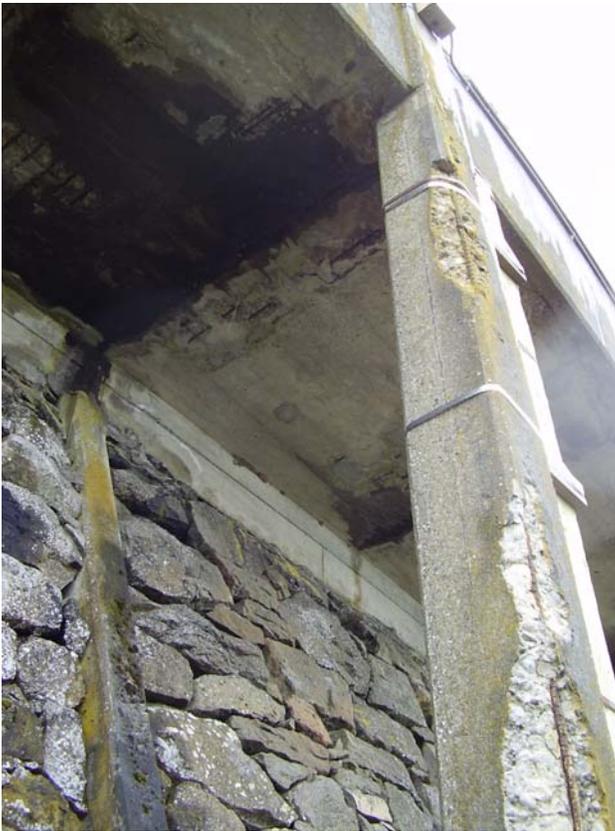
There are several large areas of deterioration consisting of delamination and concrete spalls. There are also sections of the columns that have different appearances from various repairs over the years and do not match the appearance of the original concrete.

Concrete deterioration in column and timber post strengthening.

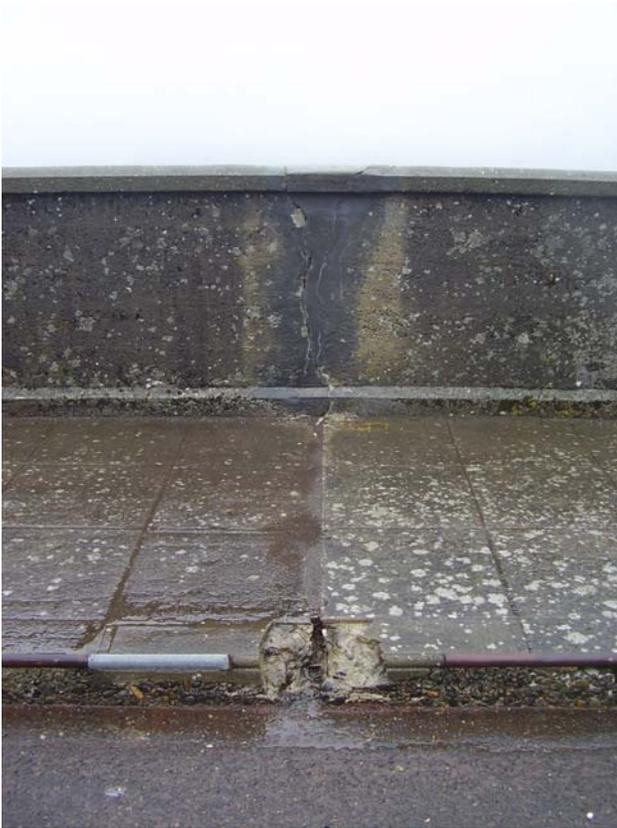
Generally, the concrete railing was found to be in good condition. There are cracks through the parapet at the crack locations noted in the longitudinal beam discussion above and in addition the parapet is cracked between Columns No. 19 and 20.

Several of the cracks have been filled with concrete epoxy grout that does not match the appearance of the adjacent concrete.

Broken parapet between columns no. 19 and 20.

- The completed project should have a minimal amount of required maintenance for 50 years. The goal is for a permanent repair.
- The design loading would be at 85 lbs per sq.ft. for pedestrians and evaluated for a vehicle wheel load such as a “Tour Bus”. It was noted that curb and parapet damage between columns 19 and 20 are indications of a vehicular overload at this location.

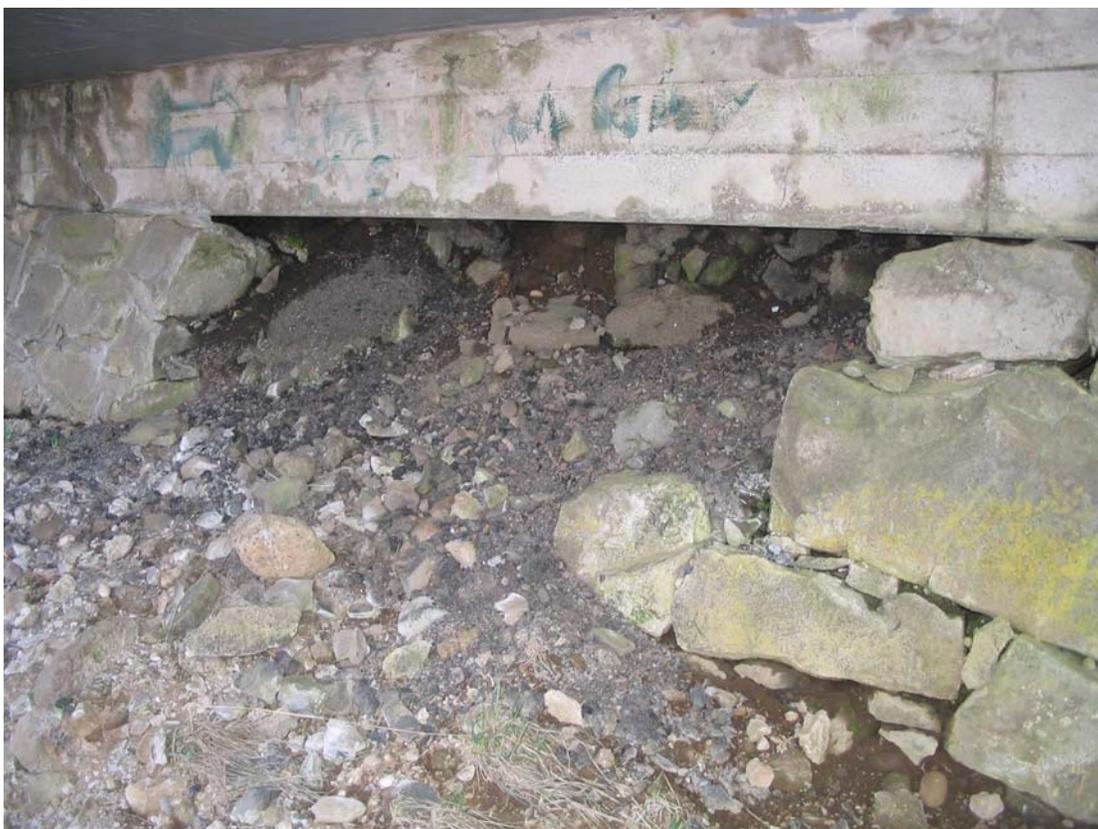
There is one section of the wall between Columns No. 18 and 19, which has collapsed.

Collapsed portion of revetment

- The grout in the rock revetment is not historical, but need not be removed as it is not visible to visitors. If necessary, establish drain ports through the grouted revetment to provide for relief from hydrostatic pressures.
