ROAD SAFETY AUDIT

Cornelius Pass Road Multnomah County, Oregon July 1-3, 2008

**Primary Author:
Nicholas Fortey, P.E
Safety Engineer
Federal Highway Administration, Oregon Division**

December 2008

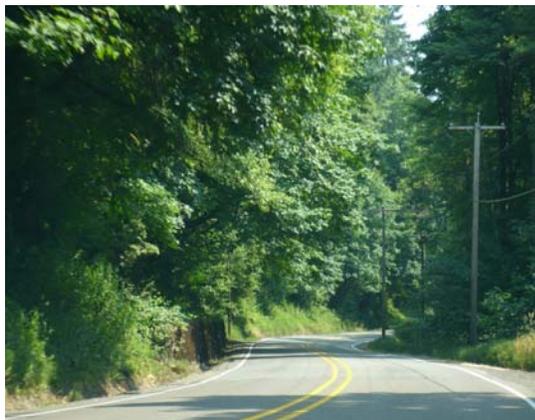
The lower section of Cornelius Pass Road in the SB direction had two rock walls close to the roadway. The aged concrete and moss covering made the wall difficult to see in the daylight hours due to shadows from trees and very difficult to see at night as the wall did not markedly stand out from the dark background.

While the recommend treatment for the rock walls is to install a crash-worthy end treatment, the leading edge of these walls should be delineated as the walls are close to the roadway, on horizontal curves, and difficult to see due to the forest canopy and dark color of the walls.

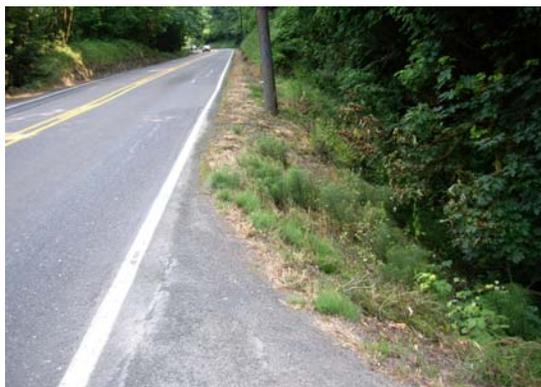
There were numerous utility poles along the corridor. Several of the poles were close to the roadway; moreover, several of these were not delineated or were located near the outside of curves where they might be struck by errant vehicles. Of note, several crash reports noted collisions with utility poles although it was difficult to determine which pole had been struck. Perhaps even more surprising was that in none of those crashes did serious injuries apparently result.

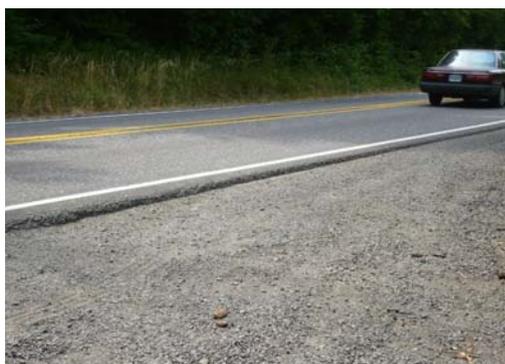
As noted, the narrow traveled way and lack of continuous shoulders and, where present, only narrow shoulders, points to the need for improved efforts to keep vehicles on the roadway. As may be expected, the narrow travel way, curvilinear alignment, and speeds increase the likelihood of vehicles occasionally straying across the paved edge of the roadway. The likely incursions of a vehicle's tires onto the gravel shoulder could result in, and was noted to result in, a drop-off condition at several locations. An errant driver losing control

of a vehicle due to a tire straying of the edge of the paved roadway may attempt to wrest control back, with the tire scrubbing the edge of the paved roadway prism; the driver may become frustrated by efforts to redirect the vehicle and may overcorrect by pulling hard on the steering wheel. This can cause the vehicle to lurch to the right or to

cross over the centerline and collide with an opposing direction vehicle or continue and run off the roadway on the opposite side.

Introduce an asphalt wedge during repaving or under maintenance operations to limit pavement drop-offs

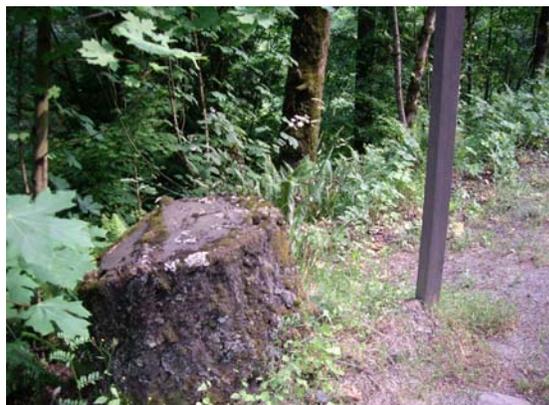
The review also noted other fixed objects adjacent to the roadway, beyond the already mentioned telephone poles and drop-offs, which are also remarkable due to the limited number of incidences, and in this case, the limited efforts necessary for their removal. For example, on the outside of one curve, just beyond the useable shoulder, lay a tree stump. While a single point hazard, its existence is less remarkable for its representation of the range of fixed objects than by the ease with which this one hazard could be removed. There were

also numerous small trees and brush which could grow into larger and potentially more difficult-to-remove hazards (such objects can also reduce sight distance although that is dealt with in a separate issue section of the report).

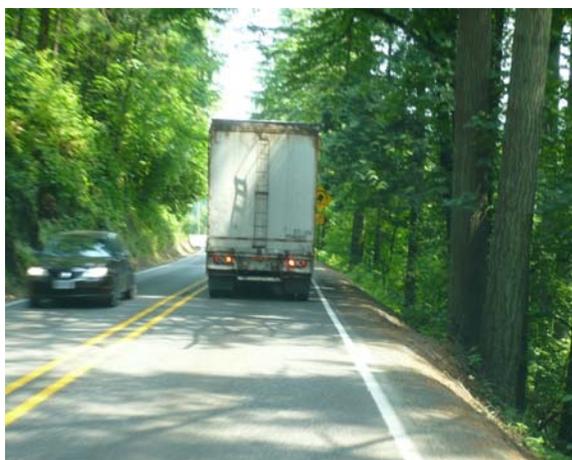
The steep embankment northbound just prior to the S-curves is unshielded and has only a minimal shoulder past the striped edge line. Large trees are present about 10 feet off the edge of the traveled way and a steep (1:1 or steeper) drop-off (in excess of 100 feet) exists. While these conditions lead to a high ranking based on severity of outcome, the roadway is on tangent alignment at this point and there is no record of adverse crash history. Additionally, the length of the hazard, the constrained roadway prism, and the likely need to perform slope stabilization would result in a relatively costly remediation

(placement of guardrail). Thus, guardrail is not considered cost-effective in this location.

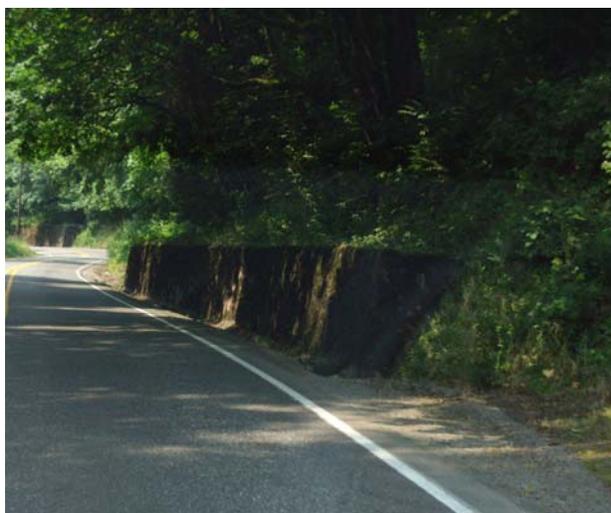
Proceeding southbound from Highway 30, the driver is presented with a series of rock walls on the right. The rock walls are linear hazards but the ends are considered point hazards. The potential for an errant vehicle to strike the walls is considered high as approaching vehicles come off Highway 30 with its considerably more open road context leading to higher expected speeds, while horizontal curves become introduced in this section. The consequence of a crash is also considered severe as errant vehicles would abruptly stop upon collision with attendant high deceleration forces.

The cost of treatment of these point hazards, however, would be relatively low. Given the high severity and moderate to high expected likelihood of errant vehicles in spite of no adverse crash history, installing

appropriate end treatments, such as tapered end cut into the back slope, is considered a high priority. Removal or relocation of the rock walls is not feasible as they provide slope stability in the presence of steep cut slopes. The walls are masonry rock walls with the rocks forming a rough curvilinear surface paralleling the roadway. While the rough surface may be a concern for vehicle snagging, a fronting guardrail would reduce the shoulder width and a cast-in-place safety shape rock wall would be expensive; the road safety audit team concludes that while this should be examined an appropriate end treatment remains the far higher priority. Currently the ends are unprotected. Casting a concrete safety shape end section which could then be itself terminated by standard practice of burying into the back slope of the cut would provided a safe transition. Similarly an alternative design could be employed to use a guardrail end section buried into the back slope or terminal section. Given the presence of the cut section and, limited space to generate acceptable end section performance, a buried into the back slope treatment is recommended.

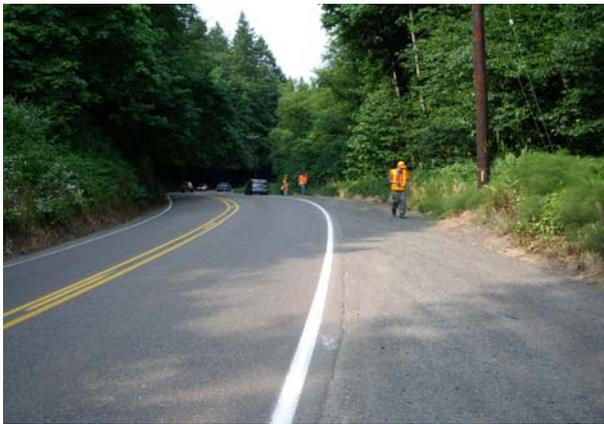
In the opposing direction a slight curve to the right is followed by a curve to the left. Both curves are unsigned and follow a section of the roadway where, based on observation and roadway character (the descending grade and the transition out of the section with a high density of horizontal curves), vehicle speeds are likely to increase. Additionally, there was a recent fatal crash at this location where a vehicle went off the roadway embankment. While the crash report does not enable firm

conclusions to be made on the cause, the severity may be addressed by guardrail installation. Moreover, the physical conditions here would appear to allow installation with sufficient offset from the traveled way and allow installation of a crash worthy end terminal without requiring extensive additional grading or fill material.

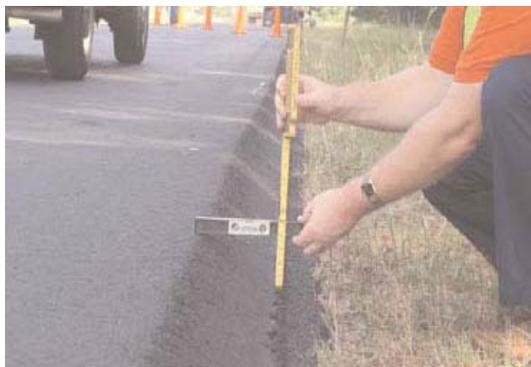
While acknowledging that pavement resurfacing is both a relatively costly and future year action (the condition of the pavement during the review did not indicate a need for resurfacing), future planned resurfacing should strongly consider incorporating an asphalt wedge to minimize sharp drop-offs. The bevelled edge reduces the sharpness of the pavement edge drop-off and the associated loss of driver control allowing an errant driver to regain control.¹⁰ Shoulder rock

could also be pulled up adjacent to the traveled way. While valuable in the short run, the traffic volume and limited paved width support consideration of a more permanent asphalt wedge.

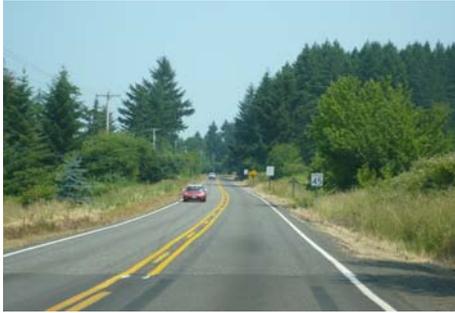
been marked with paint while the existing passing line, marked in thermoplastic, has been retained.

This creates a potential safety problem as the two materials wear at different rates: the paint will wear much faster than the thermoplastic such that after traffic, rain, and beginning of winter the marking will appear to allow passing. While these “revealed passing zones” will be in the same location as the original passing zones, this will negate the safety benefits of a no-passing zone; further, immediate correction will be highly unlikely and undesirable in

winter conditions due to cold temperatures, wet pavement conditions, and potential snow and ice conditions as winter intrudes.

A two-stage approach is suggested. The existing skip lines should be permanently removed by grinding and shot-blasting. This would leave a consistent no-pass marking. The second stage would involve analyzing the cost effectiveness of placing a durable no-passing line in place of the painted lines. The analysis should also consider the use of a profiled line to provide an audible warning to drivers who cross the centerline. Use of a durable marking product would provide a greater presence throughout the year and should yield improved retroreflectivity especially in inclement weather conditions and would remove the need for yearly re-tracing. The ice and snow conditions and the attendant plowing, however, would necessitate that the line be recessed to prevent destruction by the plow blades. Since the elevation (and attendant linear roadway distance) affected by snow and ice is not known and the elevation gain is fairly rapid, a continual durable line should be considered for the entire corridor that is under County jurisdiction.

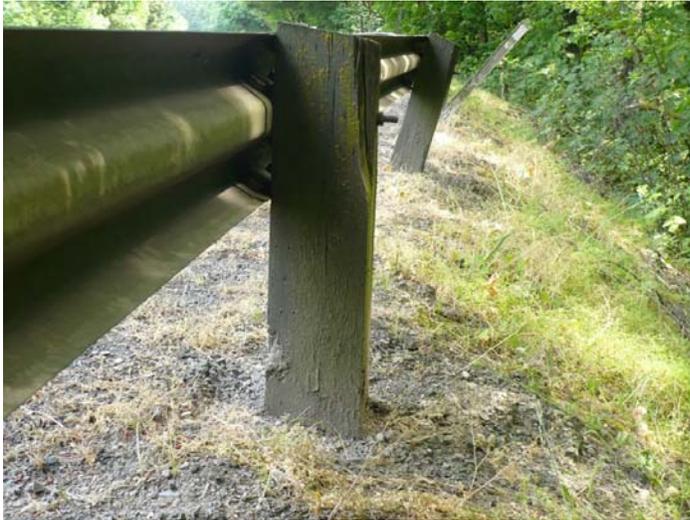
The road safety audit also noted several deficiencies with existing guardrail runs. Some sections were too far back from the roadway such that shoulder and roadside discontinuities may result in the rail being hit at an undesirable height.¹² On some guardrail runs, the supporting posts were leaning, which resulted in a lower height of the rail and may indicate that there would be insufficient resistance in the case of a crash. Further compounding this latter concern was the apparent minimal support for some guardrail

posts. Providing adequate support behind posts helps ensure the rail functions as intended. Several existing barriers appeared to be too short to adequately shield the hazardous object they were installed to shield. Finally, there were, as previously mentioned, several sections of the roadway where additional guardrail runs appeared warranted but had not been installed.

A guardrail needs analysis should be done comprehensively in league with a hazard assessment for the entire roadside.¹³ This review should include the need for barriers, a prioritization to identify the most needed areas, and an assessment of length of need for the attendant guardrail runs.

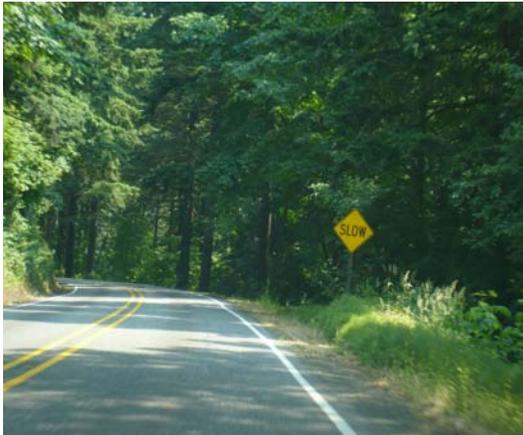
The audit noted the need to review some signs for appropriateness; certain curves appeared to be able to be safely navigated at the posted speed of the roadway, thus they do not need to be signed. The “oversigning” of a facility or network can lead to driver disregard of the signs, especially when the sign may be critical to safely negotiating a curve; in short, curve advisory signing should only be used if necessary per the Manual on Uniform Traffic Control Devices.

In other cases there seemed to be a number of unnecessary signs in the corridor (e.g. “Slow” sign). These signs may offer unspecific information to the driver, may distract from other more pertinent messages, or may obscure other signs. A comprehensive review of sign placement should suffice to address those few signs that are unneeded.

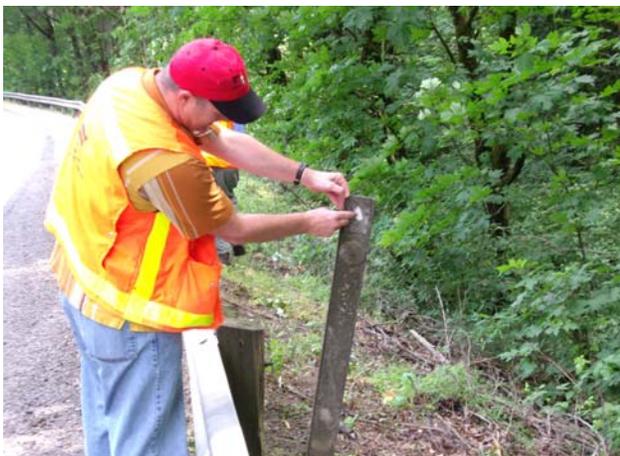
Previous recommendations addressed upgrades to signing along Cornelius Pass Road. The audit also noted that many of the existing signs and delineators were obscured with a film of grime and algae on signs and delineators, reducing daytime and night-time visibility. While the number

of delineators on the corridor is small and they are not placed uniformly through the corridor, immediate improvements could be made to increase their visibility. To ensure that there is an adequate level of sign visibility at day and night throughout the year the County should consider increasing the frequency of maintenance cycles.

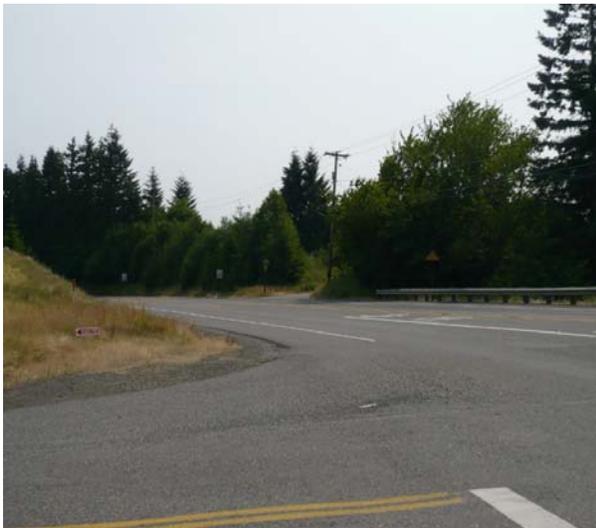
Poles and signs may obscure the sight distance of an oncoming vehicle and require the driver to pull further forward or to stop beyond the stop bar. In some cases multiple man-made objects were aligned or the man-made objects had been placed to align with natural features. Limited sight distance reduces the driver's ability to see oncoming traffic or to judge acceptable gaps in traffic to enter or cross the roadway. Among natural features a range of constraints was present leading to a range of solutions and attendant costs. For example, there were sight distance restrictions caused by horizontal and

vertical curves (Highway 30, Skyline Road (photo to left), Sheltered Nook, and several driveways) and there was a traffic signal obstruction for northbound drivers at Highway 30 (vertical curve combined with vegetation). These latter cases would necessitate more involved solutions than simple brushing or trimming (although that may reduce the severity of horizontal restrictions).

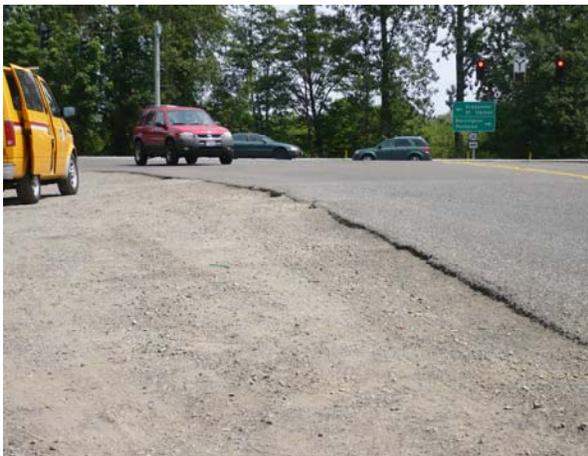
While acknowledging that the State has conceptual plans for the Highway 30 and Cornelius Pass Road intersection, there remain actions that can be taken in conjunction with or absent that project. The team noted that the sweeping eastbound right turn lane off Highway 30 resulted in high exiting speeds for Highway 30 traffic and created an undesirable speed “impression” for newly entering traffic. The lack of a deceleration/turning lane, edgeline delineation, and the presence of a large unpaved area adjacent to the turn raised

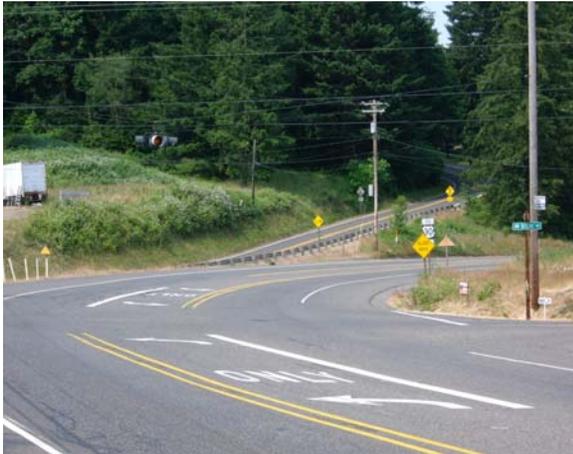
The road safety audit team observed a potential for driver confusion at this intersection. Northbound drivers on Cornelius Pass Road could mistake the old roadway alignment as being part of the mainline. The new mainline has a horizontal curve whereas the old alignment creates a visual continuation of the mainline prior to Skyline Road. While the grass shoulder makes the separation of the roads apparent in the day, these visual cues are not present at night. Even a small potential straying could cause drivers to enter the opposing direction of
