**ARMORFORM<sup>®</sup> ARTICULATING  
BLOCK MAT EROSION  
CONTROL SYSTEM**

**Final Report**

**Experimental Feature Project OR 89-05**

Salmon Creek Bridge  
Oakridge, Oregon

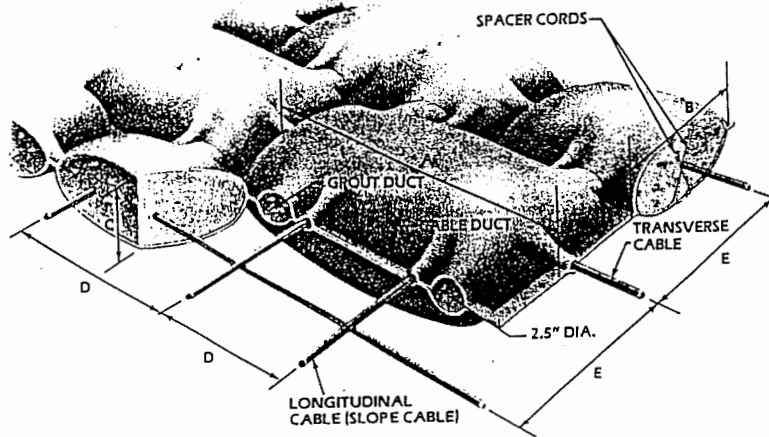
Figure 1.3: Cut away view of ABM formerly produced by Nicolon Corporation.

The ABM is a fabric formed concrete mat (see Figure 1.3). The system consists of closely spaced bags that are interconnected by grout ducts and flexible polyester cables. When the bags are filled with a cement rich concrete grout, it forms a solid mat, consisting of a series of connected blocks.

The blocks are aligned horizontally but staggered vertically which limits the ability of the mat to articulate diagonally. Because of this block configuration, it is easier for the mat to articulate along the axis which is parallel to the stream flow than to articulate along the axis which is normal to the stream flow. The mat also will not articulate until the grout ducts shear. A future design consideration is to configure the blocks so that there is no offset vertically. This would allow the mat to articulate in all directions.

Future designs should also consider the configuration of the ABM blocks. Consideration should be given to configuring the blocks so that there is no vertical alignment offset versus staggering the blocks. Aligned rows of blocks would allow articulation in all directions.

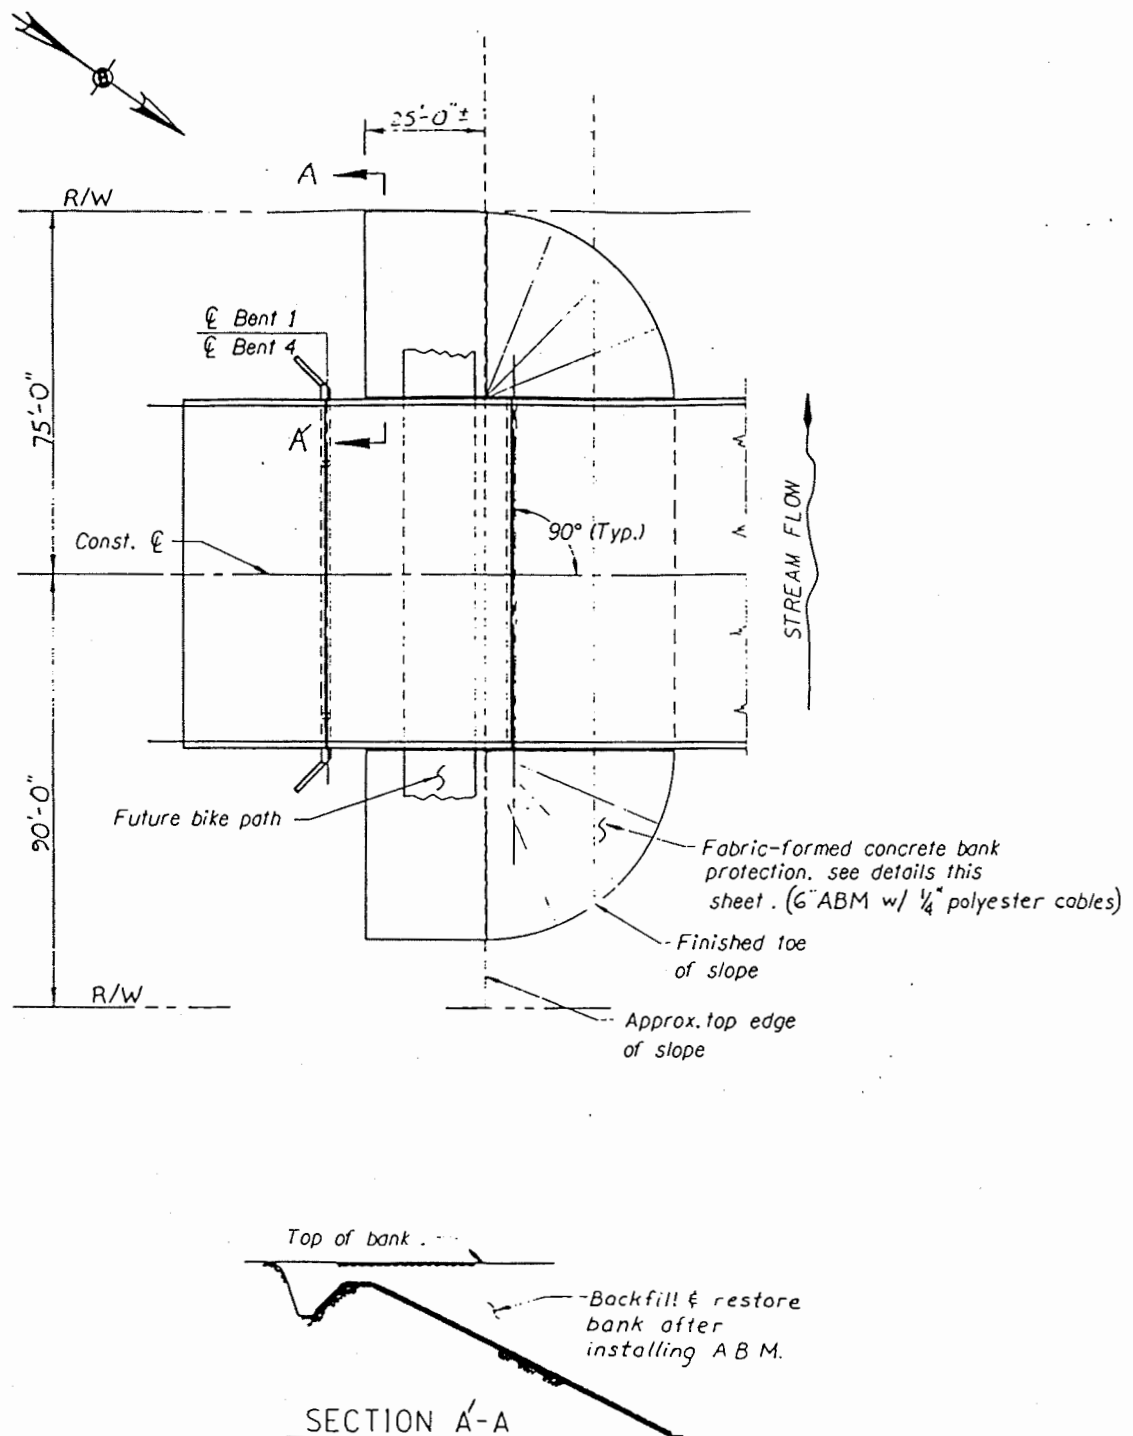
Figure 1.4 Original Fan-Shaped Design.

The original ODOT design terminated the ABM by burying it 4 ft (1.2 m) into the channel banks. The design was modified, however, by the manufacturer due to the limitations of the product. That is, the fabric forms could not be terminated in a fan shaped pattern, as shown on the original ODOT plans (see Figure 1.4).

The construction report stated that the modification by the manufacturer could make the system less effective than the original design to control erosion from progressing by flanking around the end of the ABM. (Scholl, 1991) The original ODOT design and as-constructed drawings are included in the construction report. Prior to construction, the stream had washed out the west bank riprap upstream from the northwest corner of the ABM. The riprap was replaced to protect the leading edge of the ABM under a price agreement with the contractor. (Hunt, 1993) This same area eroded again during the February 1996 flood and has since been heavily riprapped.

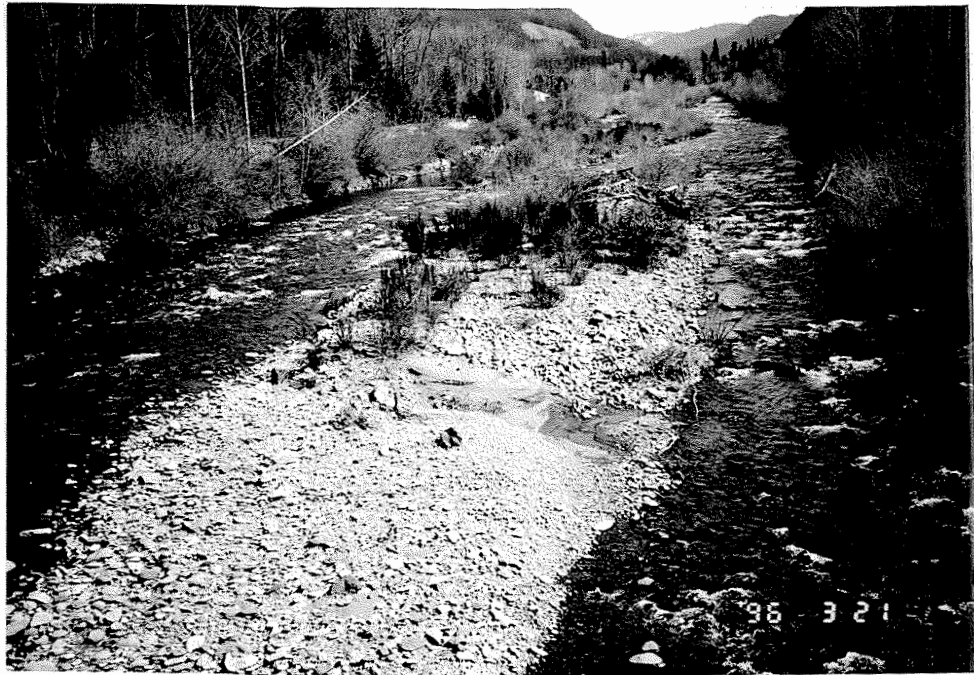
A large island developed just upstream from the bridge. Chris Dunn, FHWA Regional Hydraulics Engineer, noted that islands in the Salmon Creek channel increase high water velocities due to narrowing the channel. The island upstream from the bridge also redirects the current into the bank in the area where the riprap was lost and the bank was eroded. (See Figures 2.1 and 2.2). An estimated 170 cubic yards (130 m<sup>3</sup>) of bank and riprap had been washed out upstream from the northwest corner of the ABM. This hole extended about 38 ft (12 m) upstream from the edge of the ABM and gouged out the bank about 5.5 ft (1.7 m) (compare Figures 2.3 and 2.4). No other riprap damage was found.

Figure 2.1: Large gravel island near bridge decreases the channel area.

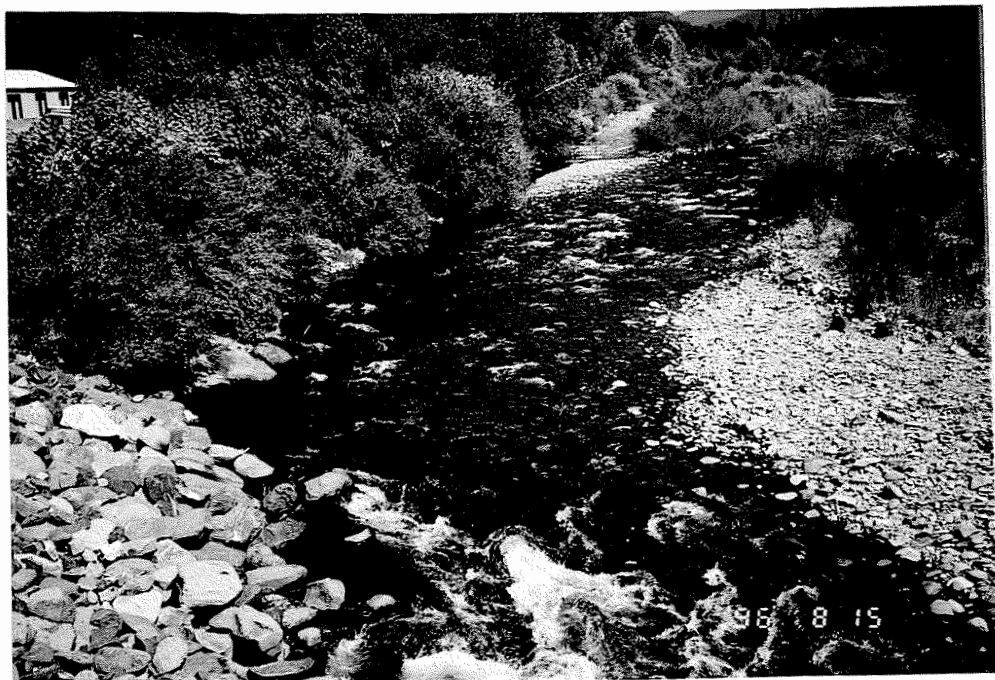
Figure 2.2: Gravel island directs current into northwest bank.

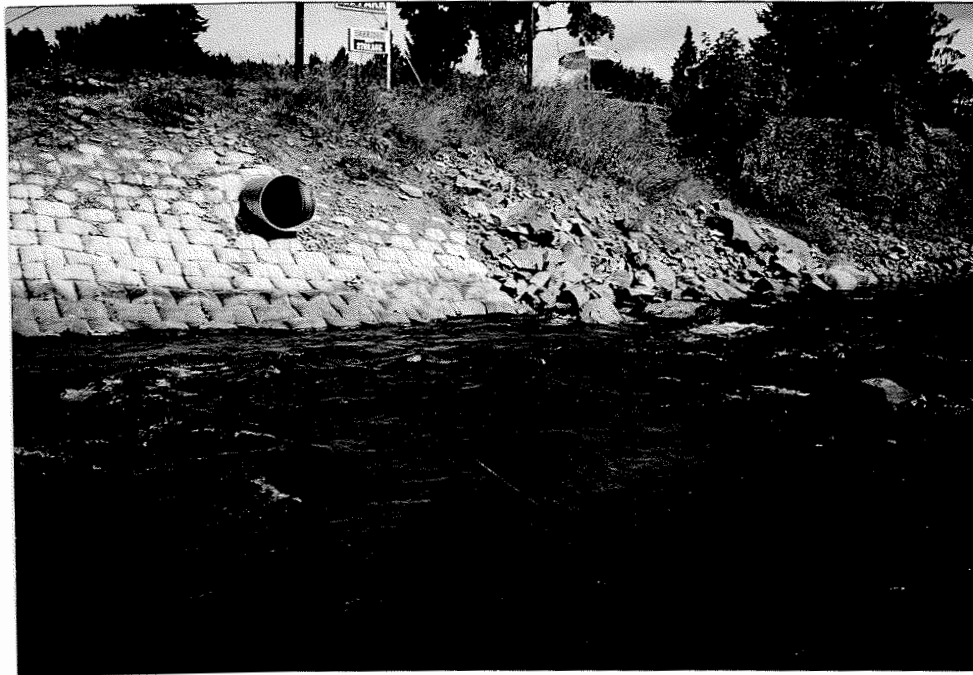
Figure 2.3: Northwest corner before flood, note the size of the riprap.

Figure 2.4: Northwest corner after flood, note the slope change of the ABM.

Damage to the ABM was confined to about 16 ft (5 m) of the northwest corner of the mat. The mat in the area of the large steel culvert pipe had changed slope (compare Figures 2.3 and 2.4). The slope was constructed on a 2H:1V and had dropped to almost vertical in some places. Although the ABM had been undermined on the north edge, it did articulate somewhat. The leading edge appeared to be stiff, however, leaving an opening for further undermining, causing several blocks to break free and plunge to the bottom of the streambed (see Figure 2.7).

The bank erosion damage was repaired in late March. Larger boulders 400 lbs $\pm$  (200 kg) were end-dumped to replace the washed out area of the bank. This riprap also covered the exposed northwest corner of the ABM. At the bottom of this fill, large elongated boulders were placed upstream from the washout at right angles. These "finger jetties" were placed to reduce the stream velocity next to the bank (see Figures 2.5 and 2.6).

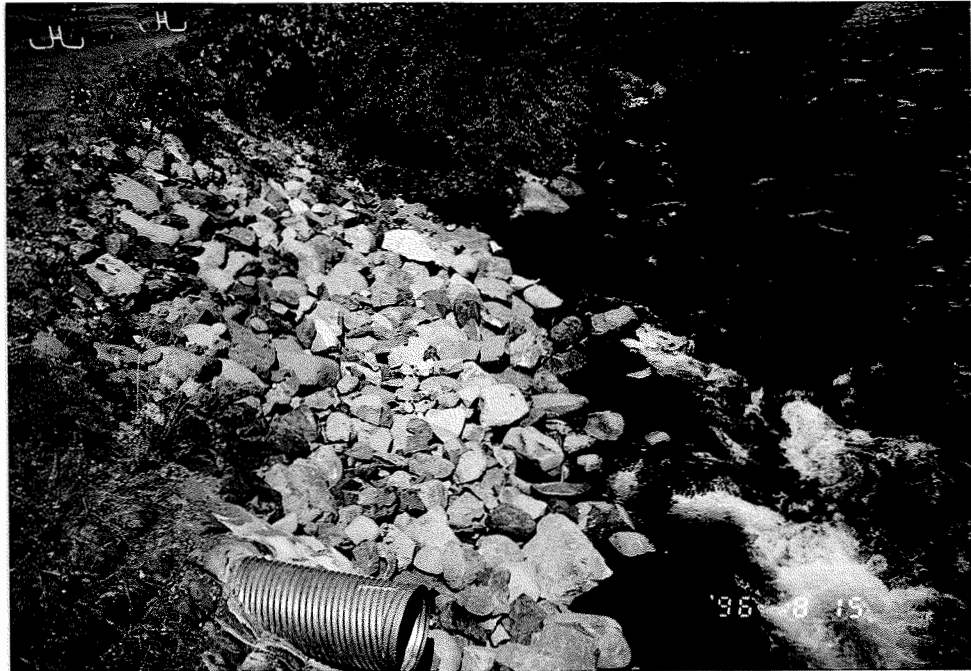
Figure 2.5: New riprap, note larger boulders in streambed near whitewater.

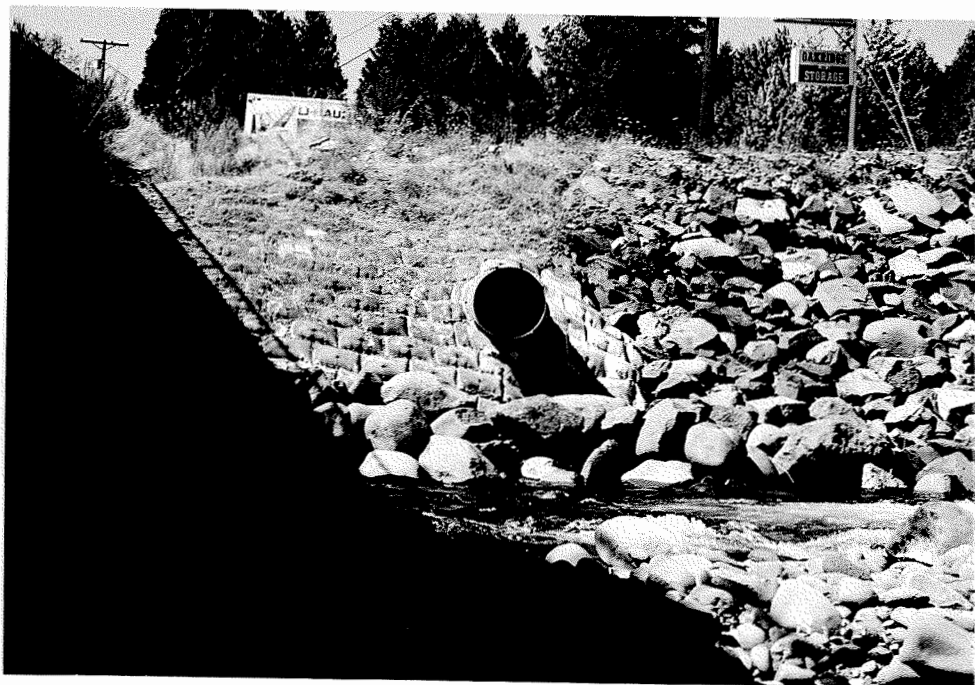
Figure 2.6: New riprap at northwest corner.

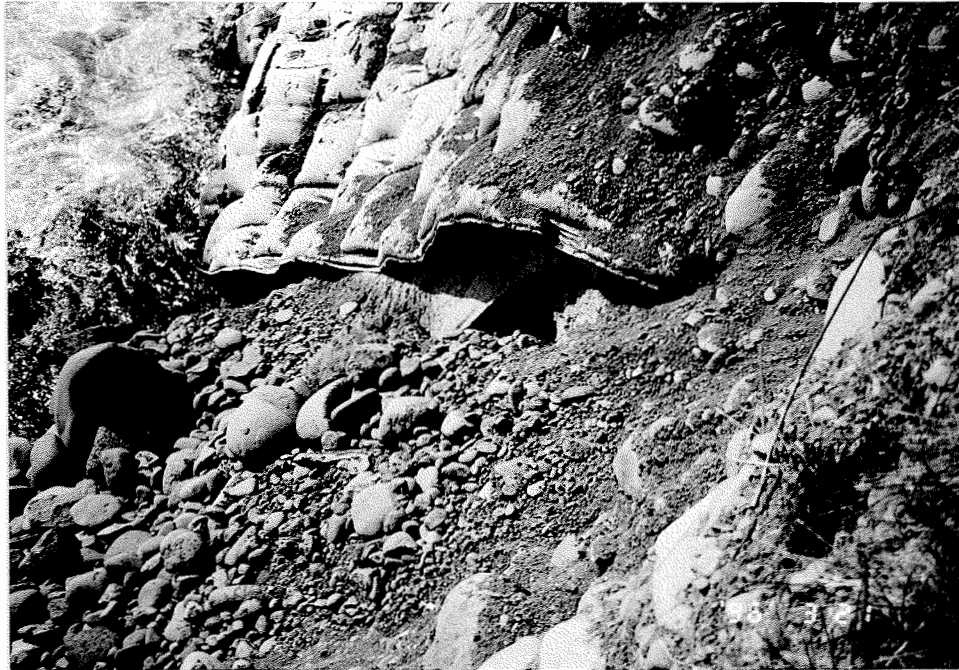
Figure 2.7: Northwest corner of ABM, note undermined edge.

No direct maintenance has been done on the ABM. The blocks, which broke free from the mat during the 1996 February flood, have not been replaced. Such repairs are possible but would be very costly according to the current manufacturer of the system. Repairing the lost blocks would include using a concrete drill to make holes for the polyester cable. The new bags could then be reconnected to the blockmat, and the holes grouted shut. If they were below water, a temporary dam would be needed. This would be very costly. The missing blocks could be replaced with riprap (750 lbs (340 kg)) at less cost.

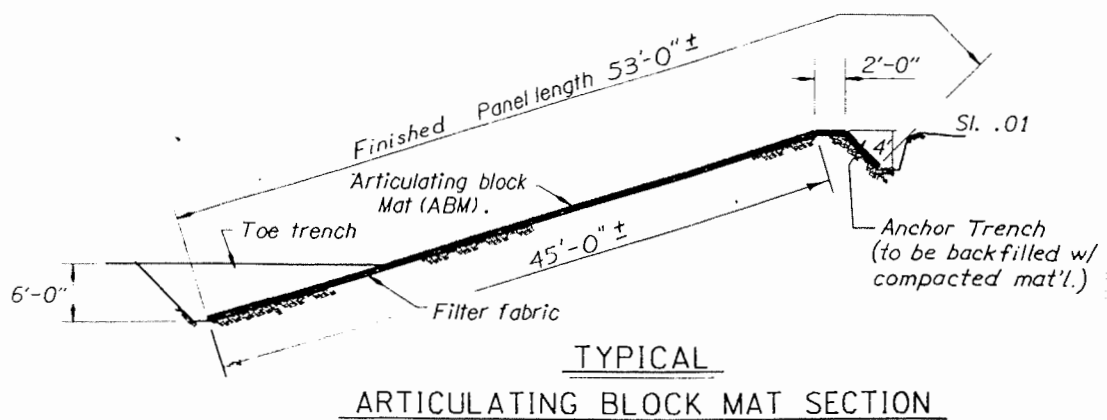
Most of the break-away blocks came from the bottom of the ABM. This section had been buried under a gravel blanket at construction (see Figure 2.8). The gravel had been scoured away in two sections, each about 2 ft (0.6 m) long (see Figure 2.9). Some blocks were broken away from the polyester cable or were still held by one strand. Sections of the block mat fabric form were also noted swaying in the current near the bottom. For some blocks, the fabric was the only connection to the blockmat (see Figure 2.10). Three blocks which had broken free were found at the downstream end (southwest corner) of the ABM (see Figure 2.9). One block and two block fragments, still bound together by the polyester cable, were found about 66 ft (20 m) upstream from the northwest corner of the ABM. It is unknown how the blocks were transported.

Figure 2.8: Detail of toe trench.

Future designs subject to similar flow conditions should consider keying the upstream edge 10 ft (3 m) into the bank and burying the toe 8 ft (2.4 m) into the channel bottom. In addition, the design should include riprap to protect the flanks of the mat. The ideal situation would be to construct the mat as designed with the fan shaped ends. The ABM appears to be most suited for active streambeds susceptible to erosion with slopes steeper than 1.5H:1V (steeper than is reasonable to place riprap).

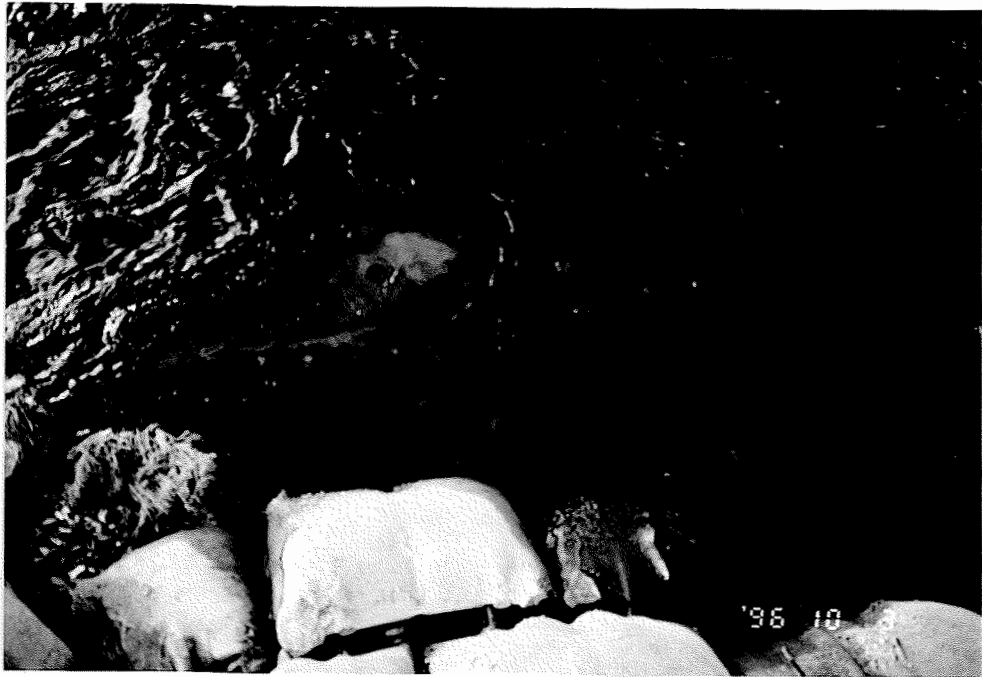
Figure 2.9: Exposed blocks after fill material in toe trench was scoured out.

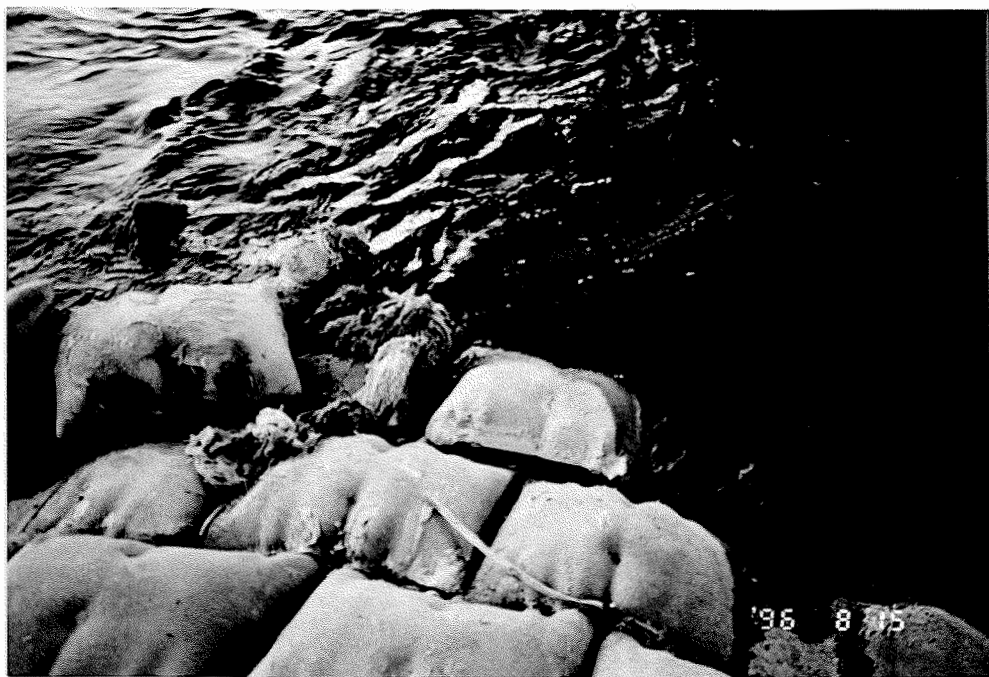
Figure 2.10: Blocks in damaged area are held only by fabric bag.

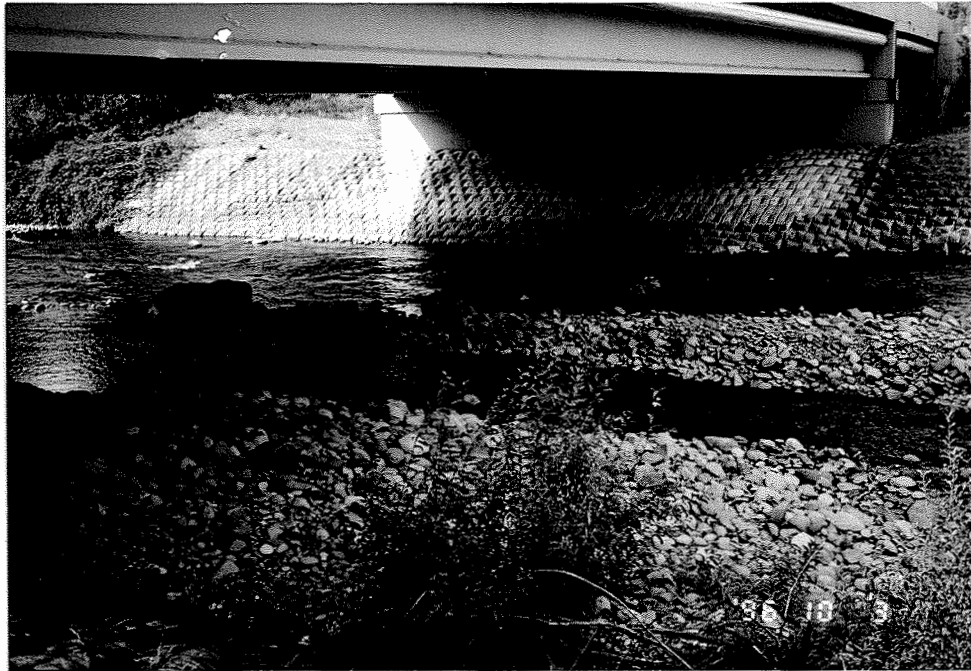
The damage covered only about 5% of the entire system. The southwest side of the ABM had no visible damage (see Figure 2.11).

Figure 2.11: Most of the west side was not damaged.

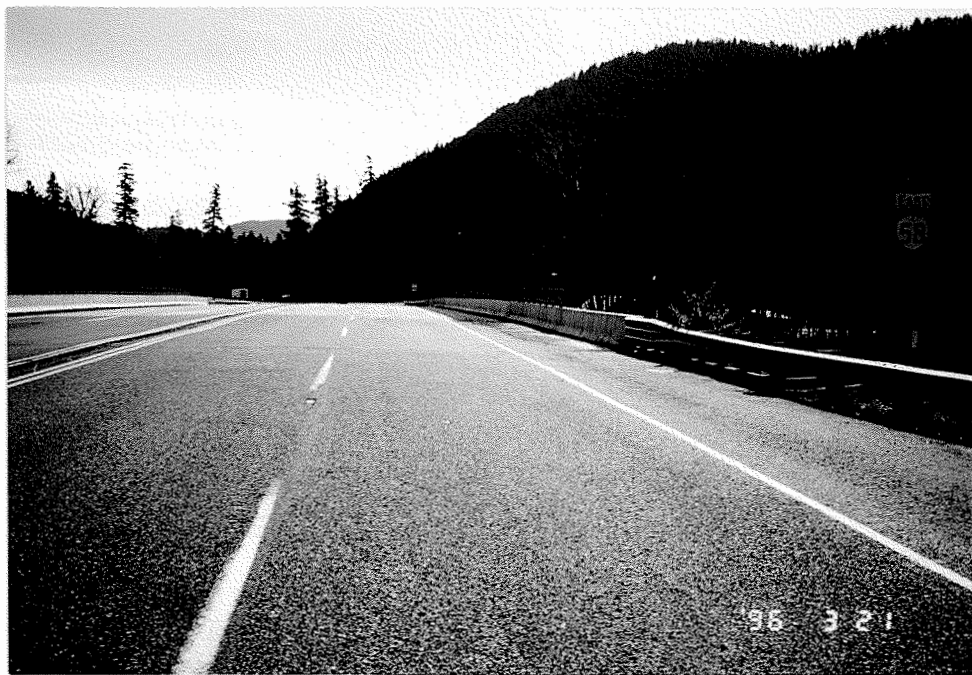
Evaluating the aesthetic value of the ABM is difficult because it is a subjective quality. One opinion of the mat was that it was too white and uniform, so it did not blend in with the natural setting. Another opinion was that the mat looked nice and provided a finished look to the embankment. During the site visits, it was noted that the fabric enclosing the grout is slowing wearing away.

Figure 2.12: Motorist view of blockmat.
