ELECTRIC HEATING OF I-84 IN LADD CANYON, OREGON

Final Report

SPR 304-461

June 2006

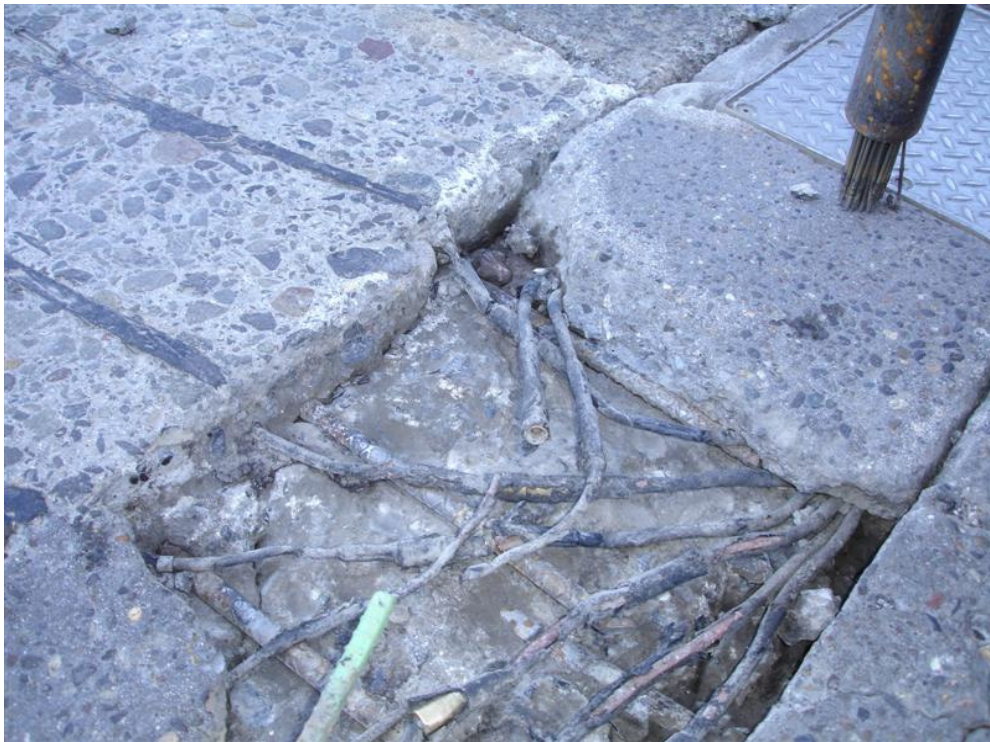
Figure 4.1: Damaged heating cables

- Junction boxes have proved difficult to seal and require frequent inspection. Placement of the junction boxes has proven to be problematic, but this is in part a function of the topology of the installation site.
- Two of the four heating cables in the short section north of the bridge are currently non-functional because of traffic damage to the replacement concrete where heat cables enter the junction box (Figure 4.1).
- One of the junction boxes in the roadway was steaming and the heat cable circuit breaker was open. The suspected cause was water permeation of an electrical connection. This junction box will be repaired this summer.
- Thermocouple sensors in the pavement have proven to be difficult to calibrate and are unreliable. The master roadway information system is being used to turn the entire system on and off, resulting in wasted energy.

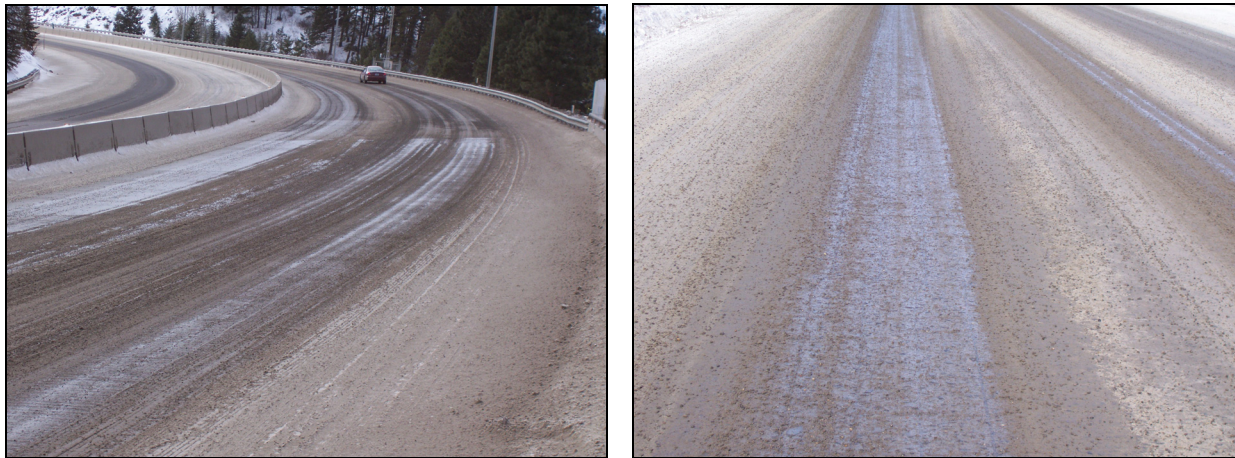
Figure 5.1: Melted snow on tire paths due to heating cables

Figure 5.1 shows the system in operation. The system currently has no data logging capability, so the times and lengths of operation are not known. A data recorder is planned for next season. The cost of electricity for operation during the winter months averages slightly over \$5,000 per month with a peak electric bill of about \$9,000.
