# **MILLABRADING TEST EVALUATION**

**Norwood Road – M.P. 287.02  
(Southbound Interstate 5)**

**Construction Report**

**FHWA-OR-RD-00-02**

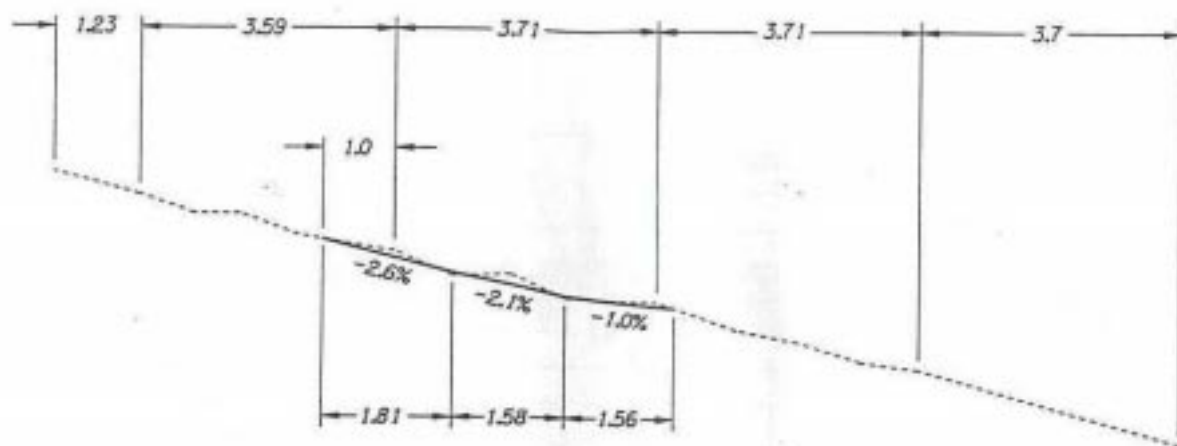
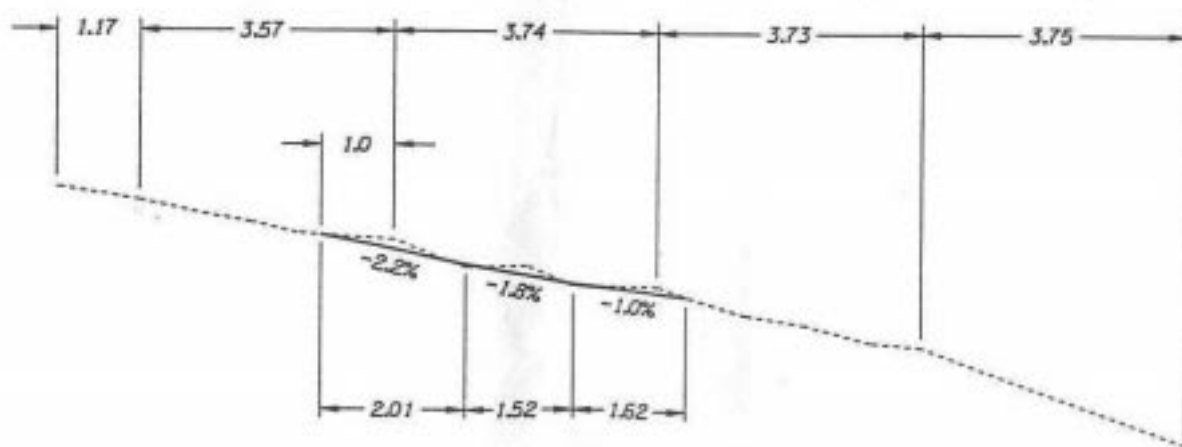
Figure 2.3: Design Cross Sections

The design cross sections are shown in Figure 2.3. A minimum cross slope of 1% was set to maintain drainage. A maximum cross slope of 3% was allowed. Approximately 16 mm of PCC pavement would be removed. Project monitoring included identifying any impacts associated with creating a broken slope in the middle lane. Would the different slopes affect automobile handling and/or increase accident frequency?

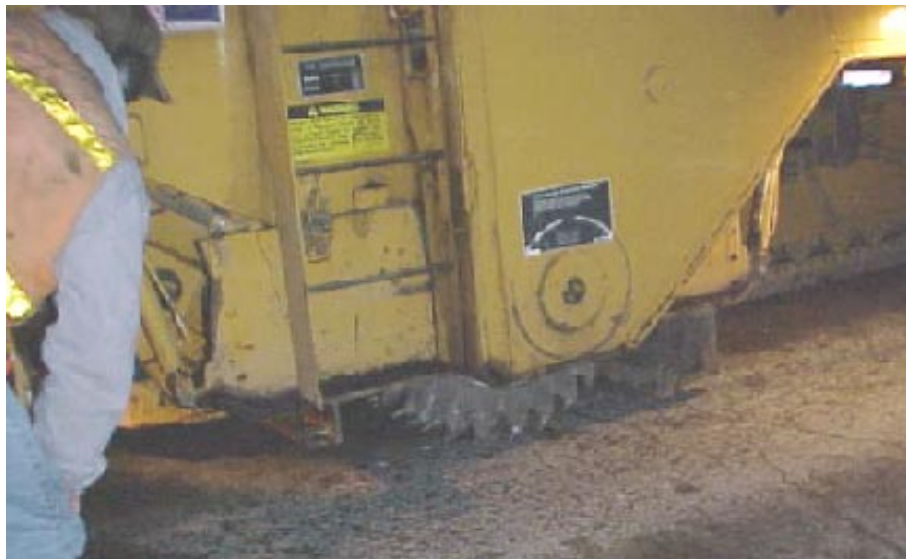
Figure 3.1: Modified Rotomill Drum

The milling process utilized a rotomill built by CMI out of Oklahoma City, model PR-800-7. The machine weighed 33.6 Mg and operated at 597 kW. Modifications to the unit included a modified drum speed, automated grade control skis, and a custom built drum. MillCo, also out of Oklahoma City, manufactured the drum. The 2.1 m wide drum provided a tooth spacing of 4.5 mm (*Halton 1999*). The rotomill is reported to operate at about 6 m/min over a 2.1-m wide path. Based on discussions with the contractor, machine weight and drum speed, along with tooth spacing were found to be critical to the effectiveness of the milling. Figure 3.1 includes a photograph of the modified drum.

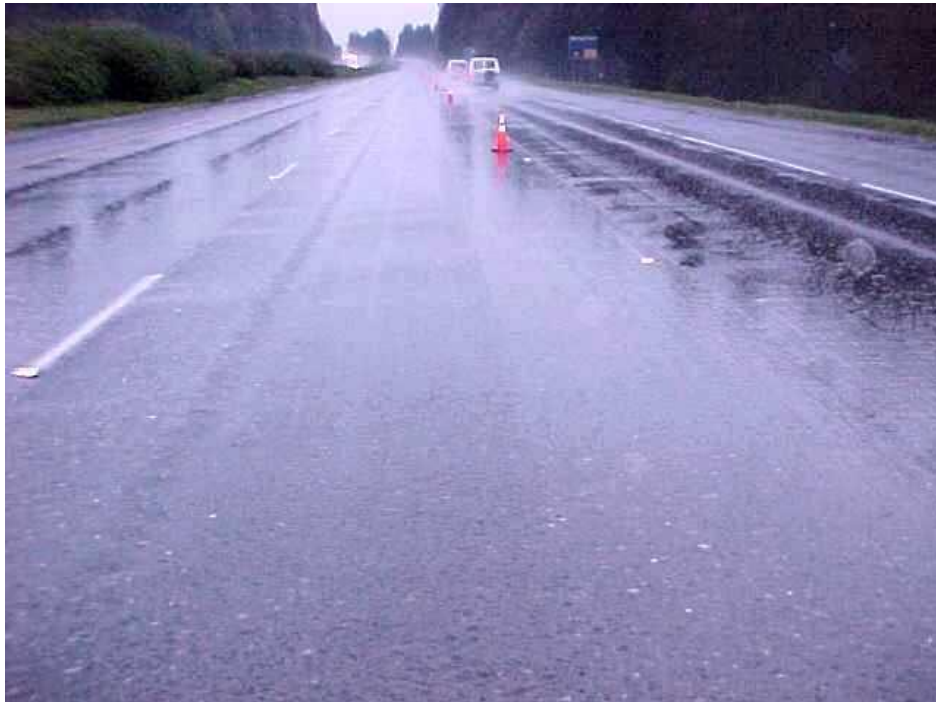
Figure 4.1: Post Construction Pavement Looking South (4/10/99)

Based on discussions with ODOT District Maintenance personnel, the millabraded section appears to be performing adequately. No problems with drainage have been noted. Following construction, there are still ruts in all the wheel paths, however, even with the change in the cross slopes, no drainage problems have been noted.

The test section was inspected on April 10, 1999. The local maintenance office provided a two-lane closure so that the middle and fast lanes could be inspected. Random rut measurements using a rut bar varied from 10 to 16 mm in the middle lane. Some remaining rut depth was expected based on the project design, however, not to the degree measured. The greater rut depths may have been due to insufficient pre-construction survey data used for the design. Figure 4.1 shows the middle lane pavement appearance looking south.

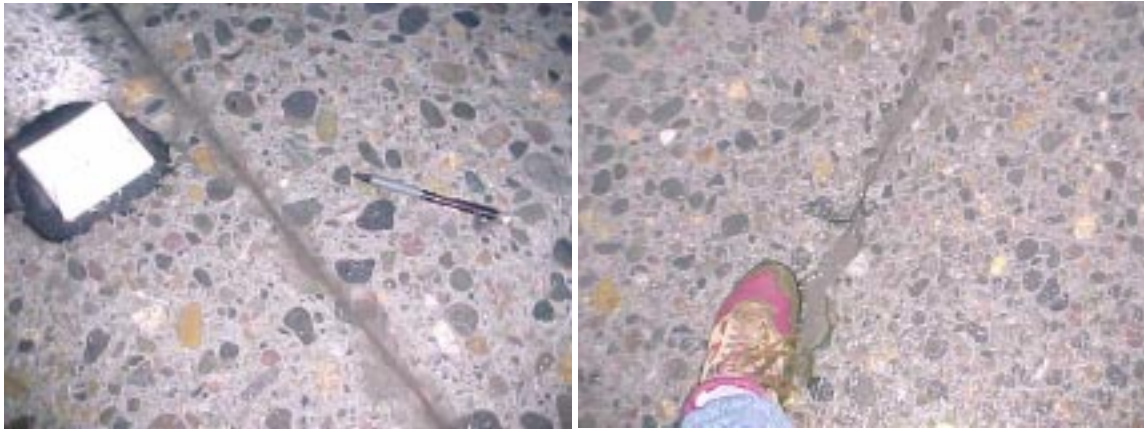
Figure 4.2: Low Severity Spalling at Construction Joint (4/10/99)

The sawcut joint between the fast and middle lane appeared more spalled than the construction joint between the middle and truck lane. The spalling noted for both longitudinal joints would be classified as low severity as defined by the *SHRP Distress Identification Manual for the Long-Term Pavement Performance Project (SHRP 1993)*, however, it was more apparent than before milling. Figure 4.2 shows the spalling observed between the fast and middle lane sawcut joint at two locations.

Consideration should be given to the potential impacts of spalling associated with rotomilling. A more open joint allows moisture into the base and subgrade materials, which could reduce the pavement performance. In addition, spalled joints could create a hazard for motorcycle traffic. Also, if the pavement will be overlaid in the future, the joint would need to be treated prior to overlaying to provide adequate support to prevent reflective cracking.

- Crack filling using proprietary filler or other slurry type material should be investigated to reduce spalling of longitudinal joints.
- Millabrading specifications need to specify the machine weight and tooth spacing as shown in the test project's Special Provisions. Both factors are critical to the project outcome. Future projects should also specify a production rate, shown to minimize potential aggregate popout and spalling.

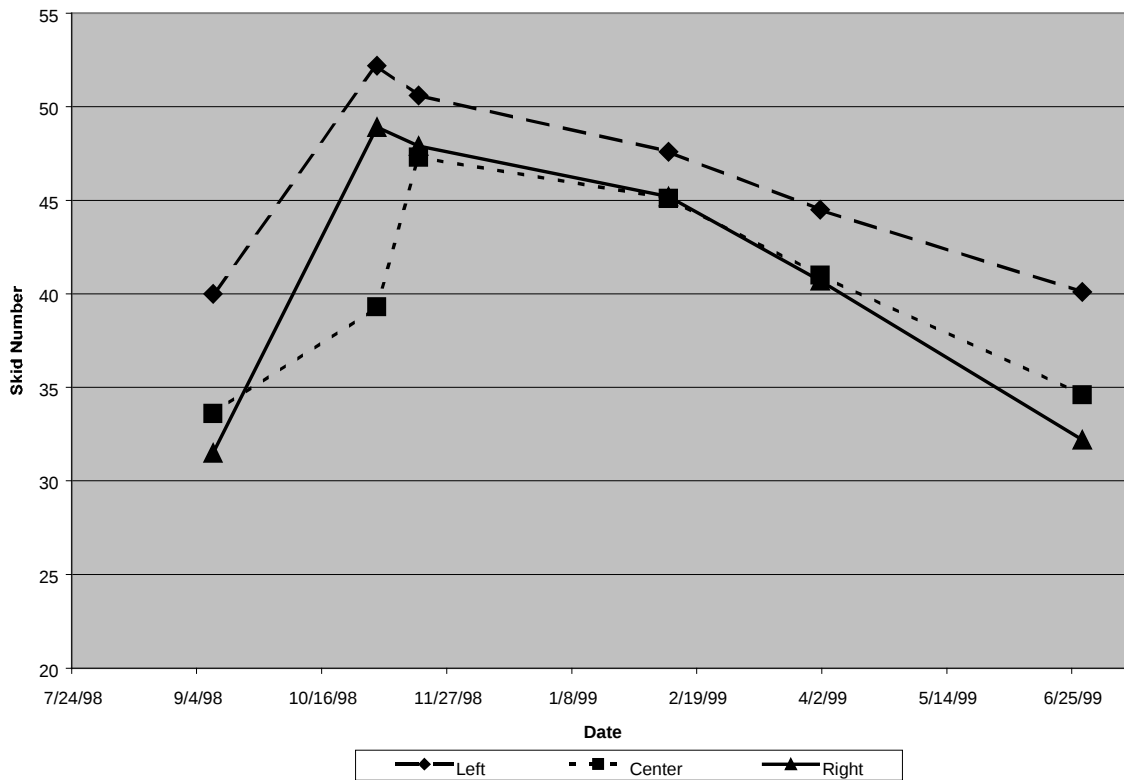
Figure 4.3: Friction Testing Results

All friction testing was done at speeds near 64 km/hr in the left wheel path of all three lanes using a K.J. Law trailer. The data from the tests were converted to standard 64 km/hr friction numbers using correlation equations. Skid testing was performed before the milling and then several times after project completion. One skid test was done after the milling but prior to the shot blasting in the middle lane. The average skid numbers for the three lanes are shown in Figure 4.3.

The November 3, 1998 friction testing includes results for shot blasted sections (fast and slow lanes) and a section with only milling (center lane). The milling increased the skid number from 34 to 39 in the center lane. With the shot blasting, the center lane skid number increased from 39 to 47. Skid numbers, however, have continued to decline, returning to near the preconstruction skid numbers.

- The need for the shot blasting should be further investigated. Shot blasting is primarily necessary for cleaning the surface, reducing the micro-cracking, and increasing skid resistance. It is not known whether additional sweeping could clean the surface or if micro-cracking is a significant issue. The benefits of improved skid resistance from the shot blasting appear to be short term.
