**ARMORFORM<sup>®</sup> ARTICULATING  
BLOCK MAT EROSION  
CONTROL SYSTEM**

**Final Report**

**Experimental Feature Project OR 89-05**

Salmon Creek Bridge  
Oakridge, Oregon

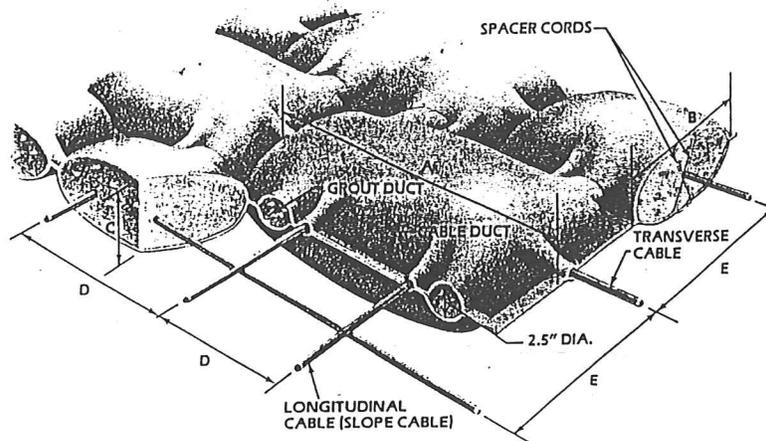
The ABM is a fabric formed concrete mat (see Figure 1.3). The system consists of closely spaced bags that are interconnected by grout ducts and flexible polyester cables. When the bags are filled with a cement rich concrete grout, it forms a solid mat, consisting of a series of connected blocks.

The blocks are aligned horizontally but staggered vertically which limits the ability of the mat to articulate diagonally. Because of this block configuration, it is easier for the mat to articulate along the axis which is parallel to the stream flow than to articulate along the axis which is normal to the stream flow. The mat also will not articulate until the grout ducts shear. A future design consideration is to configure the blocks so that there is no offset vertically. This would allow the mat to articulate in all directions.

Figure 1.3: Cut away view of ABM formerly produced by Nicolon Corporation.

Future designs should also consider the configuration of the ABM blocks. Consideration should be given to configuring the blocks so that there is no vertical alignment offset versus staggering the blocks. Aligned rows of blocks would allow articulation in all directions.

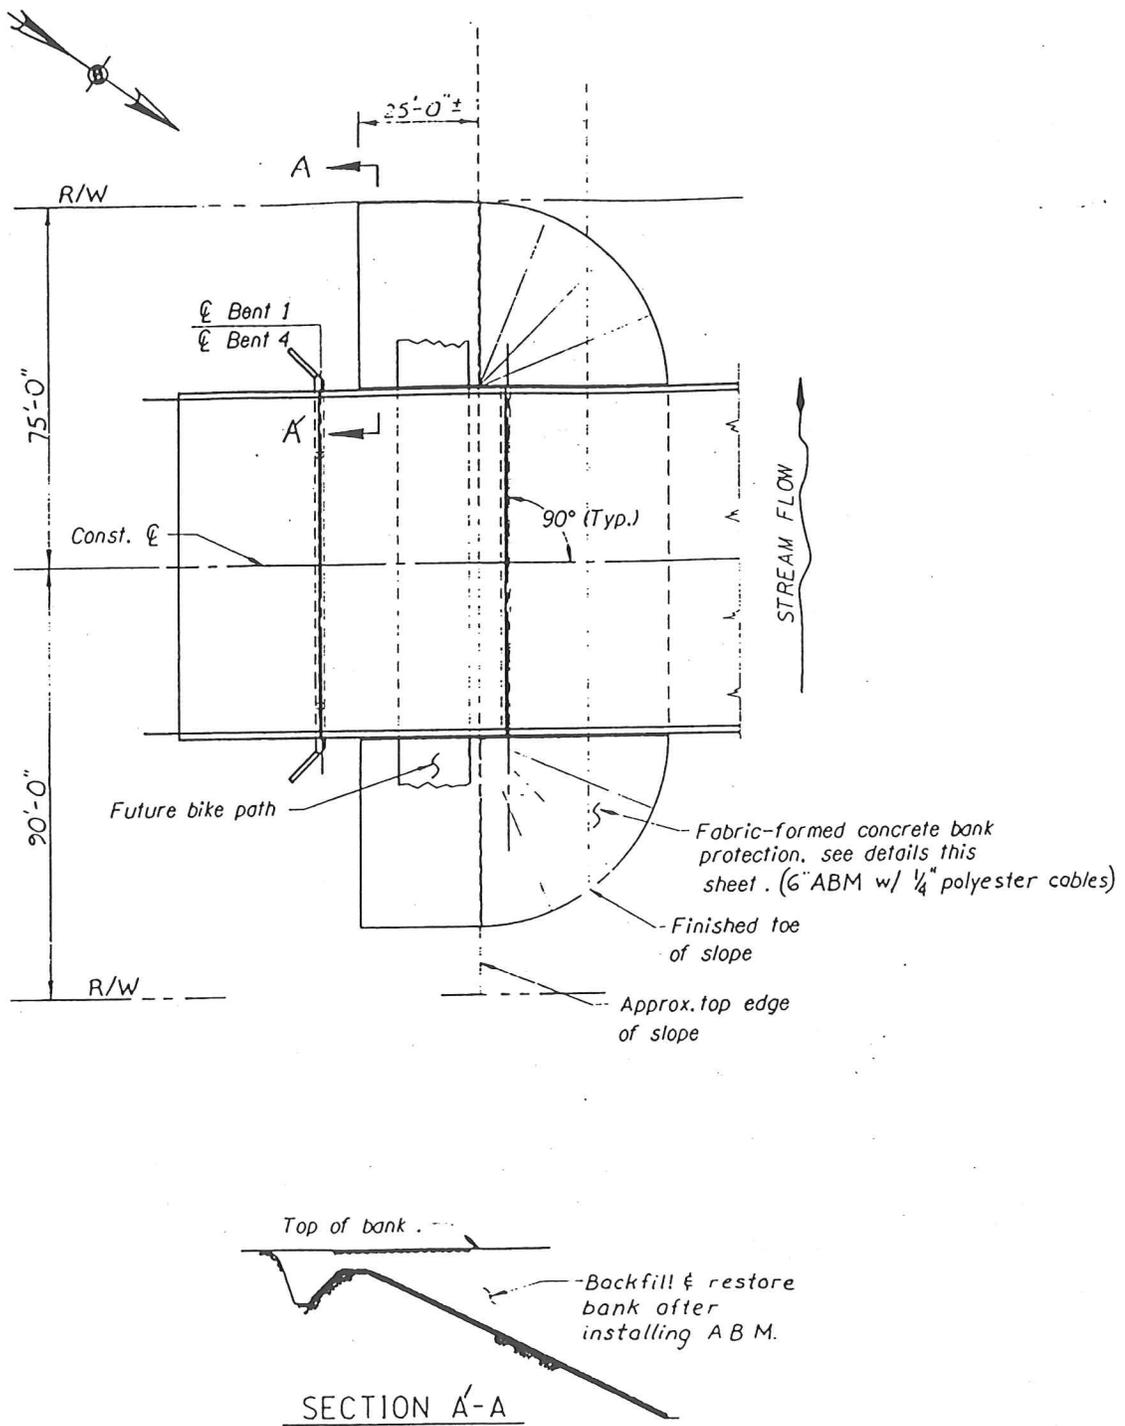
The original ODOT design terminated the ABM by burying it 4 ft (1.2 m) into the channel banks. The design was modified, however, by the manufacturer due to the limitations of the product. That is, the fabric forms could not be terminated in a fan shaped pattern, as shown on the original ODOT plans (see Figure 1.4).

The construction report stated that the modification by the manufacturer could make the system less effective than the original design to control erosion from progressing by flanking around the end of the ABM. (Scholl, 1991) The original ODOT design and as-constructed drawings are included in the construction report. Prior to construction, the stream had washed out the west bank riprap upstream from the northwest corner of the ABM. The riprap was replaced to protect the leading edge of the ABM under a price agreement with the contractor. (Hunt, 1993) This same area eroded again during the February 1996 flood and has since been heavily ripped.

Figure 1.4 Original Fan-Shaped Design.

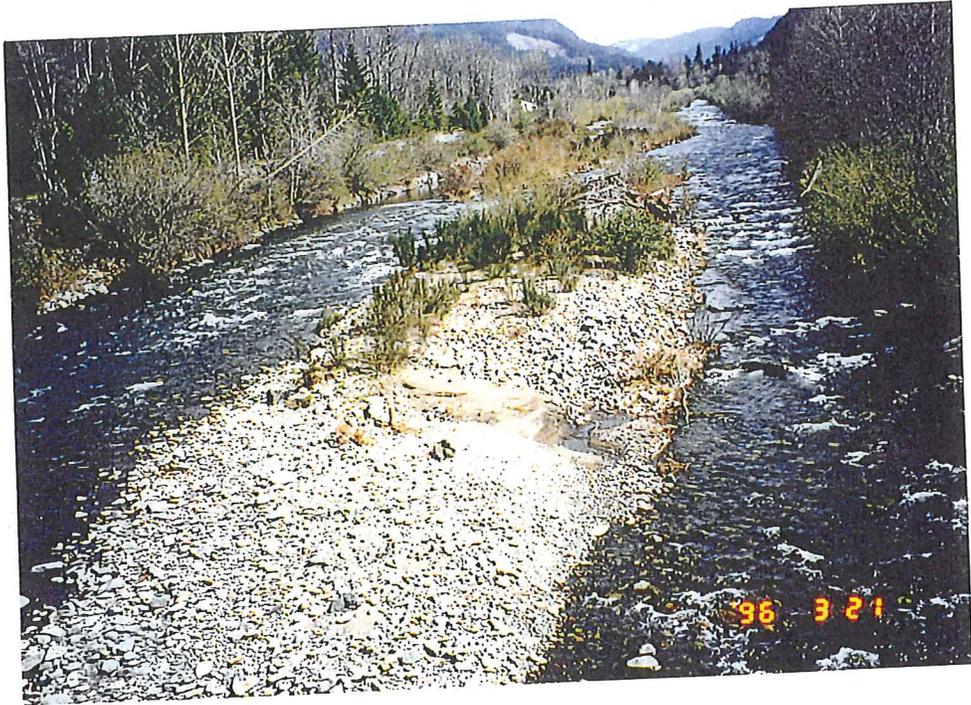
A large island developed just upstream from the bridge. Chris Dunn, FHWA Regional Hydraulics Engineer, noted that islands in the Salmon Creek channel increase high water velocities due to narrowing the channel. The island upstream from the bridge also redirects the current into the bank in the area where the riprap was lost and the bank was eroded. (See Figures 2.1 and 2.2). An estimated 170 cubic yards (130 m<sup>3</sup>) of bank and riprap had been washed out upstream from the northwest corner of the ABM. This hole extended about 38 ft (12 m) upstream from the edge of the ABM and gouged out the bank about 5.5 ft (1.7 m) (compare Figures 2.3 and 2.4). No other riprap damage was found.

Figure 2.1: Large gravel island near bridge decreases the channel area.

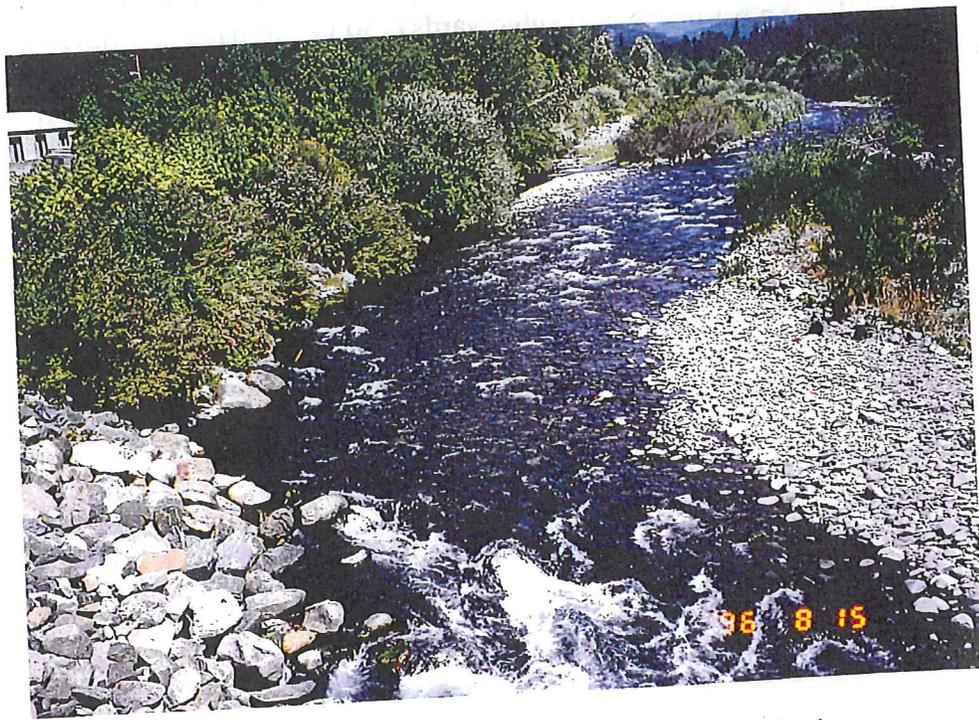
Figure 2.2: Gravel island directs current into northwest bank.

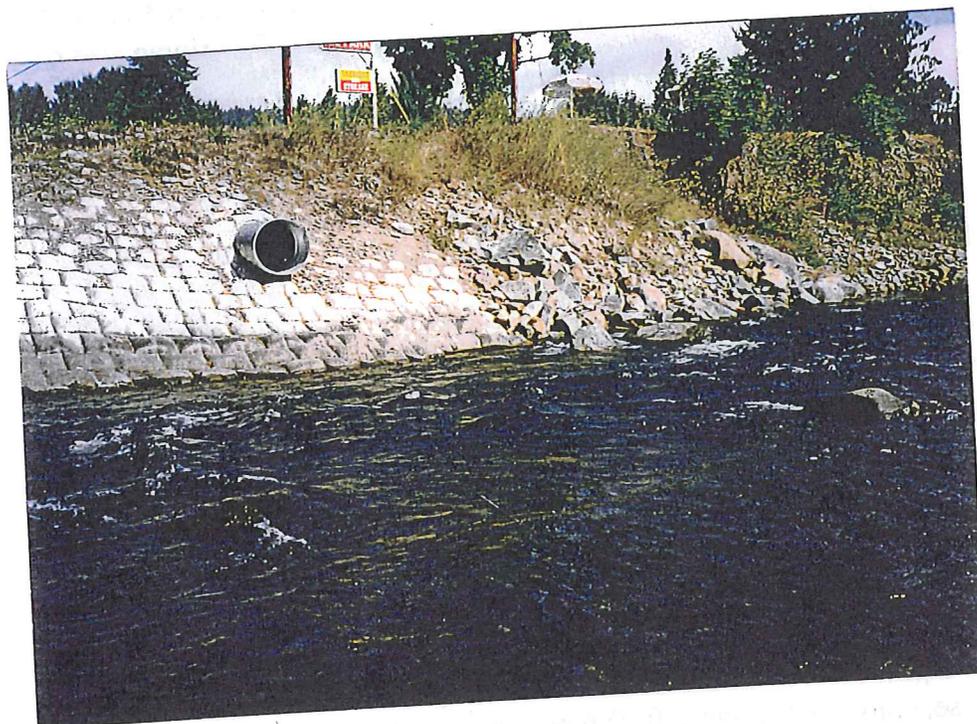
Figure 2.3: Northwest corner before flood, note the size of the riprap.

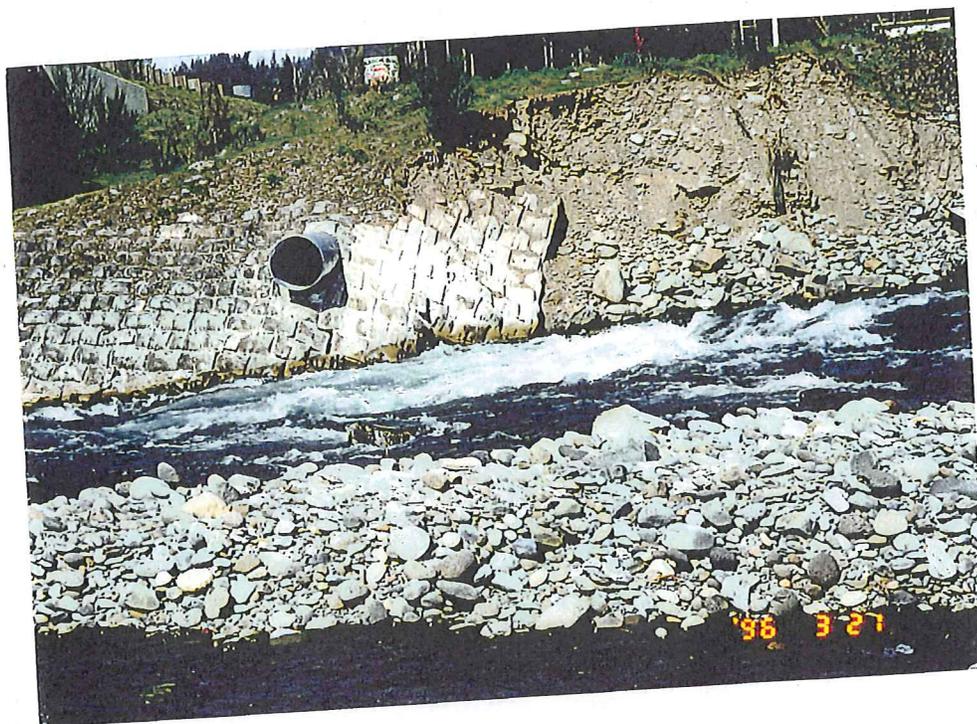
Figure 2.4: Northwest corner after flood, note the slope change of the ABM.

Damage to the ABM was confined to about 16 ft (5 m) of the northwest corner of the mat. The mat in the area of the large steel culvert pipe had changed slope (compare Figures 2.3 and 2.4). The slope was constructed on a 2H:1V and had dropped to almost vertical in some places. Although the ABM had been undermined on the north edge, it did articulate somewhat. The leading edge appeared to be stiff, however, leaving an opening for further undermining, causing several blocks to break free and plunge to the bottom of the streambed (see Figure 2.7).

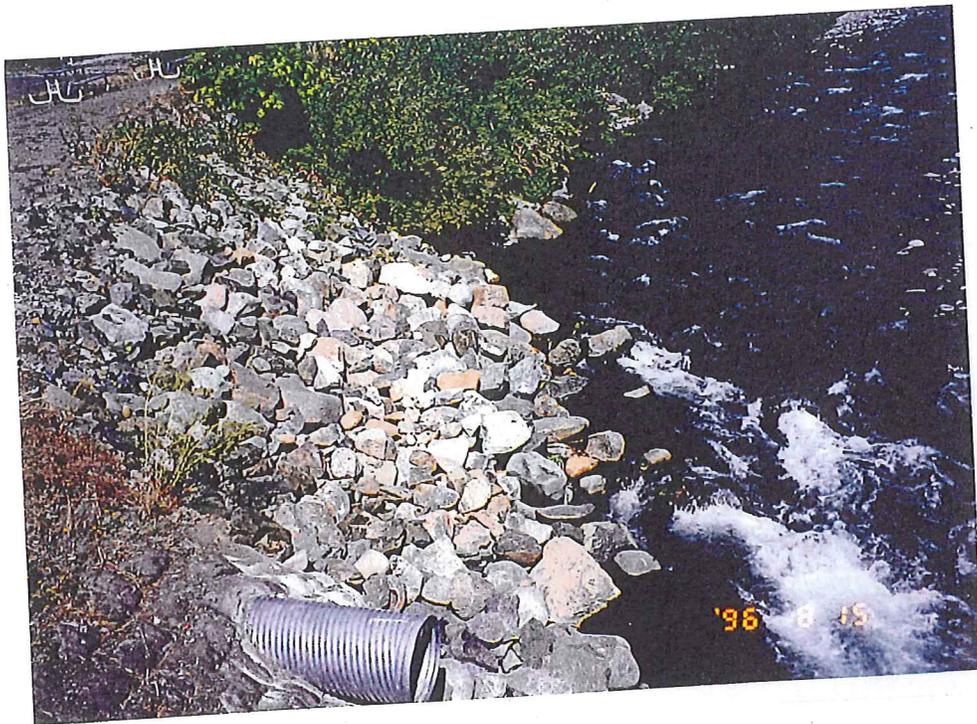
Figure 2.5: New riprap, note larger boulders in streambed near whitewater.

The bank erosion damage was repaired in late March. Larger boulders 400 lbs± (200 kg) were end-dumped to replace the washed out area of the bank. This riprap also covered the exposed northwest corner of the ABM. At the bottom of this fill, large elongated boulders were placed upstream from the washout at right angles. These "finger jetties" were placed to reduce the stream velocity next to the bank (see Figures 2.5 and 2.6).

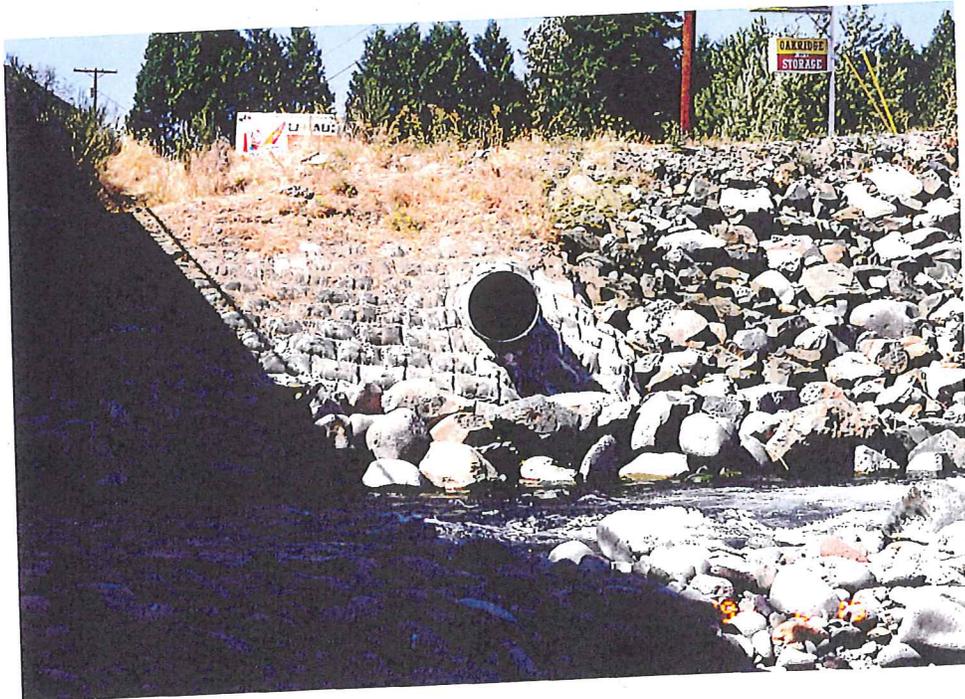
Figure 2.6: New riprap at northwest corner.

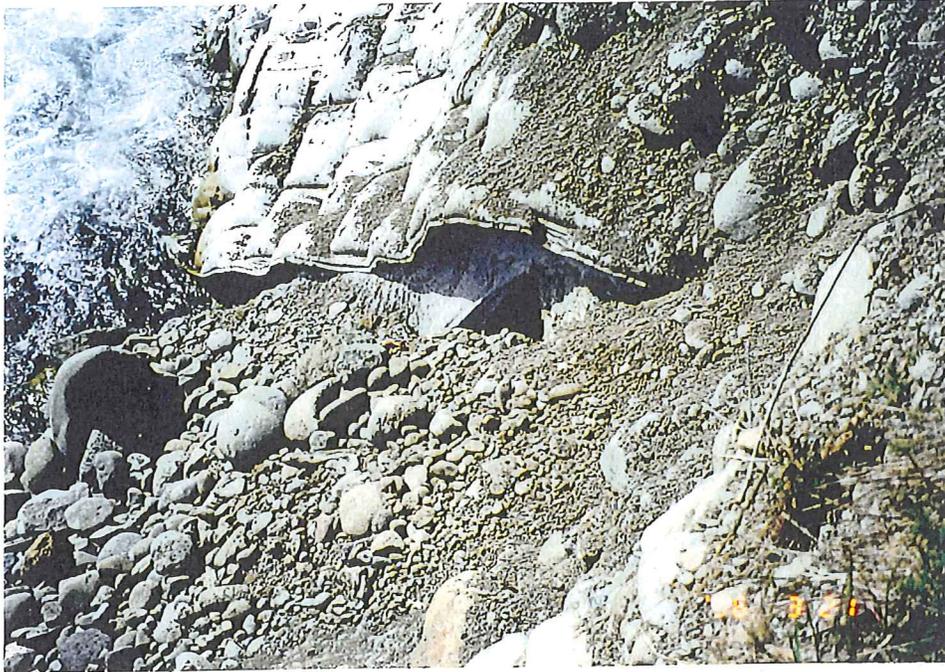
Figure 2.7: Northwest corner of ABM, note undermined edge.

No direct maintenance has been done on the ABM. The blocks, which broke free from the mat during the 1996 February flood, have not been replaced. Such repairs are possible but would be very costly according to the current manufacturer of the system. Repairing the lost blocks would include using a concrete drill to make holes for the polyester cable. The new bags could then be reconnected to the blockmat, and the holes grouted shut. If they were below water, a temporary dam would be needed. This would be very costly. The missing blocks could be replaced with riprap (750 lbs (340 kg)) at less cost.

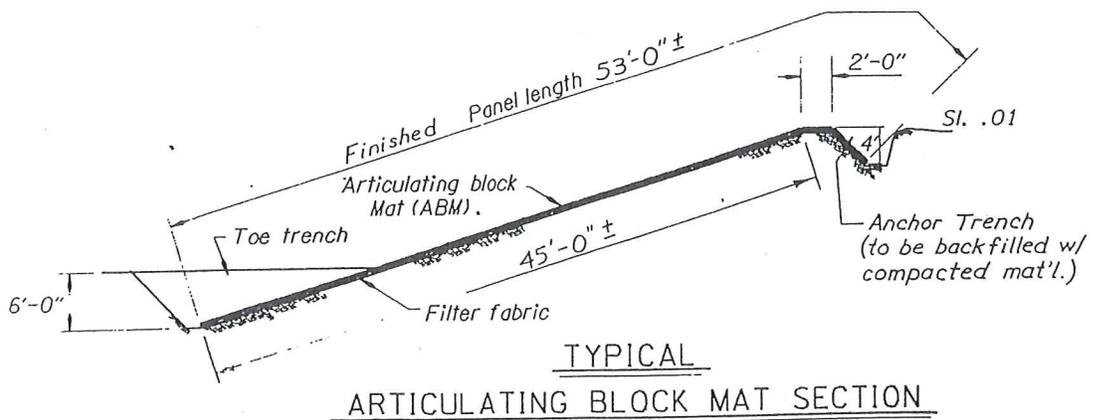
Most of the break-away blocks came from the bottom of the ABM. This section had been buried under a gravel blanket at construction (see Figure 2.8). The gravel had been scoured away in two sections, each about 2 ft (0.6 m) long (see Figure 2.9). Some blocks were broken away from the polyester cable or were still held by one strand. Sections of the block mat fabric form were also noted swaying in the current near the bottom. For some blocks, the fabric was the only connection to the blockmat (see Figure 2.10). Three blocks which had broken free were found at the downstream end (southwest corner) of the ABM (see Figure 2.9). One block and two block fragments, still bound together by the polyester cable, were found about 66 ft (20 m) upstream from the northwest corner of the ABM. It is unknown how the blocks were transported.

Figure 2.8: Detail of toe trench.

Future designs subject to similar flow conditions should consider keying the upstream edge 10 ft (3 m) into the bank and burying the toe 8 ft (2.4 m) into the channel bottom. In addition, the design should include riprap to protect the flanks of the mat. The ideal situation would be to construct the mat as designed with the fan shaped ends. The ABM appears to be most suited for active streambeds susceptible to erosion with slopes steeper than 1.5H:1V (steeper than is reasonable to place riprap).

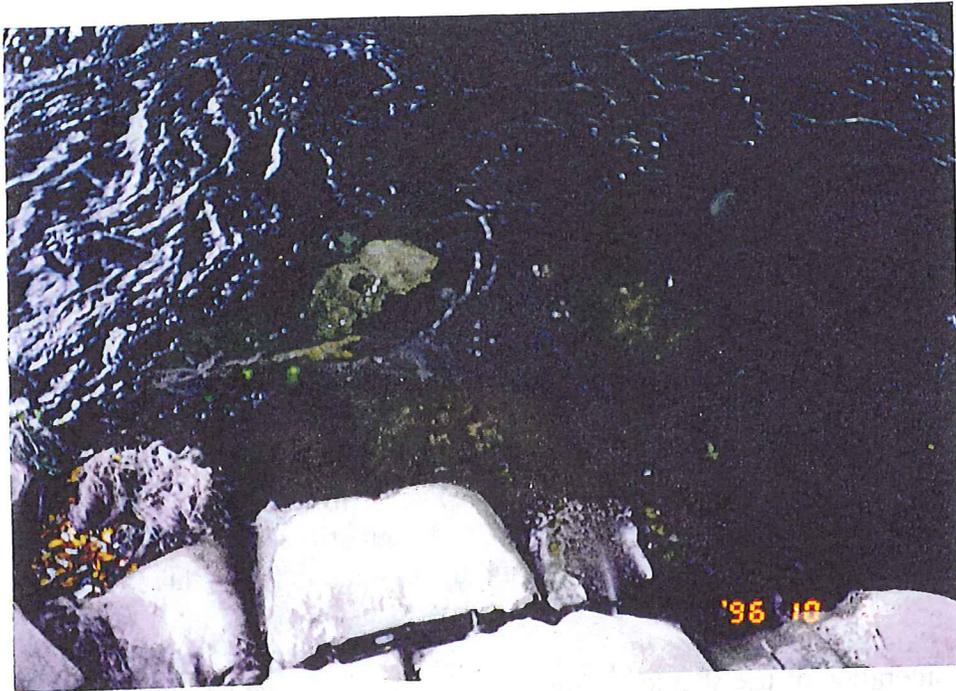
Figure 2.9: Exposed blocks after fill material in toe trench was scoured out.

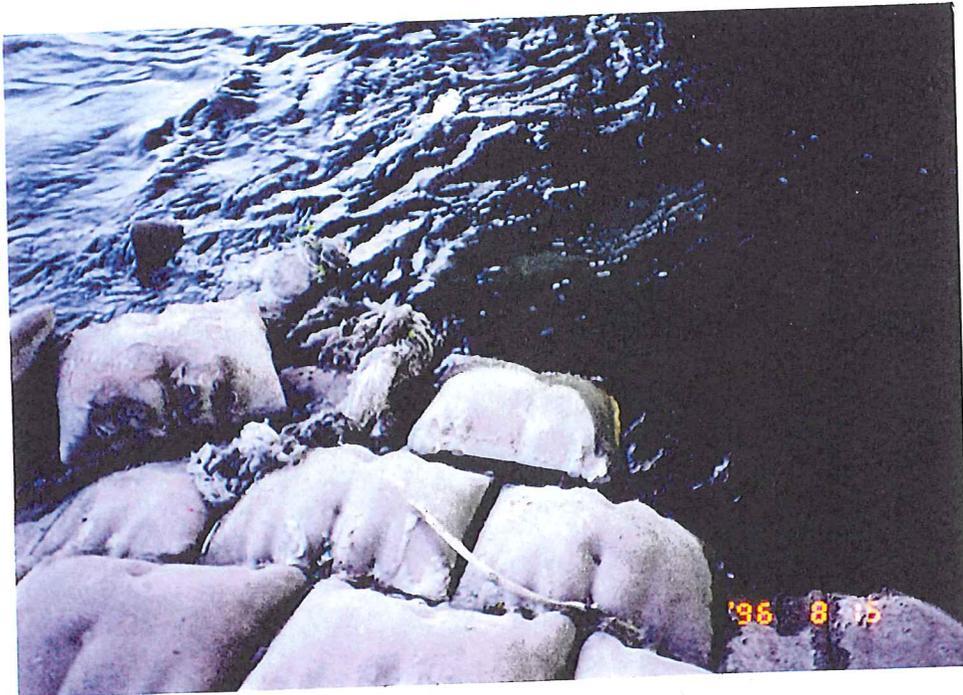
Figure 2.10: Blocks in damaged area are held only by fabric bag.

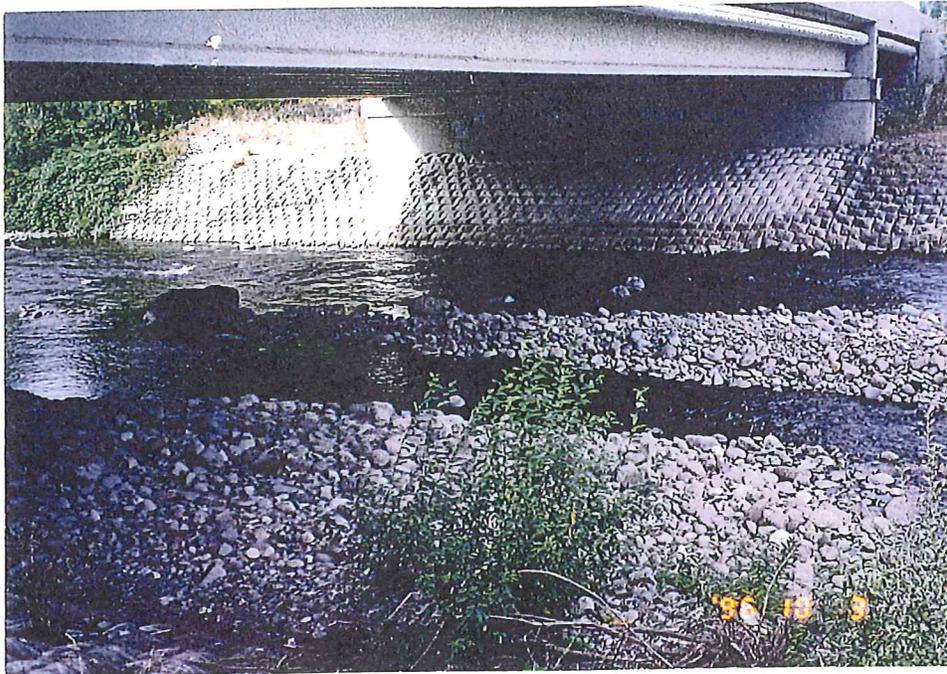
The damage covered only about 5% of the entire system. The southwest side of the ABM had no visible damage (see Figure 2.11).

Figure 2.11: Most of the west side was not damaged.

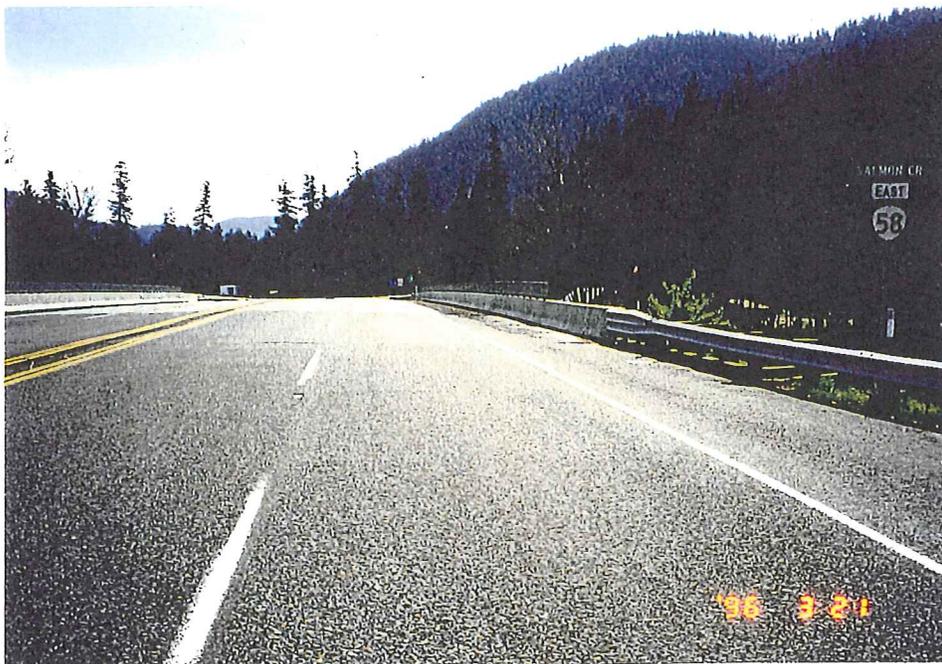
Evaluating the aesthetic value of the ABM is difficult because it is a subjective quality. One opinion of the mat was that it was too white and uniform, so it did not blend in with the natural setting. Another opinion was that the mat looked nice and provided a finished look to the embankment. During the site visits, it was noted that the fabric enclosing the grout is slowing wearing away.

Figure 2.12: Motorist view of blockmat.
