EVALUATION OF BOND-CONTROLLED,  
EPOXY-COATED PRESTRESSING STRAND  
on  
HUBBARD CREEK BRIDGE  
Bridge No. 3339A

Experimental Features Project OR 84-06

Final Report

October 1990

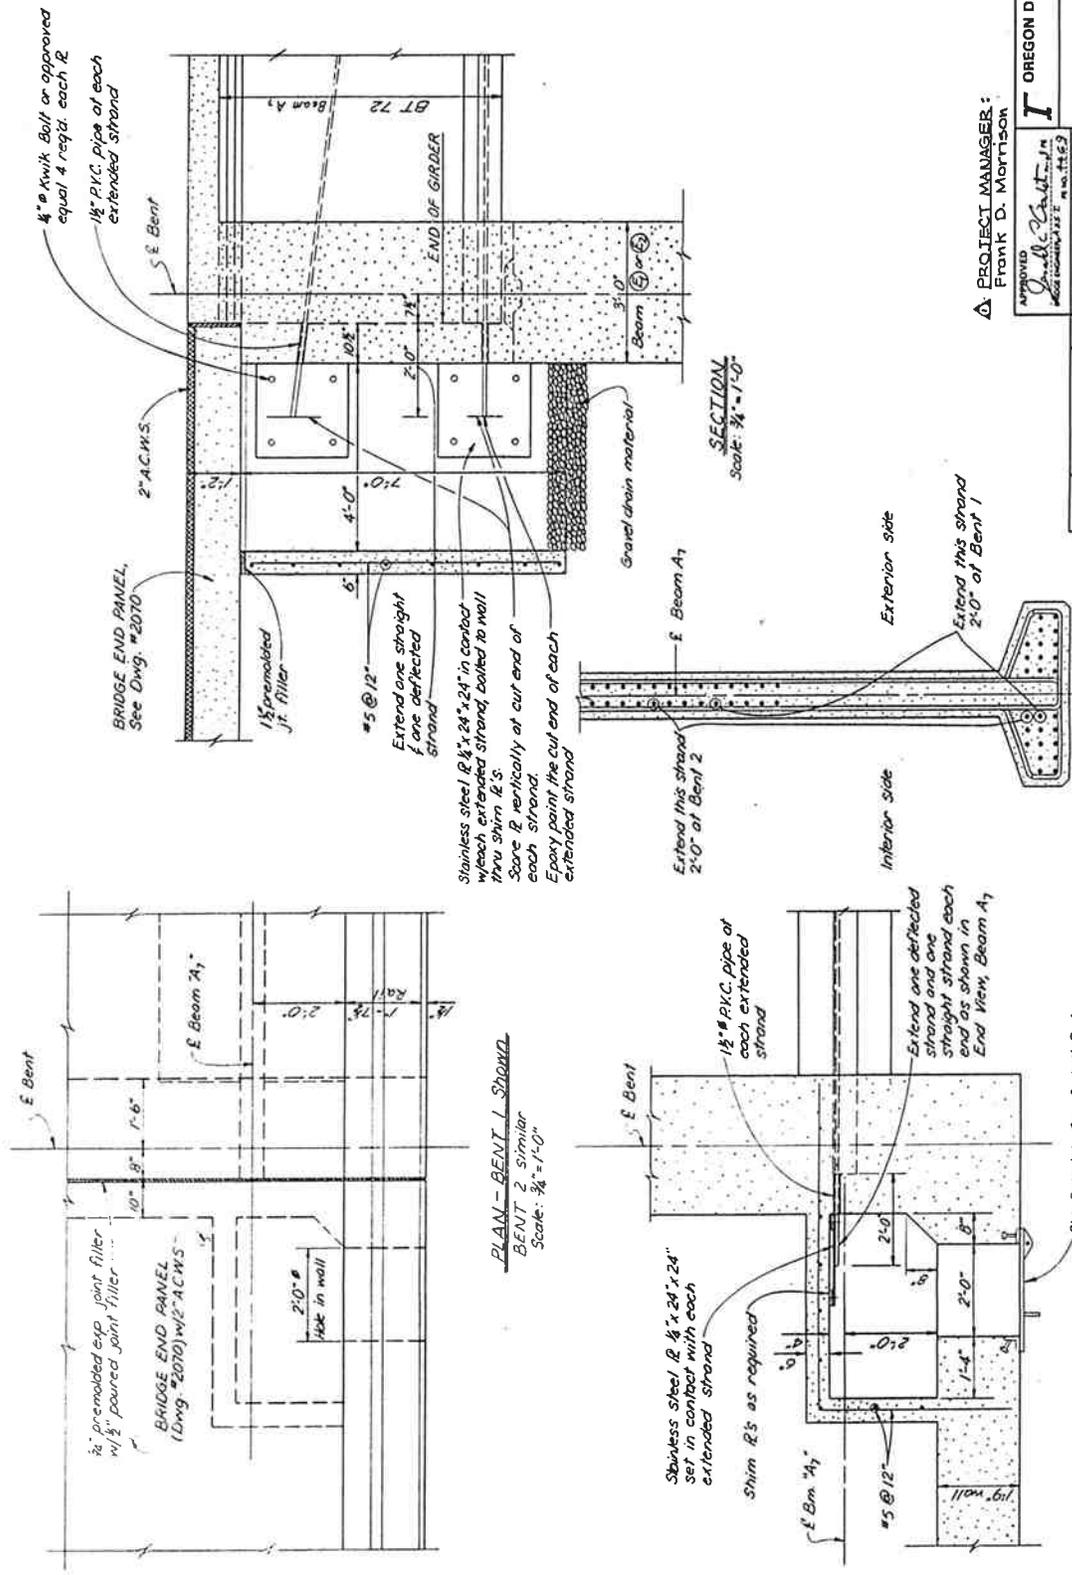
Figure 2

Eight strands were left extended in beam number seven (four strands at each end), and the ends of these strands were measured relative to a fixed reference point. Inspection vaults were constructed at both end bents to monitor slippage of the prestressing strands (four at each end). See figure 2 in Appendix E for details on the method of strand measurement.

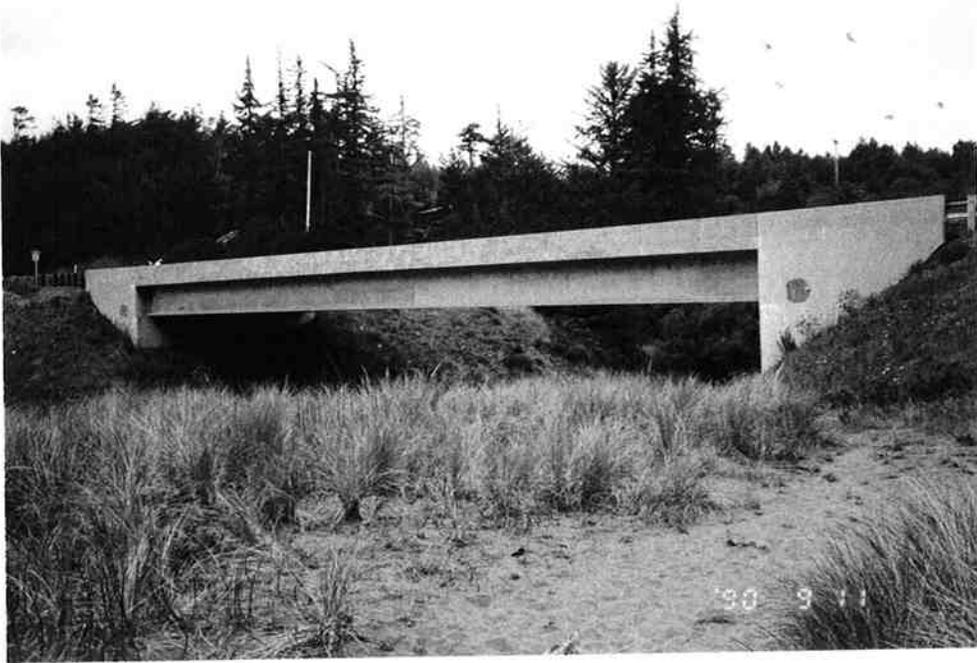
View looking northeasterly at the west side of the bridge

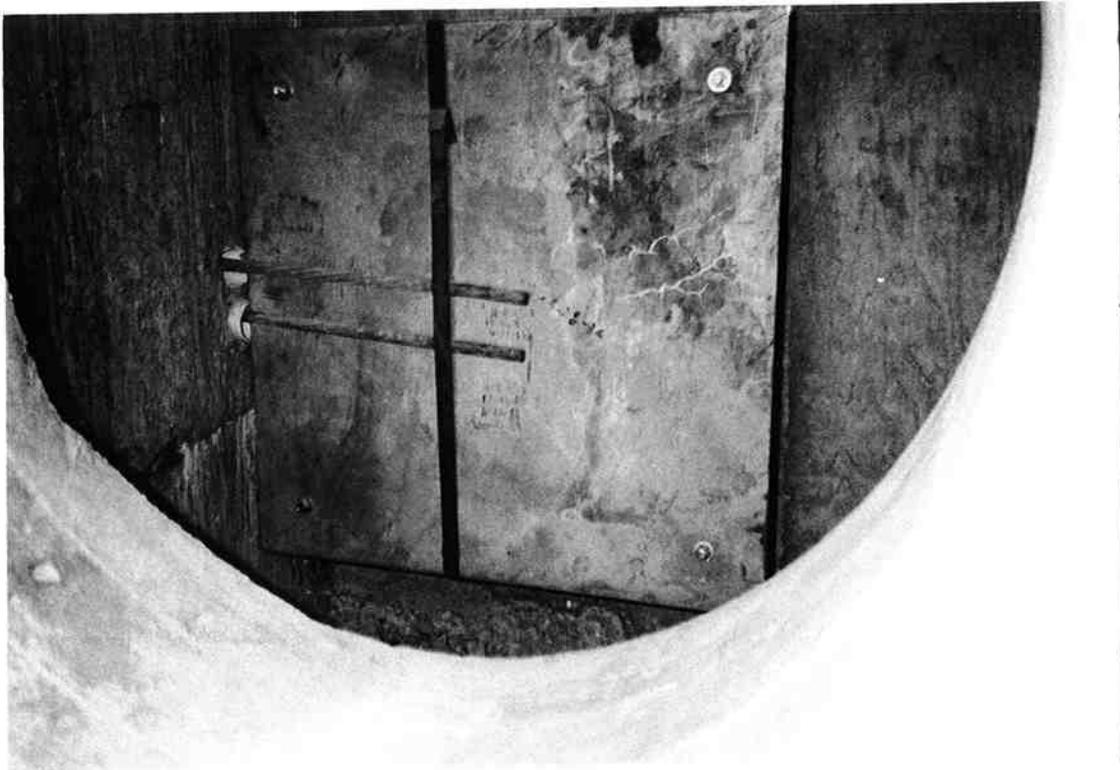
Measurements taken on the extended strands showed no measureable movement or slippage had taken place.

View looking inside of the southwesterly inspection vault
