Interim Report

POLYMER CONCRETE OVERLAY
OF CLACKAMAS RIVER BRIDGE

Basic Agreement DOT-FH-11-8876
Task Order No. Eleven

October 1983

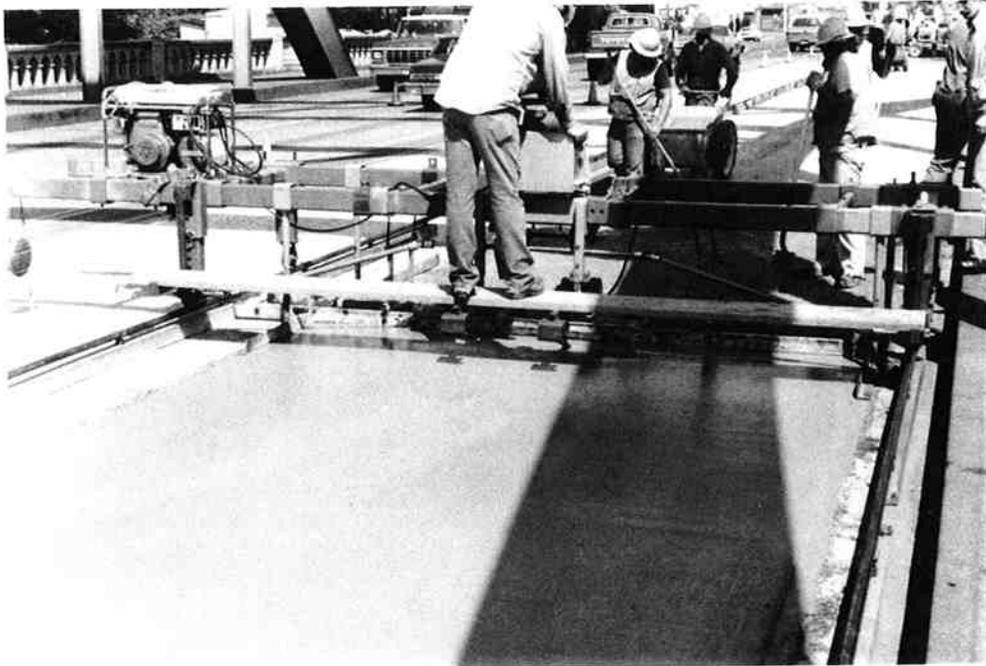
The condition of the overlay in the outside lane was generally good except for some occasional roughness which was caused by screed drag. The rough areas were found along both outside edges and in between the wheel tracks. The reason for these defects is the overlay was too thin for the size of aggregate used. The original plan called for a minimum thickness of 1/2 inch but due to the irregular profile of the deck there were areas where only a 3/8 inch overlay or less was obtained. The area in the rutted wheel tracks did not sustain screed drag because of the thicker section.

Polymer concrete in front of screed
