EXPERIMENTAL FEATURES PROJECTS

EXPERIMENTAL EXPANSION

BEARING STUDY

FINAL REPORT

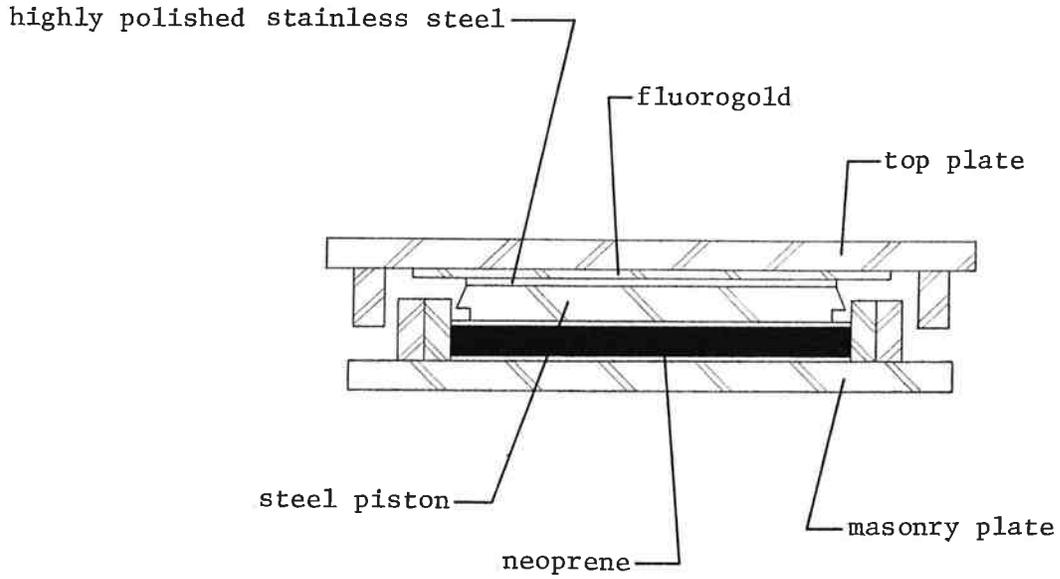
LATERALLY-RESTRICTED UNI-TON BEARING  
AASHO TYPE

The Fluorocarbon Uni-Ton bearings are functioning satisfactorily. During an inspection, a defect was found in the weld which attached the transverse shear bars to the upper sole plate on each bearing. After conferring with the manufacturer it was concluded a fabrication error had occurred which produced substandard welds. A clamping device which provides lateral restraint at each defective bearing was provided by the manufacturer and accepted by the State. Although these particular bearings had defective welds, the Uni-Ton bearing assembly is recommended for further use.

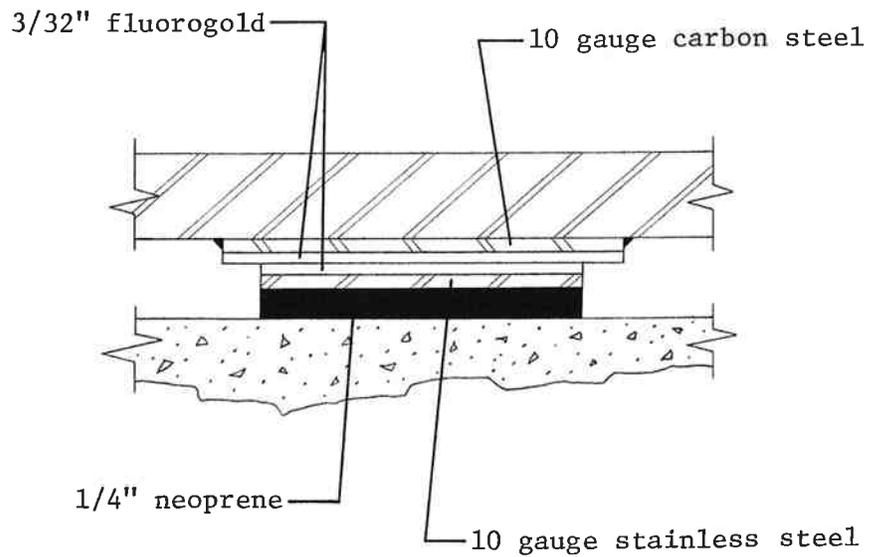
FLUOROGOLD SLIDE BEARING

The Fluorogold Slide Bearings are functioning well and appear to be in excellent condition. The bearing movement was reported to be uniform across the width of the bents. Because of the favorable inspection reports, this bearing is recommended for continued use.

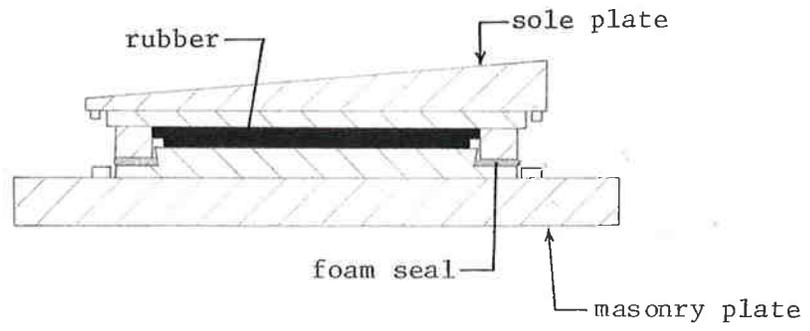
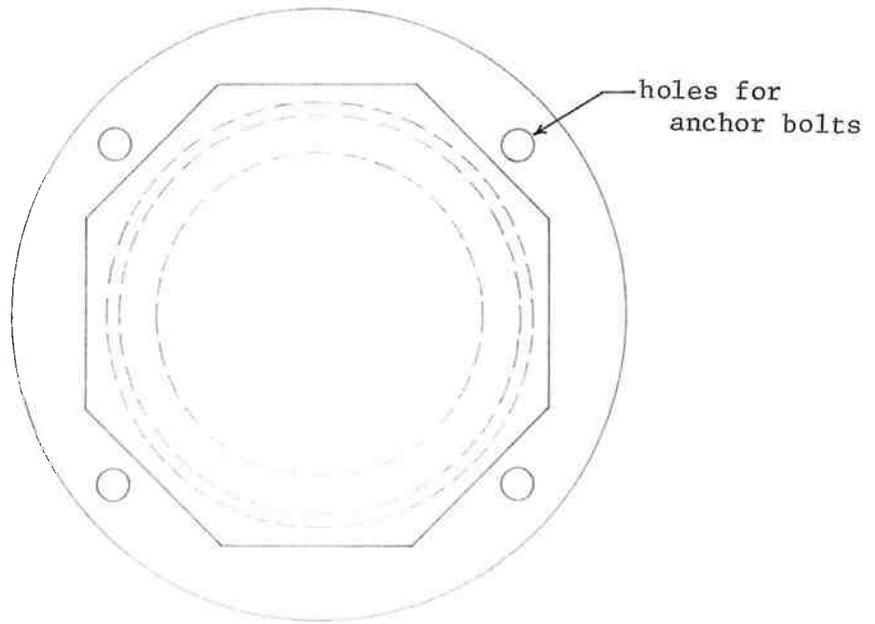
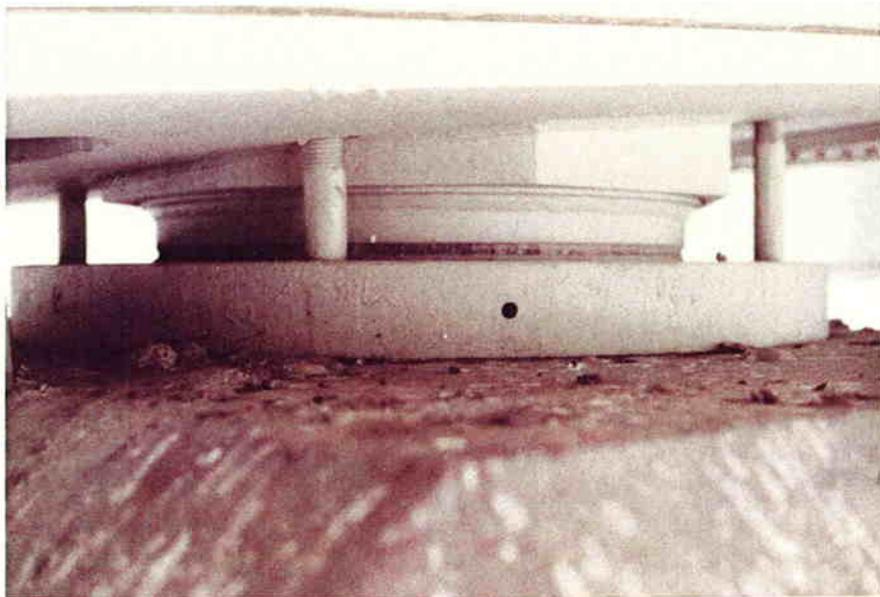
ROTA BEARING

The inspection of the Rota Bearings indicated them to be in like-new condition and functioning well. These bearings were designed for rotation only. The performance of this bearing system is satisfactory.

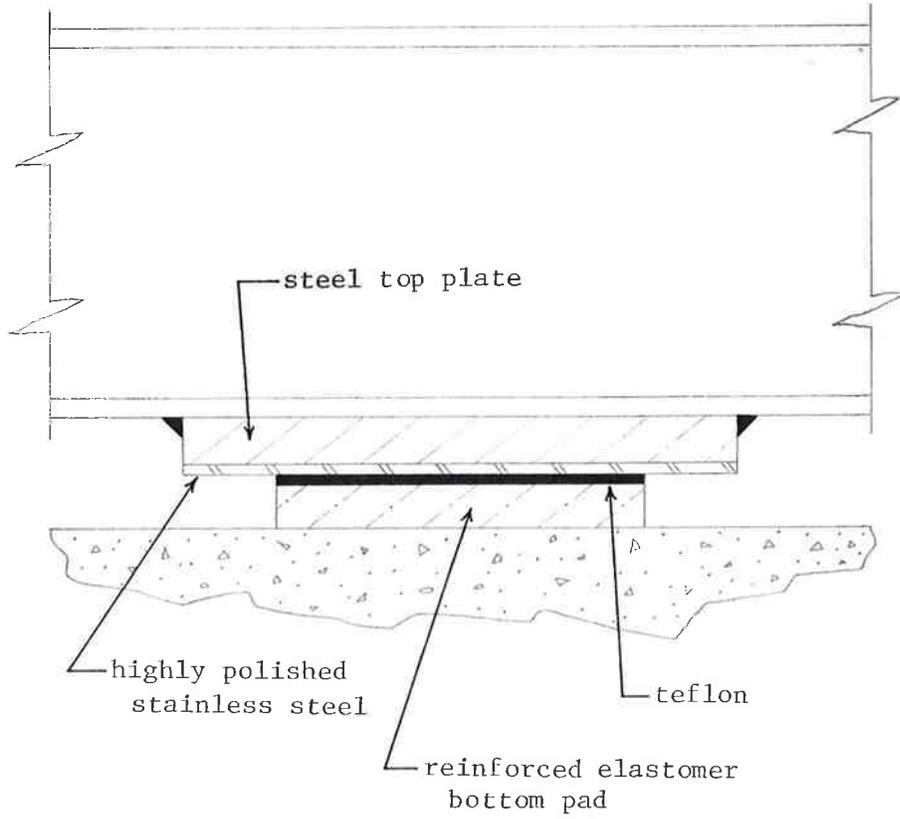
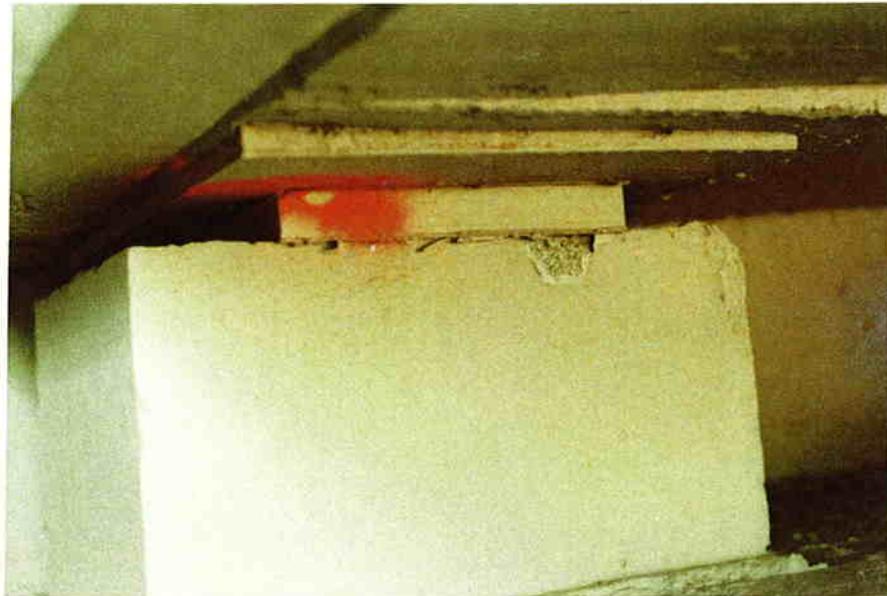
SPENCER SHORTSPAN TYPE D BEARING

The Shortspan Type D Spencer bearings are not functioning as the design anticipates. The laminated elastomeric bearing pad has moved slightly on the concrete pedestal at several assemblies causing concrete spall. At two pedestals, the bridge has moved partially off the bearing pads due to unanticipated bridge shortening. Continued thermal movements of the structure will in all likelihood worsen this condition and require the bearing to be repaired.

The bearing design concept appears to be sound but a positive method of preventing the pad movement is needed before this bearing can be considered acceptable. This bearing is currently being marketed by Dixon-Spencer Ltd.

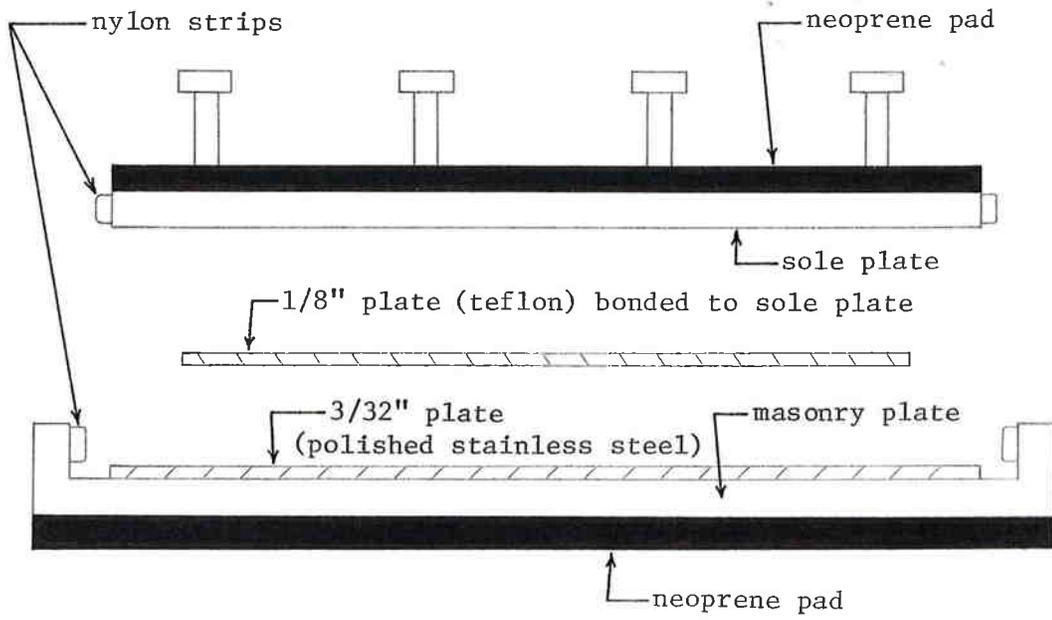
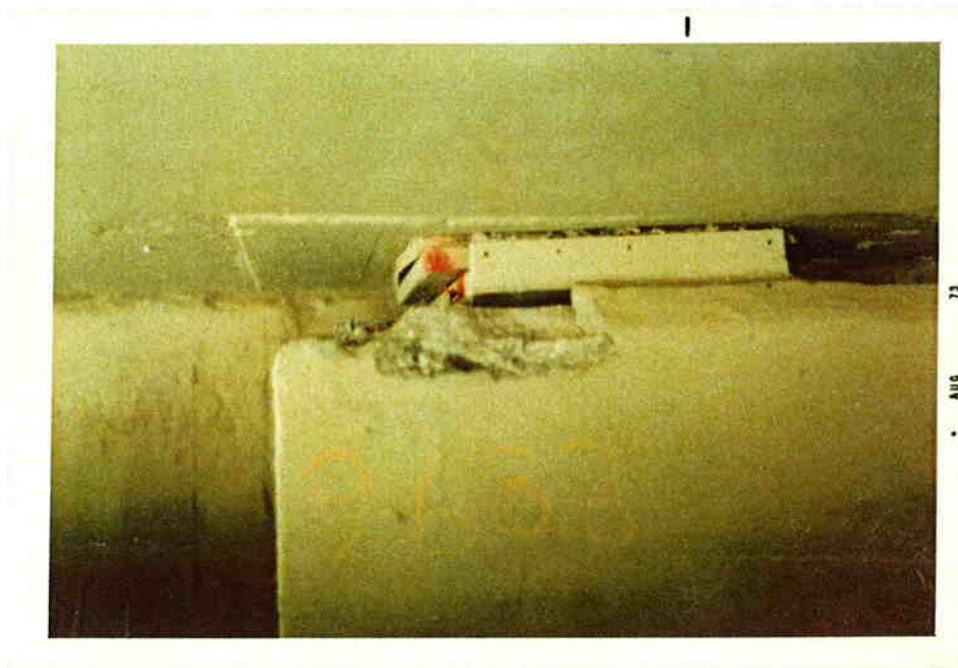
CONENCO END BEARING  
LF - 100

The Conenco expansion bearings are allowing movement as designed but early inspections found the 1/8" teflon slide plate located between the upper sole plate and lower masonry plate moving freely in several bearing assemblies. Although no problems have developed with the teflon plate, the potential for future problems clearly exists. In addition, small movement of the neoprene bearing pads which support the masonry plate has caused the concrete grout pad to crack and spall at several locations. An attempt to study these problems has been made but the manufacturer has not responded to two requests for detail shop drawings of the bearing assembly. Because of the stated problems and potential problem, these bearings are not recommended for use on future construction unless design modifications are made.

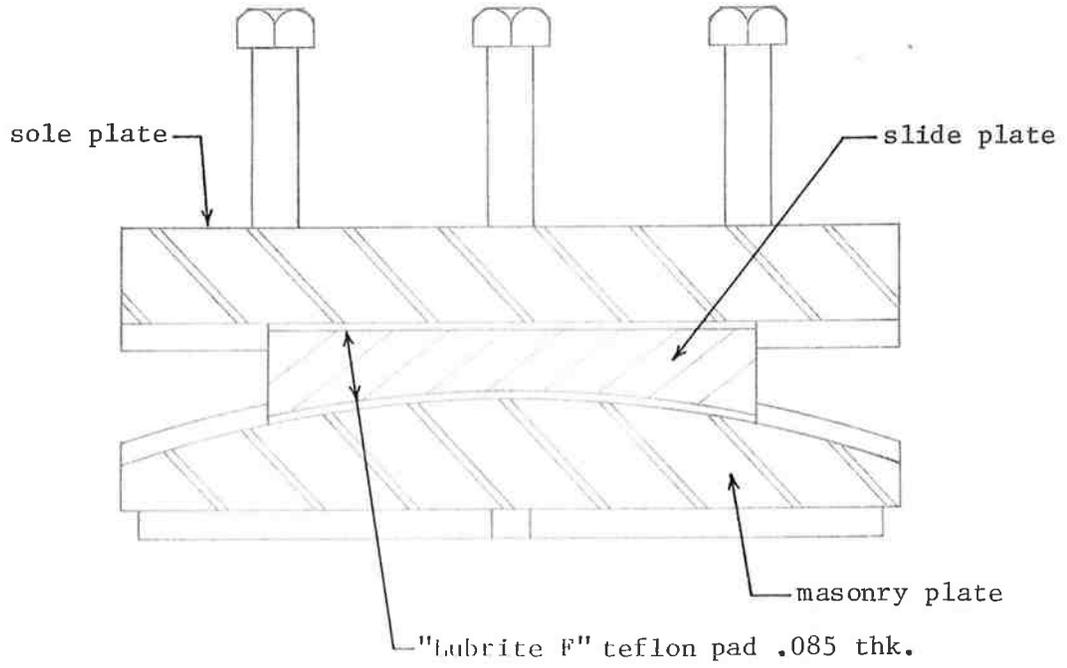
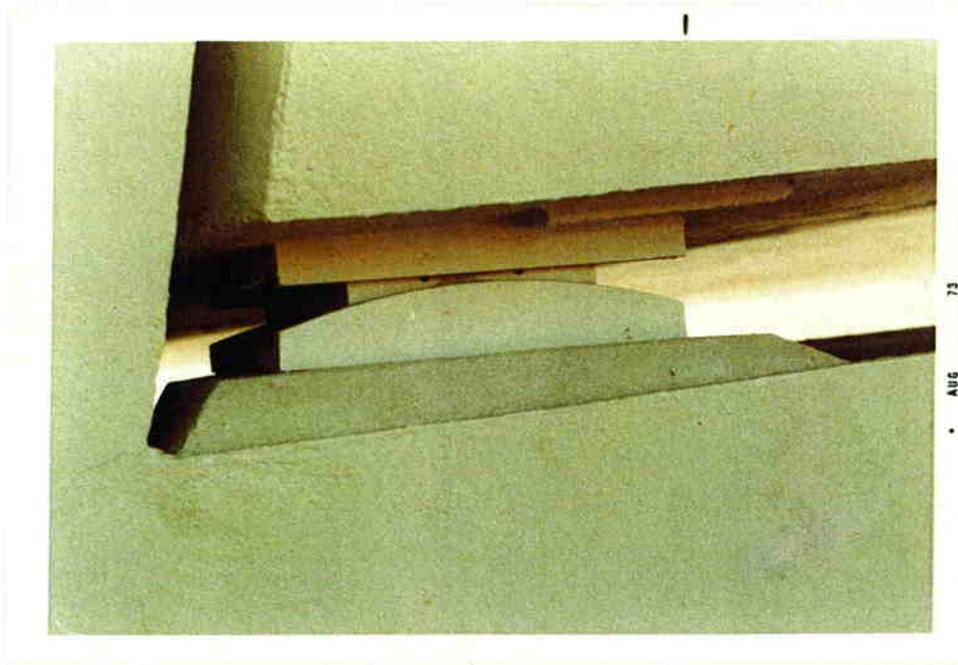
"LUBRITE F" TEFLON BEARING

The Lubrite "F" bearings were reported to be in excellent condition and performing as designed. Continued use of this bearing is recommended.
