**“FIBEROPTIC
VARIABLE MESSAGE SIGNS”**

**Ladd Canyon -
Drinking Fountain Grade Section
Old Oregon Trail Highway (Interstate 84)**

Final Report

Experimental Features Project OR 91-01

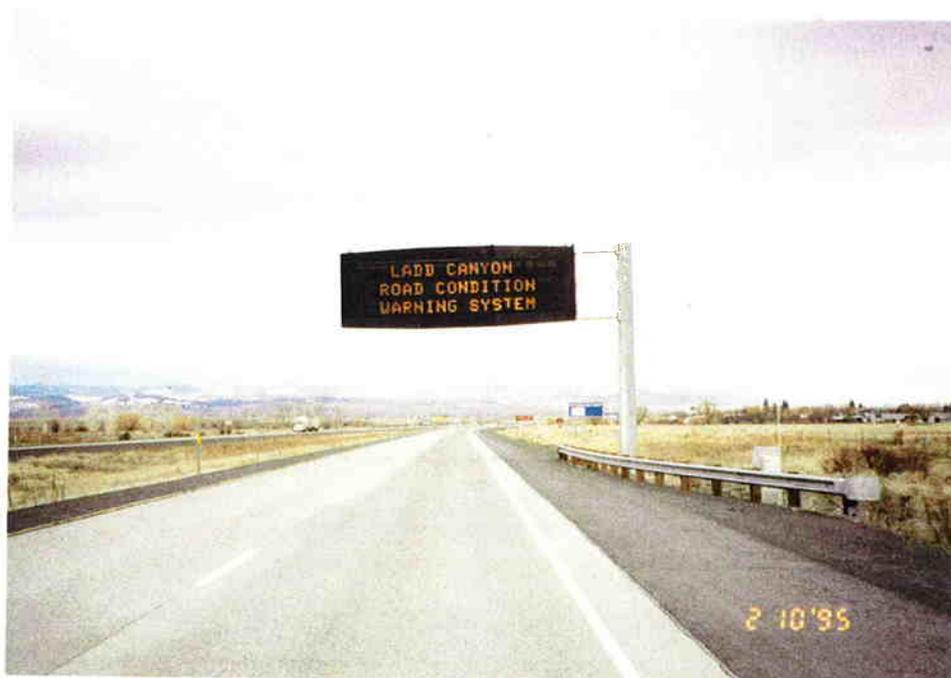
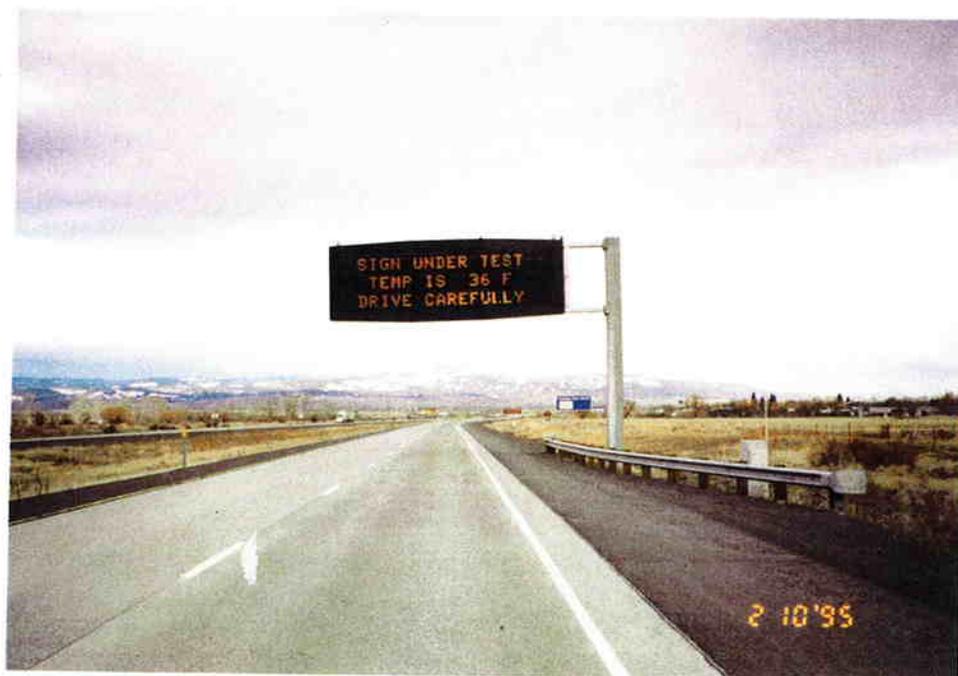
Variable Message Sign at La Grande:

Sign visibility monitored at the M.P. 263.4 VMS has been good under both day and night conditions. During the day, the sign system provides an overbright option, and at night a dimming option to reduce light bleeding can be used. At this particular installation, the overbright and dimming feature has provided favorable results. In general, the sign becomes

legible at approximately 1000 ft [300 m]. Table 2.1 provides specific information obtained from field evaluations under various weather conditions.
