EVALUATION OF
FLEXIBLE PLASTIC GLARE SHIELD
IN OREGON

OREGON STATE HIGHWAY DIVISION
Salem, Oregon 97310

May 1981

Effect of Glare Screen on Freeway Accidents

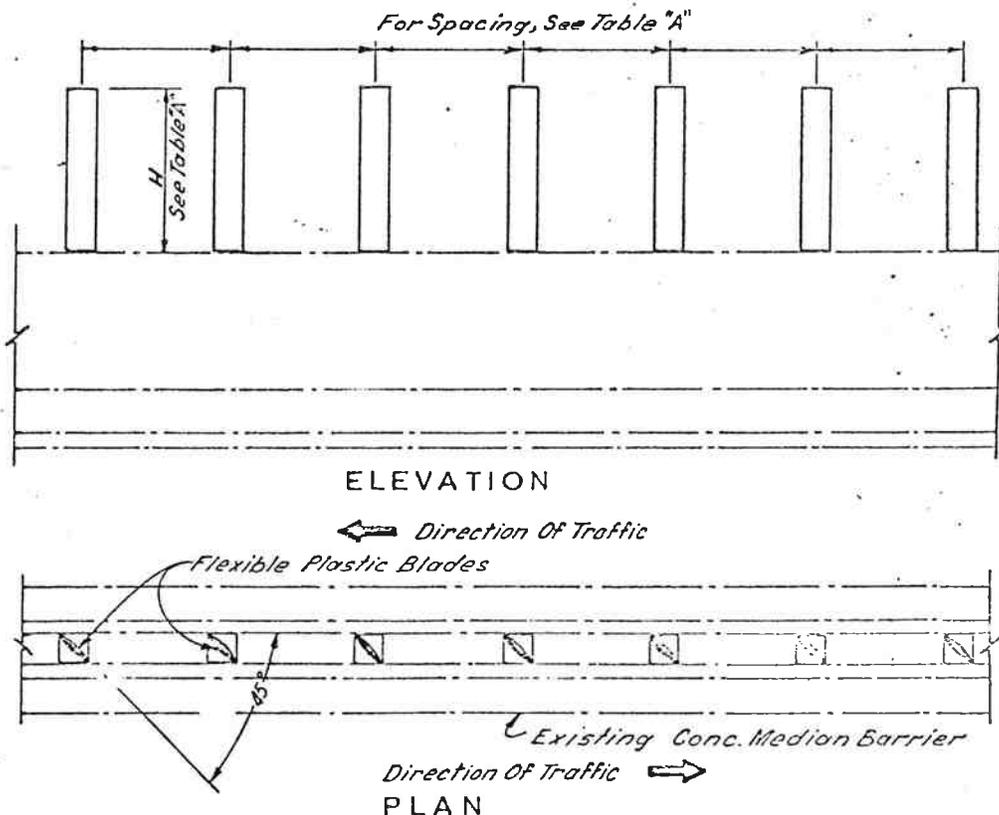
FIGURE 1

The mounting bracket used on the project used a single anchor bolt at the center of the base plate. Nine months after installation, the maintenance crew reported frequent loosening of the anchor bolts caused, presumably,

by the truck pressure wave. The loosening allowed the blades to rotate from their intended 45 degree angle to traffic, thus reducing their effectiveness. Over-torquing the single, center mounting bolt caused the base plates to warp which, in turn, reduced the contact area between the concrete barrier and the base plate. This warping aggravated the tendency of the blades to rotate. A further problem with the center mounting bolt was that the blade had to be disassembled in order to tighten the anchor bolt. The bracket was subsequently redesigned to use two anchor bolts at opposite corners of the base plate. An additional modification involved bending the bolts used to mount the blades to the base plates at a 30 degree angle. This eliminated the need for beveled washers required to fit the somewhat elliptical shape of the blades. The original design is shown in Figure 1 and the revision is shown in Figure 2. This revised mounting bracket is now being used exclusively.

3. There is a significant increase in driver comfort.
4. By replacing the paddles at a six to nine month interval, the maintenance cost is not excessive.
5. Closing a lane of the freeway to wash the reflectors is not justified.
6. The mounting bracket should contain two anchor bolts to prevent rotation of the blades and the bolt that holds the paddle to the bracket should be bent at a 30 degree angle.

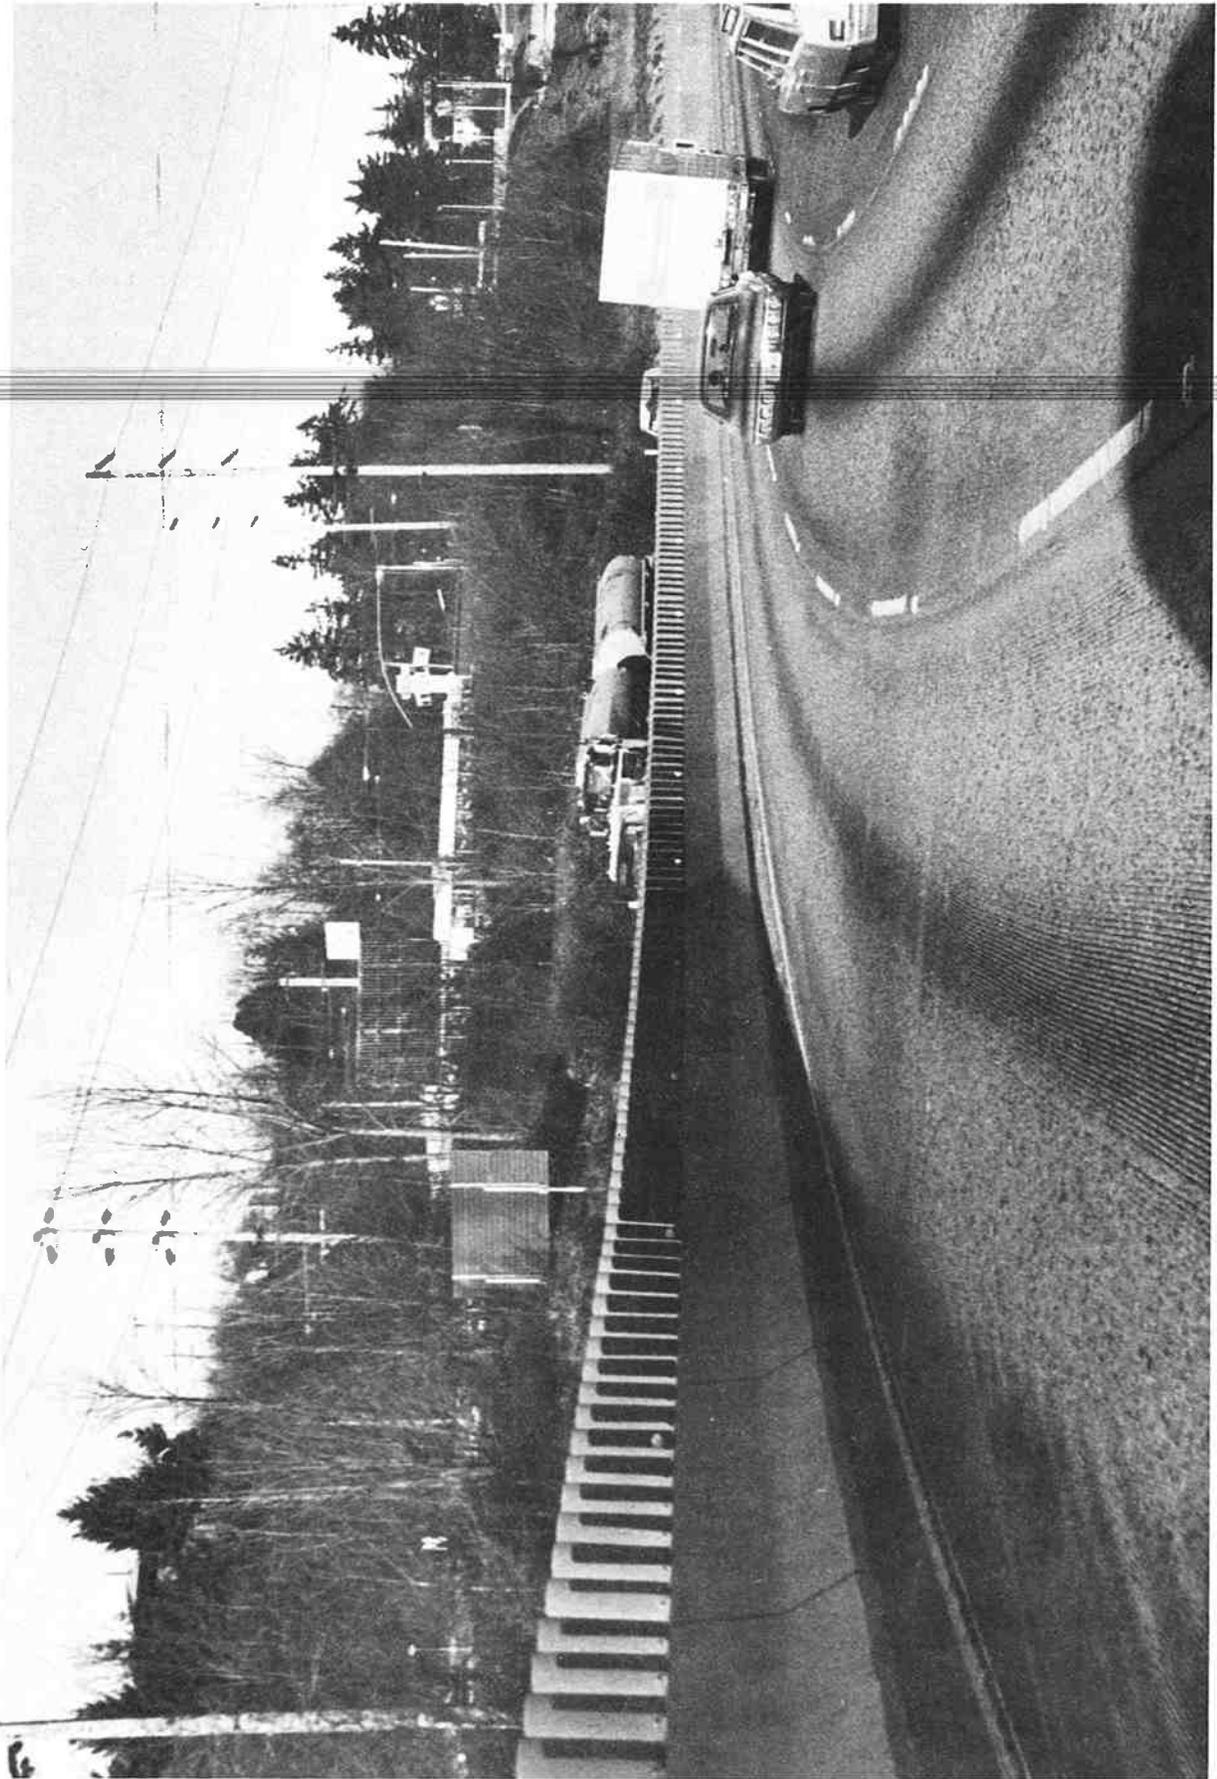
Figure 3
Northbound on a curve. Note reflectors at base of 24-inch paddles. Spacing 30 inches.

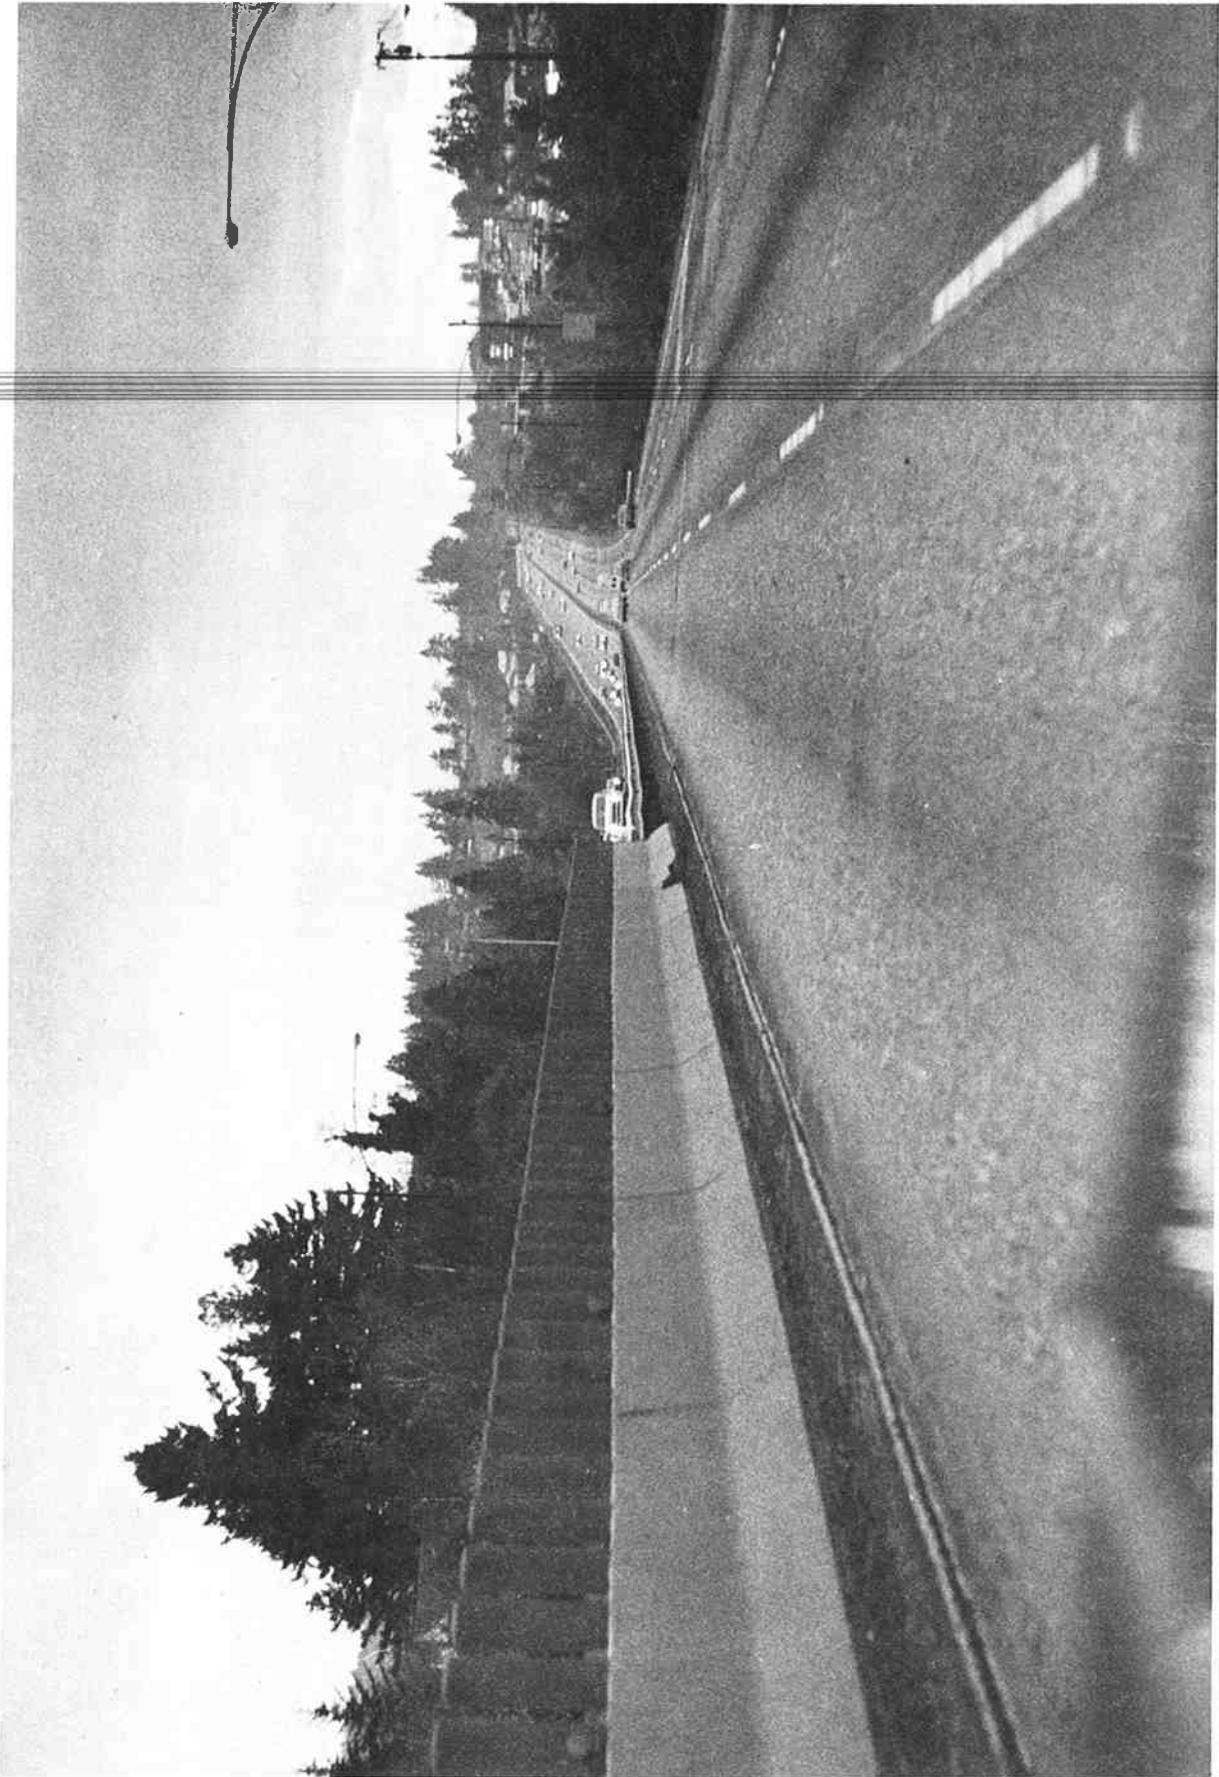
Figure 4
Southbound near end of section. 24-inch paddles, 30-inch spacing.

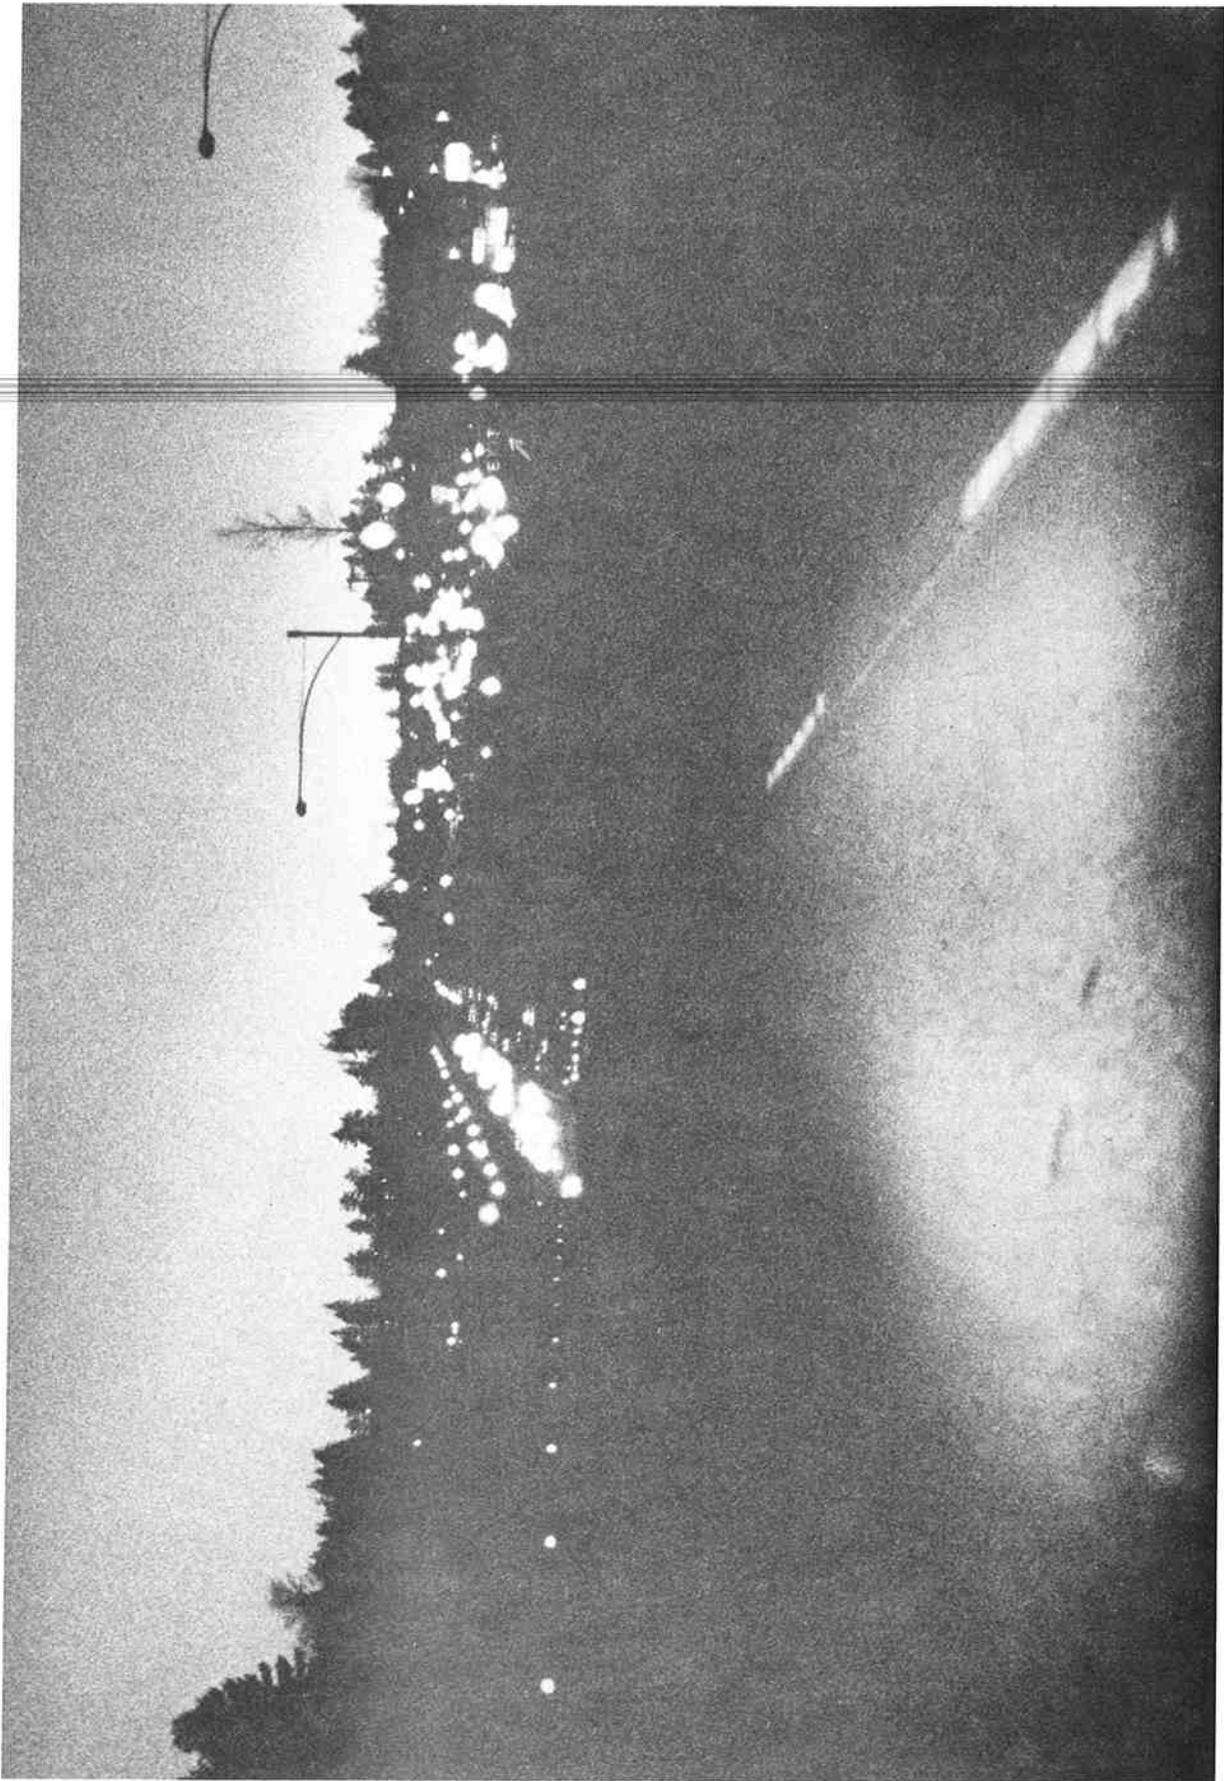
Figure 5
Southbound night view at same locations shown in Figure 4. Note contrast in headlight glare on section with and without screening.

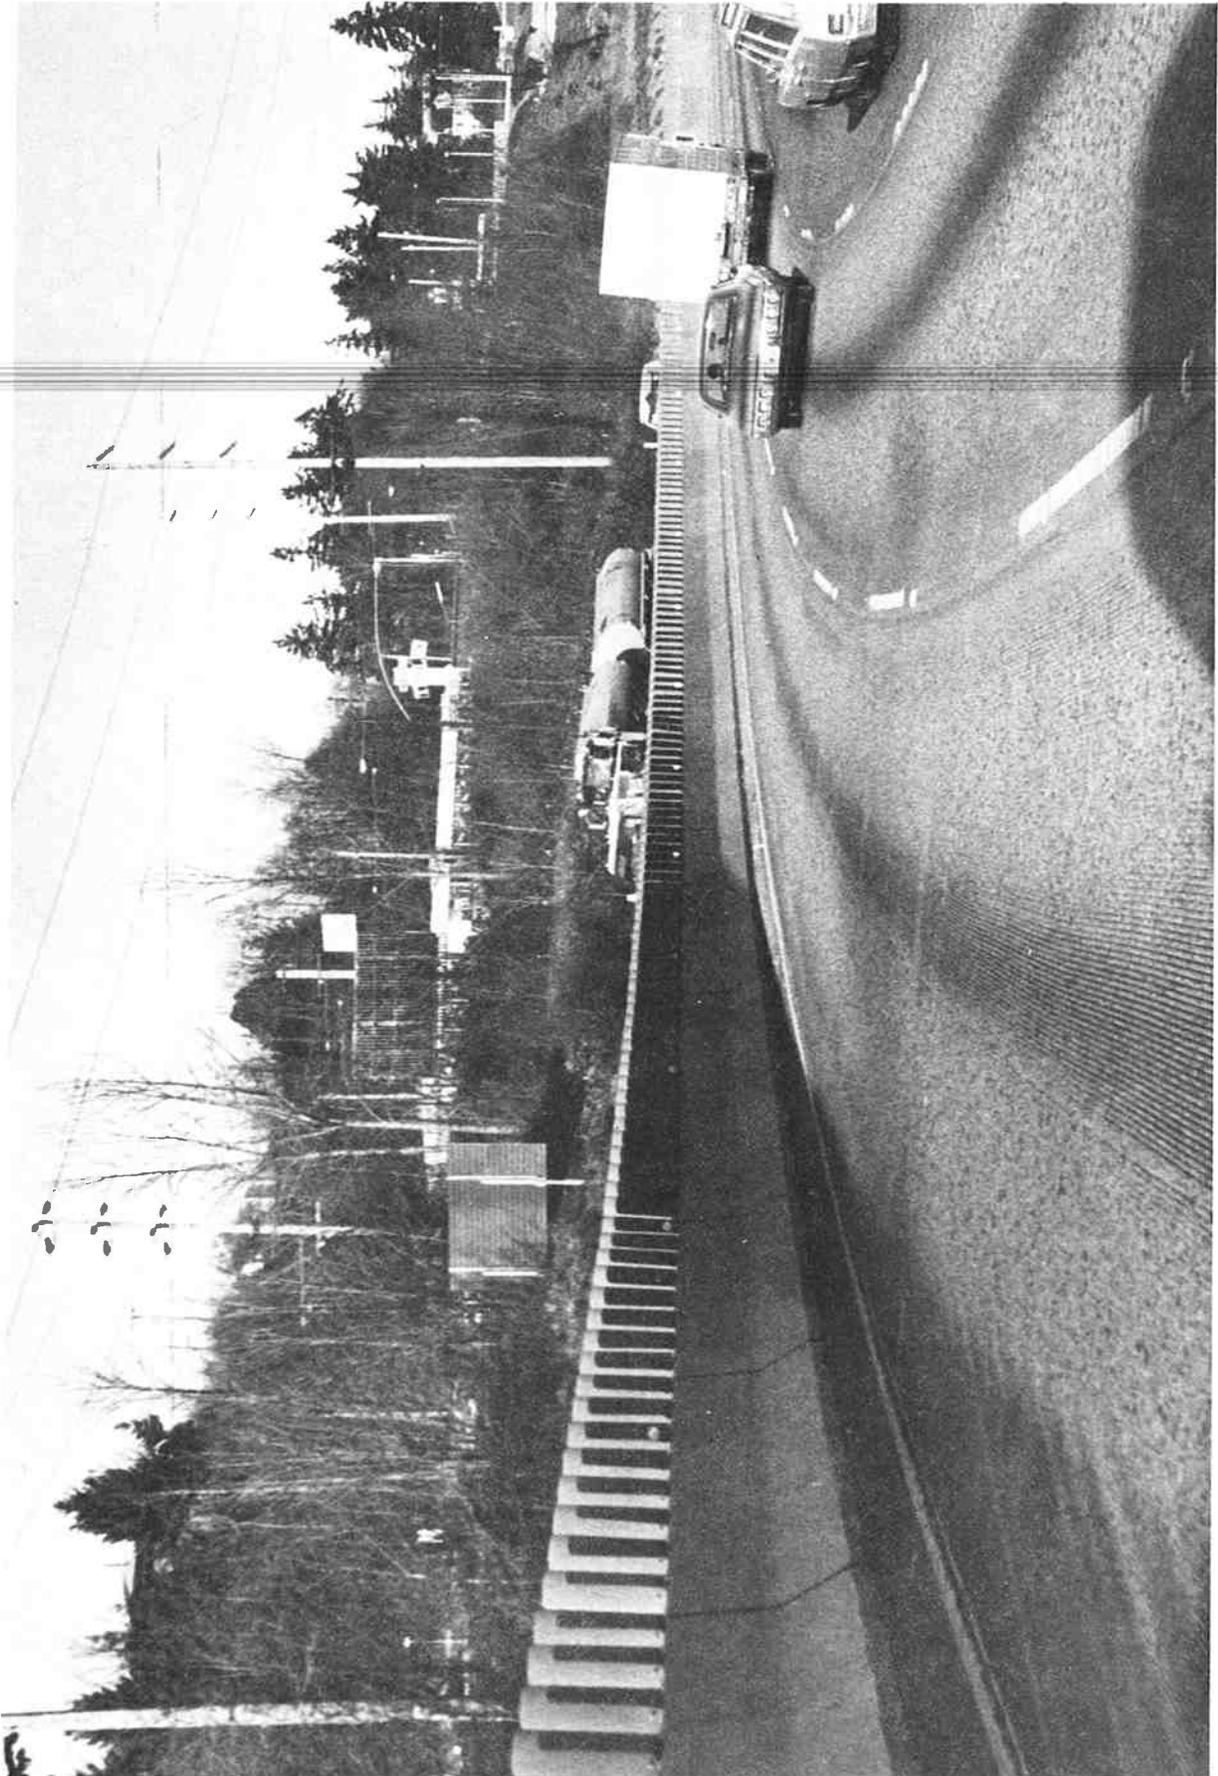
Figure 2
Northbound on a curve. Note reflectors at base of 24-inch paddles. Spacing 30 inches.

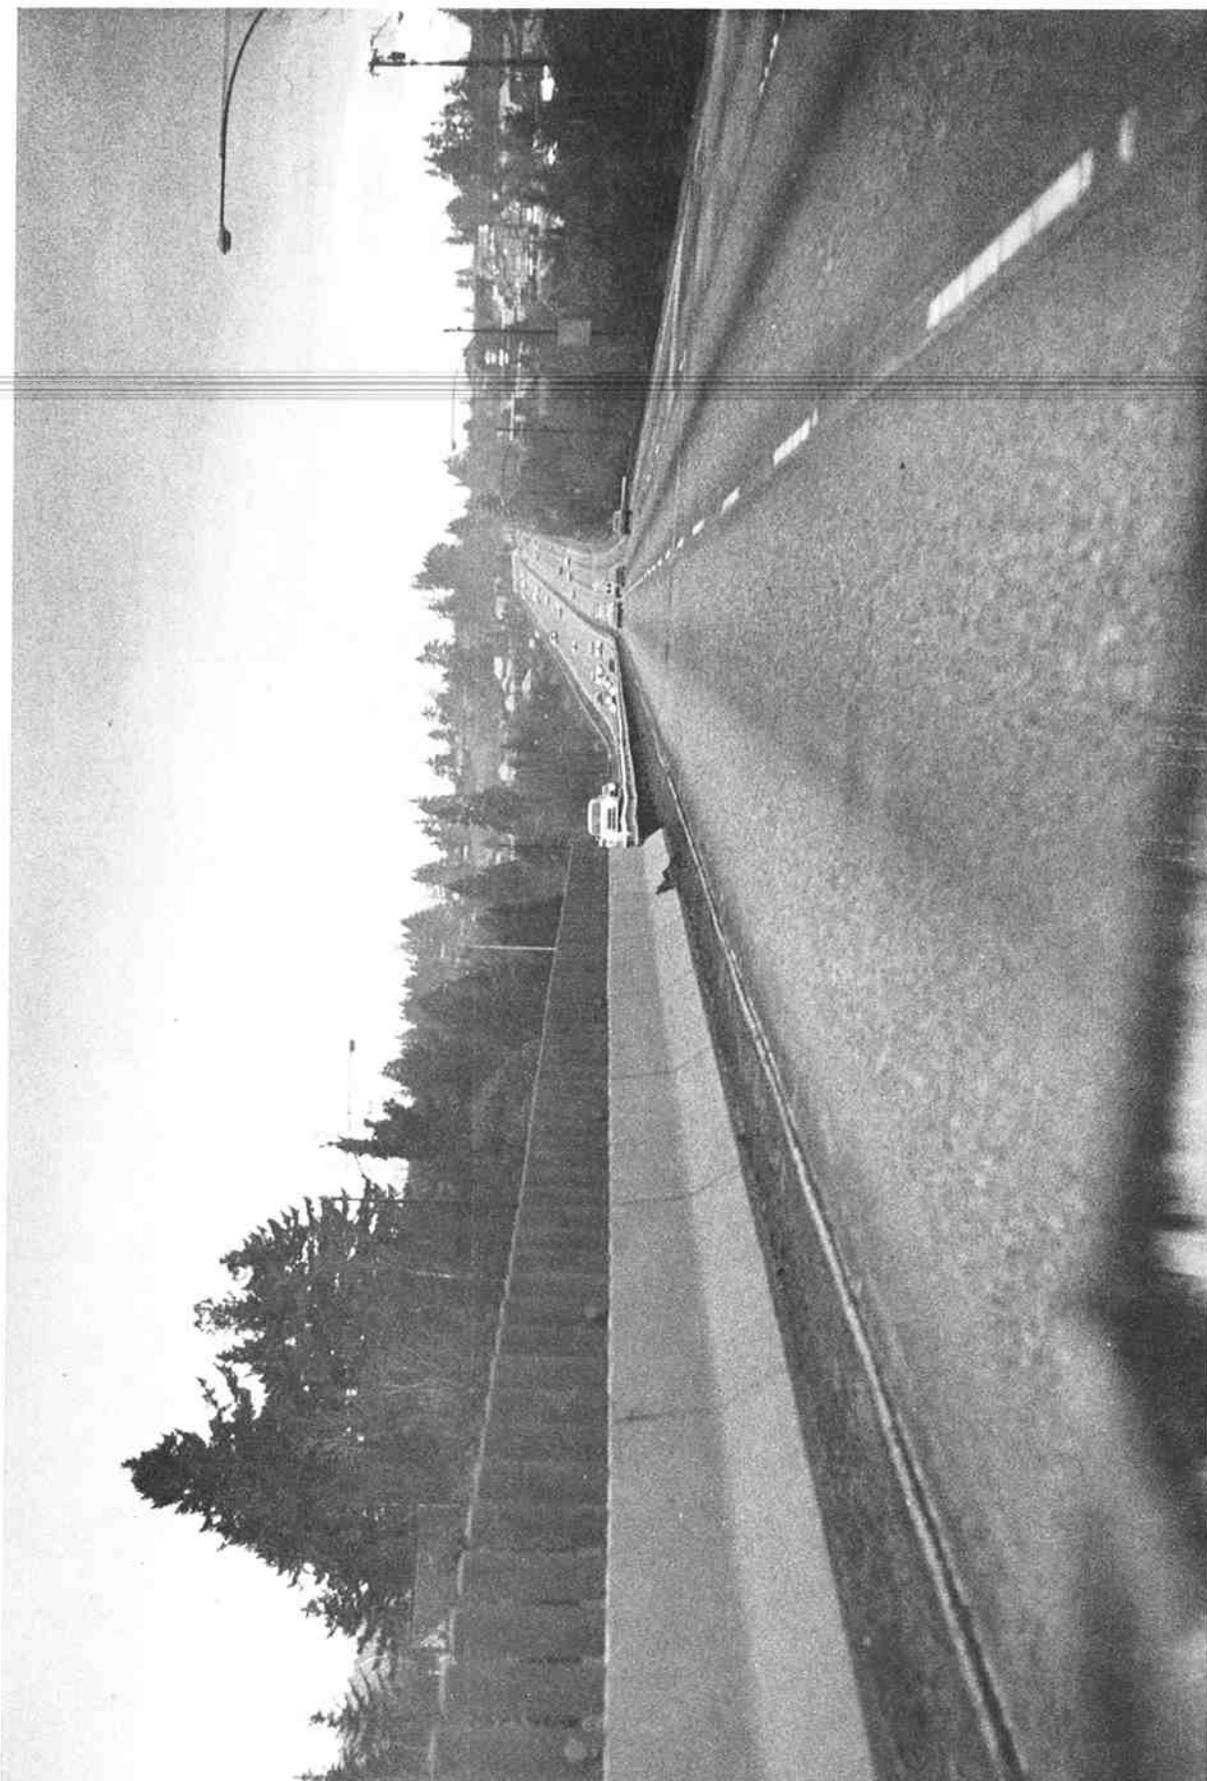
Figure 3
Southbound near end of section. 24-inch paddles, 30-inch spacing.

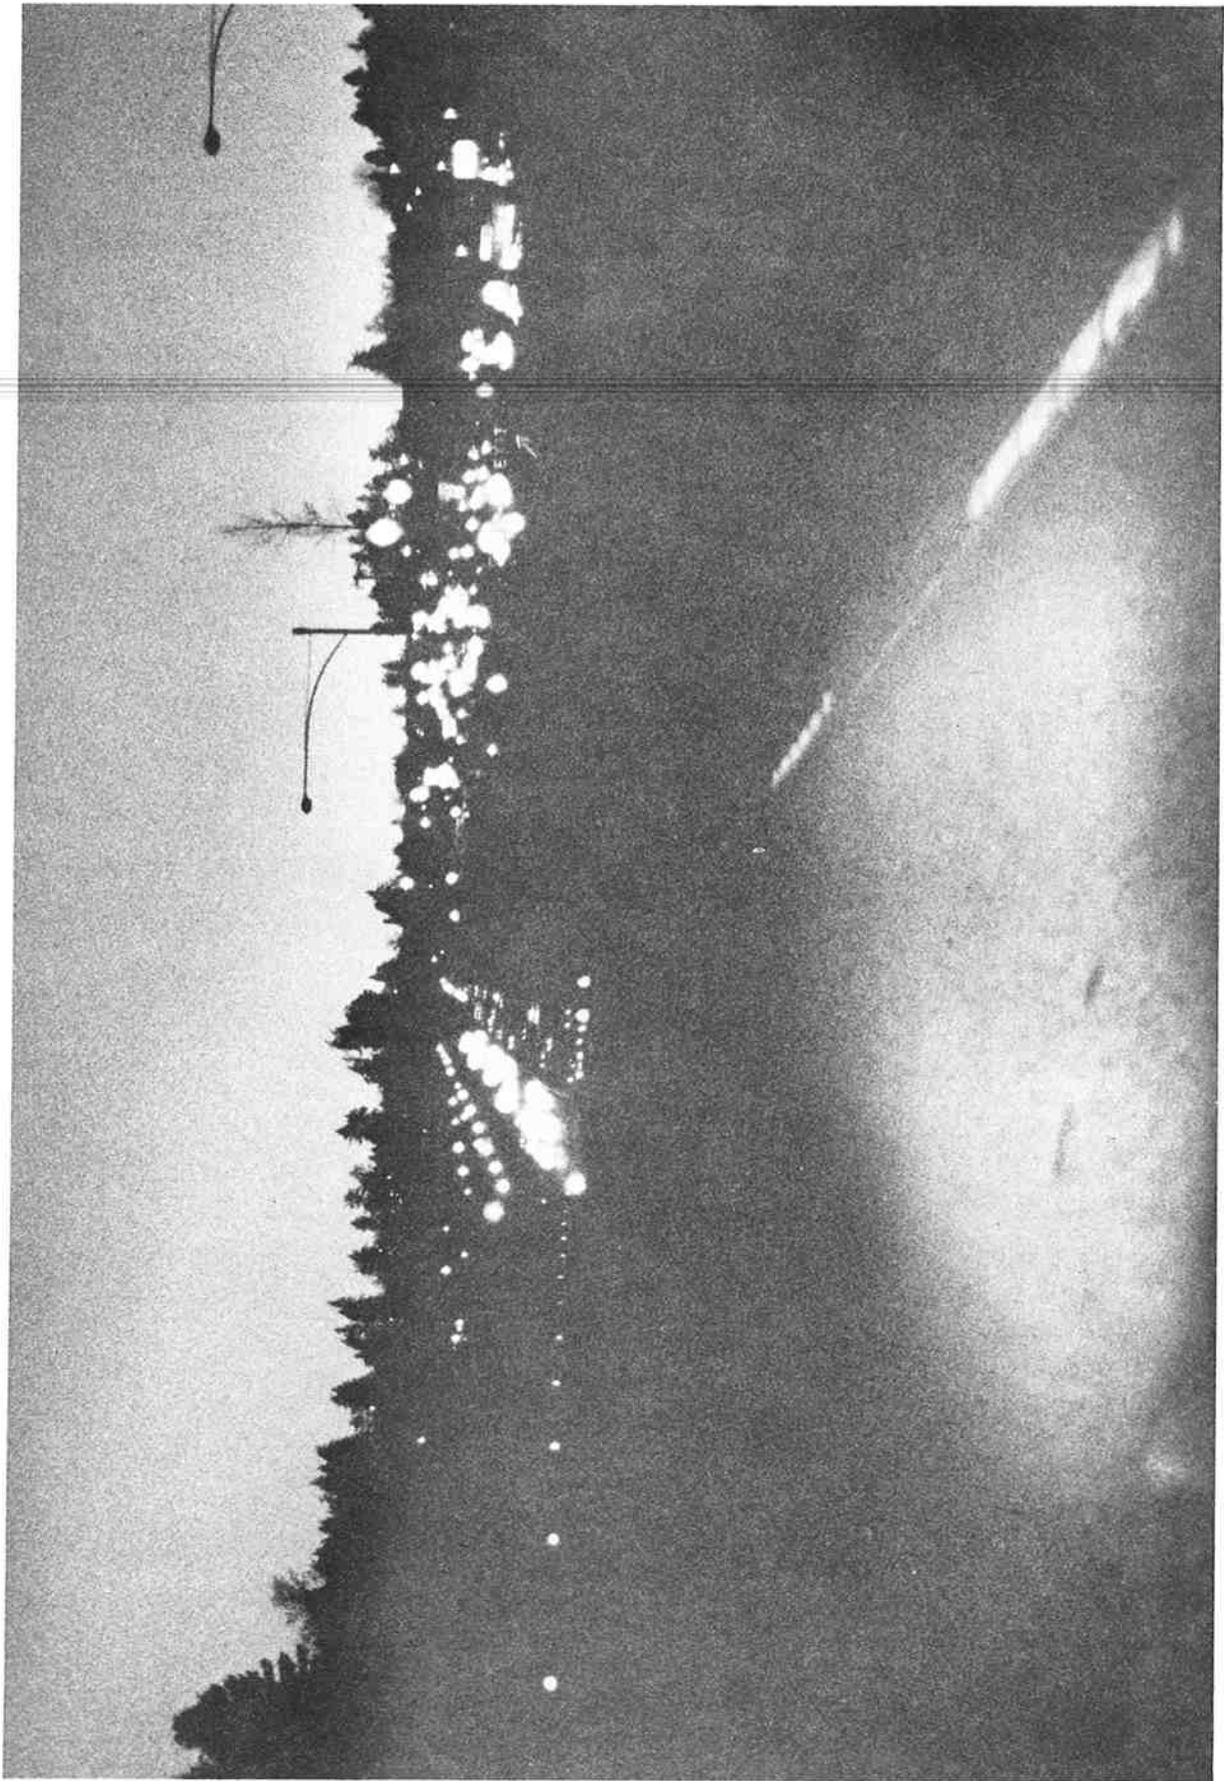
Figure 4
Southbound night view at same locations shown in Figure 3. Note contrast in headlight glare on section with and without screening.
