**MICROSILICA MODIFIED CONCRETE
FOR BRIDGE DECK OVERLAYS**

Final Report

FHWA Experimental Features

January 1997

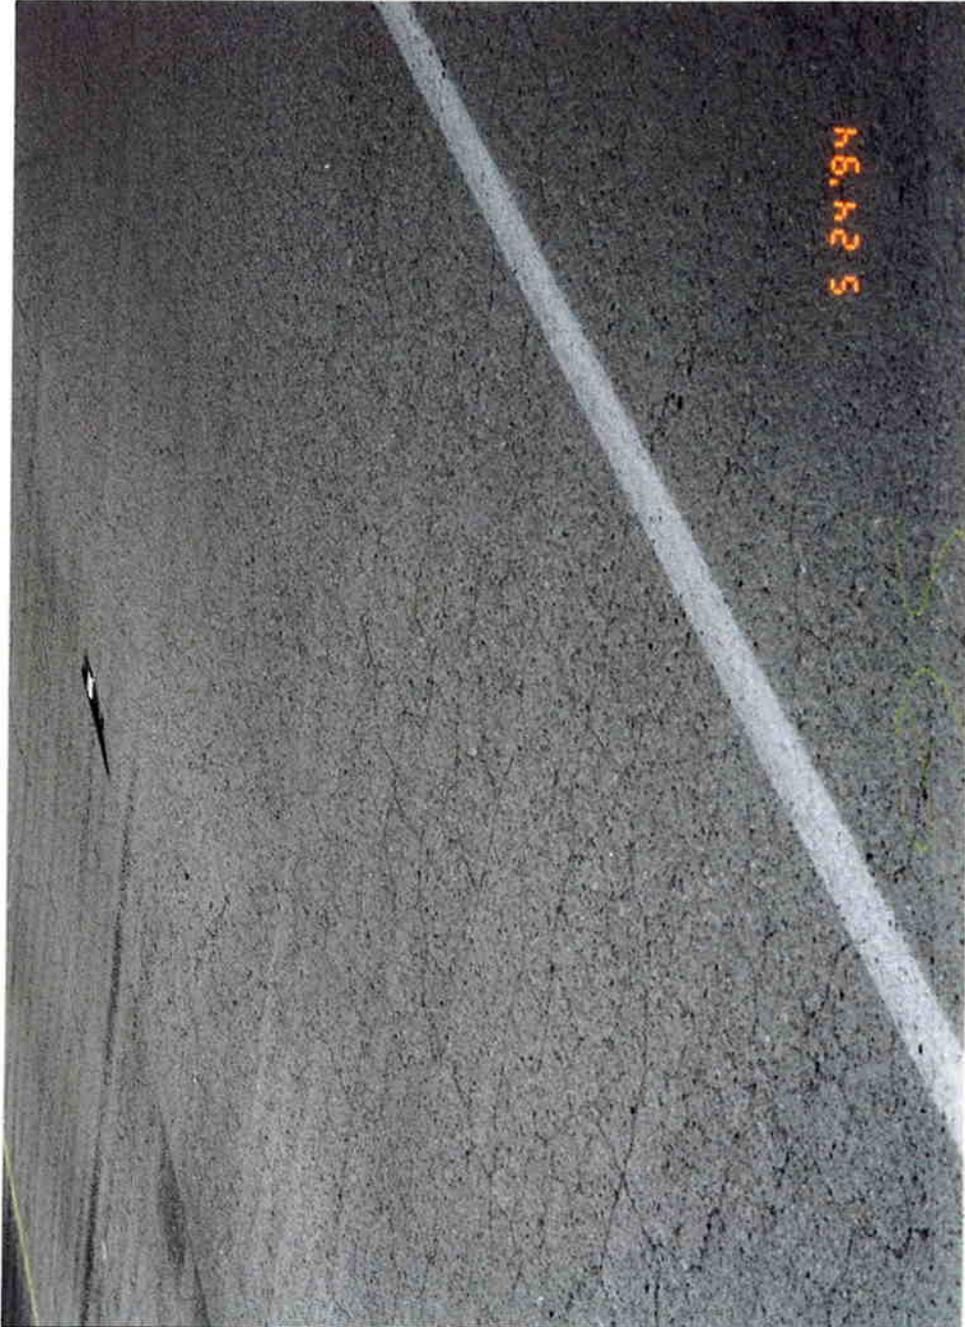
Figure 3.1: Typical Crack Pattern on Neil Creek Overcrossing.

Cracking increased from 1990 to 1993. Figure 3.1 shows a typical crack pattern. This photo was taken in the spring of 1994 on the Neil Creek Overcrossing Bridge. Cracks had interconnected into an alligator or map pattern. The interconnected, "map pattern", cracking was typical of many cracked areas on these overlays.

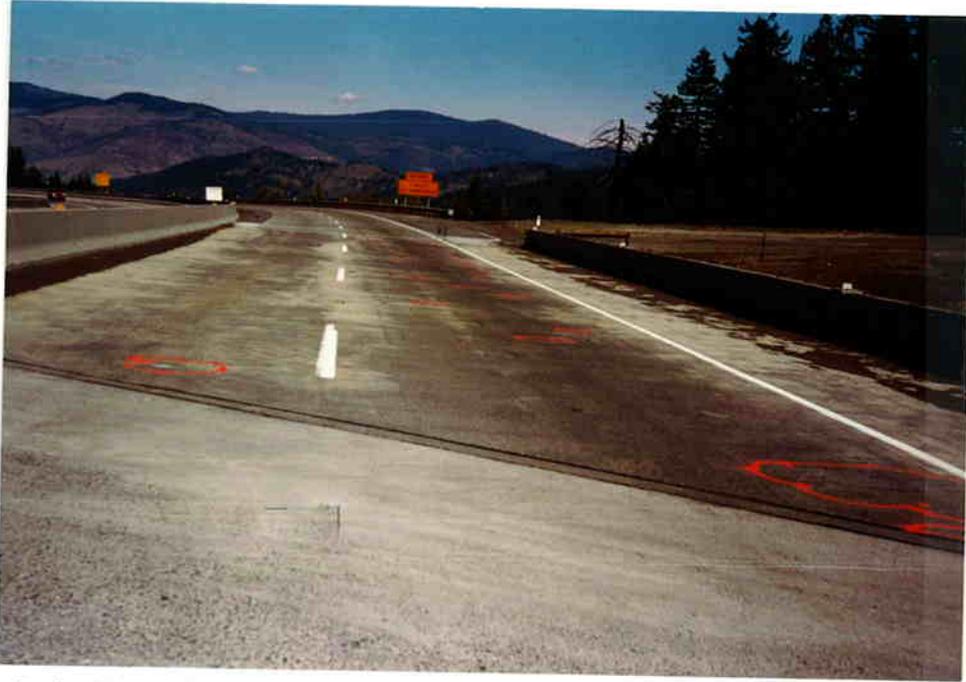
a) Cracking and delamination on the south end of the overlay in September 1990.
(Red line outline the delaminated areas)

- 4) **An increase in the number and size of delaminations.** In 1993, all four of these overlays had delaminated areas. Between 1990 and 1993, the percentage of the deck area which was delaminated increased from an average of 1.25% to an average of 3.75%. Figure 3.2 shows typical delaminations in 1990, and again in 1993. As shown in the Figure, the delaminations increased in size during the three year period.

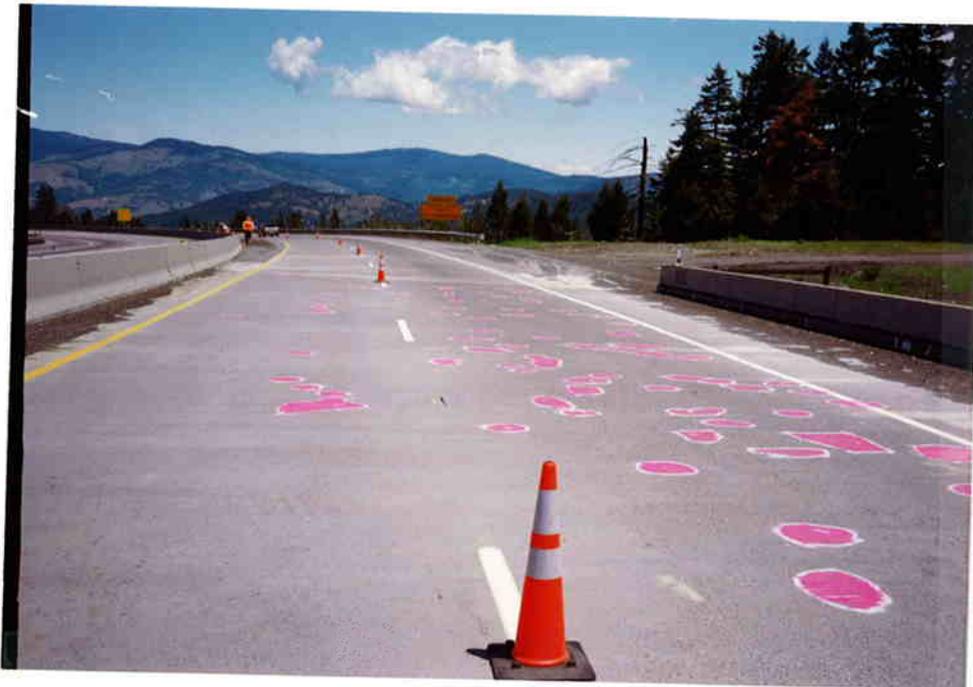
b) Delaminated areas in June 1992 (approximately same location as Figure 3.1a).
The cracking and delamination had increased.

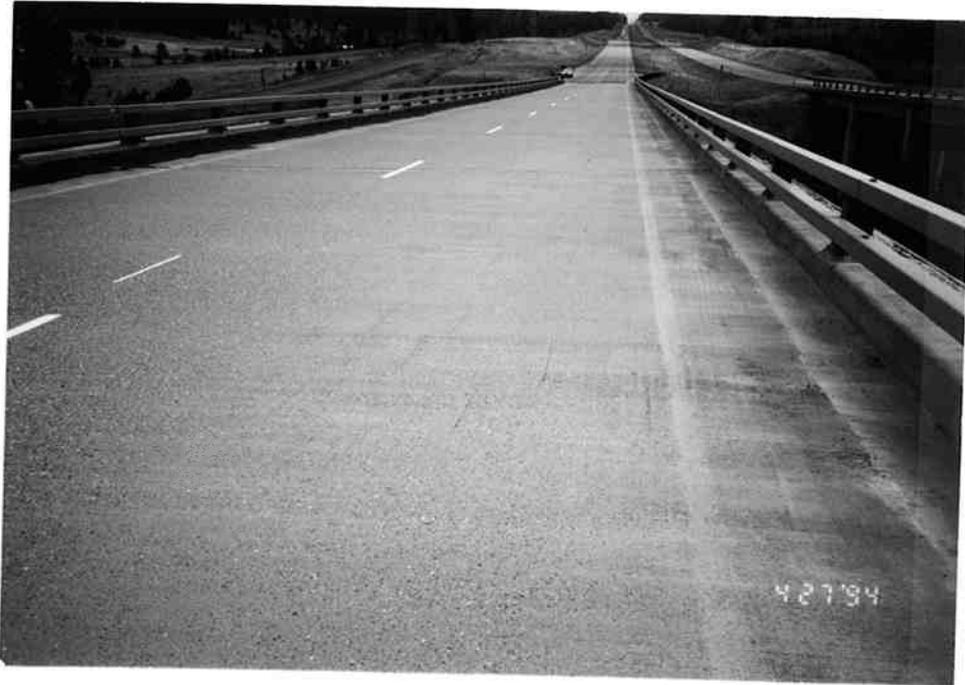
- 3) **A slight increase in cracking.** Between 1990 and 1991, the amount of cracking increased from approximately 3.4 to 4.3 lineal feet per square yard of deck surface. These cracks were very fine and their edges were not spalled. A typical square yard of the overlay in 1994 is shown in Figure 3.3.

Figure 3.2: A typical view of the Meacham Overcrossing Bridge overlay.
In this 1994 picture, cracking is sparse and difficult to see.
