**POLYPROPYLENE
FIBER-REINFORCED
MICROSILICA CONCRETE
BRIDGE DECK OVERLAY
AT LINK RIVER BRIDGE**

Final Report

Experimental Features Project 98-01

Oregon Department of Transportation

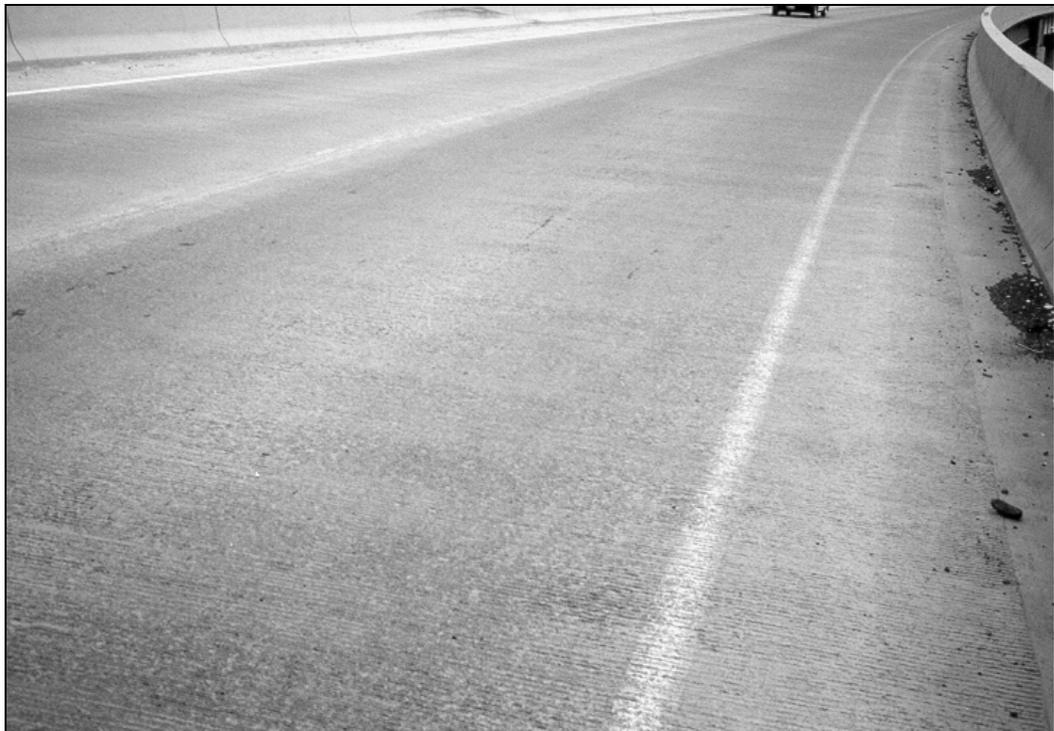
Figure 4.2: No large cracks were found in the southbound lane.
