MODIFIED ROCKFALL CATCH FENCE  
MAYFLOWER CREEK - DETROIT DAM

Experimental Feature  
Interim Report

OR 84-01

MAYFLOWER CREEK - DETROIT DAM  
NORTH SANTIAM HIGHWAY (#162)  
MARION COUNTY  
EXPERIMENTAL PROJECT NO. OR 84-01  
JULY 2, 1986

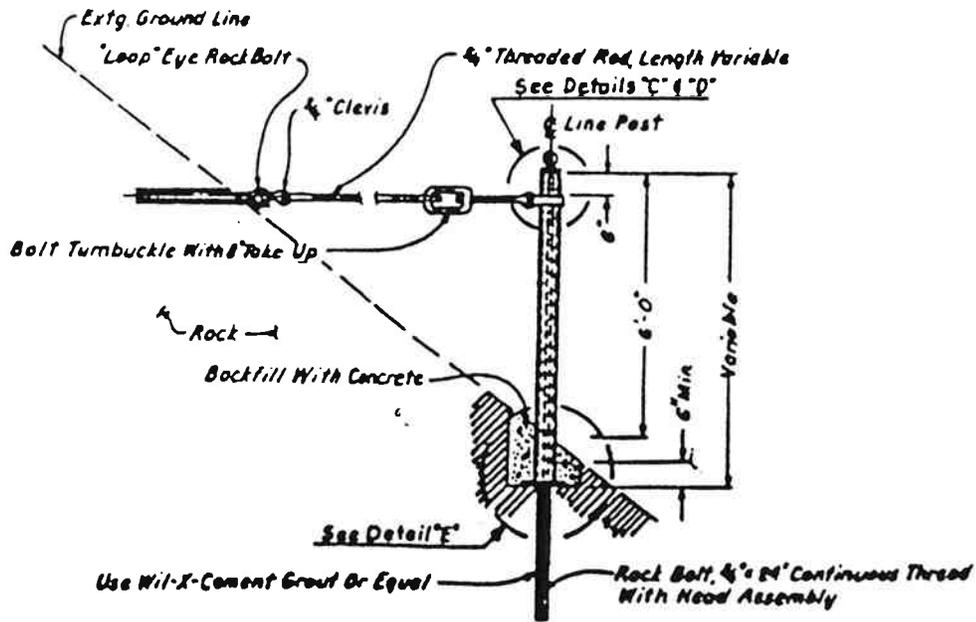
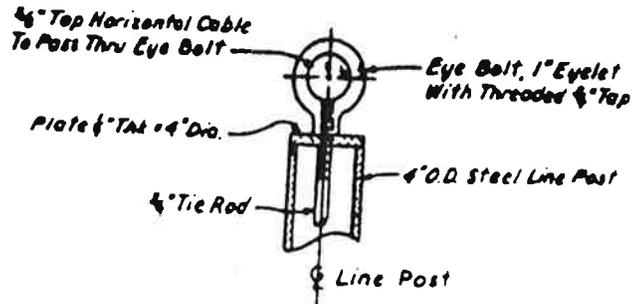
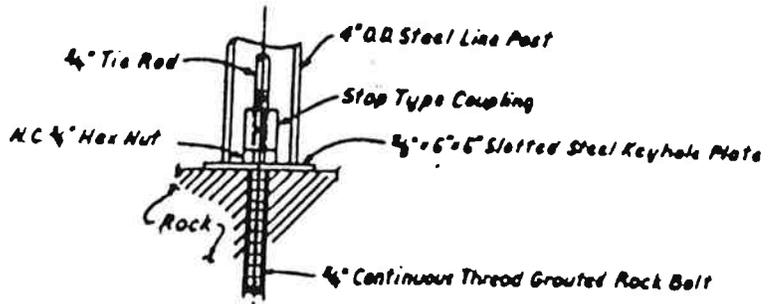
ROCK BOLT FENCE POSTS	
HWY. 162	M.P. 41.82 - 42.94
GEOTECHNICAL GROUP OREGON STATE HIGHWAY DIVISION	FIGURE 2

The rock bolt fence post assembly is shown in Figure 2. The fence posts, as shown, were constructed in the field. First a hole was drilled into the rock and a continuously threaded rock bolt, 3/4" in diameter by 24" long, was grouted in place. Next a key hole plate and hex nut were put on the rock bolt.

The rock surface had been pre-leveled for the plate. The nut and plate were set so 1" of the rock bolt extended above the hex nut. A 2" stop type coupling was added and above that a 3/4" steel tie rod was installed. The length of the tie rod varied. A 4" O.D. steel fence post (minimum length six feet) slid over the tie rod. Longer fence posts were used where needed to maintain a level top fence line; the tie rod had to extend 1 inch above the fence post. To the top of the tie rod a 1/4" steel plate and a 1" eye bolt with a threaded 3/4" tap was installed and used to tighten the fence post in place.

There were a few construction problems with this feature. One problem was due to the contractor and his fabricator misinterpreting the plans. They understood the plans to call for the key hole plates to be welded to the bottom of the fence posts. This made tightening the hex nut and the stop type coupling impossible. This error was corrected in the field by cutting the plates off the posts and regalvanizing the steel. An expanded assembly sequence drawing included in the plans would have alleviated this problem.

Also the contractor had difficulty developing level surfaces for the key hole plates in the rock. The rock tended to spall along lines roughly parallel to the slope. In some cases the contractor had to construct level surfaces with grout. This problem may have been avoided if a little more care and effort had been taken.

In addition, the fence posts slipped along their key hole plates; although attention was given to properly tightening the threaded eye bolt on top of the post. Movement occurred when the fence support cable running from post to post was tightened to the prescribed amount. This caused no appreciable construction problems. In the future, by fabricating the key hole plates to include a 1-inch high sleeve welded in place, slightly smaller than the inside diameter of the fence post, this problem can be solved. The short sleeve will not hinder tightening the hex nut or stop type coupling, but will help to strengthen the system.
