**TWO-RAIL STEEL-BACKED
TIMBER GUARDRAIL SYSTEM**

**Crown Point Highway
Multnomah County, Oregon**

Construction Report

**OREGON EXPERIMENTAL
FEATURE PROJECT #OR92-03**

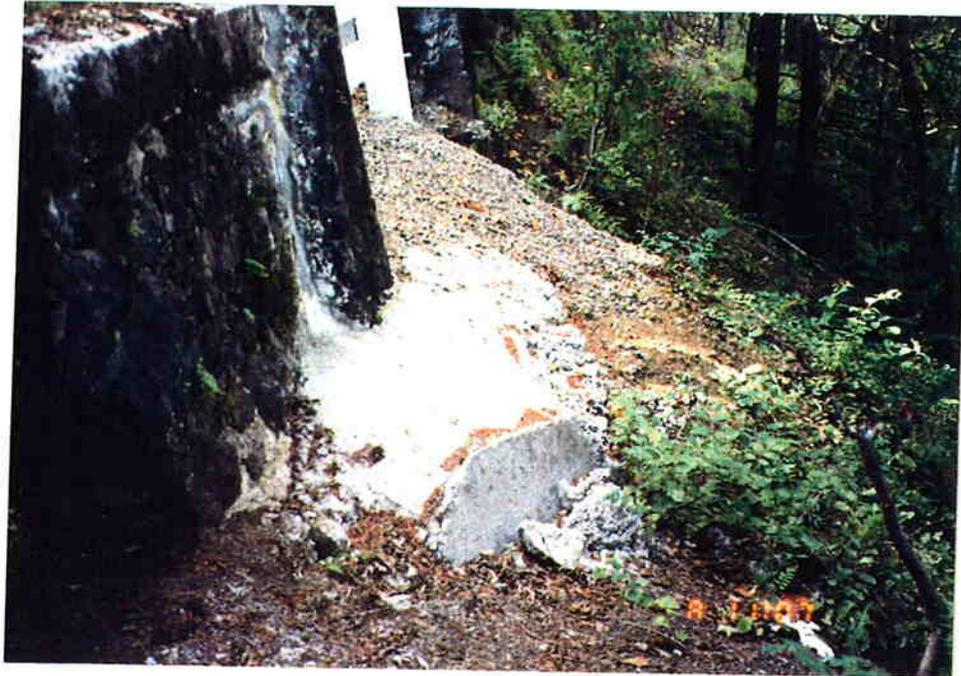
Problem: The contractor used an auger to drill a hole between two sections of a mason wall to install a guardrail post. The mason wall separated near the hole and the end piece started to fall down the hill (Figure 3.1).

Figure 3.1: Repaired mason wall with new concrete footings

Solution: The contractor wrapped a chain around the fallen section to hold it in place. While it was secured, a mason placed concrete underneath it to act as a footing.

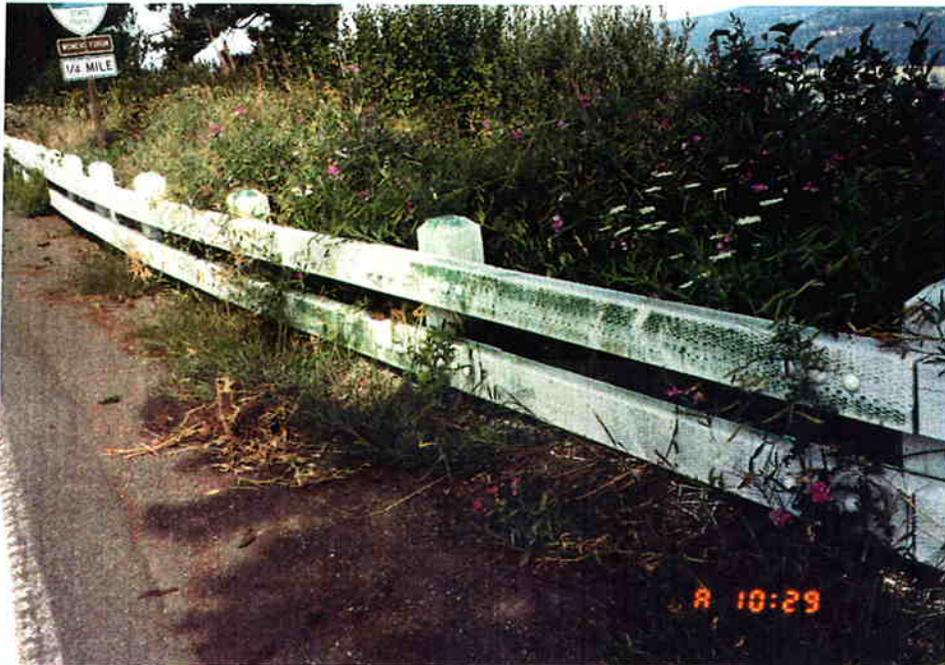
Problem: The ACZA was leaching out of the Douglas-fir, and the posts and rails turned a blue-green color (Figure 3.2).

Figure 3.2: Discoloration of the painted wood as a result of the ACZA leaching out

Solution: To try and cover the discoloration, a second coat of paint was applied to the entire guardrail system, and a third coat was applied to approximately 2000' of the guardrail. This, however, did not solve the problem. The guardrail still has a discoloration problem.

- To achieve a more aesthetic look, the wood should be left unpainted. The pressure treatment alone should be sufficient to avoid decay from microorganisms and attack from insects. This will solve the problem of the preservative leaching out through the paint, and give the guardrail a natural wood look that would better suit the surrounding environment.

- The leaching of the preservative should still be corrected to stop the corrosive reactions with the galvanized steel, and environmental concerns. The wood should be kiln dried rather than air dried after it is removed from the pressure treatment vessel.

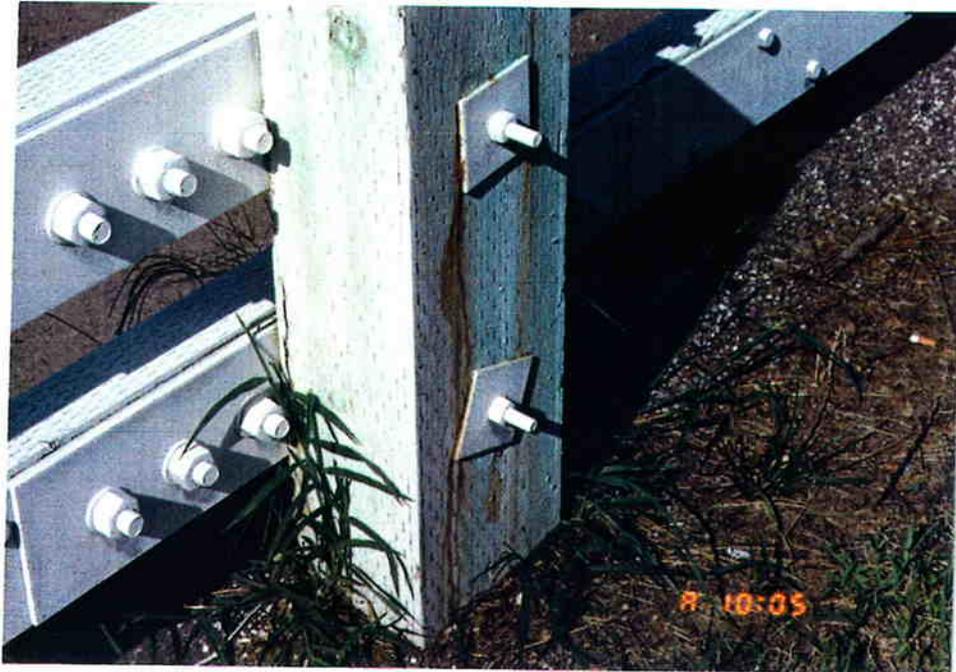
Figure 4.1 shows corrosion of the hardware that was typical throughout the length of the guardrail. One of the sections of the guardrail has 58 guardrail posts, of which 37 (64%) had visible signs of the galvanized steel corroding. This appeared to be a good representation of the entire guardrail. I believe this is a direct result of the leaching preservative attacking the galvanized steel hardware.

Figure 4.1: Corroded hardware in contact with ACZA

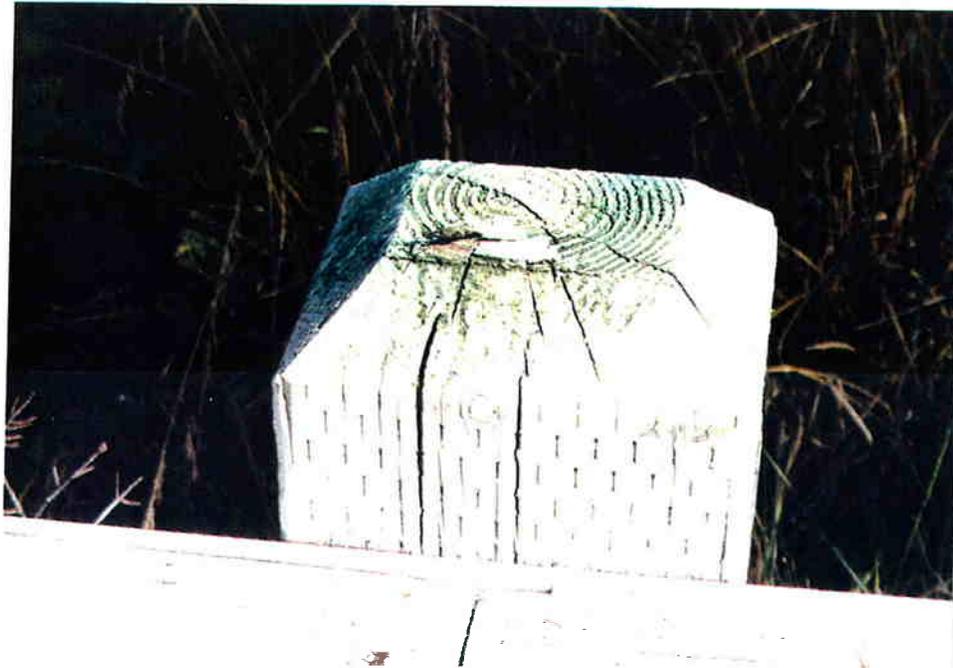
Figure 4.2: End grain of a typical post showing paint flaking and peeling off

Figure 4.2 shows the end grain section of a guardrail post. The photo shows the prominent discoloration and the flaking and peeling of the paint, which occurred mainly on the tops of the posts, where the preservative did the majority of leaching.
