CONDITION MONITORING OF CONTINUOUSLY
REINFORCED CONCRETE PAVEMENT

HP&R #5264
Final Report

Oregon Department of Transportation
Highway Division
Research Unit

March 1991

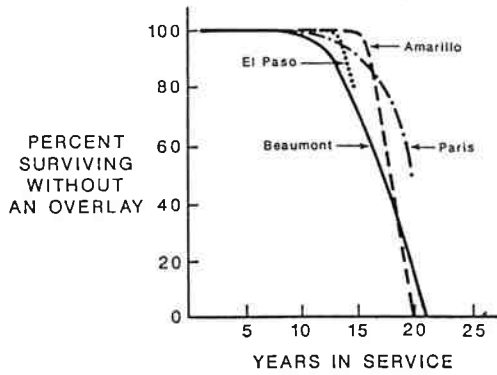
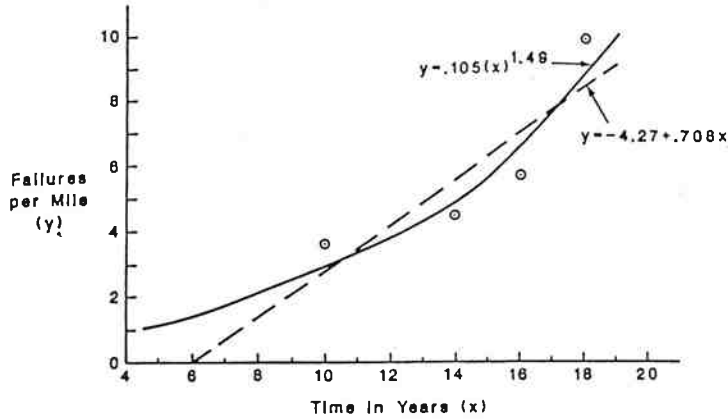
The graphs at the left, were extracted from the third Texas study. Both show trends which support the average time to failure of about twenty years. They also indicate that failure, once it begins, grows rapidly.
