**BASE ISOLATION BEARINGS
(Dynamic Isolation Systems, Inc.)**

Construction Report

OR-EF-91-02

**BASE ISOLATION BEARINGS
Construction Report**

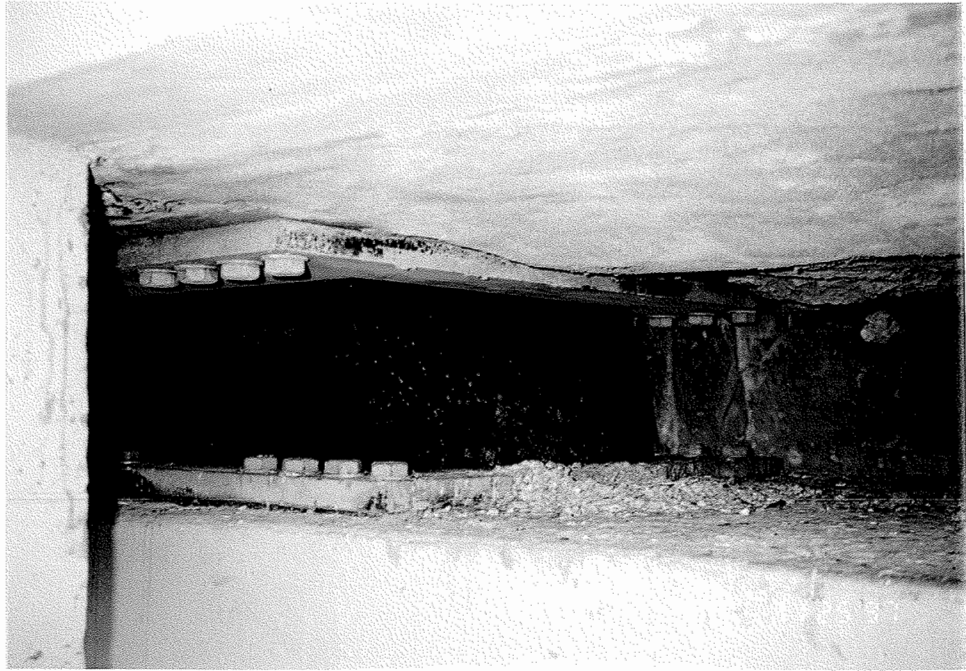
Figure 4.1 The bearing at bent 7 of BR.# 9669A is inclined to vertical and has rust on the steel plate.

- Bent 7: Right bearing shows slightly more bulging in upper portion. Offset about 1" as described for bent 6. No other defects noted.
- Bent 8: Offset about 2" (top toward bent 7). No defects noted.

All bearings should have continued serviceability monitoring. Special attention should be given to the right bearings of bents 2, 6 and 7 to verify the detected flaws are not serious.

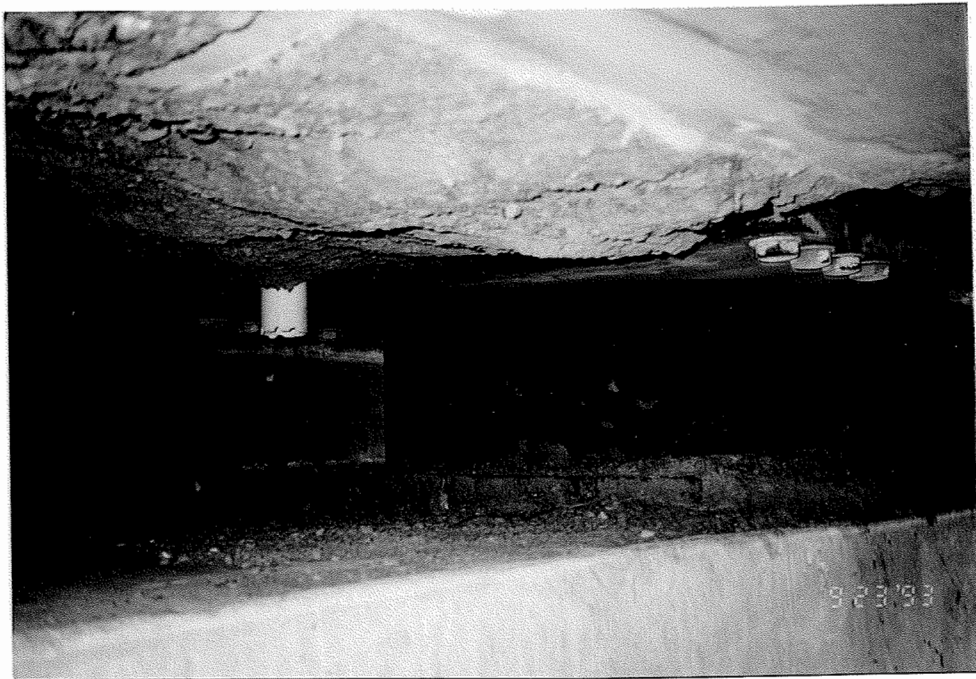
Figure 4.2 The circular bearing at bent 7 of BR.# 9669A is also inclined to vertical, and has a slight bulge.
