HISTORIC STRUCTURE REPORT

BIRCH CREEK RANCH

HISTORIC RURAL LANDSCAPE

MALHEUR COUNTY, OREGON

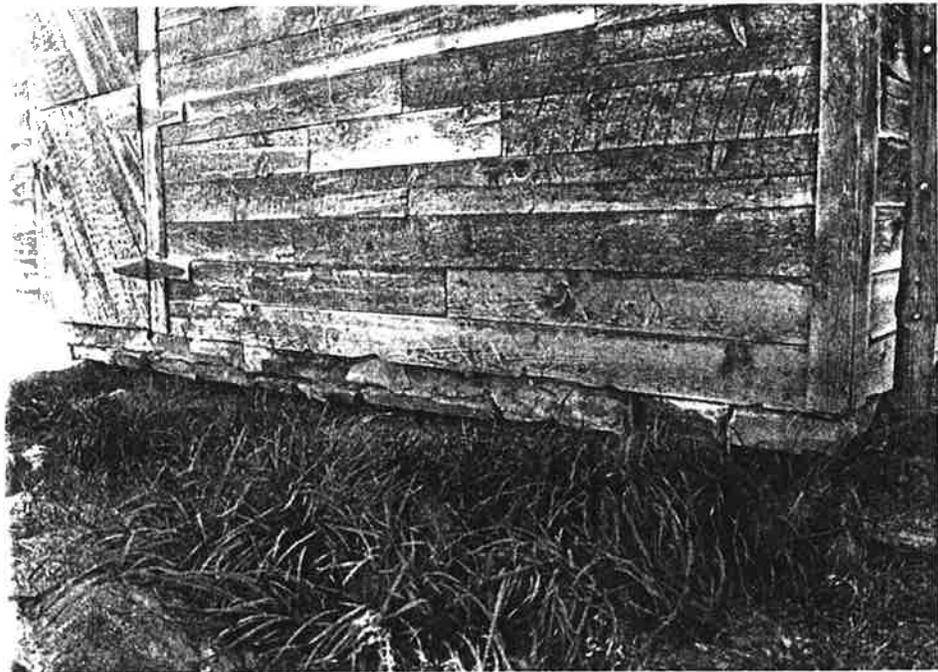
Figure 11. Birch Creek barn, north side, depicting undercutting below foundation caused by the March 1993 flood. (Neg. R2-27)

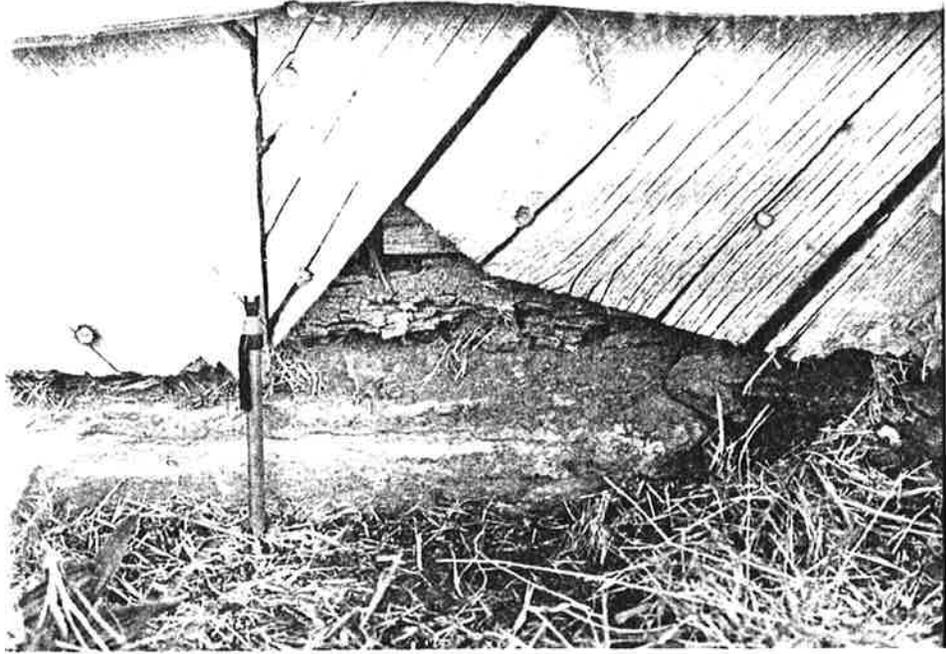
Figure 12. Birch Creek barn, west side sill decay. (Neg. R2-31)

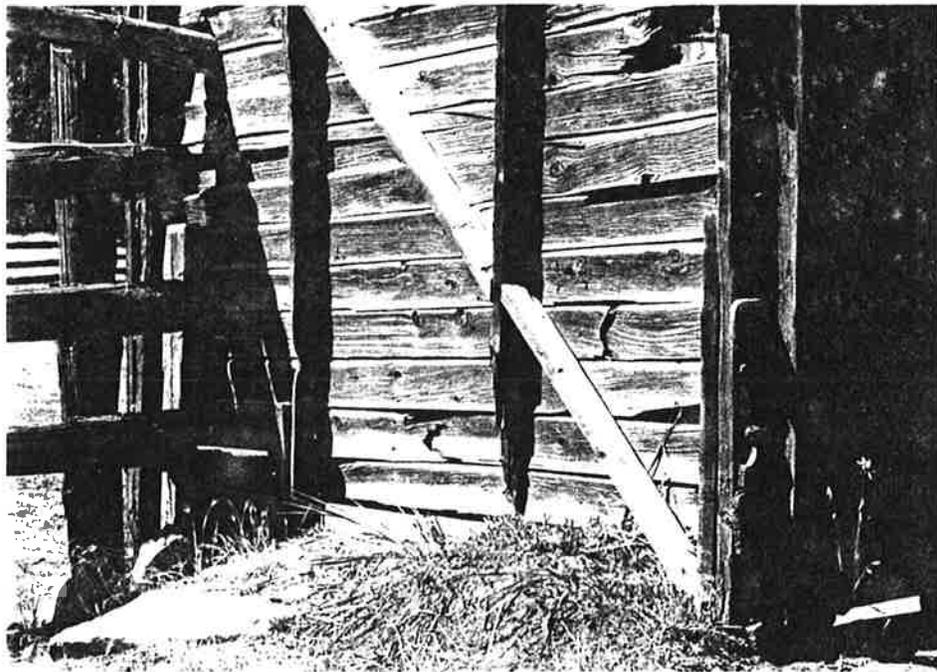
Figure 15. Birch Creek tack room building, south side. Soil has accumulated at the base of the building and acts as a sponge during wetter months by holding in moisture in direct contact with the wood framing. Note the deterioration of the studs. (Neg. R2-4)

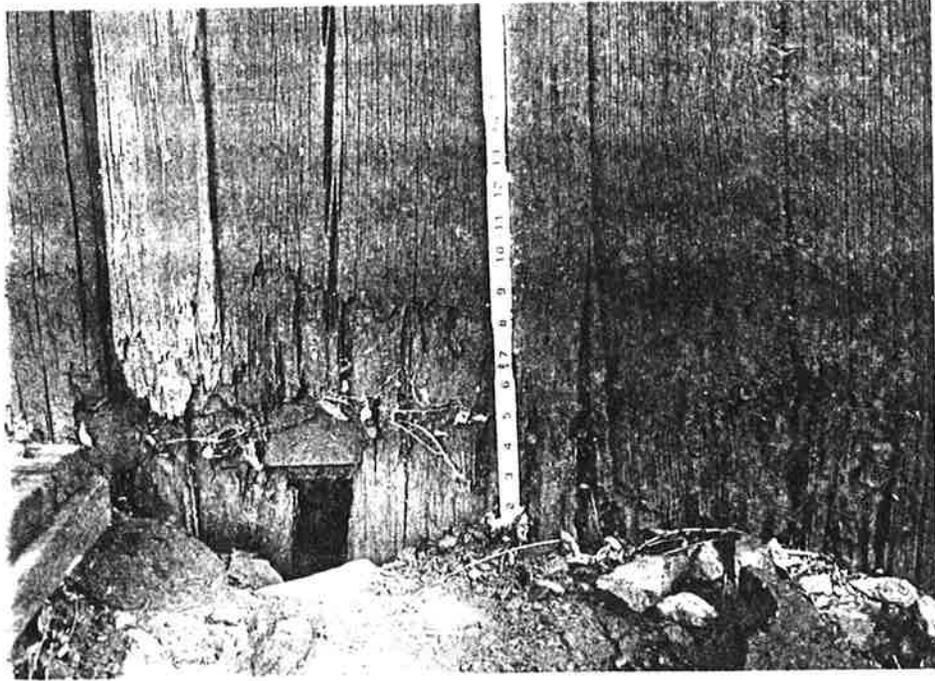
Figure 18. Birch Creek bunkhouse/shop, south side. Soil in direct contact with wood causes damage to the siding and sill by retaining moisture during wet months. (Neg. R3-8)

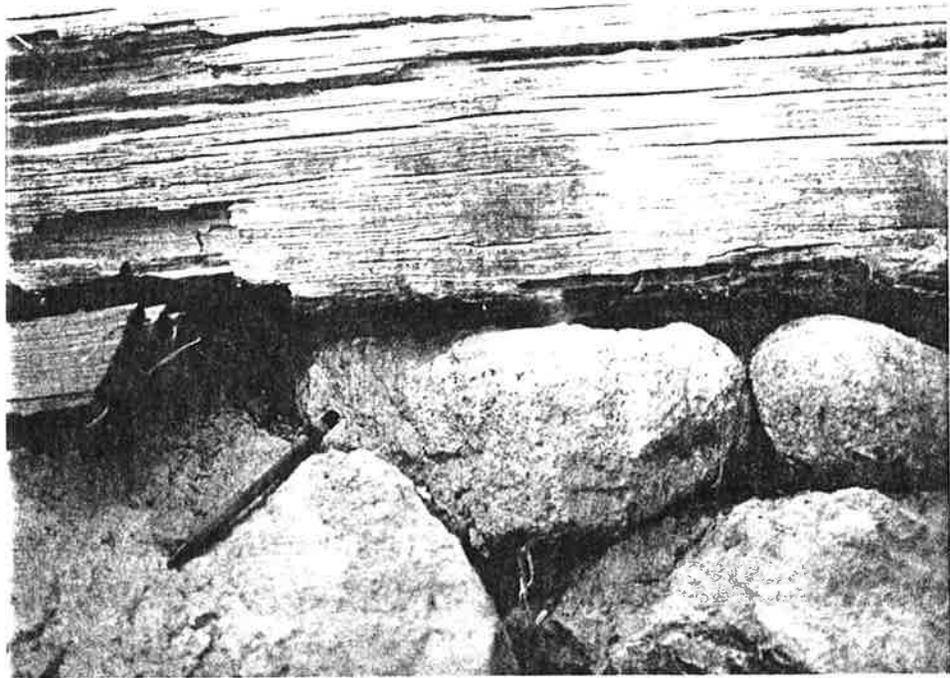
Figure 21. Birch Creek chicken house, interior view of typical sill deterioration along south wall near southeast corner. (Neg. R2-19)

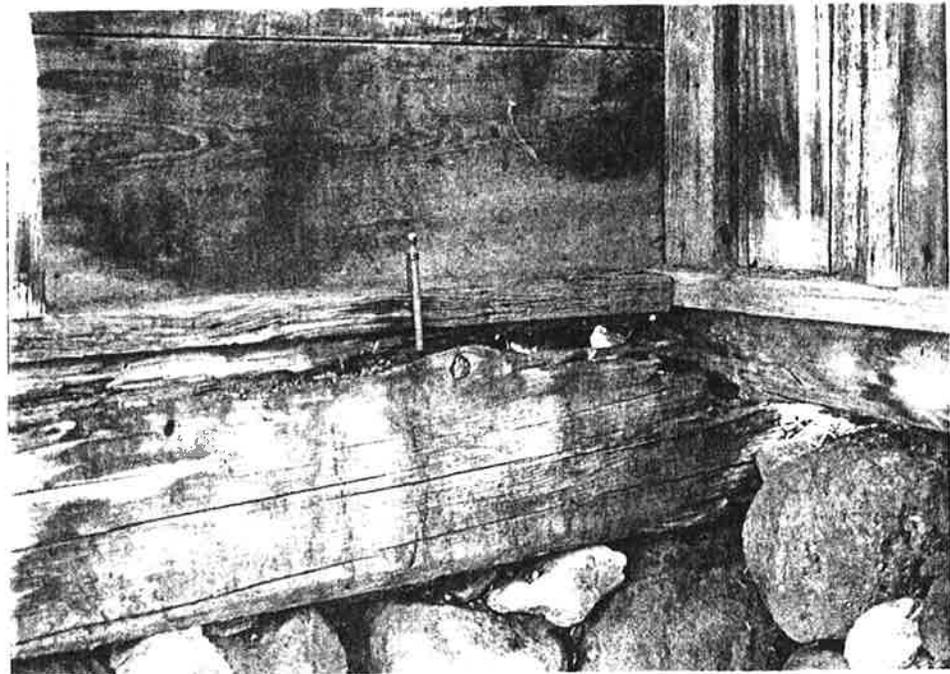
Figure 22. Birch Creek chicken house, interior view of south sill deterioration at southwest corner. (Neg. R2-20)

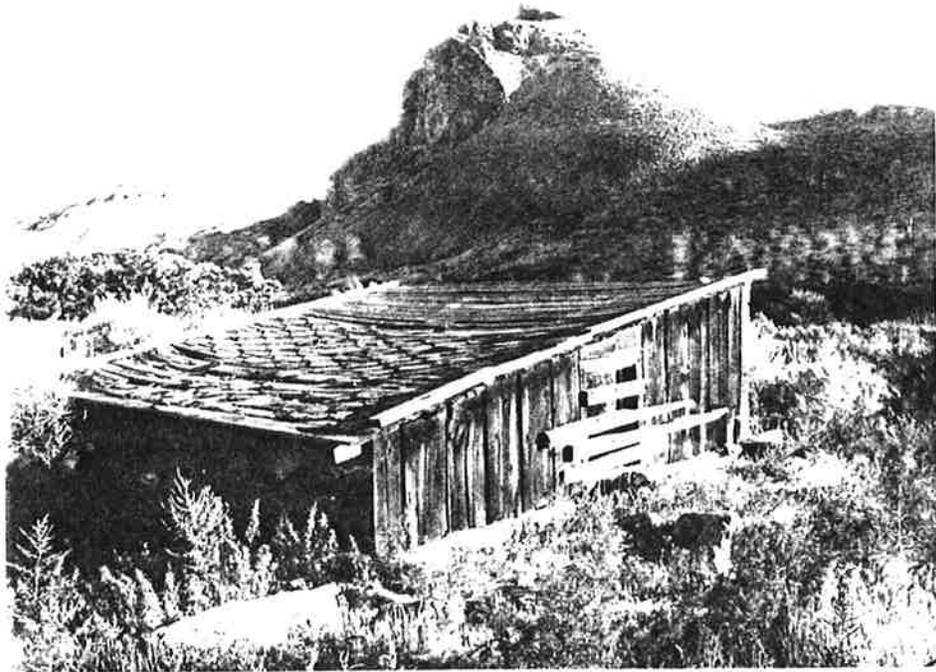
Figure 23. Birch Creek chicken house, west (rear) and south (side) elevations showing roof failure. (Neg. R2-18)

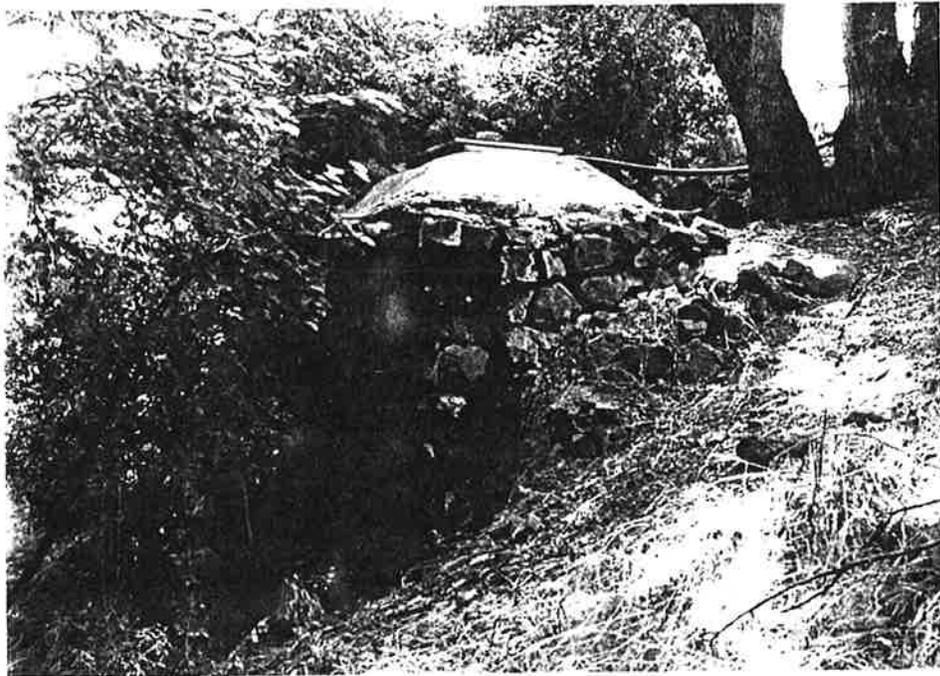
Figure 29. Birch Creek cistern, east and north elevations showing spalling of rock facing, dampness, and vegetation growing around structure. (Neg. R3-20)

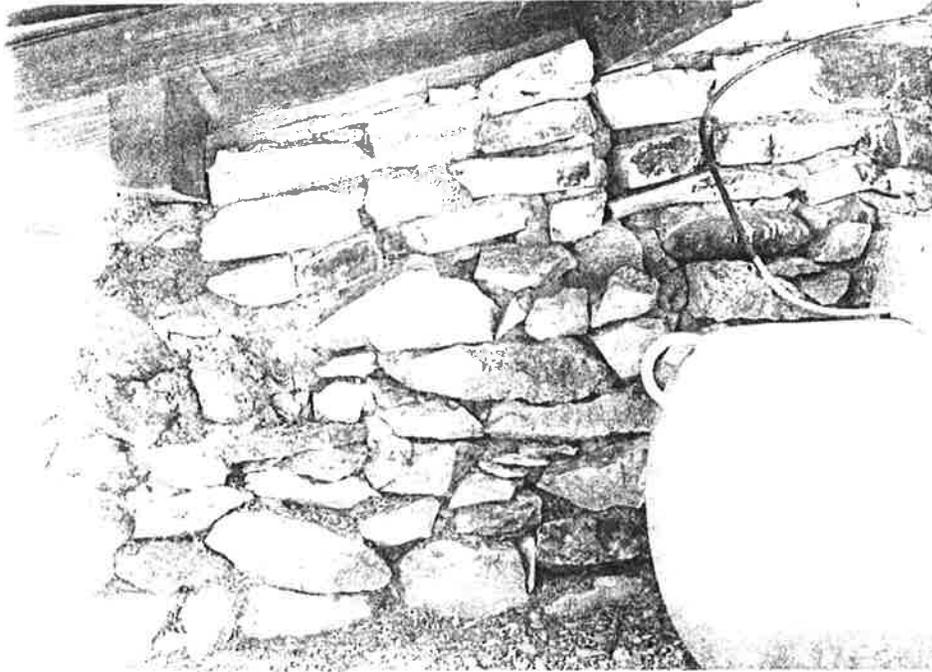
Figure 36. Morrison root cellar/bunkhouse, east side, southeast corner. Corner repaired with Portland cement without attention to original craftsmanship. (Neg. R1-6)

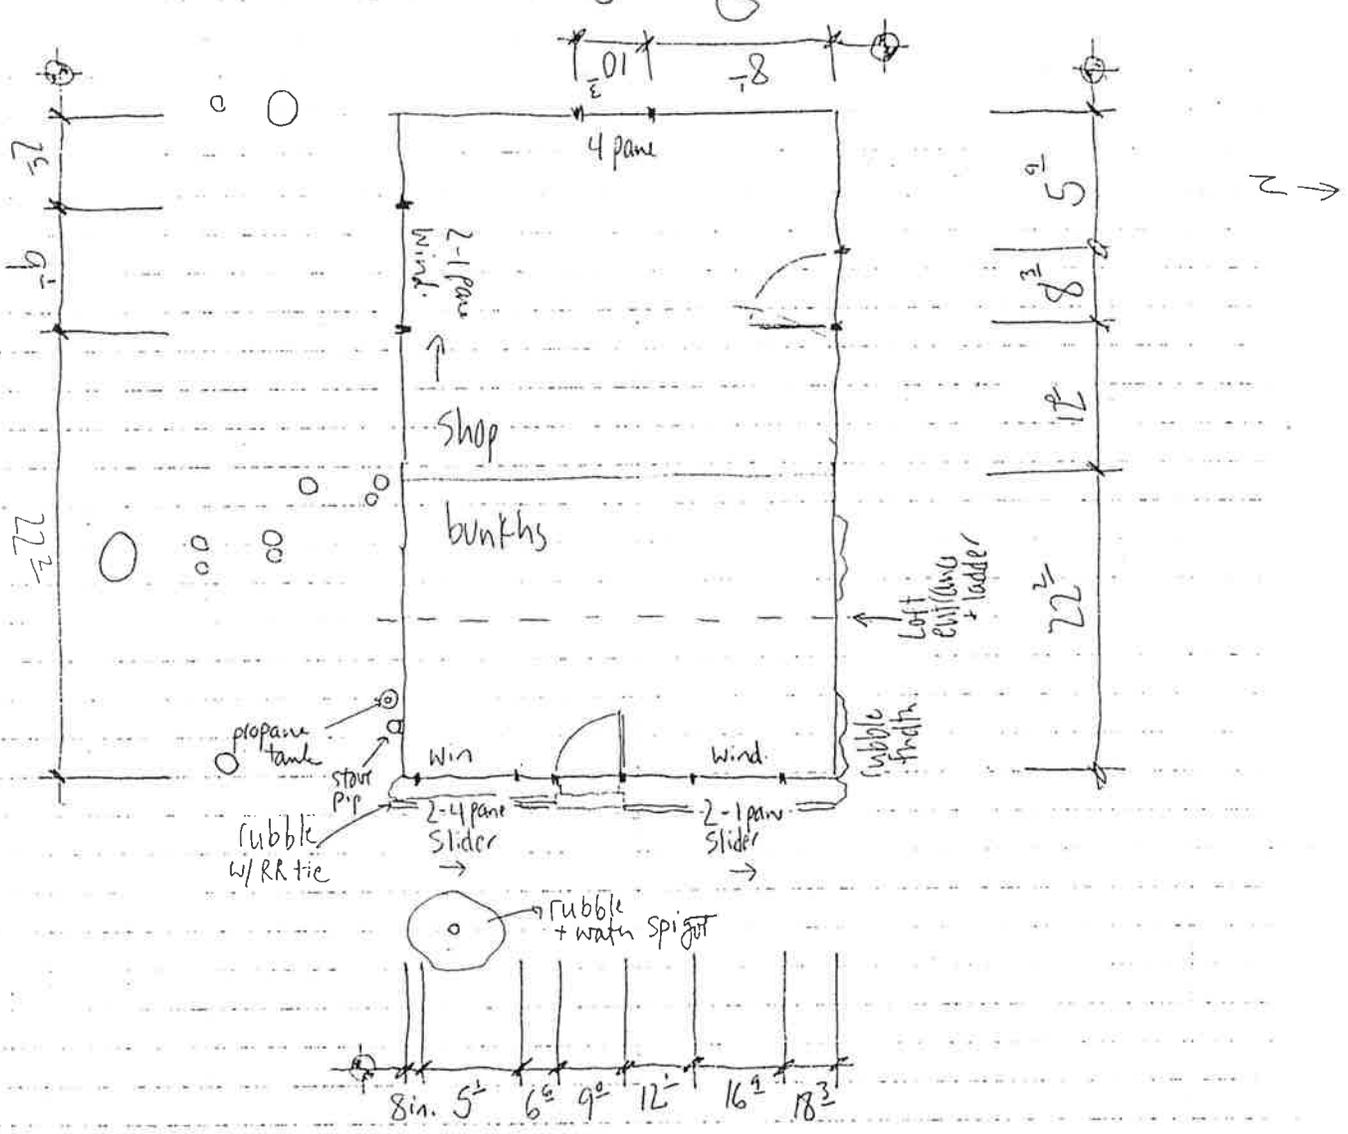
Foundation is rubble stone. There is evidence of some rot where wood members contact stone on N side near NE corner. On E side, site is weathered, but reasonably solid.
