Changing technology, changing risk – Part II
Patient Sandbags in the MRI Environment

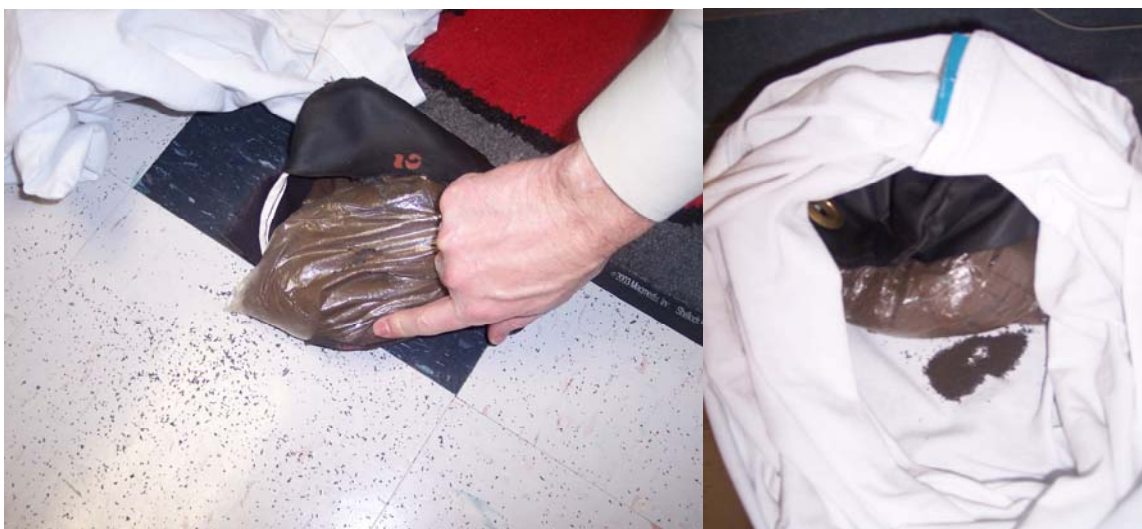
What happened: A 10-lb sandbag was placed in a pillow case under a patient in order to support an arterial line. The patient was then taken for an MRI. After changing out all of the equipment to MRI-compatible, the patient was taken into the MRI room, at which time the bag flew from under the patient into the MRI core. Staff reported that it happened so quickly, all they heard was the sound of the bag hitting the machine. Removing the bag took 3 staff and the bag split open after being removed, revealing small black grains, similar to graphite. The sandbag was unmarked; it had no manufacturer or other identifying information.
