Pavement  
Evaluation/  
Maintenance  
Management Program  
2014

Ken Jernstedt  
Airfield

**2014 Pavement Evaluation / Maintenance  
Management Program**

**Final Report – Individual Airports  
Functional Category 4, Eastern Climatic Zone**

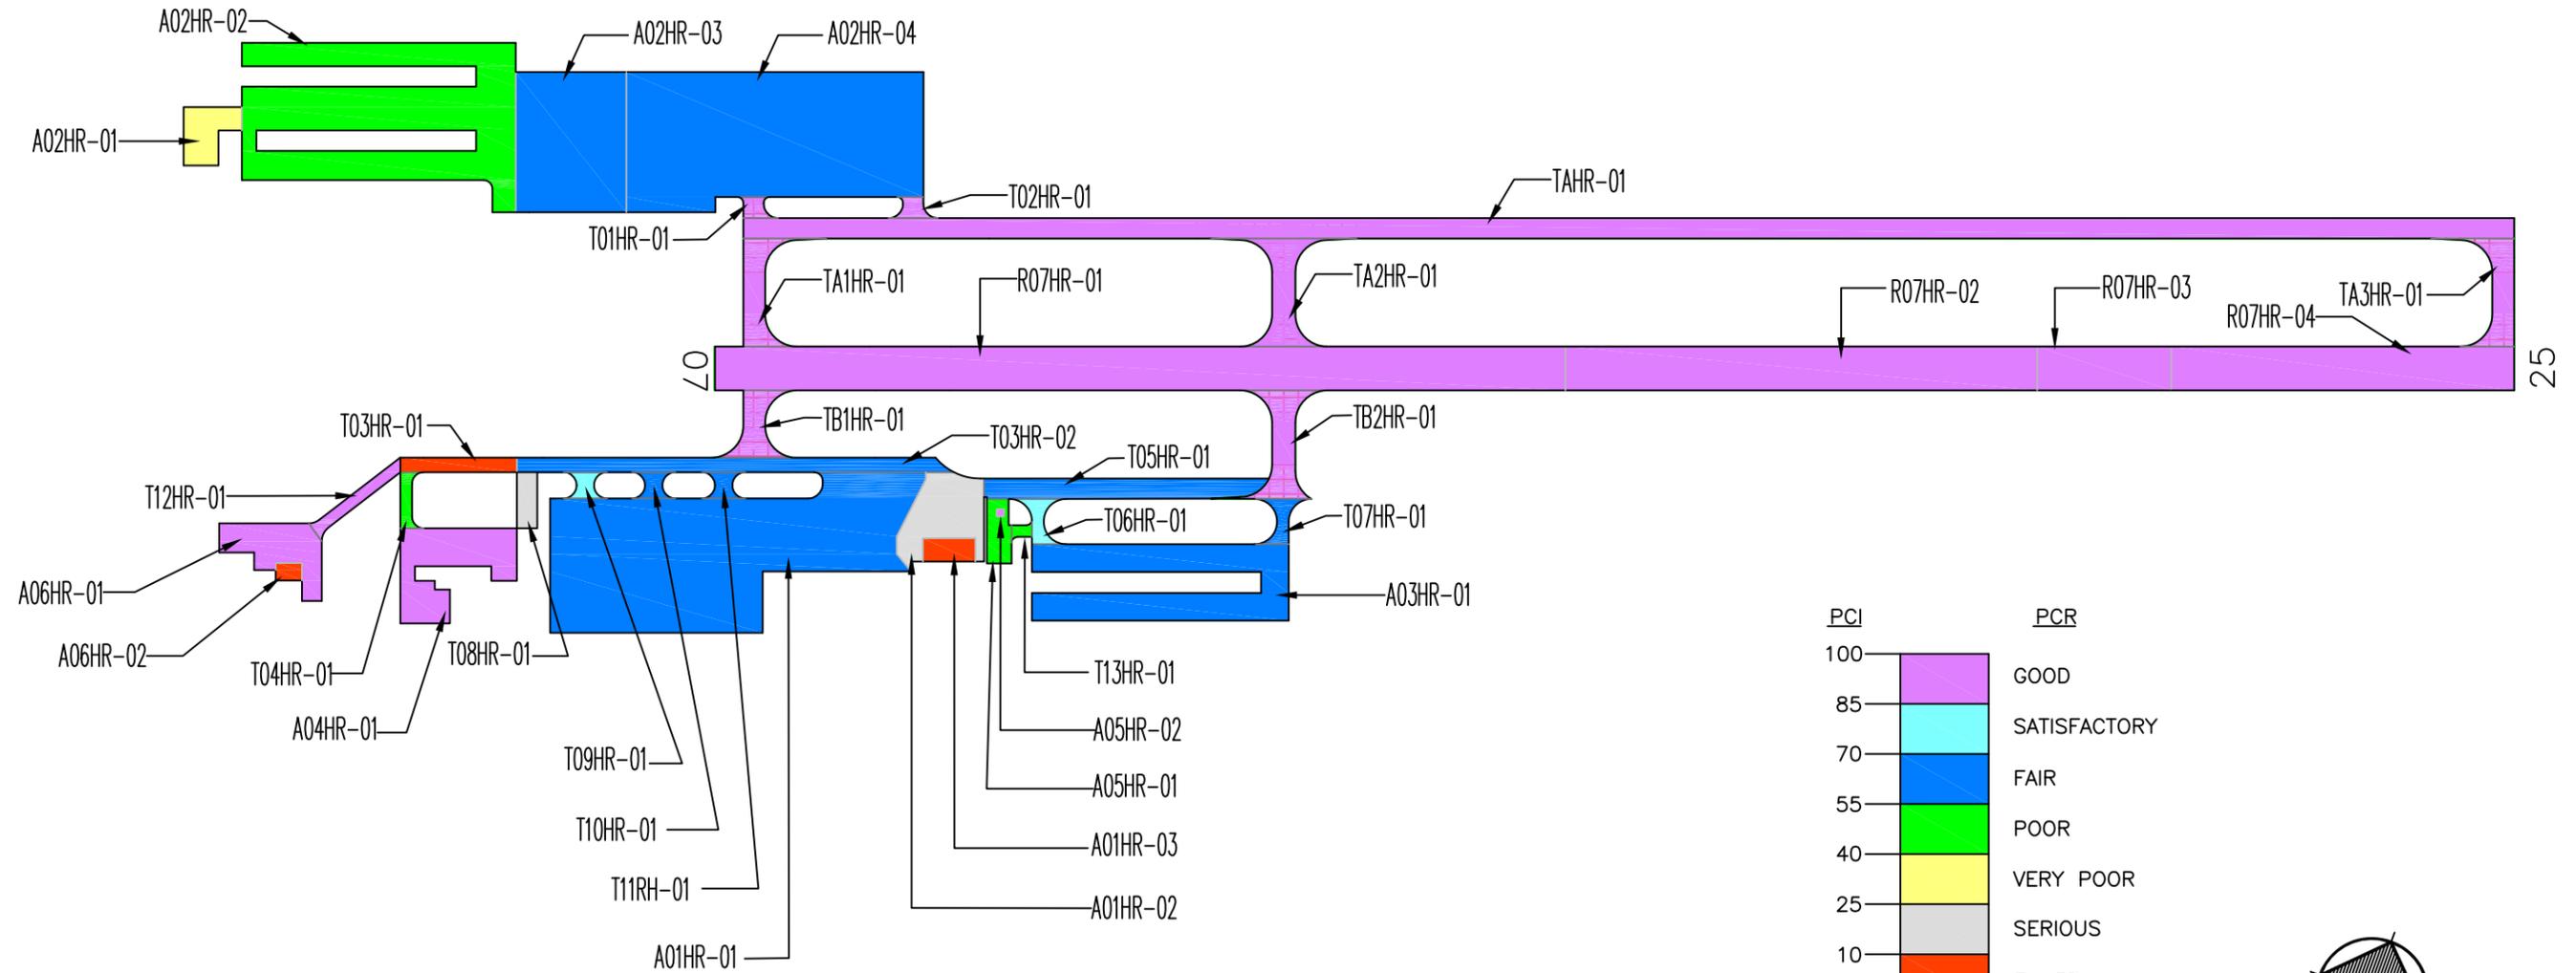
Figure HR-3. Pavement Condition in July 2014.  
Ken Jernstedt Airfield

Section PCIs at Ken Jernstedt Airfield range from a low of 0 (a PCR of “Failed”) to a high of 100 (a PCR of “Good”). The area-weighted average PCI for all airport pavements is 76, corresponding to an overall PCR of “Satisfactory”. Figure HR-4 shows how much pavement area is associated with each Pavement Condition Rating category and also shows pavement condition distribution from the inspections conducted in 2006 and 2011.

The primary distresses observed during the inspection of asphalt concrete pavements were: weathering, longitudinal and transverse cracking, block cracking, patching, depressions, alligator cracking and raveling. The primary distresses observed during the inspection of portland cement concrete pavements were: shattered slabs and joint spalls.
