Mulino State
Airport

**2012 Pavement Evaluation / Maintenance
Management Program**

**Final Report – Individual Airports
Functional Category 4, Central Climatic Zone**

October 2012

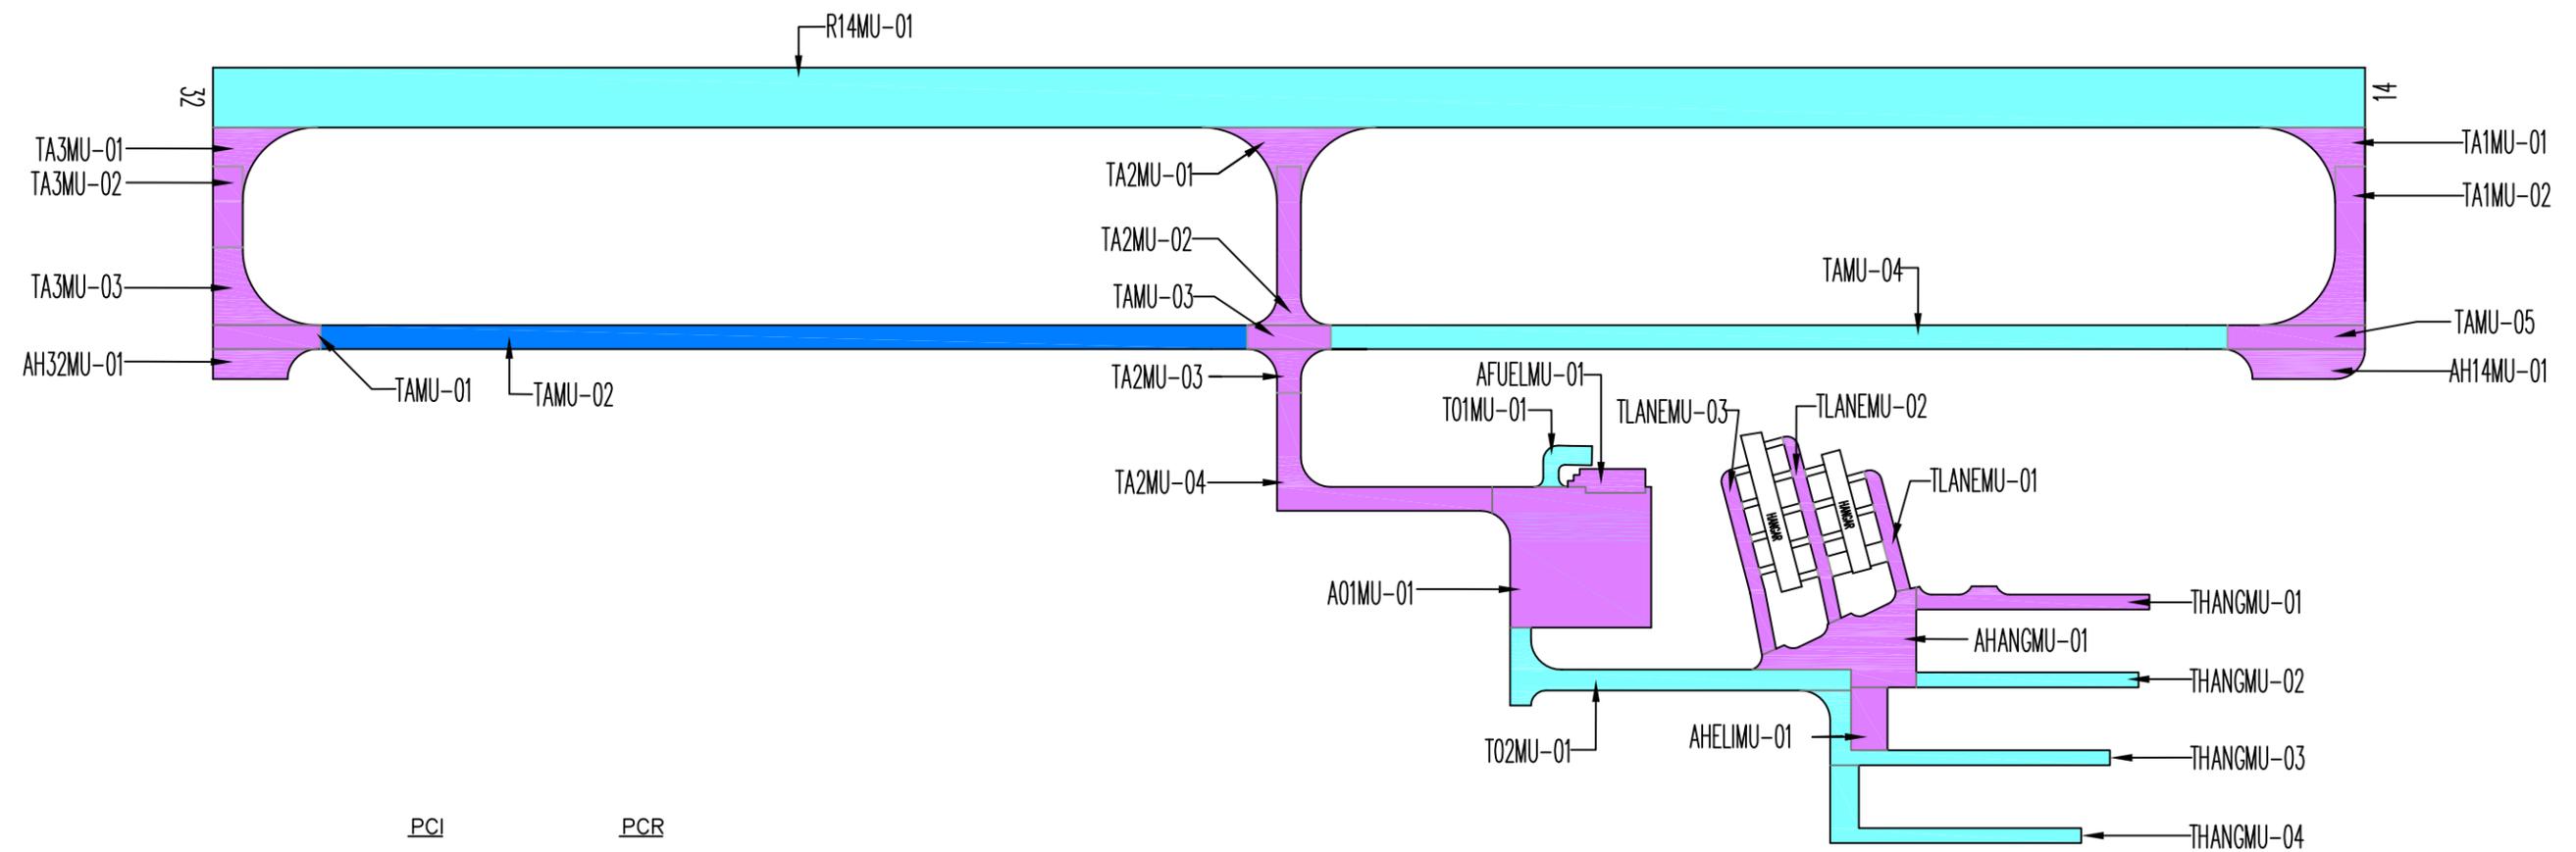
Figure MU-3. Pavement Condition in July 2012.
Mulino State Airport

Section PCIs at Mulino State Airport range from a low of 69 (a PCR of “Fair”) to a high of 100 (a PCR of “Good”). The area-weighted average PCI for all airport pavements is 84, corresponding to an overall PCR of “Satisfactory”. Figure MU-4 shows how much pavement area is associated with each Pavement Condition Rating category and also shows pavement condition distribution from the inspections conducted in 2004 and 2008.

The primary distress observed during the inspection was longitudinal and transverse cracking with an isolated occurrence of depression and raveling.
