Pavement
Evaluation/
Maintenance
Management Program
2014

Prineville
Airport

**2014 Pavement Evaluation / Maintenance
Management Program**

**Final Report – Individual Airports
Functional Category 4, Eastern Climatic Zone**

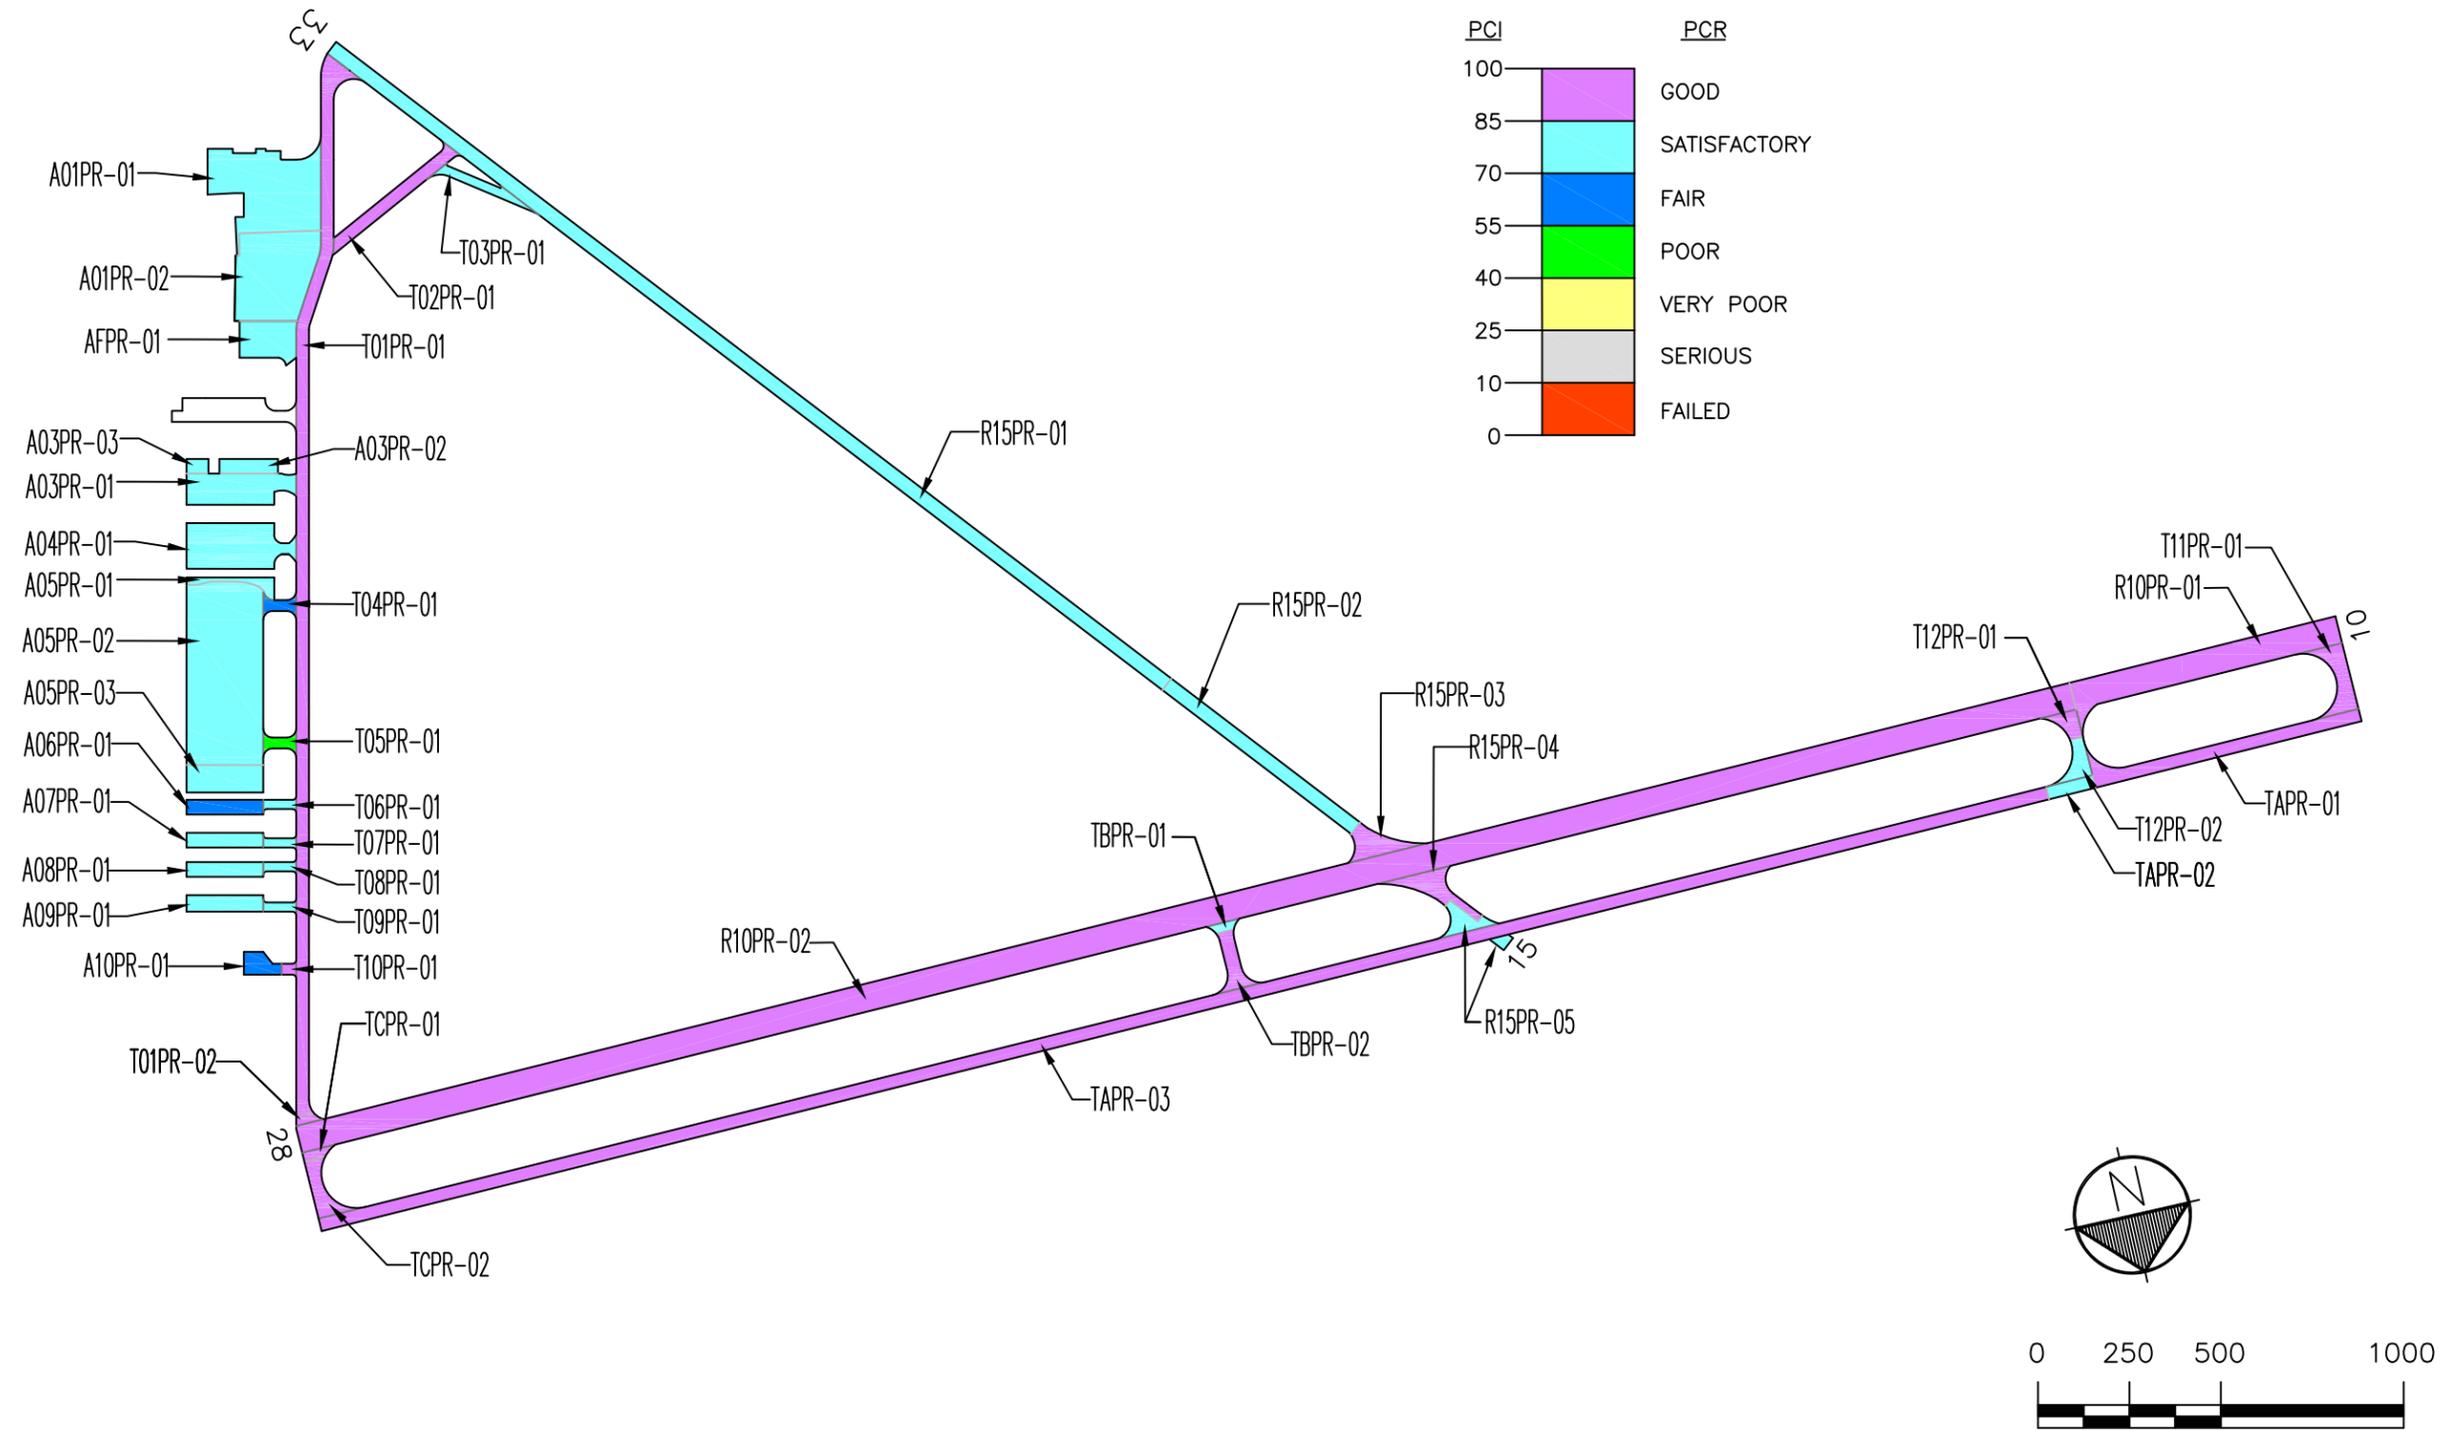
Figure PR-3. Pavement Condition in August 2014.
Prineville Airport

Section PCIs at Prineville Airport range from a low of 42 (a PCR of “Poor”) to a high of 100 (a PCR of “Good”). The area-weighted average PCI for all airport pavements is 87, corresponding to an overall PCR of “Good”. Figure PR-4 shows how much pavement area is associated with each Pavement Condition Rating category and also shows pavement condition distribution from the inspections conducted in 2006 and 2011.

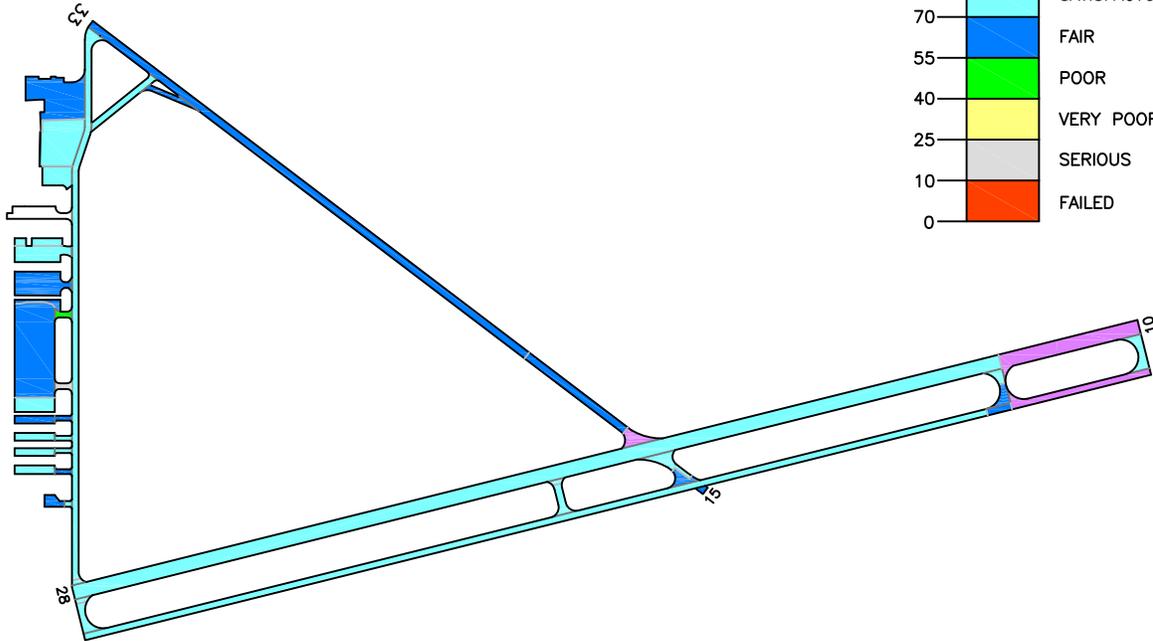
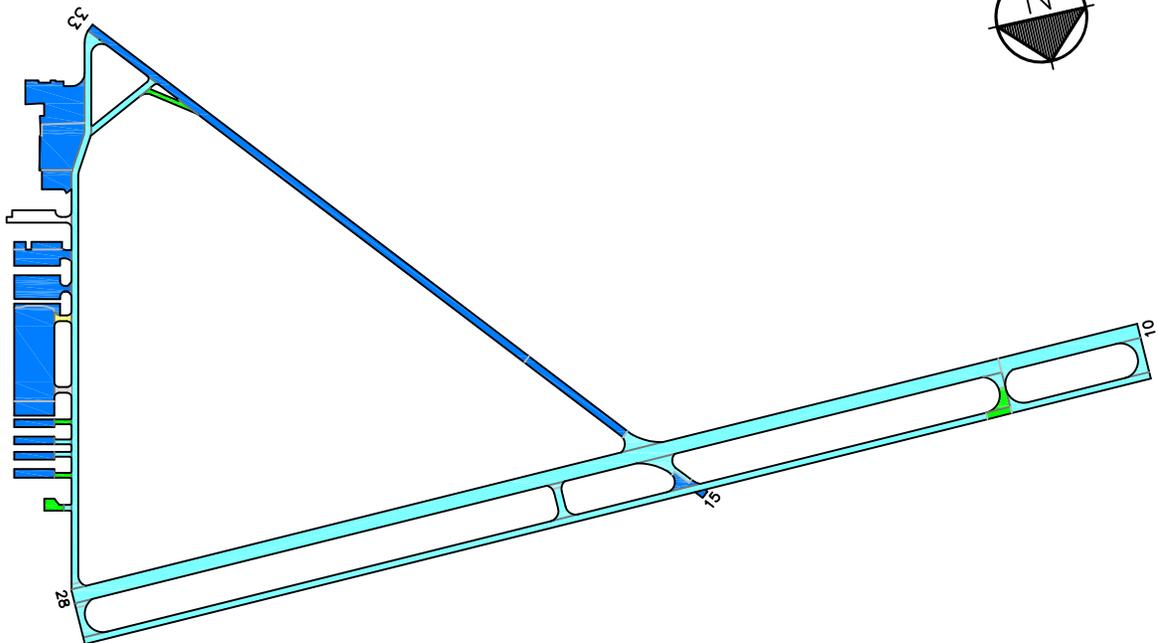
Figure PR-5. Future Pavement Condition.

A graphical representation of the projected PCIs listed in Table 1 is shown in Figure PR-5.
