Pavement
Evaluation/
Maintenance
Management Program
2014

Sunriver
Airport

**2014 Pavement Evaluation / Maintenance
Management Program**

**Final Report – Individual Airports
Functional Category 4, Eastern Climatic Zone**

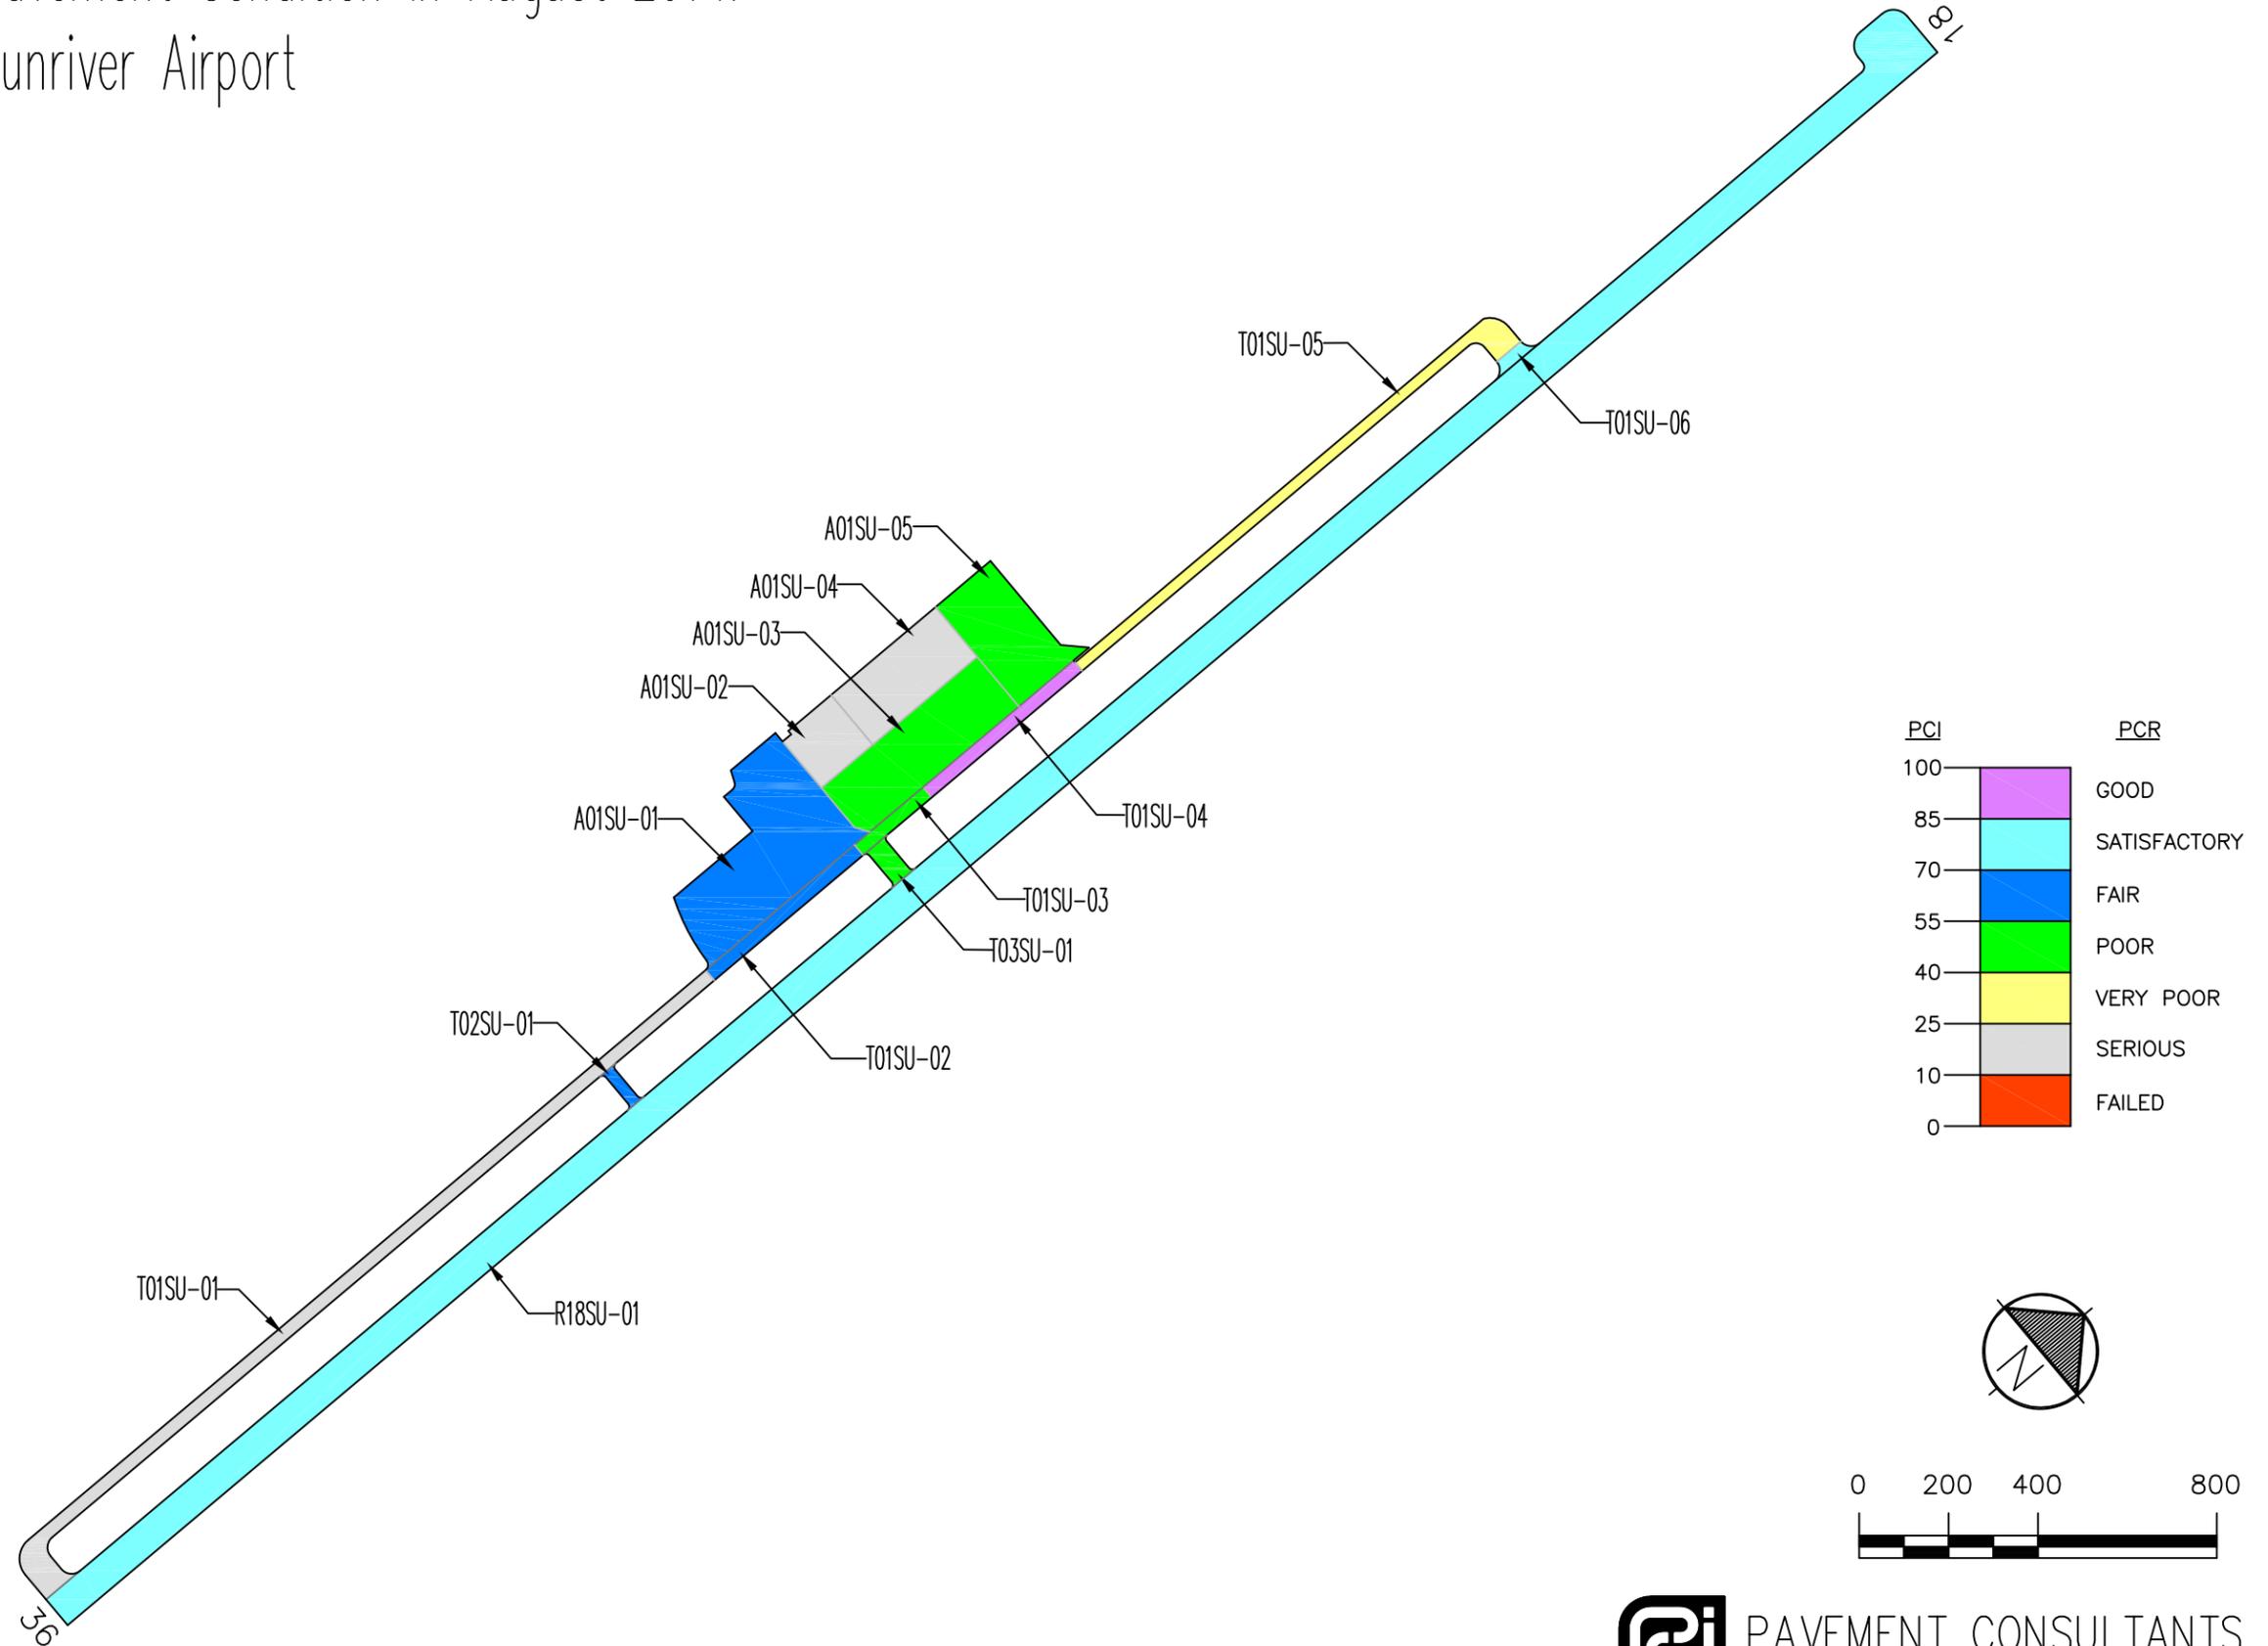
Figure SU-3. Pavement Condition in August 2014.
Sunriver Airport

The Branch Condition Report in Appendix 1 summarizes current pavement condition by branch while the Section Condition Report in Appendix 2 lists pavement condition by section. The current PCR is shown graphically in Figure SU-3.

Section PCIs at Sunriver Airport range from a low of 12 (a PCR of “Serious”) to a high of 100 (a PCR of “Good”). The area-weighted average PCI for all airport pavements is 63, corresponding to an overall PCR of “Fair”. Figure SU-4 shows how much pavement area is associated with each Pavement Condition Rating category and also shows pavement condition distribution from the inspections conducted in 2006 and 2011.

The primary distresses observed during the inspection were: weathering, longitudinal and transverse cracking, alligator cracking, block cracking, and patching with an isolated occurrence of rutting.

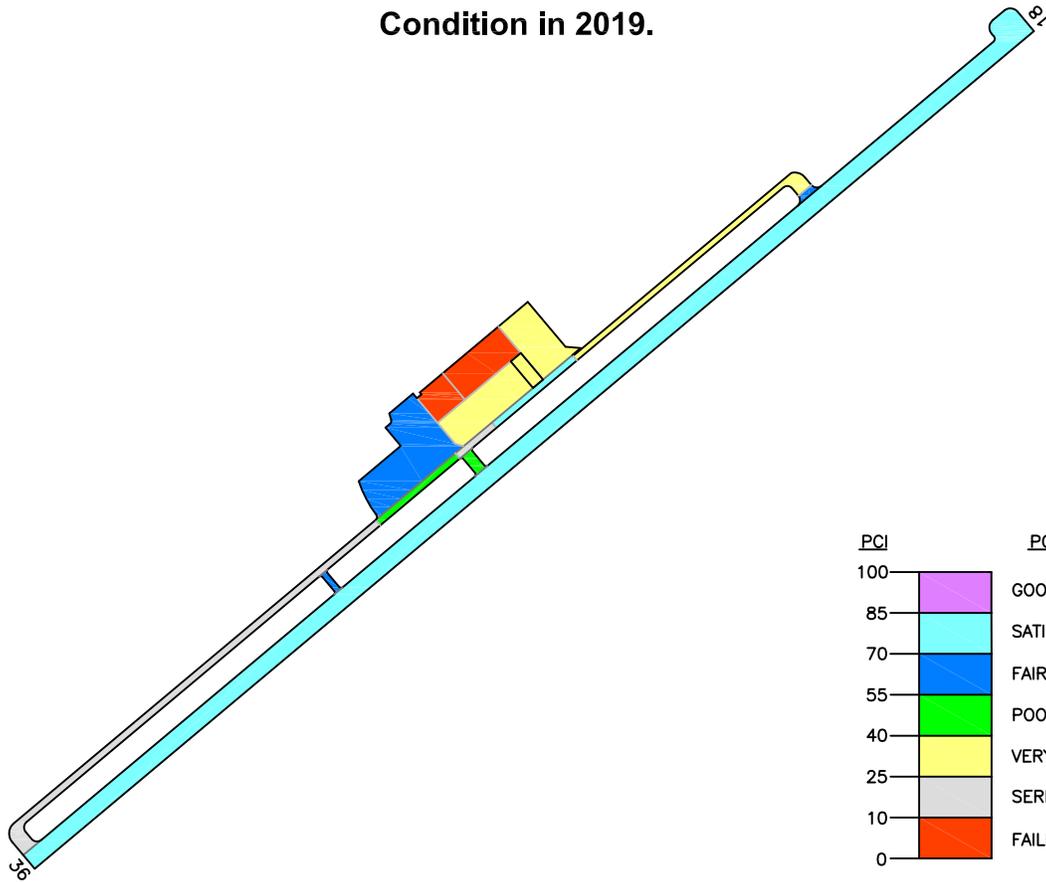
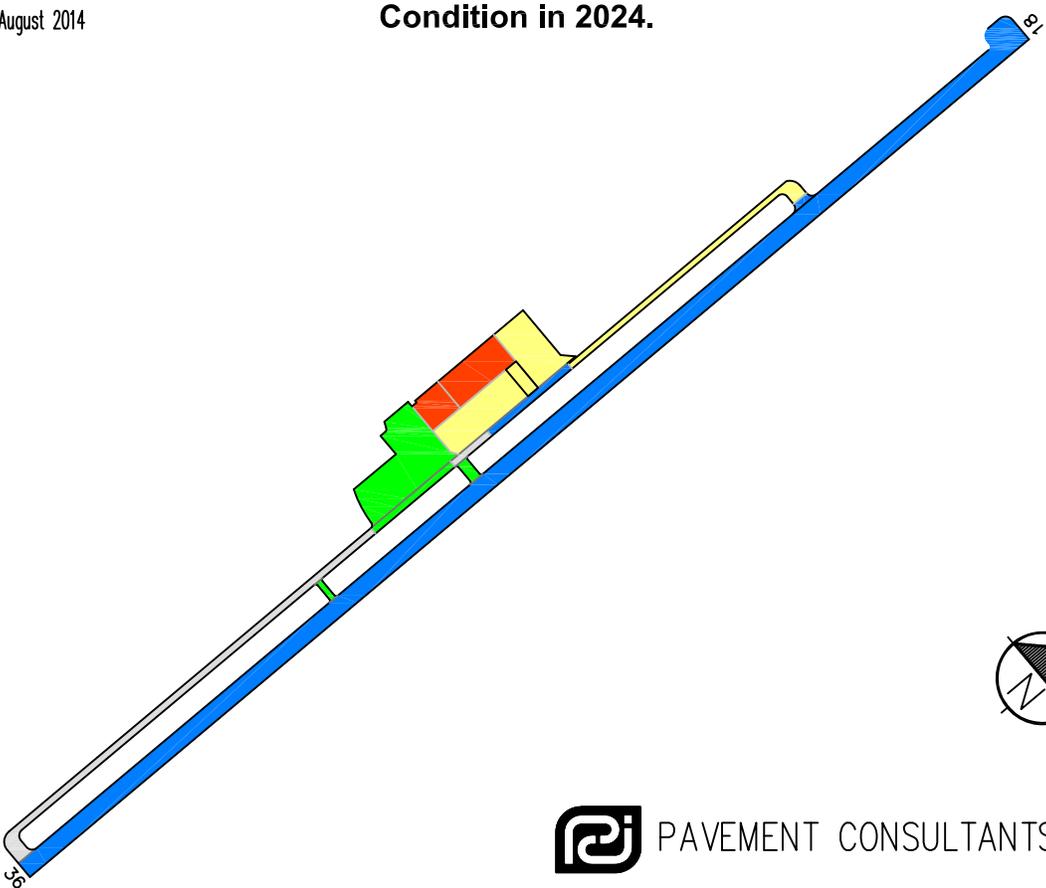
Figure SU-5. Future Pavement Condition.

A graphical representation of the projected PCIs listed in Table 1 is shown in Figure SU-5.
