Pavement
Evaluation/
Maintenance
Management Program
2012

Tillamook Airport

**2012 Pavement Evaluation / Maintenance
Management Program**

**Final Report – Individual Airports
Functional Category 3, Coastal Climatic Zone**

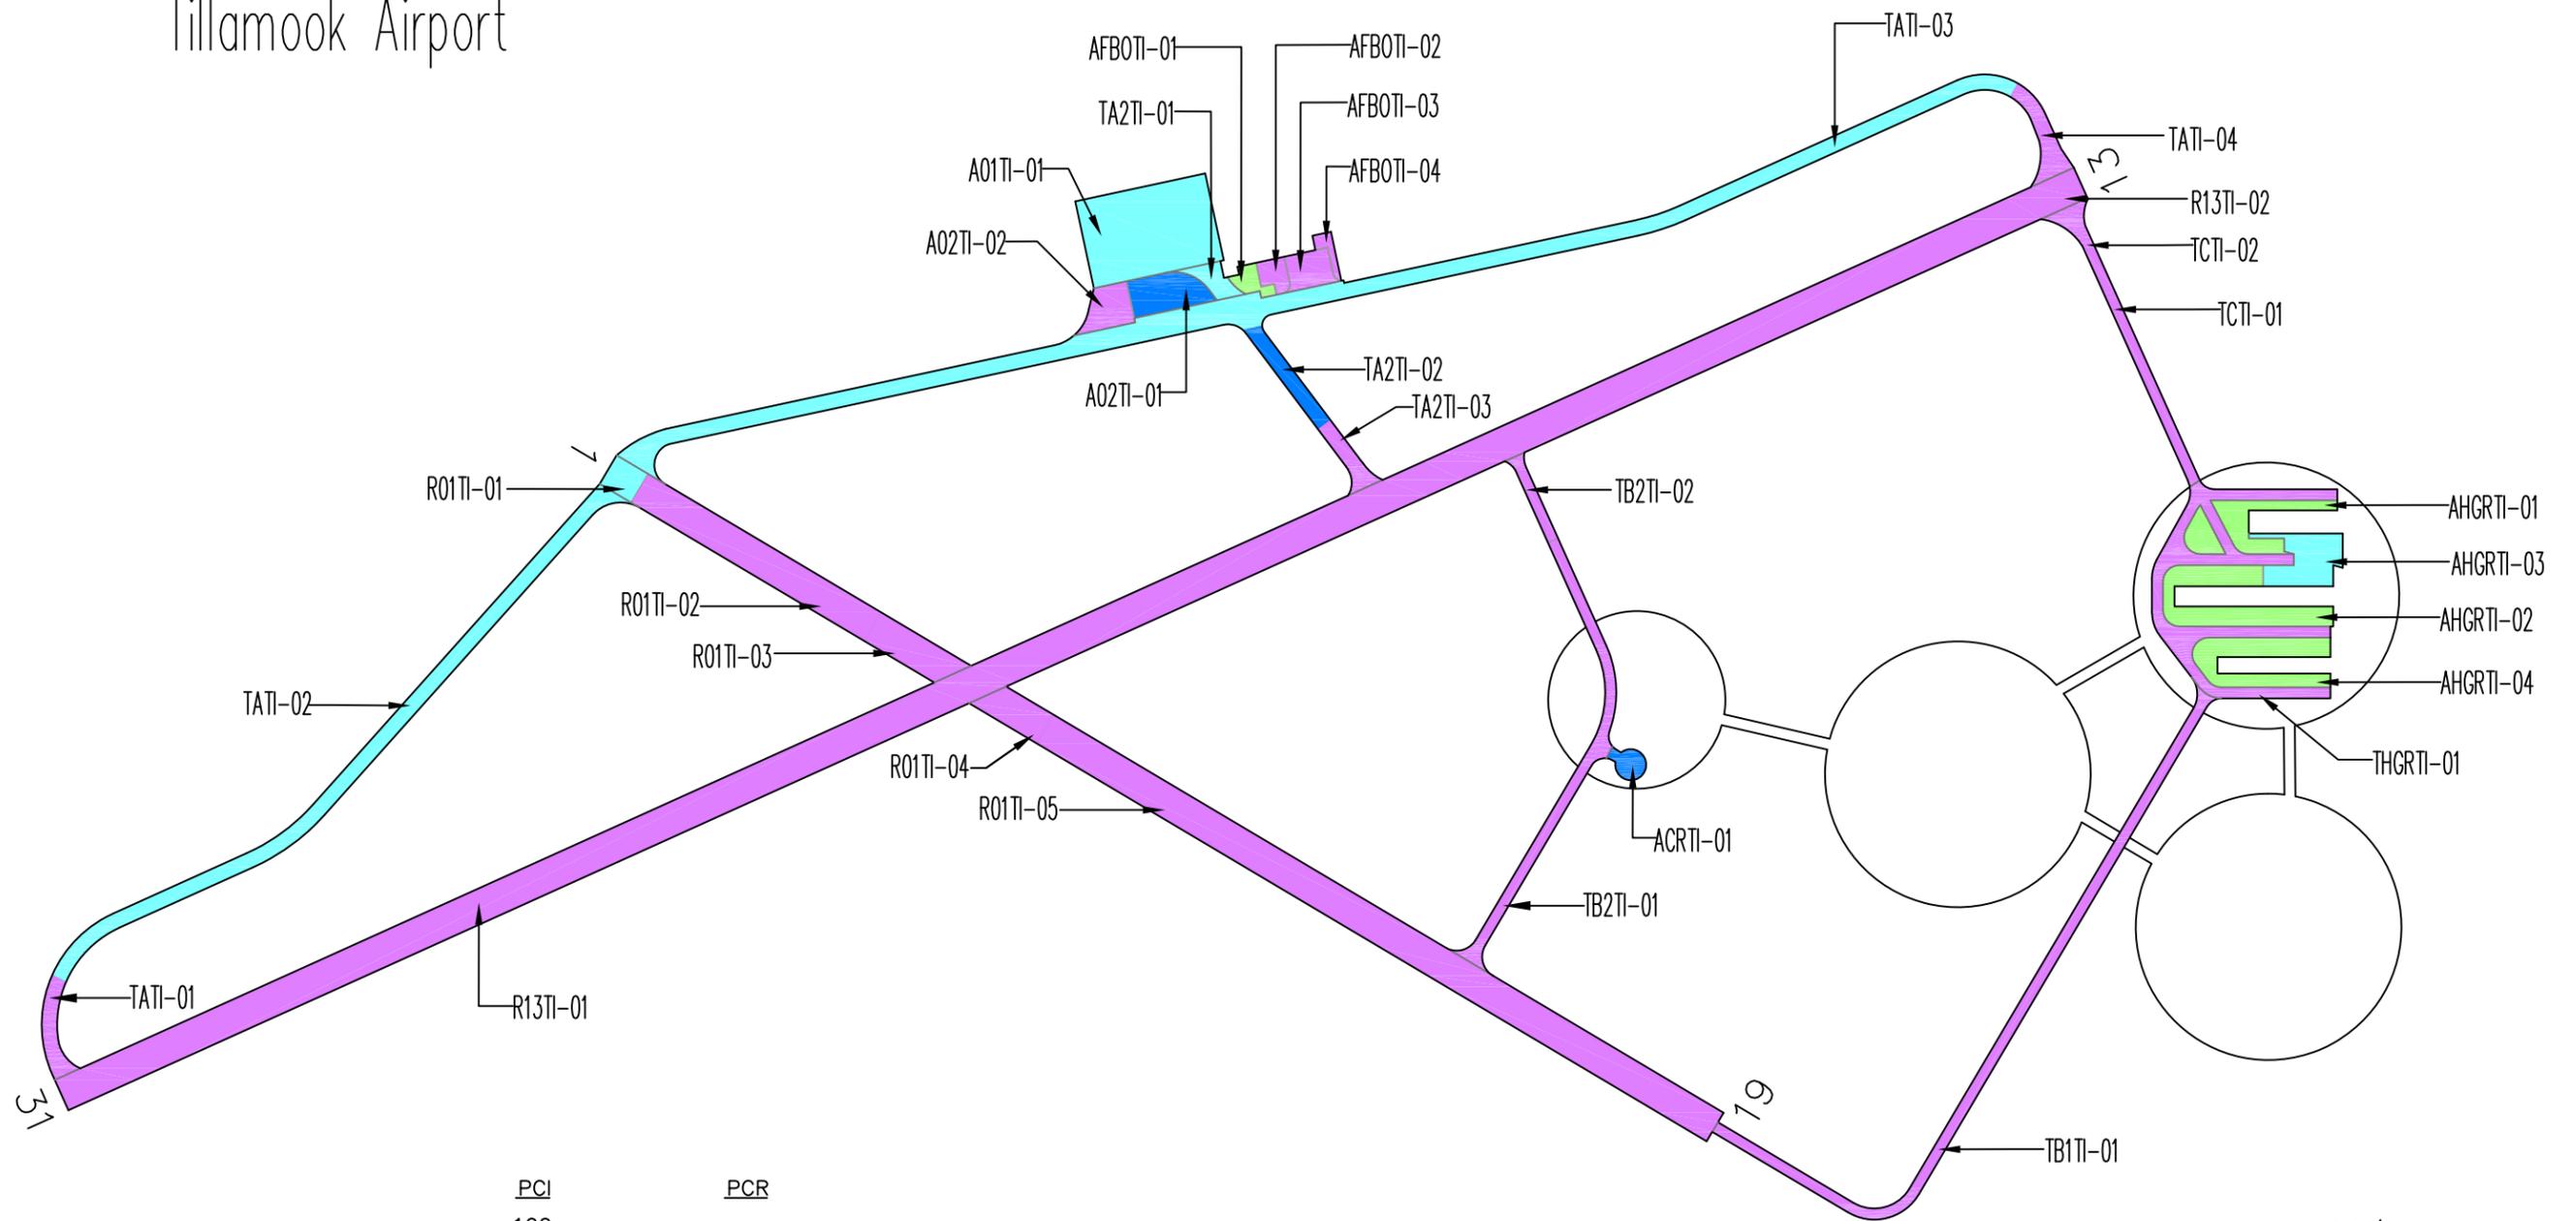
Figure TI-3. Pavement Condition in July 2012.
Tillamook Airport

Section PCIs at Tillamook Airport range from a low of 47 (a PCR of “Poor”) to a high of 100 (a PCR of “Good”). The area-weighted average PCI for all airport pavements is 90, corresponding to an overall PCR of “Good”. Figure TI-4 shows how much pavement area is associated with each Pavement Condition Rating category and also shows pavement condition distribution from the inspections conducted in 2004 and 2008.

The primary distresses observed in the asphalt pavements during the inspection were: longitudinal and transverse cracking, block cracking, raveling and depressions. Joint spalling, joint seal damage, small patches and linear cracking were observed in the concrete pavement.
