Boardman
Airport

**2011 Pavement Evaluation / Maintenance
Management Program**

**Final Report – Individual Airports
Functional Category 4**

July 2011

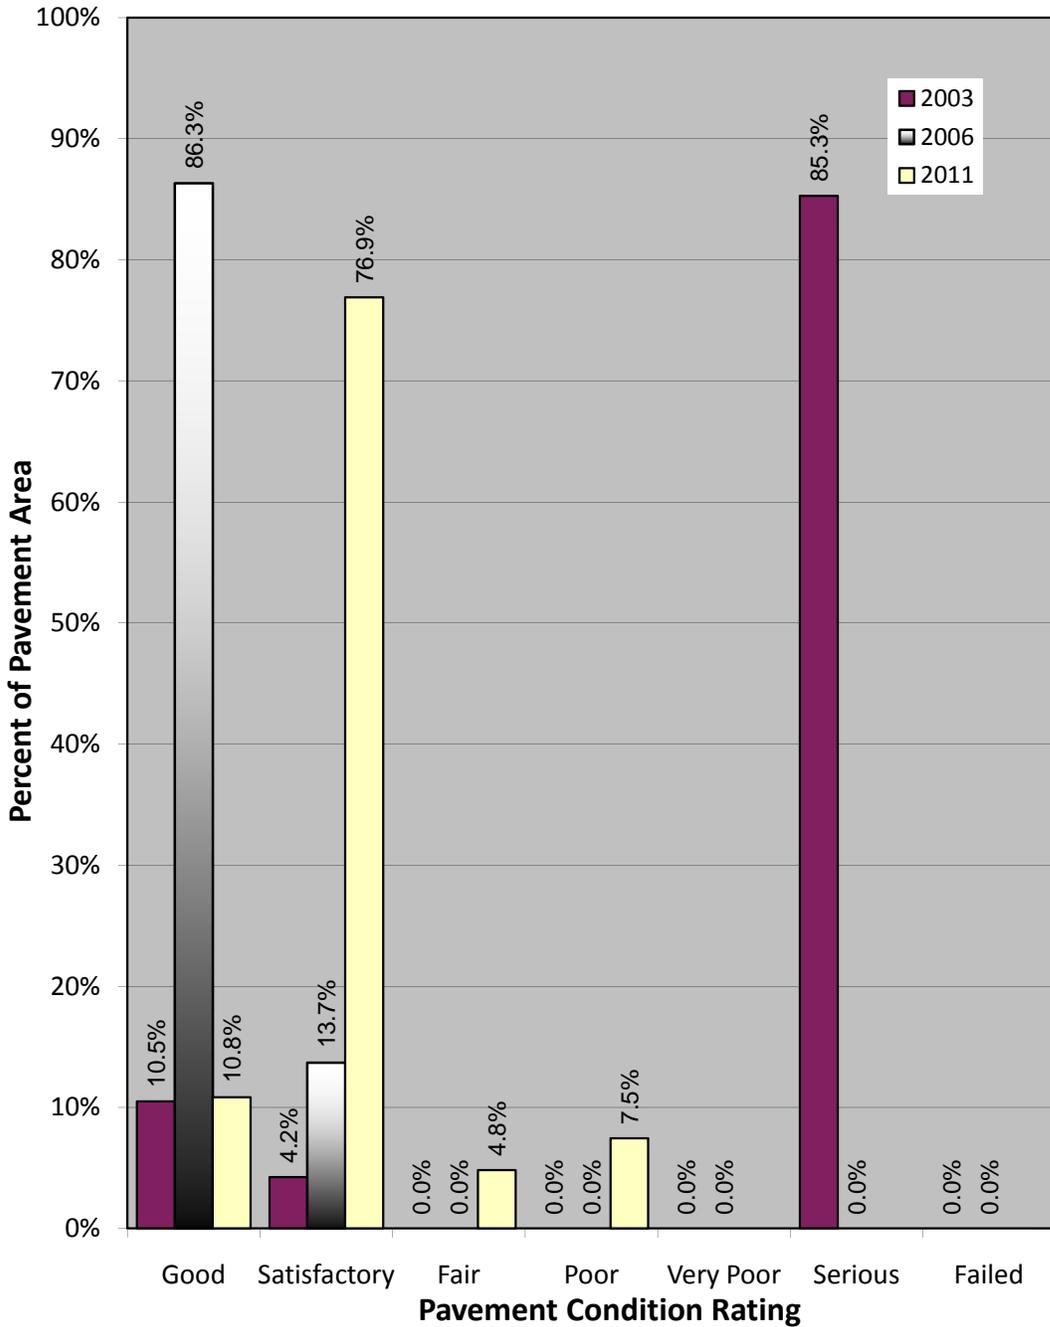
Figure BO-4. Distribution of Pavement Condition Boardman Airport

Section PCIs at Boardman Airport range from a low of 52 (a PCR of "Poor") to a high of 100 (a PCR of "Good"). The area-weighted average PCI for all airport pavements is 75, corresponding to an overall PCR of "Satisfactory". Figure BO-4 shows how much pavement area is associated with each Pavement Condition Rating category and also shows pavement condition distribution from the inspections conducted in 2003 and 2006.

The primary distresses observed during the inspection were: block cracking, weathering, and longitudinal and transverse cracking with isolated occurrences of depressions.
