Field Exercise

Preliminary Building Evaluation

Oregon Main Street Workshop: Field Exercise

M & N Building
*904 - 906 Commercial Street
254 - 256 9th Street
Astoria, Oregon*

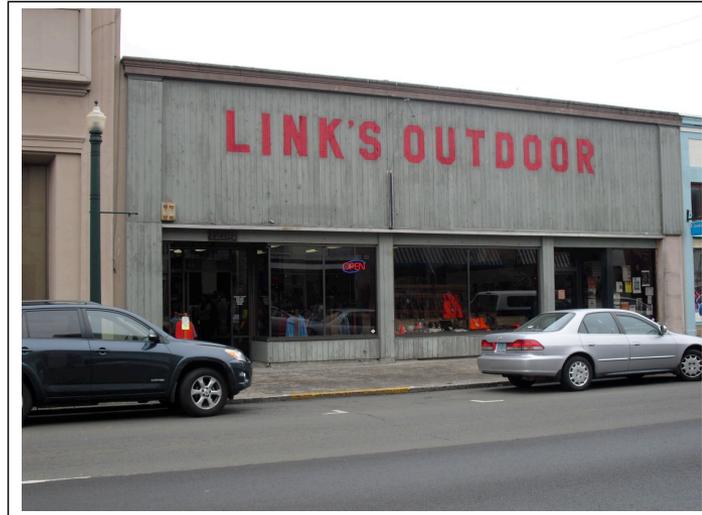
Exterior alterations include vertical wood siding and aggregate panels attached to original front façade. The alterations obscure the frieze, transom windows, and kickplate, south; original copper-lined storefront windows replaced with aluminum frame of like size, south; T-111 siding, south; T-111 siding, north.

The Griffin Building as seen today.

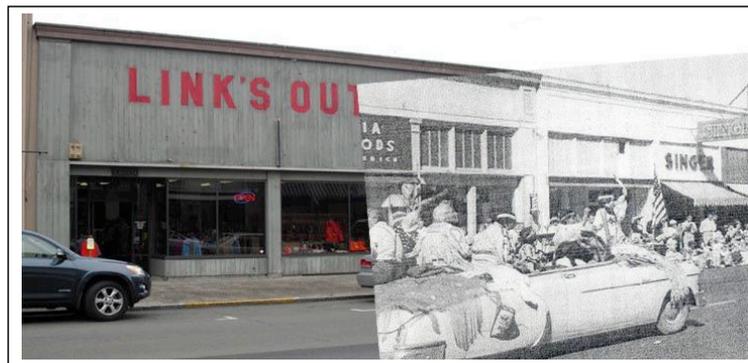
If restored, the building would take on its 1961 appearance.

- 1) Remove wood siding from front (Commercial St.) façade and expose original wood transoms. All transoms still exist, but are in need of reglazing and minor repair. Existing aggregate paneling—which obscures the original brick façade—could remain, but receive a coat of plaster to make it appear as if it were finished concrete.
- 2) Remove both wood siding and aggregate paneling to expose original brick façade. Repair or replace brick as necessary and reglaze and repair wood transoms as needed.

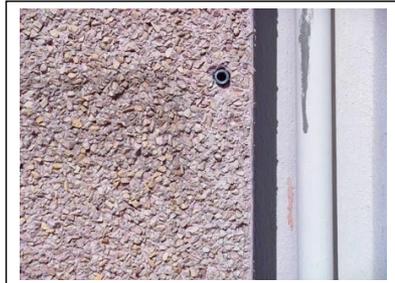
Detail of aggregate panel applied over original brick façade.

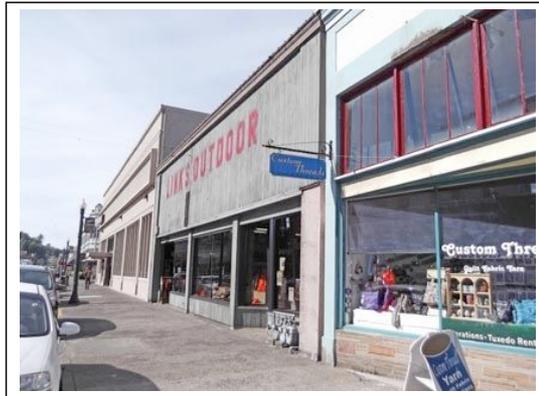
The Griffin Building's transoms are similar in design to those of its neighbor.
