## Department of Transportation

Subject: Preliminary Hazardous Materials Assessment  
West Linn Solar Project  
Hwy 64, MP 6.4 to 6.8  
Clackamas County

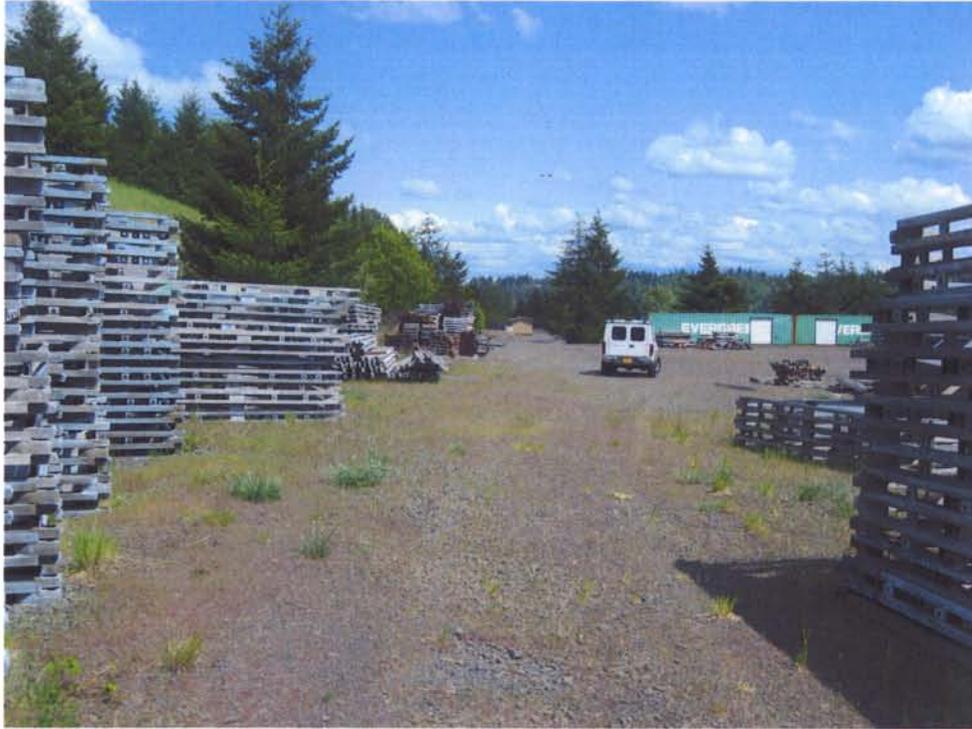
ODOT stockpile yard looking east toward brown wood shed in the distance.

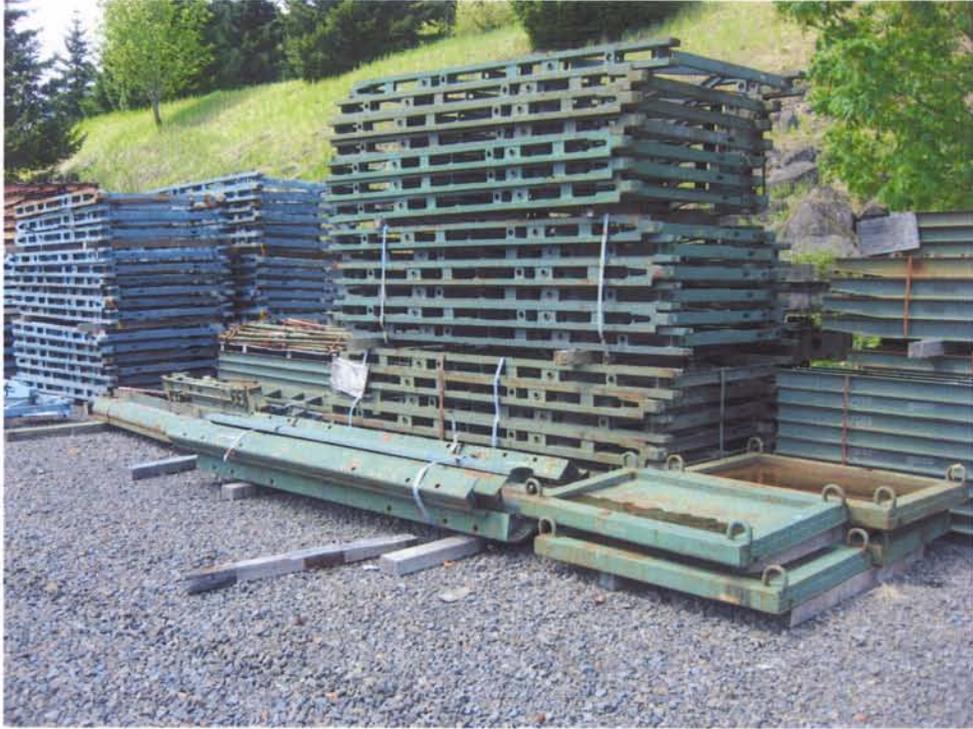
Some of the metal bridge components are painted. The paint may contain lead and other metals. Several cubic yards of road sweepings were also present near a small wooden garage. These may contain petroleum, metals, and other contaminants.

Portable bridge components stored at the stockpile yard.

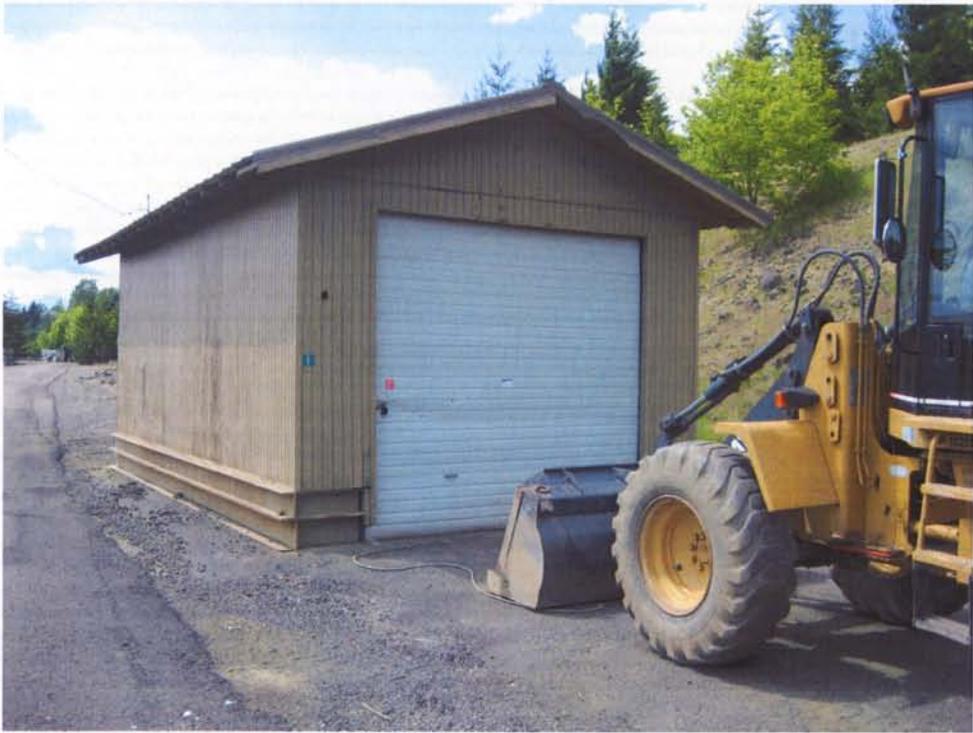
Shed used for front end loader.

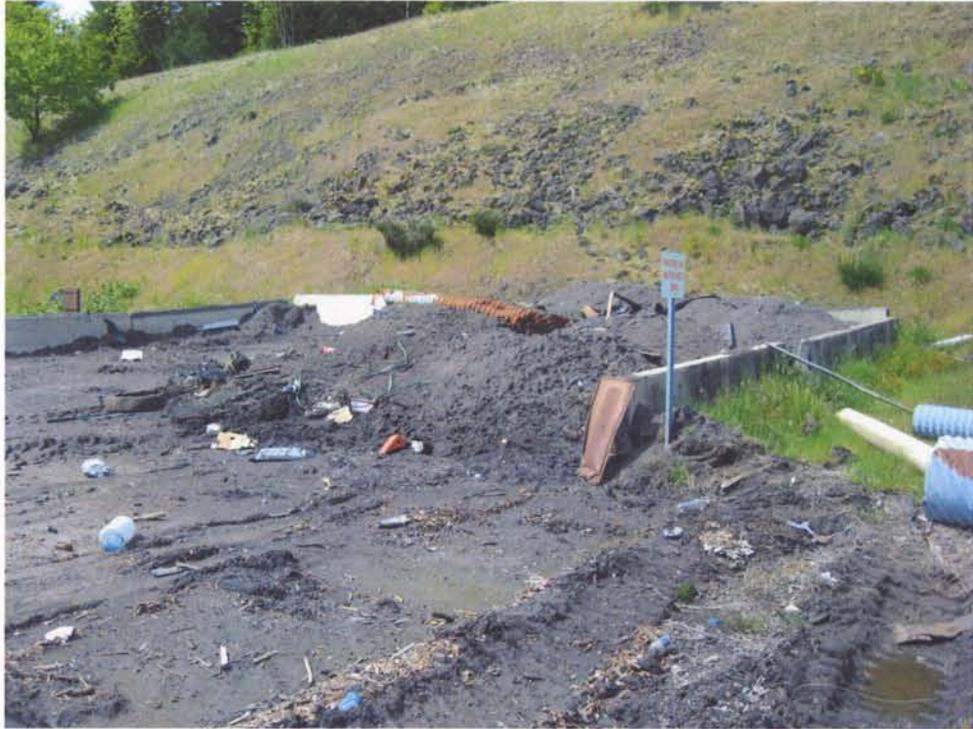
Road sweepings debris stored at the stockpile yard.

Based on the site visit, it is possible the gravel ballast in the stockpile yard has been impacted by low concentrations of petroleum, metals, and other contaminants due to some of the materials that have been stored there. Testing and analysis may be required by the Oregon Department of Environmental Quality if any of the gravel ballast must be removed and hauled off site.

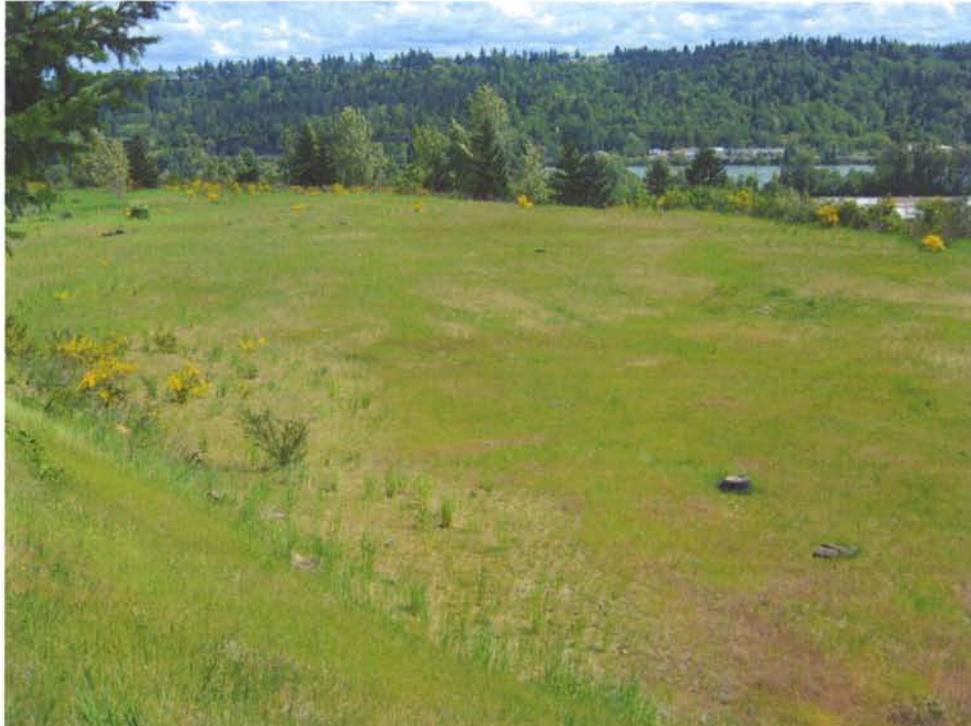
Looking down from the top of the buttress near the west end. Tires are visible in the field below. View is to the southeast.

The abandoned automobile tires in the field west of the stockpile yard should be collected and disposed accordingly. They may have been illegally dumped. It is also possible they were once incorporated in the fill and have floated to the surface now as a result of a high groundwater table.

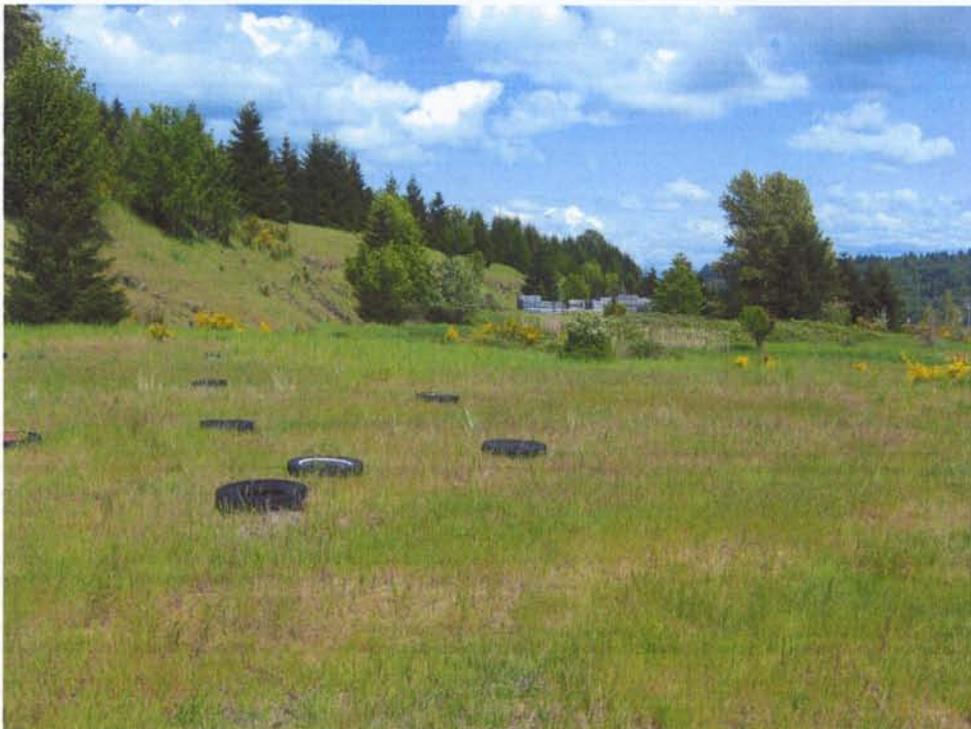
No surface stains or odors were observed in the vicinity of the wetland at the west end of the stockpile yard. Old automobile tires were scattered on top of the ground there and further west. Elsewhere on the subject property, small quantities of metal, concrete and other debris were observed including an old appliance with exposed insulation.

Tires scattered across the field at the toe of the buttress. ODOT stockpile yard visible in the distance. View is to the east.

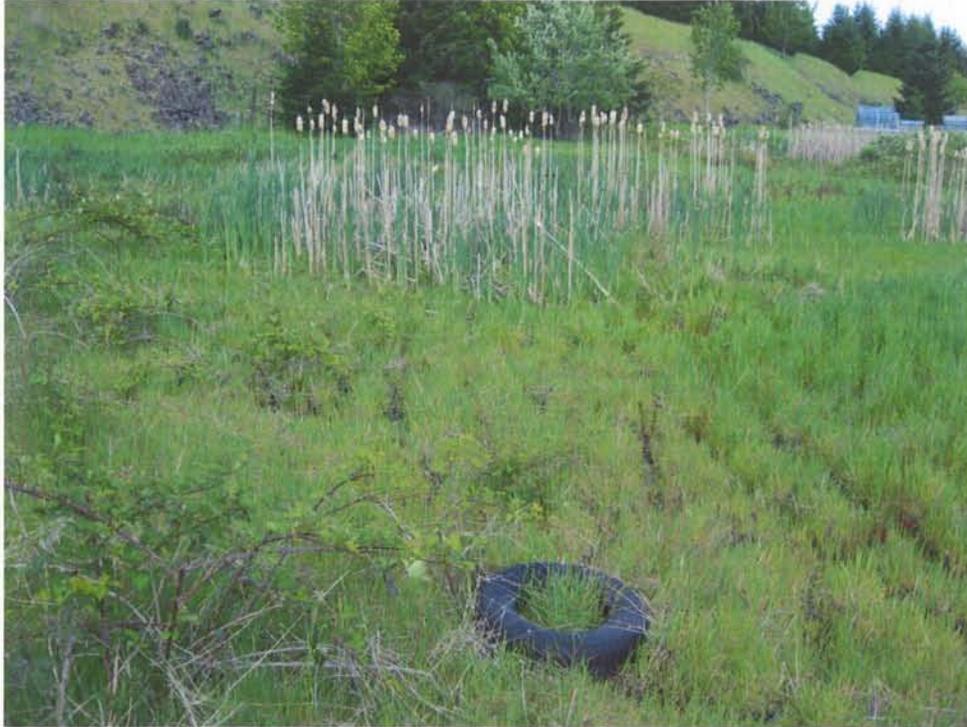
Possible wetland area at the toe of the buttress.  
Stockpile yard is visible in the upper right corner.

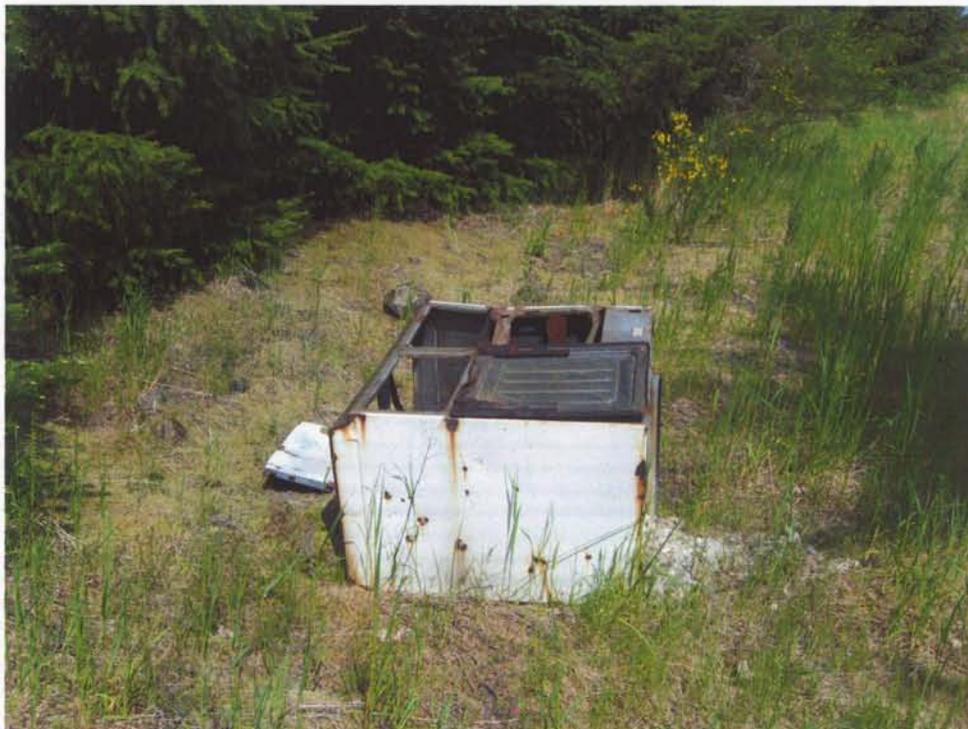
Abandoned appliance found on the top of the buttress.  
Loose insulating material is visible on the ground.

The metal and concrete debris present on the subject property should be collected and recycled or disposed. A sample of the exposed insulation found next to the appliance has been collected for asbestos analysis. If asbestos is detected ODOT will hire an asbestos abatement company to handle and dispose of that material.

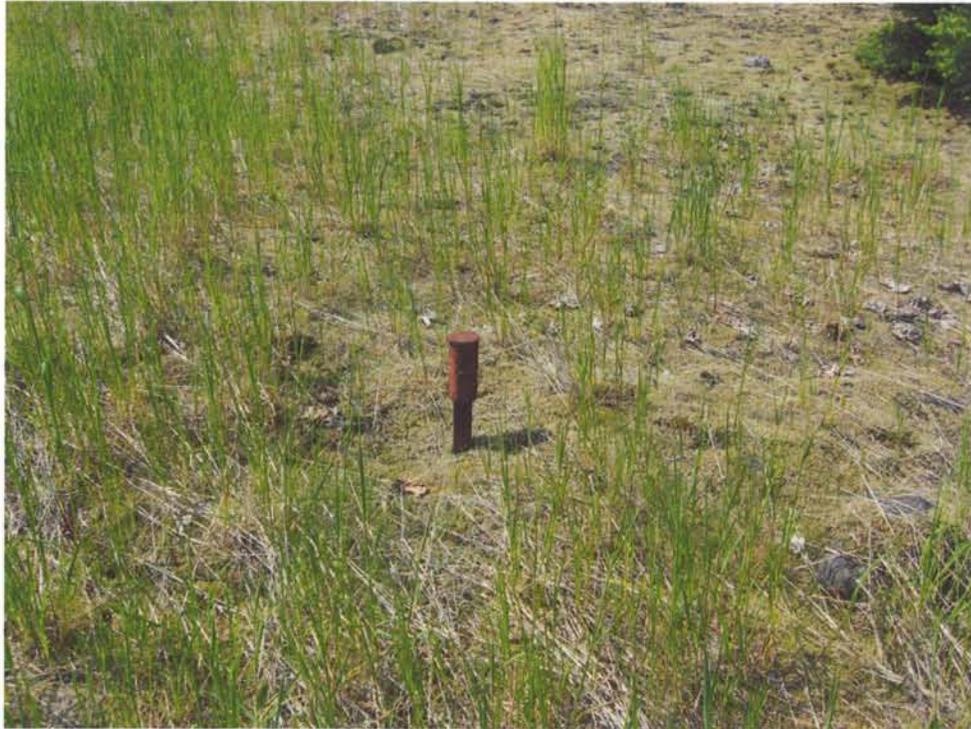
Two vertical, square metal pipes were observed at different locations on top of the buttress. Both pipes are capped and rise approximately 12 inches above ground. These appear to be inclinometers that were once used for measuring slope stability.

One of two possible inclinometers found on the top of the buttness.
