CULTURAL LANDSCAPE INVENTORY:
SHELLROCK MOUNTAIN TO RUTHTON POINT

HISTORIC COLUMBIA RIVER HIGHWAY

Prepared For:
Oregon State Department of Transportation

January 2010

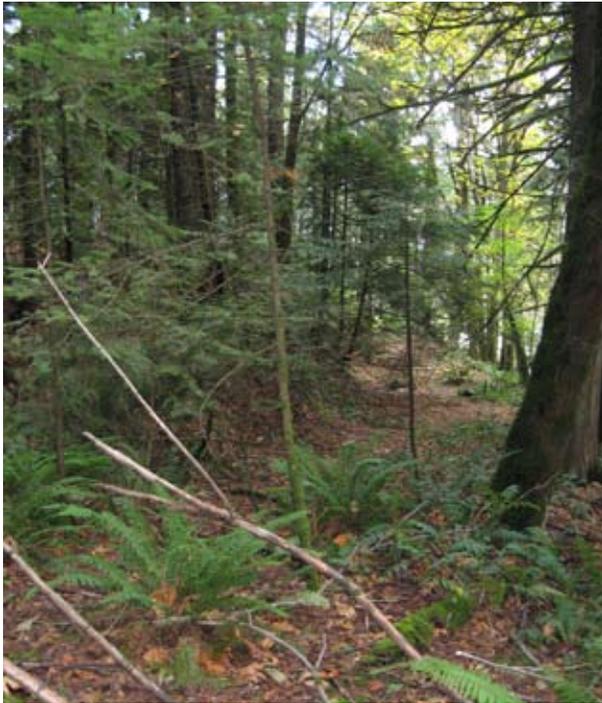
Lindsey Creek intersection, abandoned road

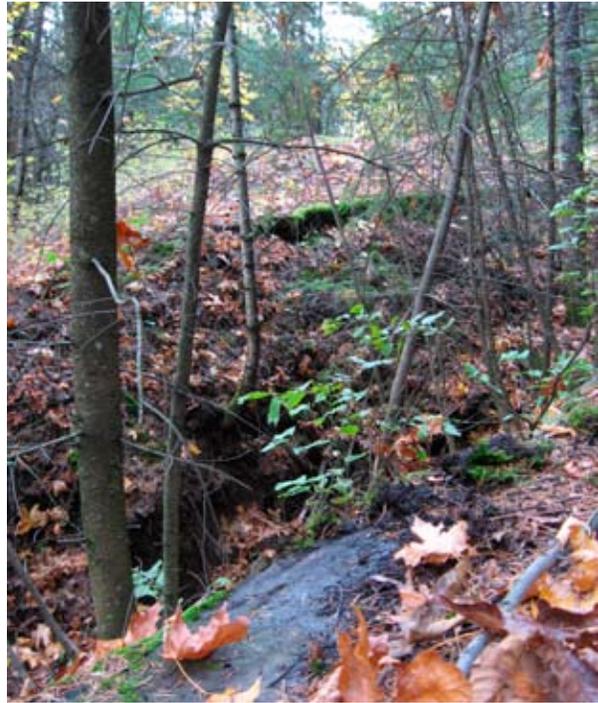
Broken Pavement, Mitchell Creek diversion, Mitchell Point 2

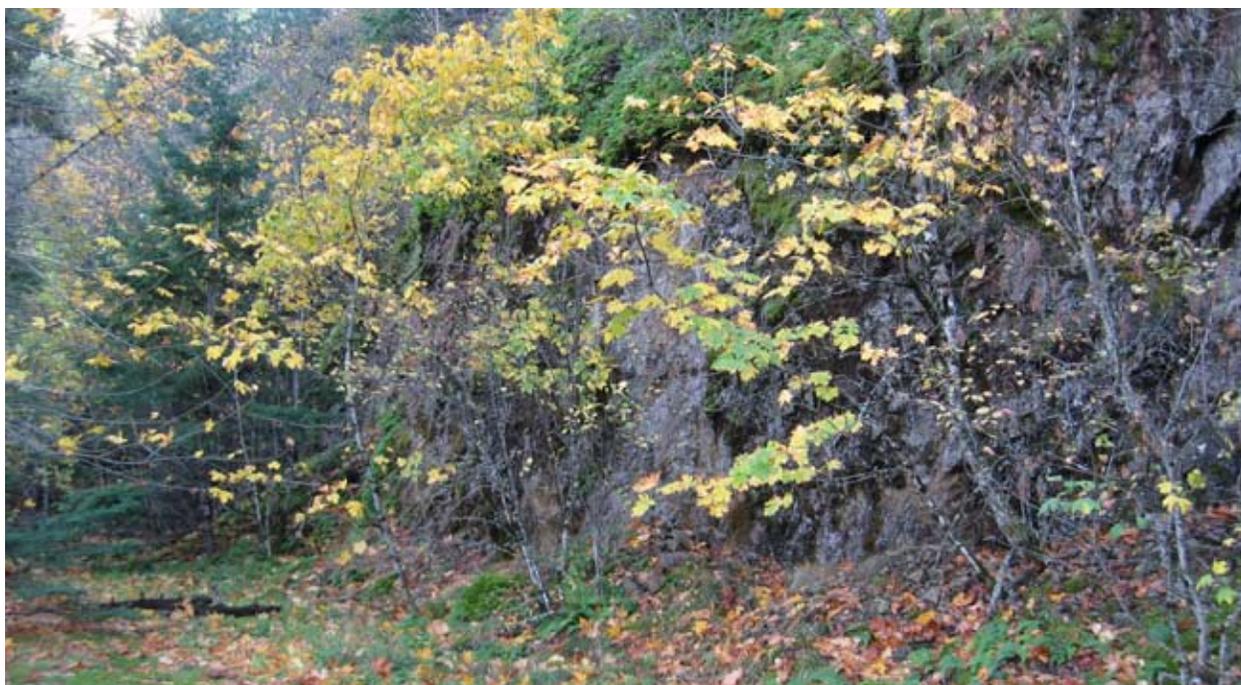
Rock Cut, Mitchell Point. The vegetation and piled debris at its base are signs of poor condition. Note the slide in the background.

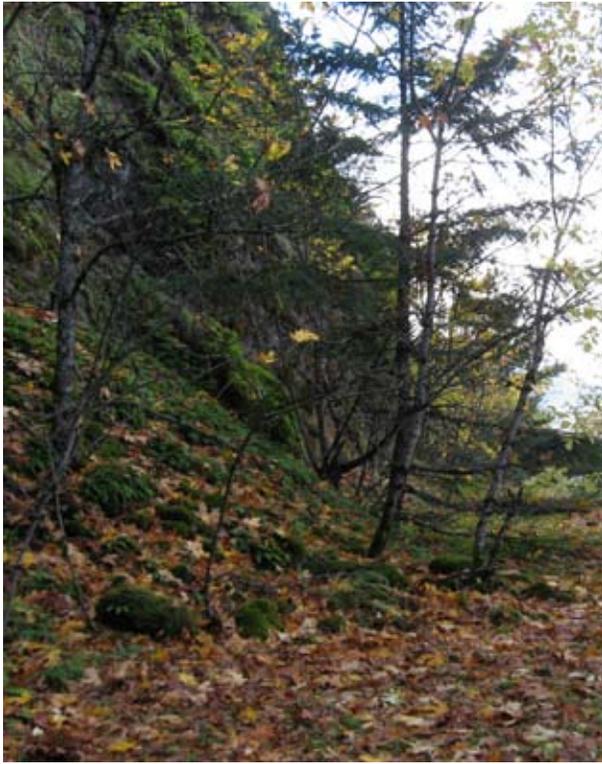
Rock cut, slide, Perham Creek

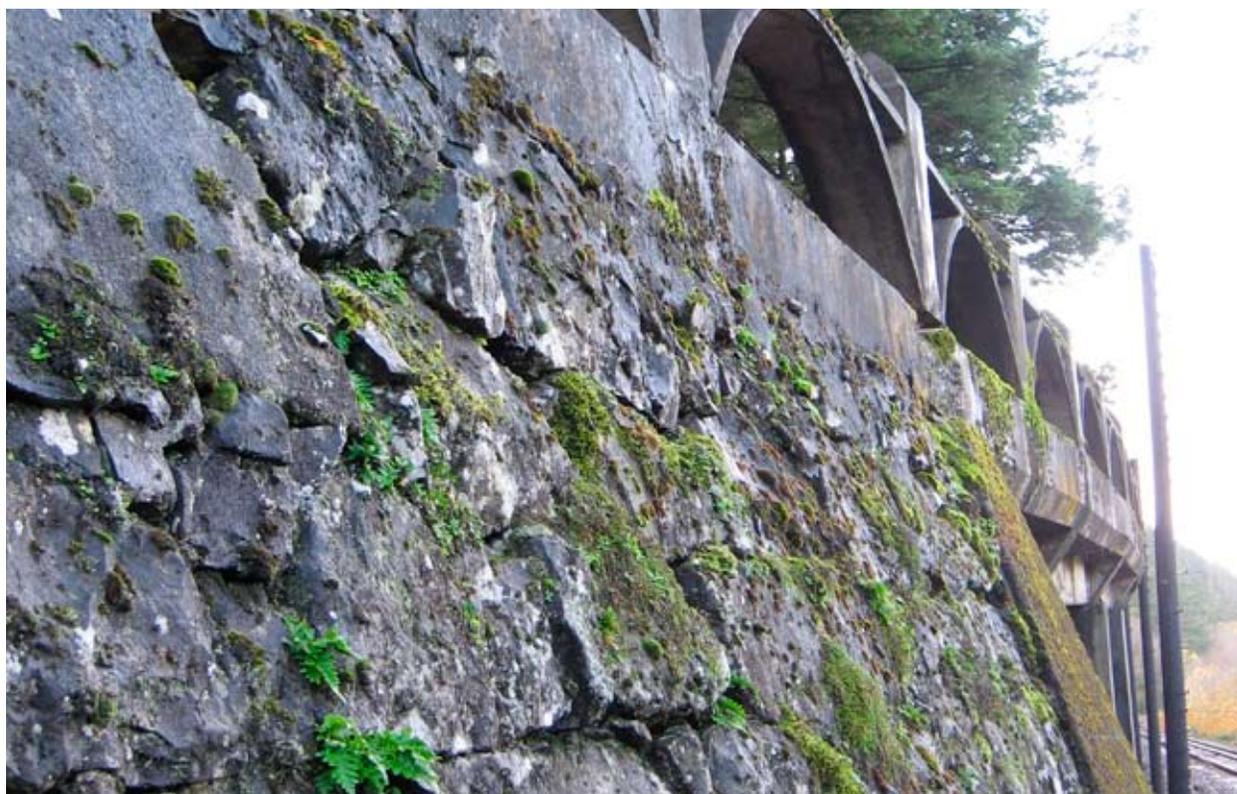
Retaining wall, viaduct and guard rail, near Multnomah Falls. The retaining wall is battered (sloped to the base), dry laid, unbossed, and laid in a random pattern. Many chink stones are missing, some can be seen.

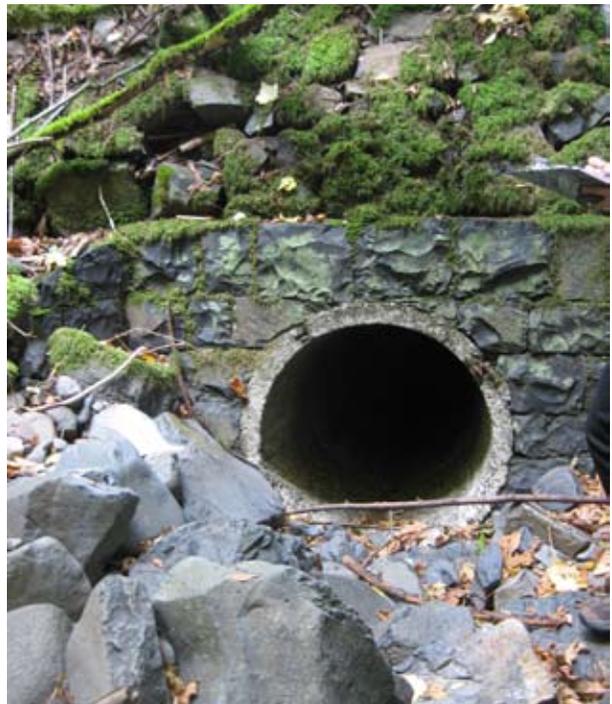
Cabin Creek culvert

Drainage structures along the segments included in the inventory are almost all buried or washed out, and it was not possible to relocate them within the scope of this project. Some potentially could be relocated from the road log. The inventory found five culverts, all in poor condition. All but one appeared to be clogged, and one to have been repaired or extended with corrugated steel pipe. At Cabin Creek, the culvert is clearly designed to be seen from the path up to the falls, with a hewn, bossed basalt head wall on the inlet side, topped by a rubble wall. Another culvert in the same segment located from the historic road log includes a dry laid stone head wall. This culvert also has a stone rim on the concrete pipe.

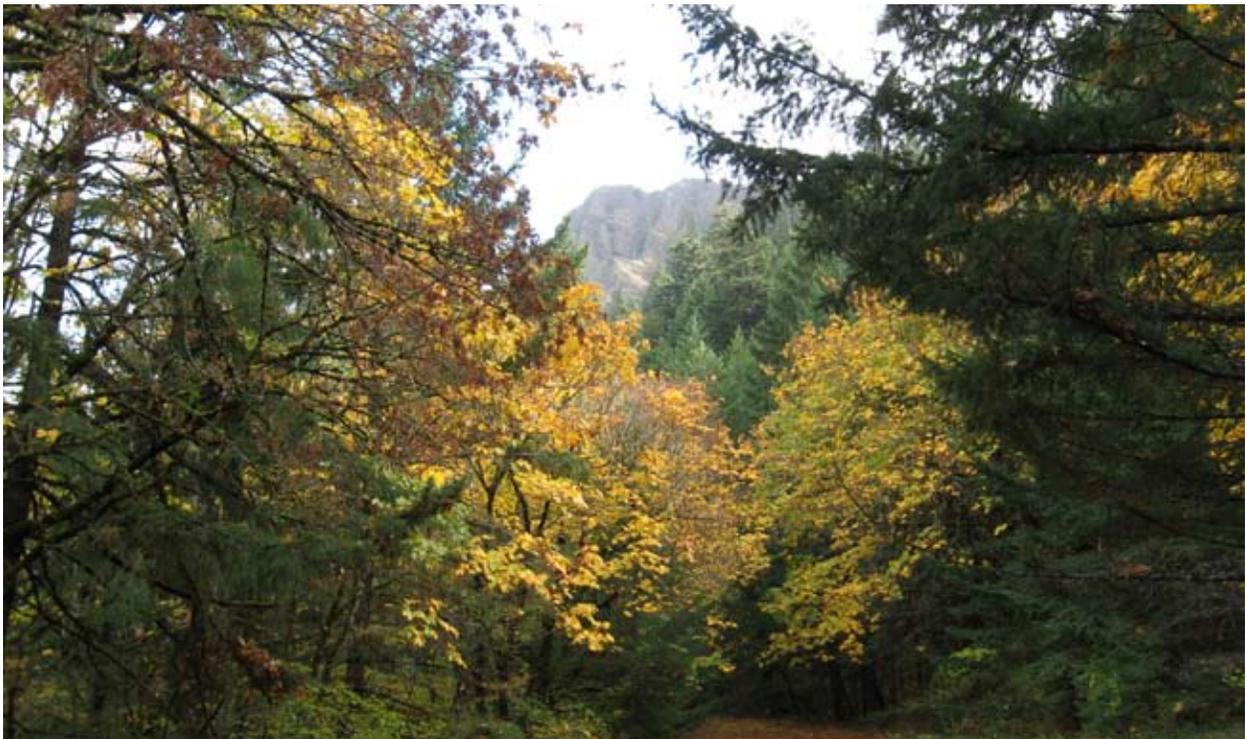
Framed, axial view of Mitchell Point , overgrown with vegetation

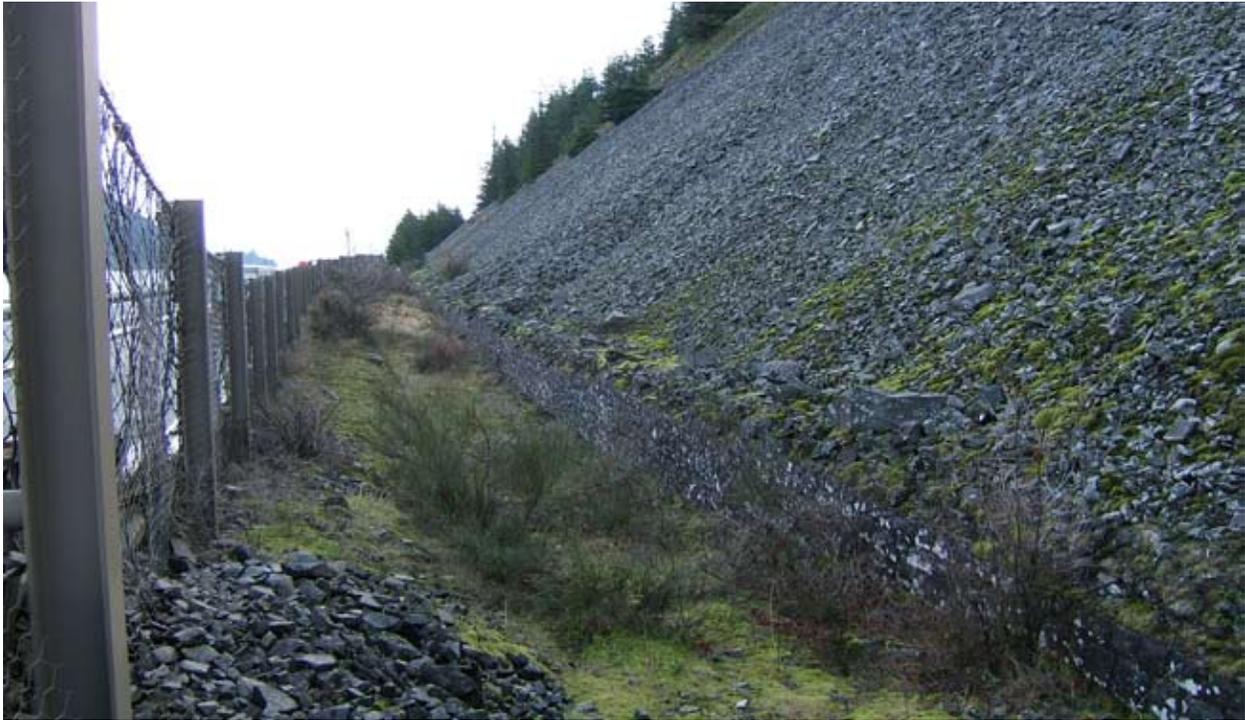
masonry parapet are piled along the top of the wall, and talus has accumulated there as well. These wall fragments reveal how thick this retaining wall is, and the size of the stones used in it. The second retaining wall, located about two thousand feet east of the first, is about 150 feet long and 10 feet high, but like the first the top is broken or missing in places. The stones are hewn basalt, laid in a random arrangement with some mortar at least at the top. This second wall is buried in vegetation and overgrown with trees. It is in poor condition, but impressive nevertheless.

Retaining wall and rock catchment, Shellrock Mountain

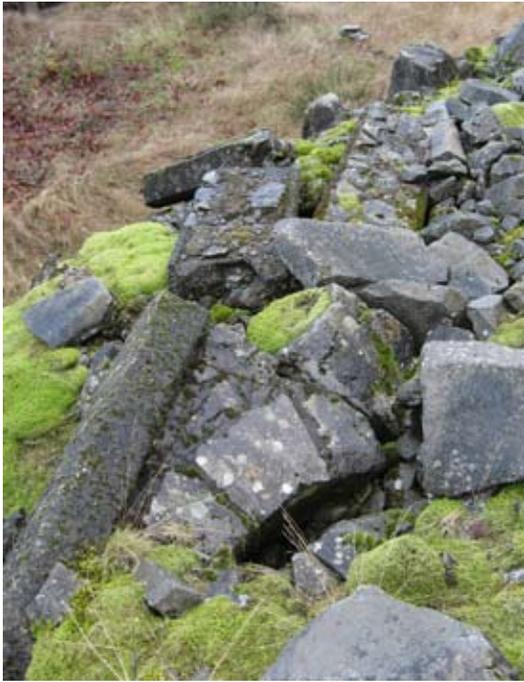
Broken parapet, Shellrock Mountain

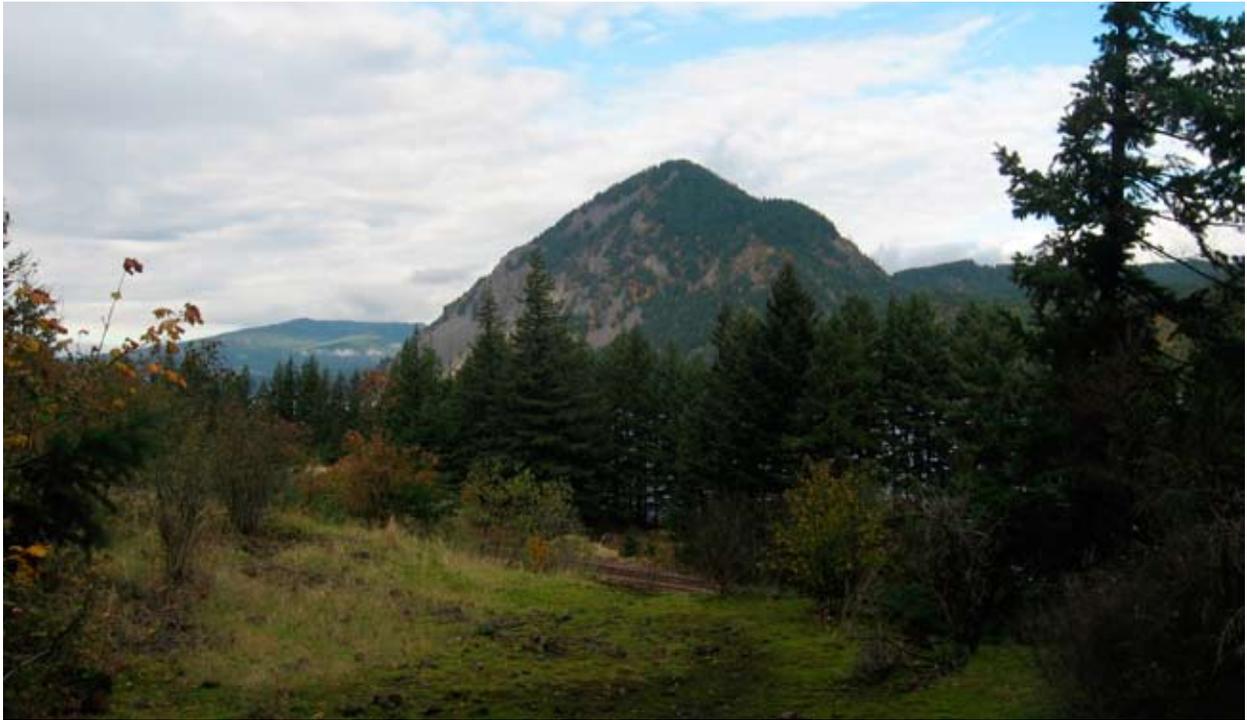
The view of Wind Mountain at the western end of the segment is in poor condition, compromised by vegetation, the concrete barrier at the end of the segment, and the Interstate below. The inventory also identified a vista to the south, up a steep draw framed by interesting rock formations. This vista is in poor condition as well, as it is overgrown with small trees.

View of Wind Mountain from east end of Lindsey Creek Segment

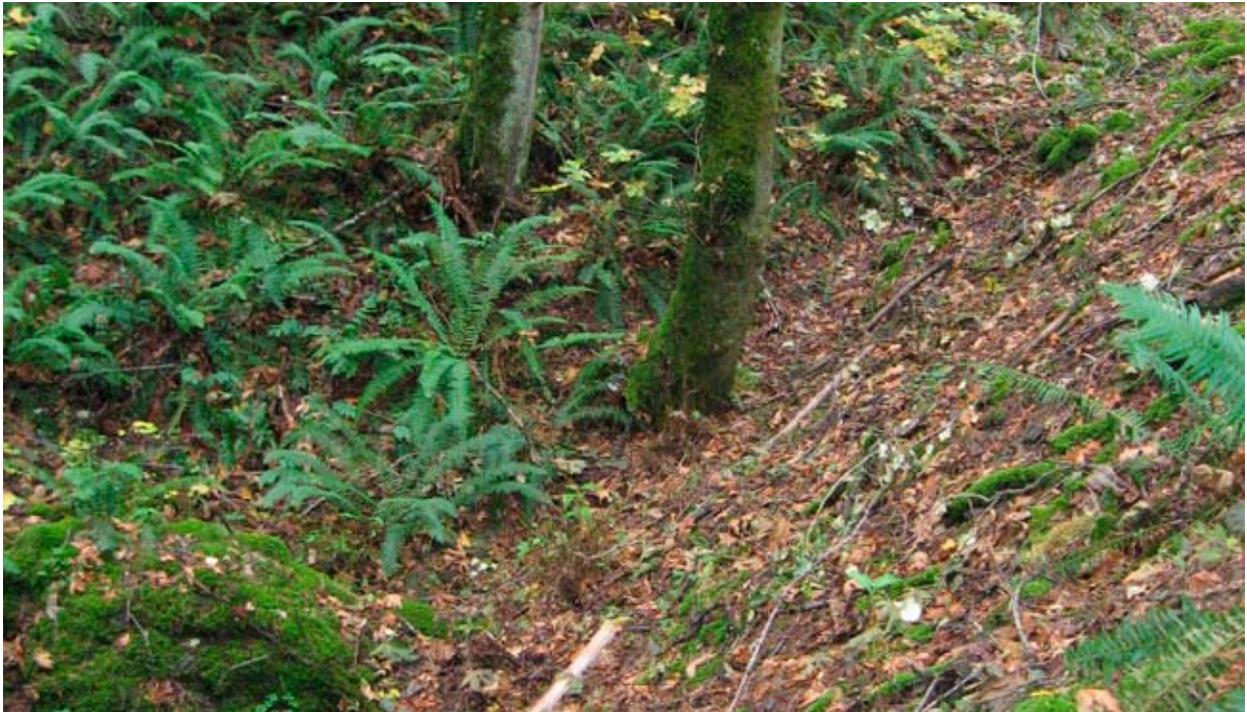
Fill-through, blocked drainage, Lindsey Creek Segment

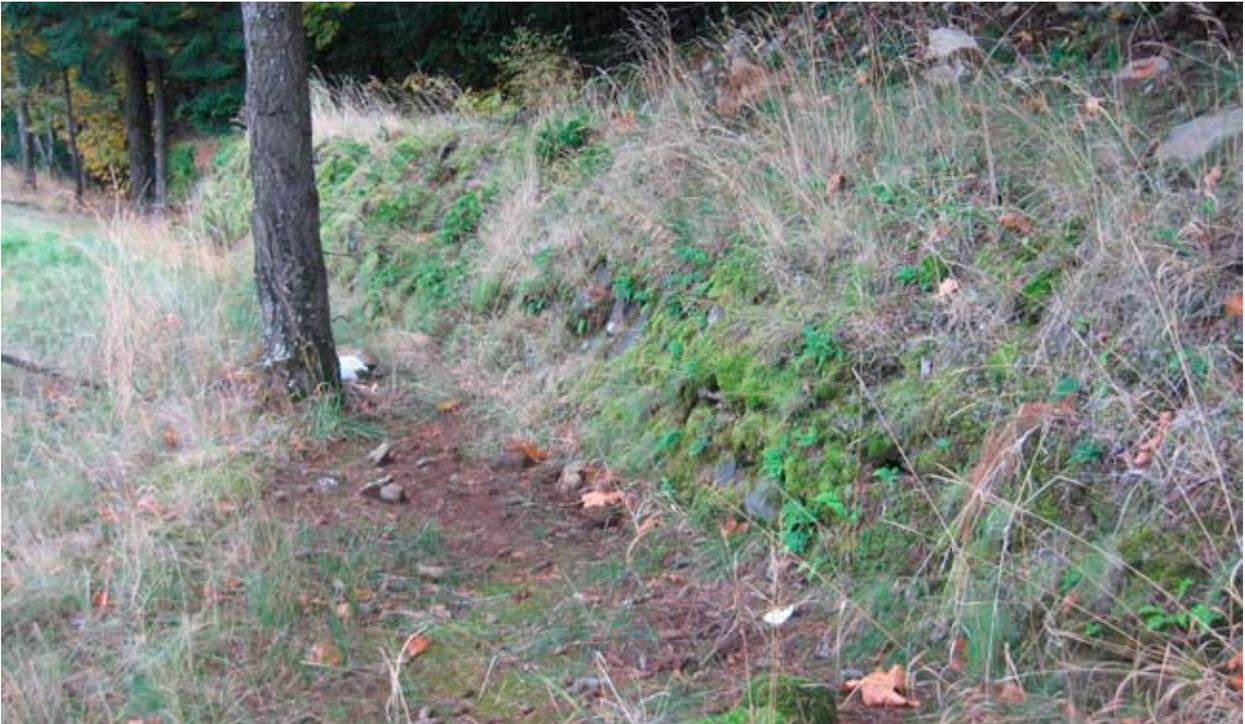
The inventory recorded a 270-foot long retaining wall in below the road on the north side of the highway, in the area of Cabin Creek. It is a typical coursed, dry laid stone retaining wall, with a mortar cap. The wall is in poor condition, with a crumbling mortar, some missing stones, and missing chink stones. It is overgrown with vegetation. The mortar cap may be a later addition.

Retaining wall north of Historic highway. This may be part of a longer wall. It is damaged by the ferns and other vegetation, missing chink stones.

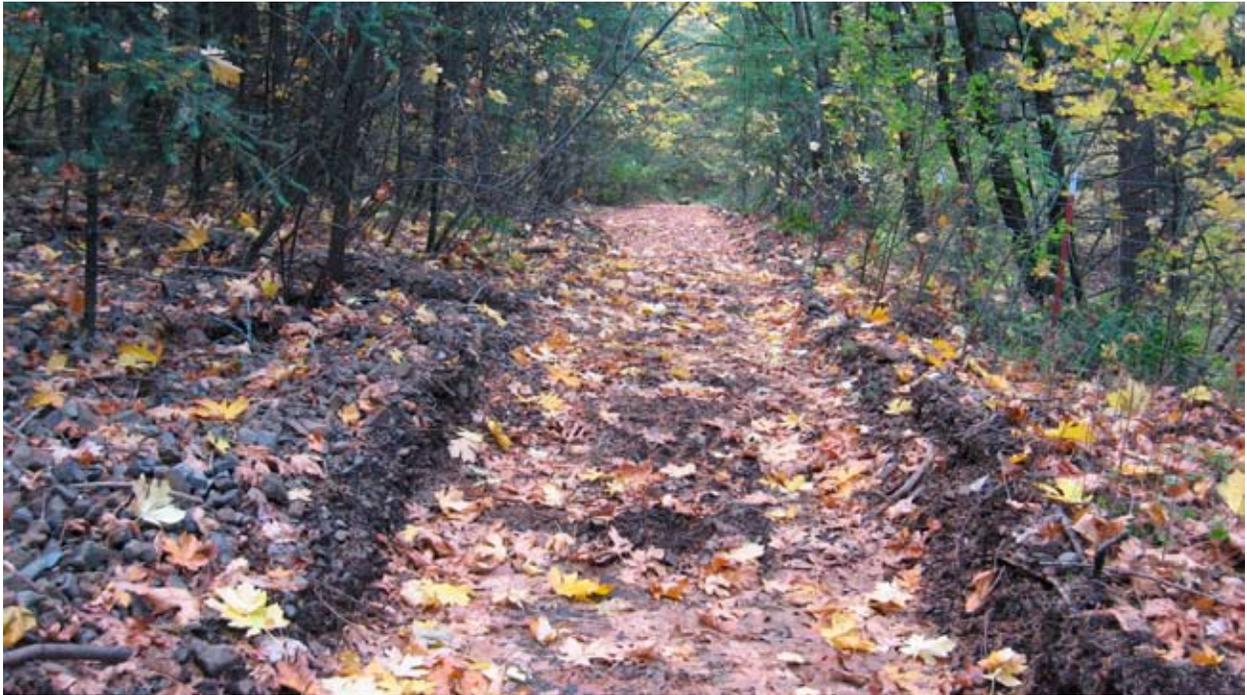
Washed out, buried road bed, Viento Segment 1. Contemporary wire fence on right.

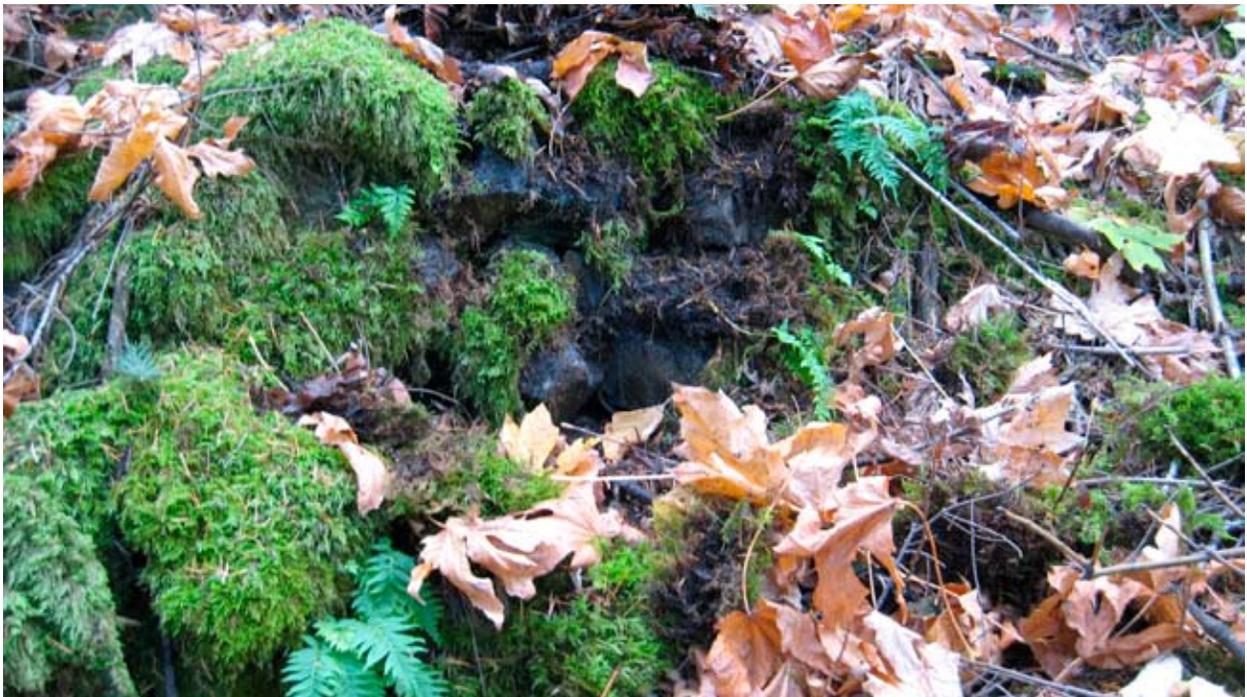
Battered stone retaining wall/ rubble fill. Viento Segment 1.

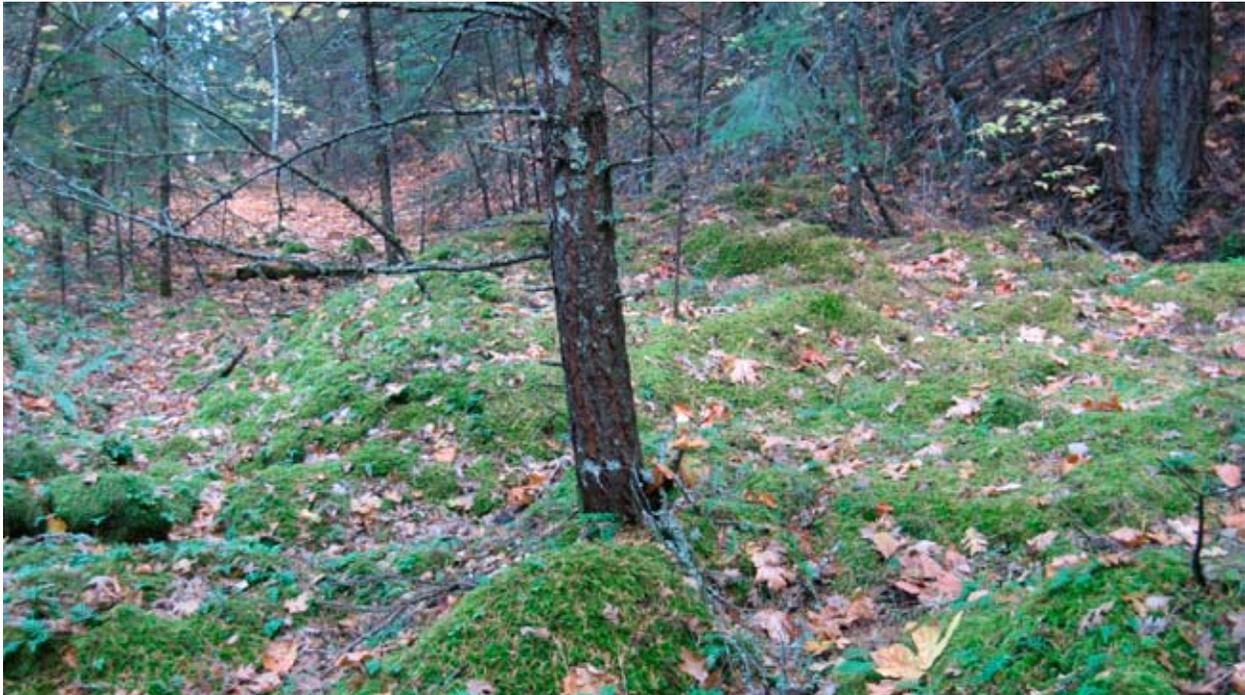
Pile of asphalt and rubble from removed roadbed, Viento Segment 3. The roadbed in the background has buried, fragmented pavement in poor condition, overgrown vegetation.

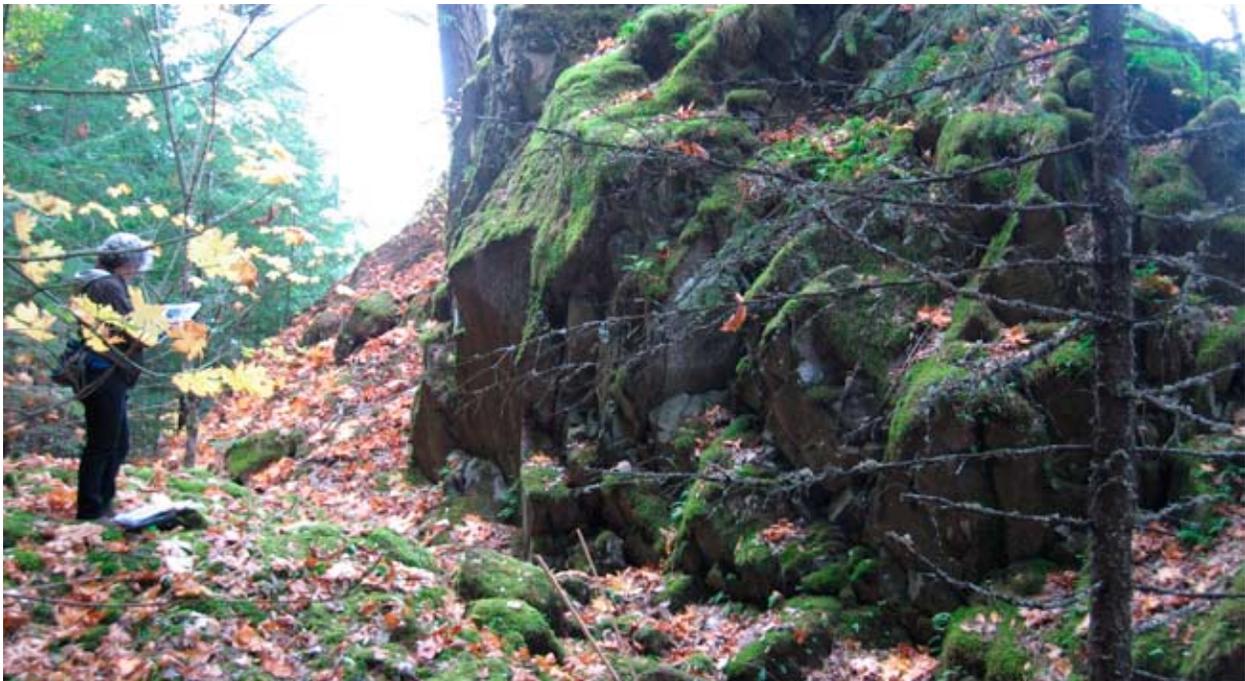
Rock Cut, associated with cut-through, Viento Segment 3. The roadbed is piled with asphalt.

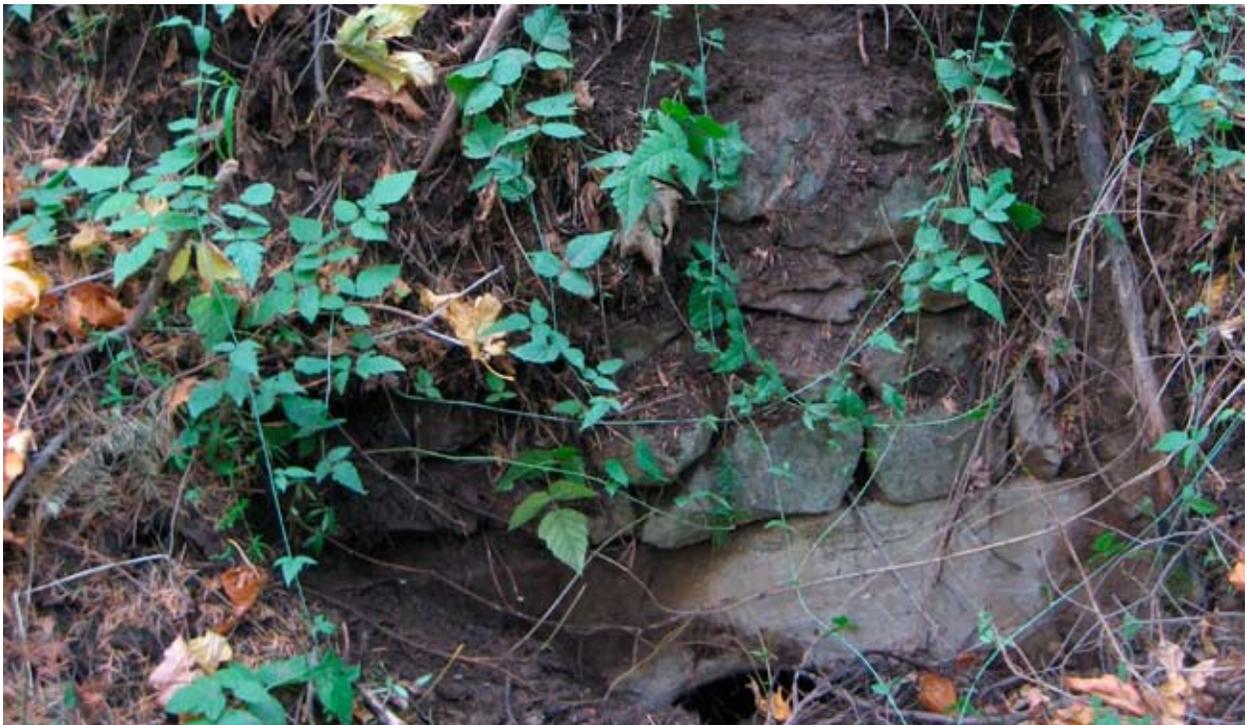
Clogged concrete culvert, Mitchell Point Segment 2

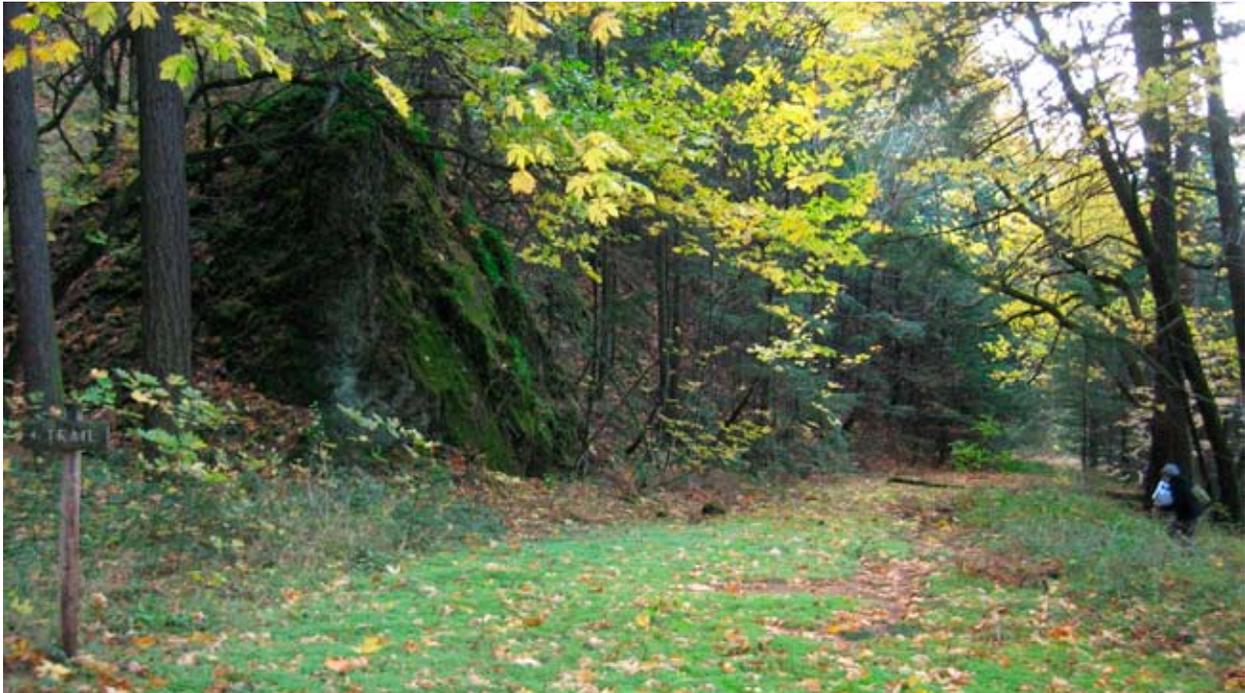
Mitchell Point Segment 2, Wyzant trail intersection. Overgrown pavement, clogged drainage system.

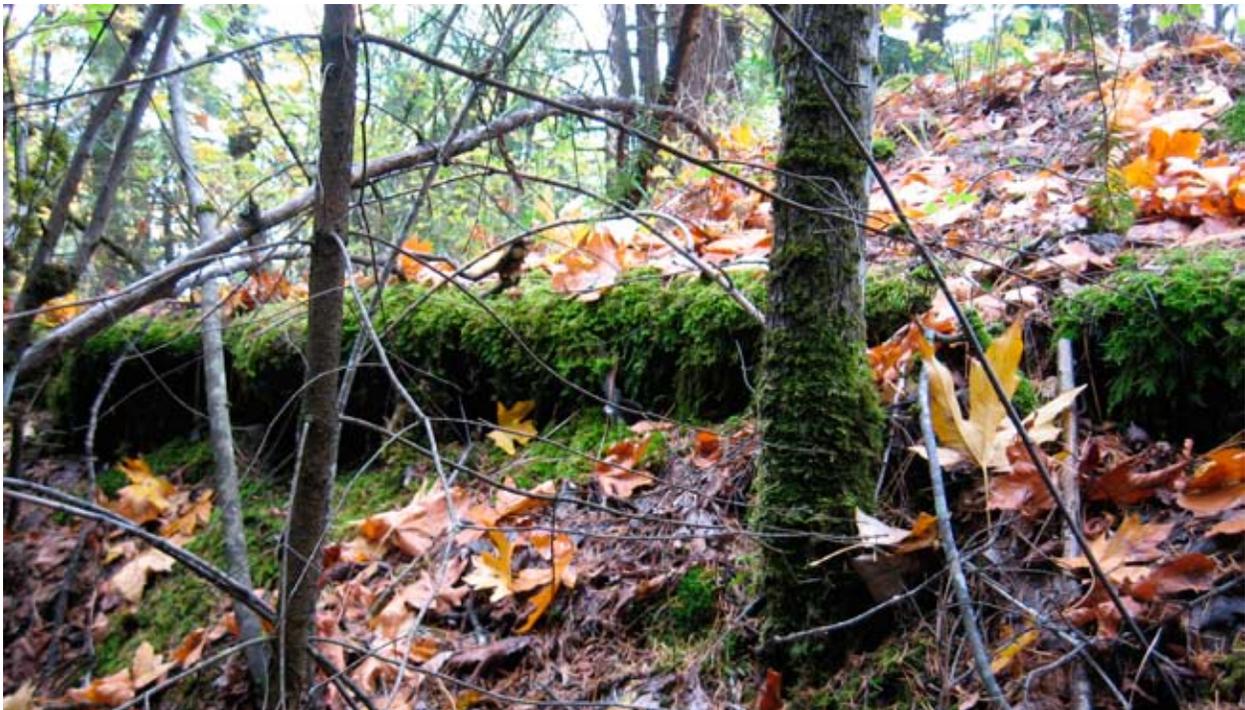
Pavement edge, washout at Mitchell Creek, Mitchell Creek Segment 2

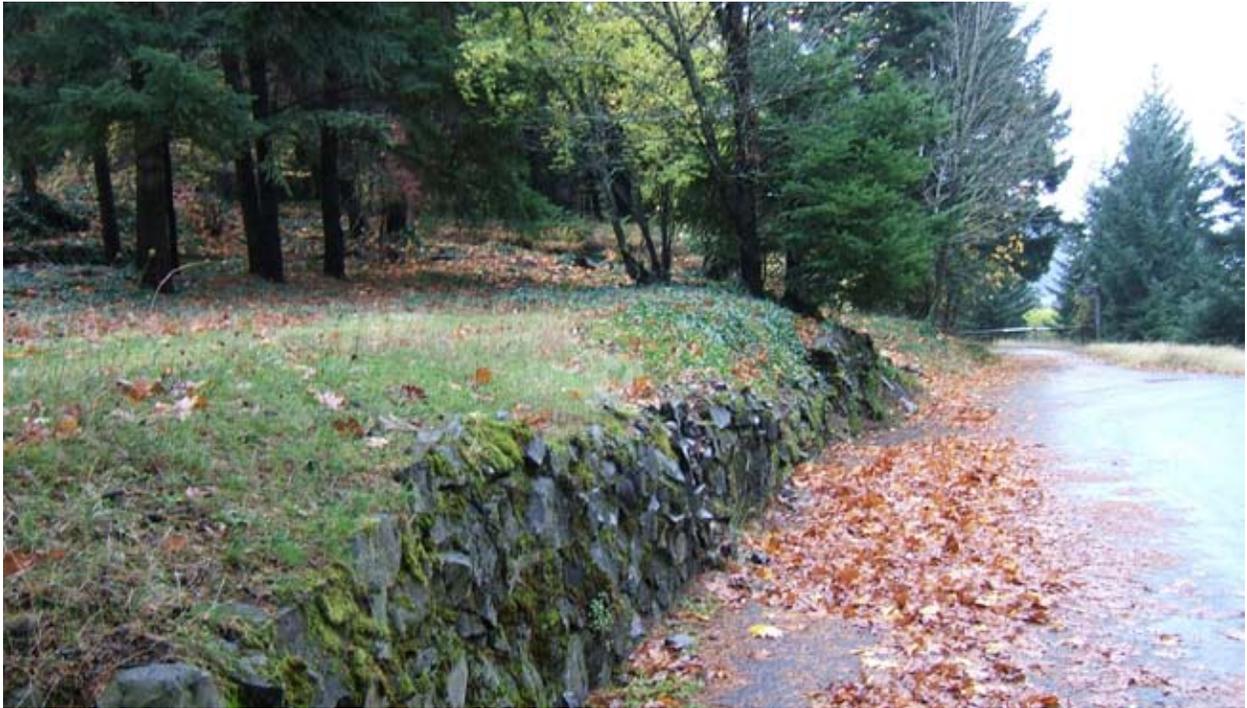
Three other small retaining walls were found, all in poor condition. Of these, one is associated with the terrace and entry of the development associated with the road at Mitchell Point and has been patched with rubble and repaired with mortar in several places.

Mitchell Point Segment 3, retaining wall and settlement site from parking lot. The wall has failed and been patched with mortar and rubble.

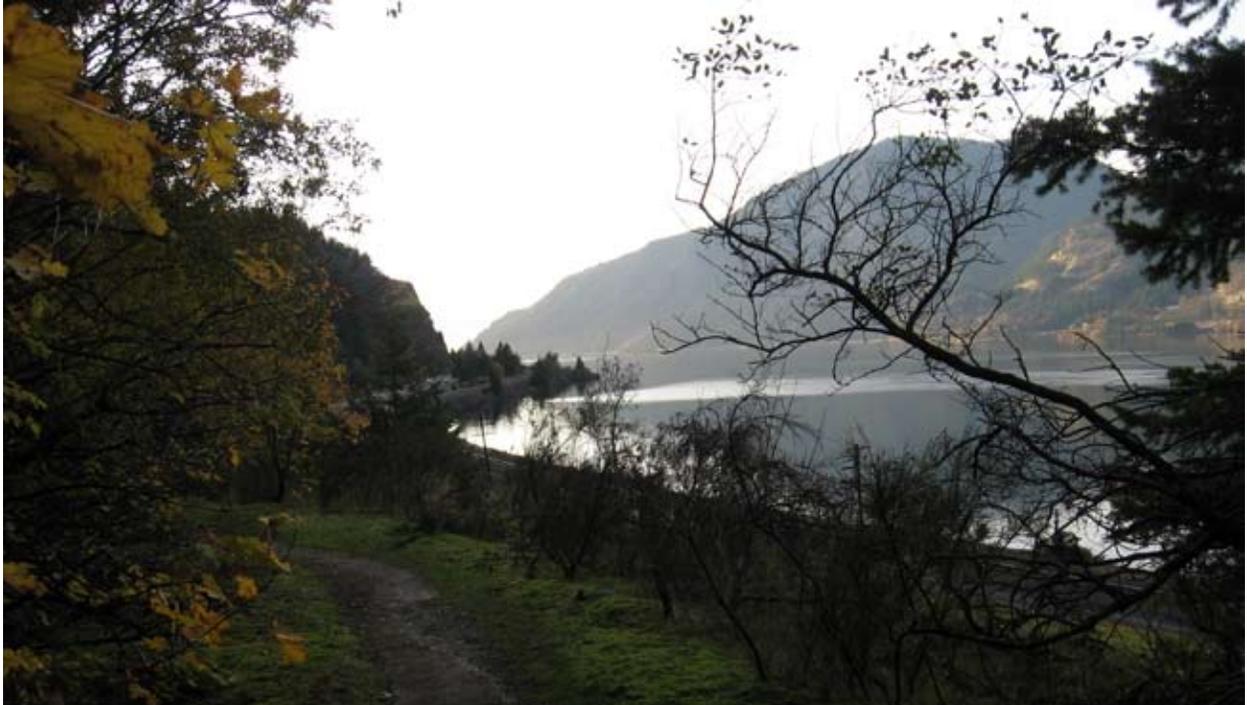
Partially missing pavement, contemporary view, Mitchell Point Segment 2.

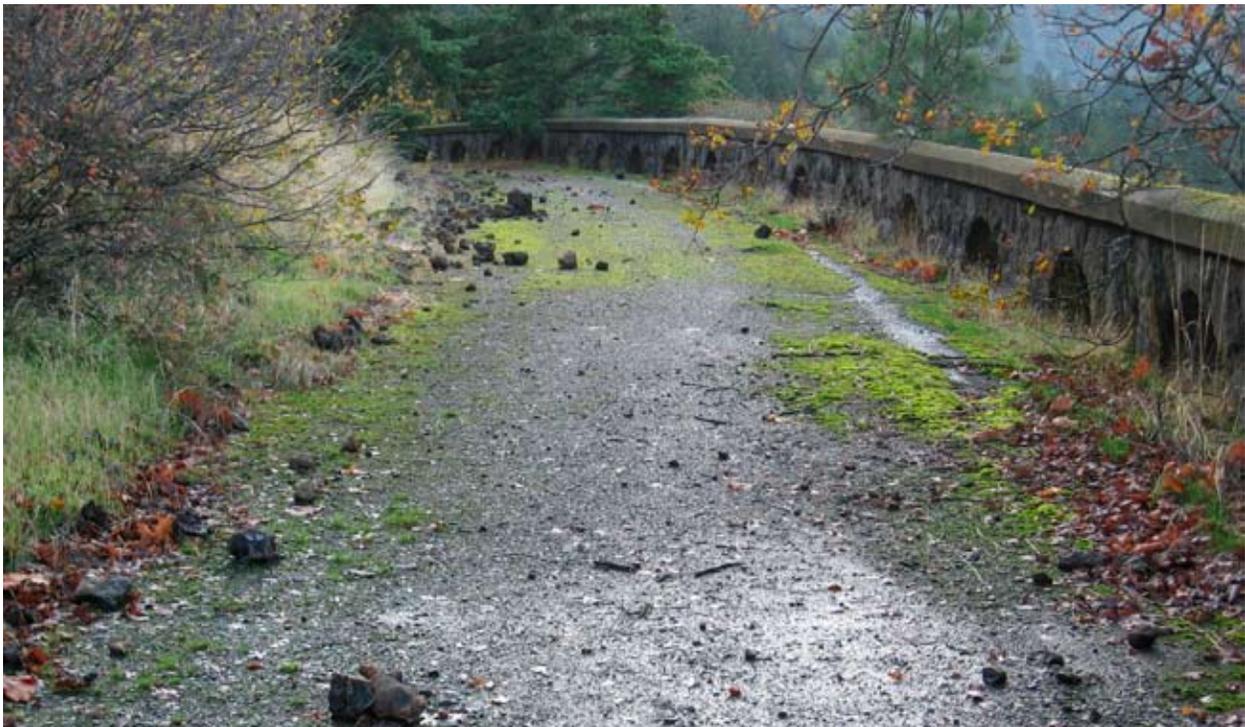
Reconstructed and repaired rubble masonry parapet, damaged and partially buried roadbed, Ruthton Point

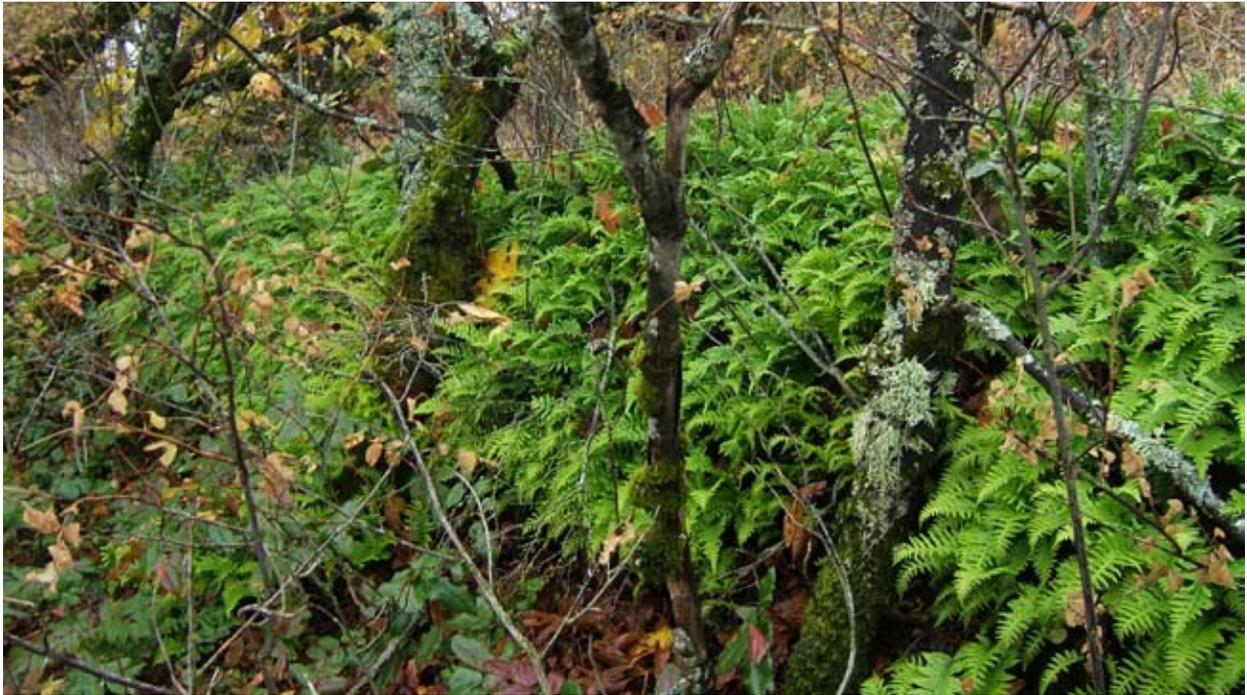
Retaining wall, Ruthton Segment 2.
