Road Safety Audit (RSA)

Mt. Hood Highway, Mile Post 47.0 – 54.3

Project No. 10261.0

September 2009

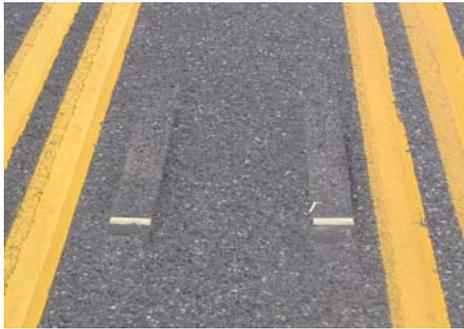
Figure 1

During the night field review, it was noticeable that the existing inlaid reflective pavement markers (RPM) and delineators have lost their reflectivity (see Figure 1). Certain sections of the road did not even have RPMs anymore and the delineator spacing was inconsistent (see Figure 2). Approximately 30% of all crashes occurred during dawn, dark, or dusk.

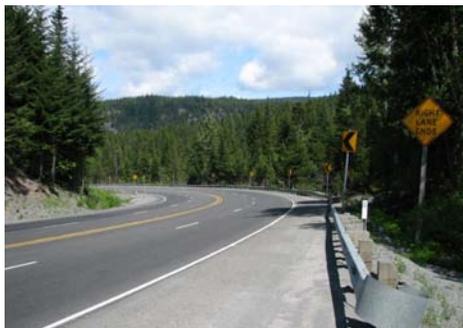
Figure 3

The signs are of varying standards with spacing (see Figure 3), number, message (see Figure 4: rocks and slides), and retro-reflectivity issues.

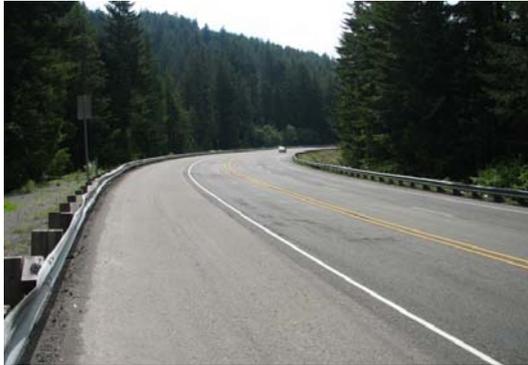
Figure 5

The existing guardrails do not have reflective markers (see Figure 5) and some guardrail ends (see Figure 6) are non-standard.

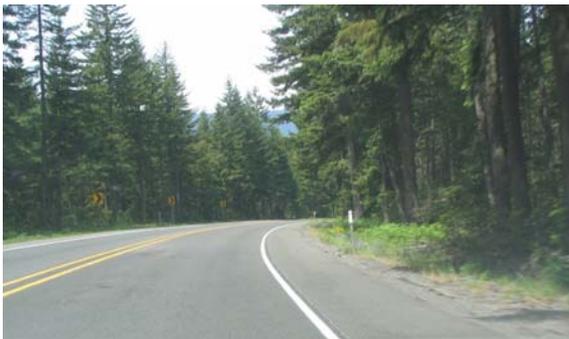
Figure 10

The existing paved shoulder from before the curve west of Camp Creek Campground entrance to just before MP 48 is typically 4-6 feet (see Figure 10). This area has trees very close to the travel lane and within the typical clear zone associated with a 55-mph facility. Due to the proximity of the trees, it is generally not comfortable for motorist to pull off on the shoulder if needed (see Figure 11). The narrow shoulder also restricts sight distance to the few access points. During the winter, the snow berms will further restrict the shoulder width and sight distances. The trees overhanging the roadway also cause concern during heavy snowfall, because chunks of snow from the overhanging branches come loose and fall into the travelway.

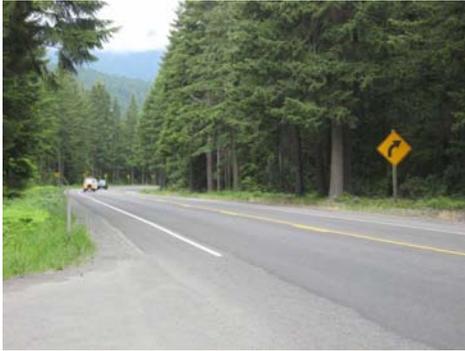
Figure 12

West of the Camp Creek Campground entrance is a curve to the right in the westbound direction (see Figure 12). There are trees in the north side of the roadway approximately 10-12 feet from the edge of travel lane that are within the typical clear zone associated with a 55-mph facility. These trees restrict the sight distance through the curve and a westbound driver's ability to see and negotiate the curve. Also, sight distance is limited for a vehicle broken down in the curve, and for seeing eastbound vehicles on Mt Hood Highway approaching the intersection (see Figure 13). This location is west of the area that crash data was provided. The "Curve Ahead" sign is 48"X48".

Consider cutting back trees to improve visibility of the curve and ability to negotiate the curve. This will also achieve decision sight distance for a broken-down vehicle in the curve and for intersection sight distance for a vehicle with a camper trailer making a left-turn from Camp Creek Campground Road. Additionally, consider increasing the size of the "Curve Ahead" to 60"x60" and use high intensity reflective sheeting to enhance retro-reflectivity. This will improve motorist awareness of the approaching curve.

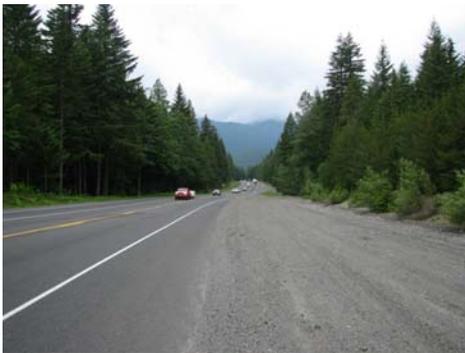
Figure 14

There are no official chain-off areas in the westbound direction but instead wide open gravel areas (see Figure 14) and the eastbound slow-moving vehicle lane is currently used as a chain-on area during winter time (see Figure 15). Traffic traveling eastbound to the Mt. Hood area receives information regarding the use of chains at the VMS at Rhododendron (MP 43.76) and then ground mounted signs along this section for the mountain area. Currently these static signs are placed by ODOT maintenance when needed.

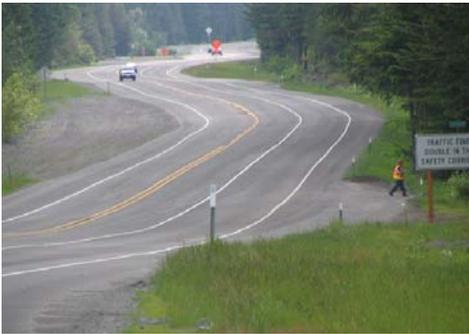
Figure 16

There are 6 consecutive reversing curves with one travel lane in each direction and an eastbound slow-moving vehicle/climbing lane starting at MP 47.9 (see Figure 16). During winter the slow-moving vehicle lane becomes the chain-on area. The existing profile has a roller coaster (up-and-down) effect (see Figure 17) and together with the winding road places oncoming traffic (especially during night time) directly in front of them from a driver's perspective. Crash data shows 15 crashes along this section with 3 crashes in 2000-2008 between eastbound and westbound traveling vehicles.

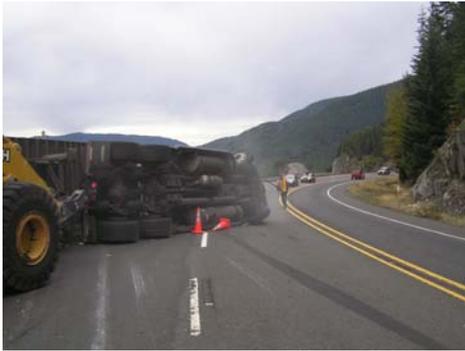
Figure 18

The crash history for this curve shows this location to be Top 15% SPIS (see Figure 18). There have been 23 crashes between 2000-2008 having no fatalities and 15 injuries. 18 of the 23 crashes were for westbound traffic; hit fixed object crashes (11) makes this the most prevalent type, with rear-end and head-on type crashes next with 4 crashes each. Crash data does show 7 crossover crashes (approximately 30%) at this location. The curve is after 1.5 miles of relatively straight road beyond the summit at Government Camp. The curve is posted for 40 mph with a "Curve Ahead" (36"x36") sign (see Figure 19).

There are multiple options for improving this location. The first is to replace the existing "Curve Ahead" sign with a 60"x60" post mounted sign with high intensity sheeting. A 60"x60" sign should be considered for future improvement as an overhead sign with flashing beacons (bouncing ball over and under). In addition to improved signage at the curve, advance signage (Sharp Curve Ahead) communicating the location of the sharp curve could be placed half-a-mile in advance of Map Curve. There is a rock-fall project scheduled for 2011 that entails cutting back the rock face. Associated with this project, other options can be considered. The rock face would be cut back approximately 30-40 feet. This could allow the westbound lane to be pulled to the inside of the curve providing a median and minimum 10 feet paved outside shoulder for incident response purposes. Within the median a barrier treatment should be considered to reduce the crossover and head-on crashes. Several median treatments (e.g., cable barrier) were discussed by the RSA Team, but for maintenance and snow removal purposes, the concrete barrier appears to be the preferred option. The concrete barrier will also eliminate the possibility of a westbound vehicle making a left turn into the Map Curve viewpoint that may be causing some of the rear-end crashes. The concrete barrier design should address decision/stopping sight distance and will likely require a wider median along certain sections (especially the eastbound traffic on the outside of the curve). The barrier should be carried through the curve and safely terminated in a tangent section. Further, the barrier could have retro-reflective treatments installed on the top of the barrier to further delineate the curve in darkness.

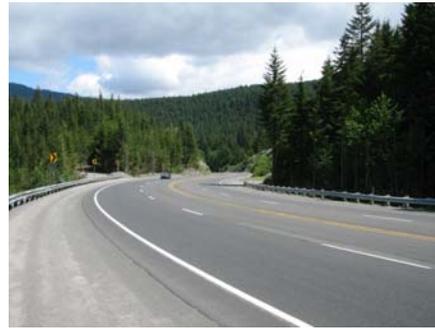
Figure 25

extending down the mountain through S-curves (see Figure 25) for approximately 3,000 feet, terminating (see Figure 26) just beyond the second curve. The signs for the termination of the passing lane have both signs mixed with the chevron signage identifying the second curve and are difficult to see (see Figure 27). The RSA Team also observed westbound vehicles passing in the no passing areas approaching this curve, because west of the aforementioned passing lane the next opportunity to pass is approximately 5-6 miles. The crash data shows there have been 10 crashes in this section with two fatalities and 5 crashes between eastbound and westbound vehicles.

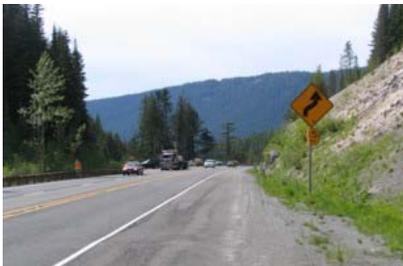
Figure 28

This curve has a higher number of crashes (compared to Map Curve) and has a curve warning sign posted for 35 mph (see Figure 28). This sign actually describes an S-curve with a 35 mph supplemental sign. The crash data shows a total of 33 crashes between 2000 and 2008 resulting in 1 fatality and 12 injuries. The crash types had a uniform mix of head-on, side-swipe, fixed object and rear end. The reports show that there were 7-9 crossover crashes with the 1 fatality in the reporting period. Most crashes occurred during inclement conditions with 27 during snow/ice road conditions and an additional 5 in wet pavement conditions. There was a uniform distribution of eastbound and westbound crashes. The field observation shows that this is the first significant curve west of Ski Bowl (MP 52.6) and is on a significant downhill grade. Driving the curve westbound, the downhill grade contributes to difficulty in speed reduction through the curve. The current "Curve Ahead" sign is post mounted and appears to be 36"x36". The RSA Team also observed westbound traffic making left turns into the Mirror Lake Trailhead parking area. This can contribute to the reported rear-end crashes. Another issue observed by the RSA Team is that the passing lane is introduced in this curve (see Figure 29). It is not very visible to westbound traffic and is not signed.

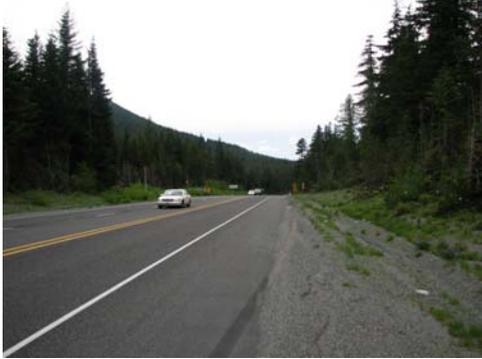
Figure 32

into Ski Bowl at this location (see Figure 32). The intersection sight distance, especially to the east, is limited due to the vertical crest curve to the east of this intersection (see Figure 33). There have been 9 crashes from 2000-2008 including 1 fatality. These crashes represent 3 fixed object, 3 rear-end, 1 turning, 1 side-swipe, and 1 head-on type crashes.

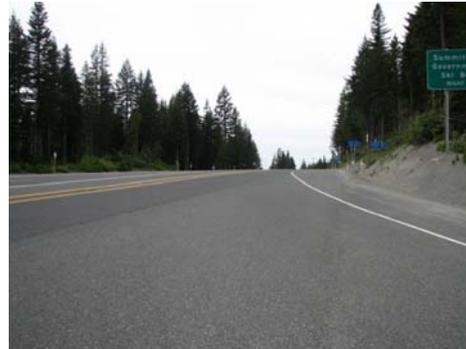
Figure 49

left-turn. There is a lot of open pavement that leads to driver confusion, especially when the pavement markings have faded and during snowy conditions. ODOT maintenance staff indicated that the several southbound right-turners from Timberline Highway use the flared right-turn and the wide shoulder as an unofficial add lane onto the highway (see Figure 49).
