Year One Results:  
Evaluation Study of the  
Mt. Hood Highway MP 30.56 to 32.32  
Cable Barrier System

Katherine Carlos, Region 1 Traffic  
*Date: October 1, 2009*

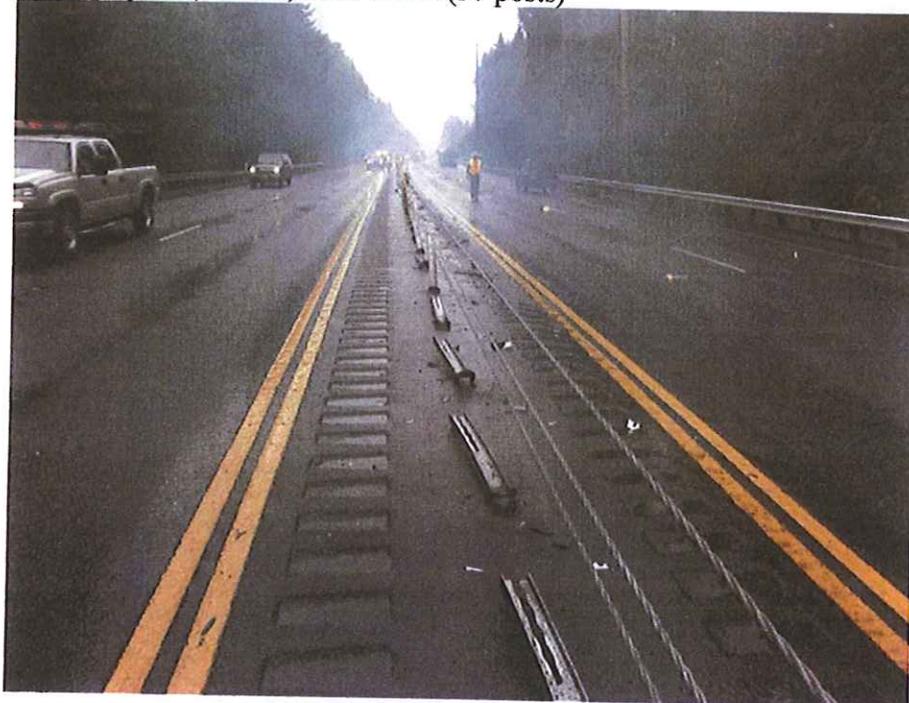
Photograph #2, June 7, 2008 Crash (37 posts)

32.00		PDO	Passenger car traveling too fast for conditions going westbound. Rainy and wet conditions. Driver hit high water and failed to maintain lane and hit the CMB. Also ran off road. SPEED and DRY			X	
31	6/2/2008	PDO	Unknown vehicle traveling eastbound, hit 2 posts.	X			
32	6/7/2008	PDO	Pick-up traveling westbound, hit 37 posts. Rain. Damage on left side of vehicle and stopped alongside CMB. RAIN	1/3	X		many

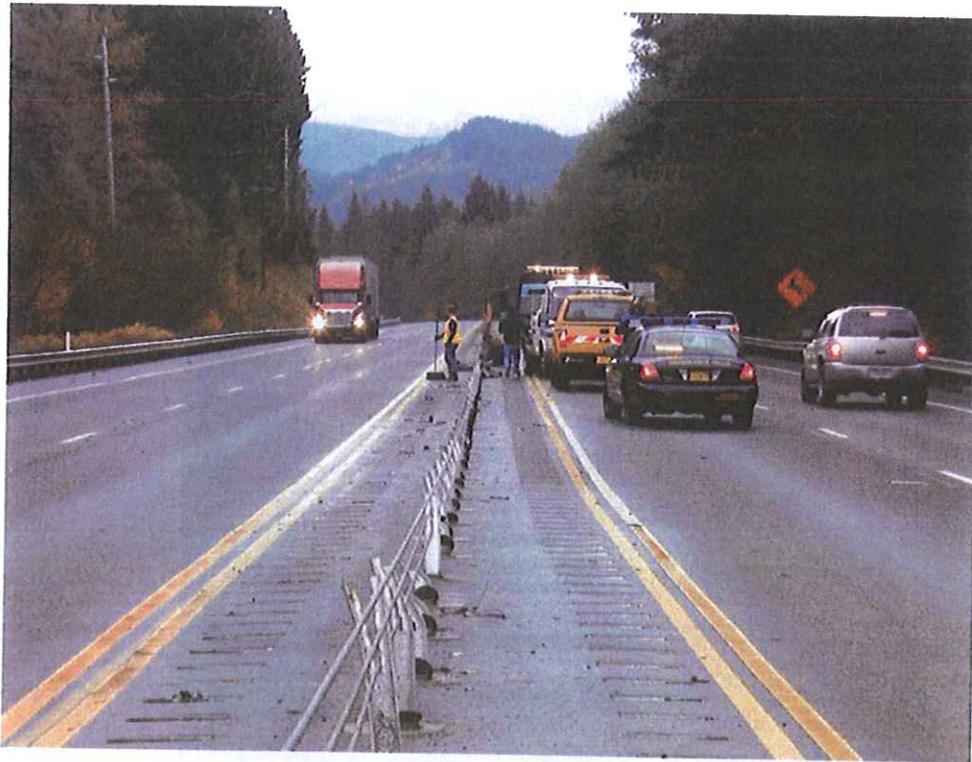
Photograph #3, March 29, 2009 Crash (34 posts)

31.5	6/22/2008	PDO	Pick-up pulling fifth wheeler traveling westbound, hit 23 posts. Cited for failing to maintain lane.	1/3	X		3
30.5	11/1/2008	PDO	Pick-up traveling eastbound, hit 53 posts. Hit front of pick-up on CMB and cited for careless driving. RAIN	1/3	X		
32	3/29/2009	PDO	SUV traveling westbound, hit left side of car on CMB. Hit 34 posts.	1/3	X
