2023 ODAV Pavement Evaluation Program Cape Blanco State Airport

Sixes, Oregon

December 29, 2023

State of Oregon Department of Aviation
3040 25th Street SE
Salem, OR 97303-1125

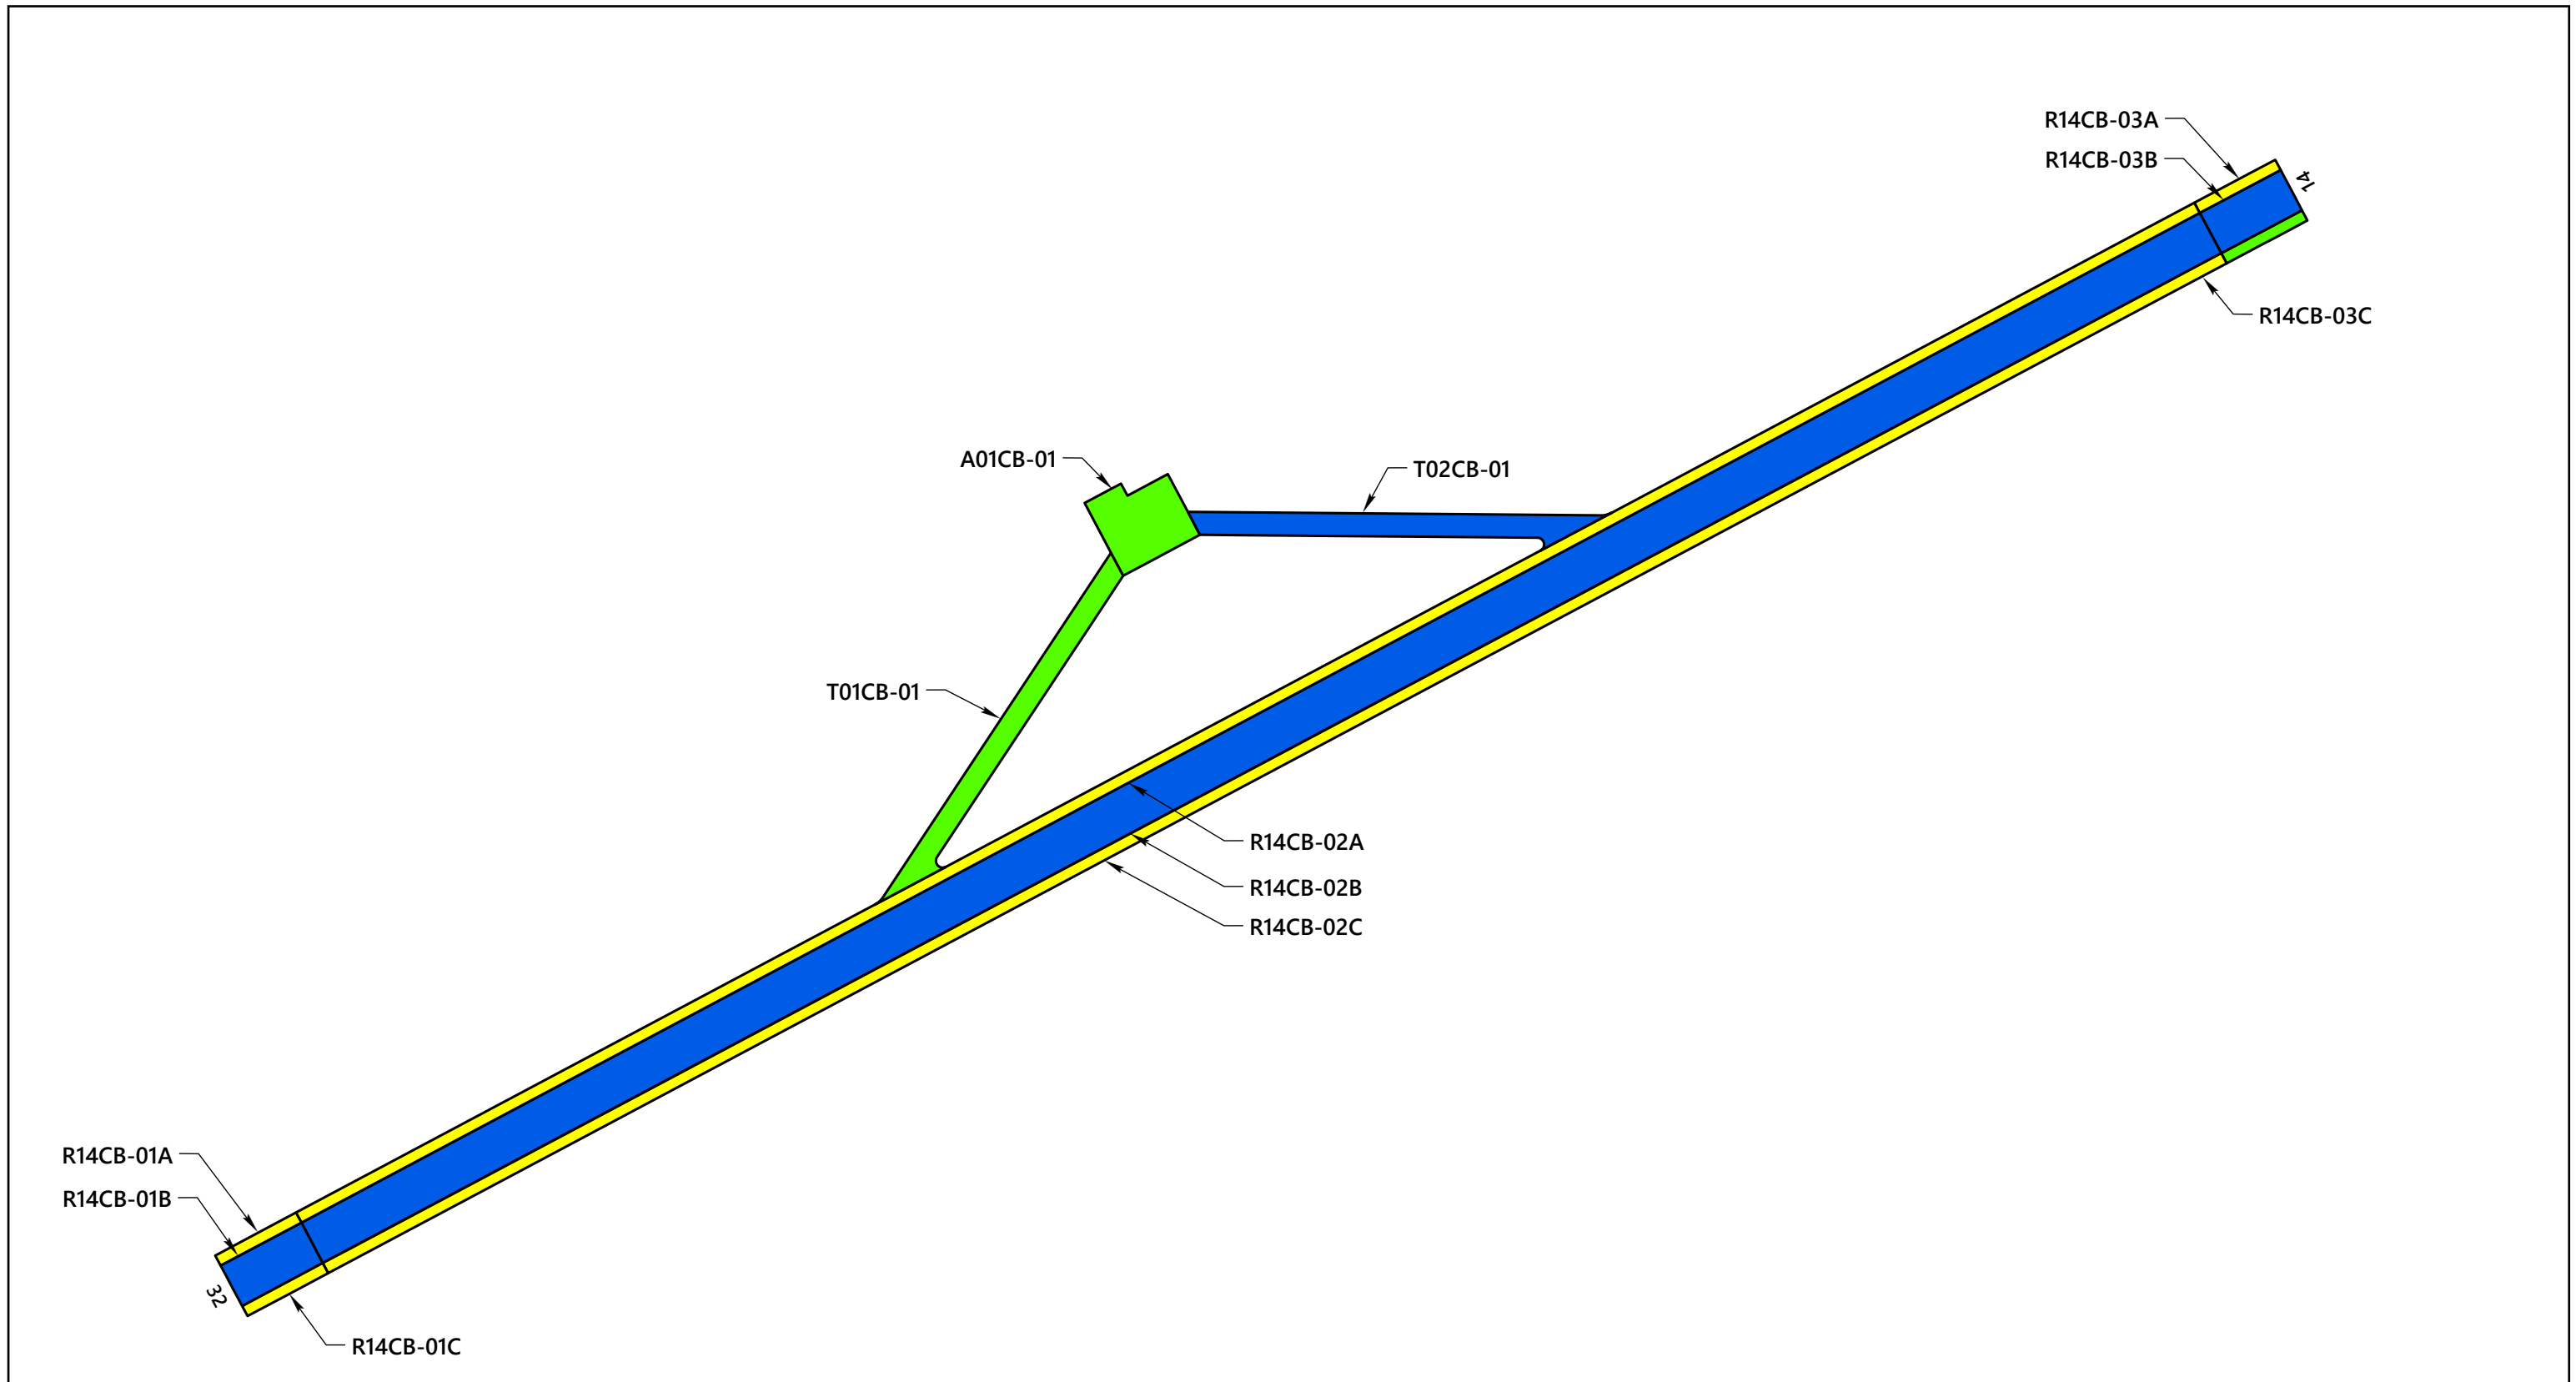
SECTION PCI

The area-weighted average PCI for all airport pavements at Cape Blanco State Airport is approximately 52. The section PCIs ranged from a low of 32 to a high of 59. The primary distresses observed during the inspection were weathering, block cracking, depression, and patching on AC-surfaced pavements. Section PCIs following our pavement survey are displayed below spatially on the Cape Blanco State Airport 2023 PCI Survey Results, Figure 3.1.

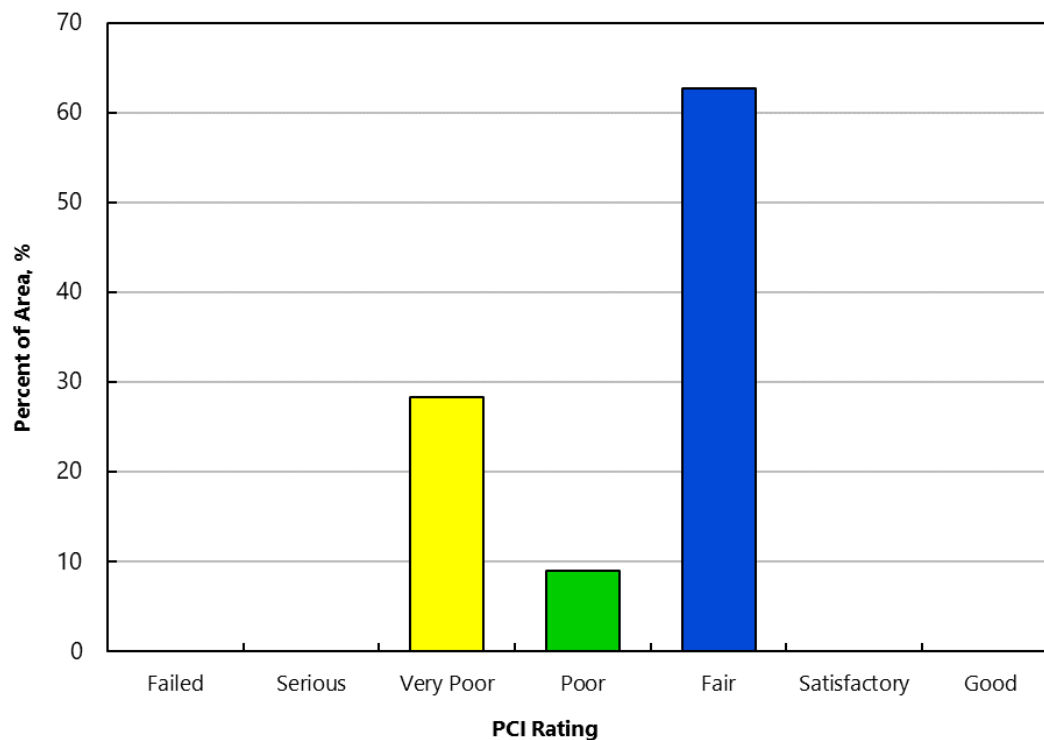
Figure 3.2: CAPE BLANCO STATE AIRPORT PAVEMENT CONDITION RATING BY PERCENT OF AREA

The condition distribution of the network by percent of total pavement area is provided on the Cape Blanco State Airport Pavement Condition Rating by Percent of Area, Figure 3.2. A summary of the pavement condition results by branch and section is included in Tables 2B and 3B of Appendix B, respectively. A comparison between the previous inspection and the 2023 inspection is provided in Table 4B in Appendix B. The re-inspection report that includes inspection details for individual sample units is provided in Table 1E in Appendix E.

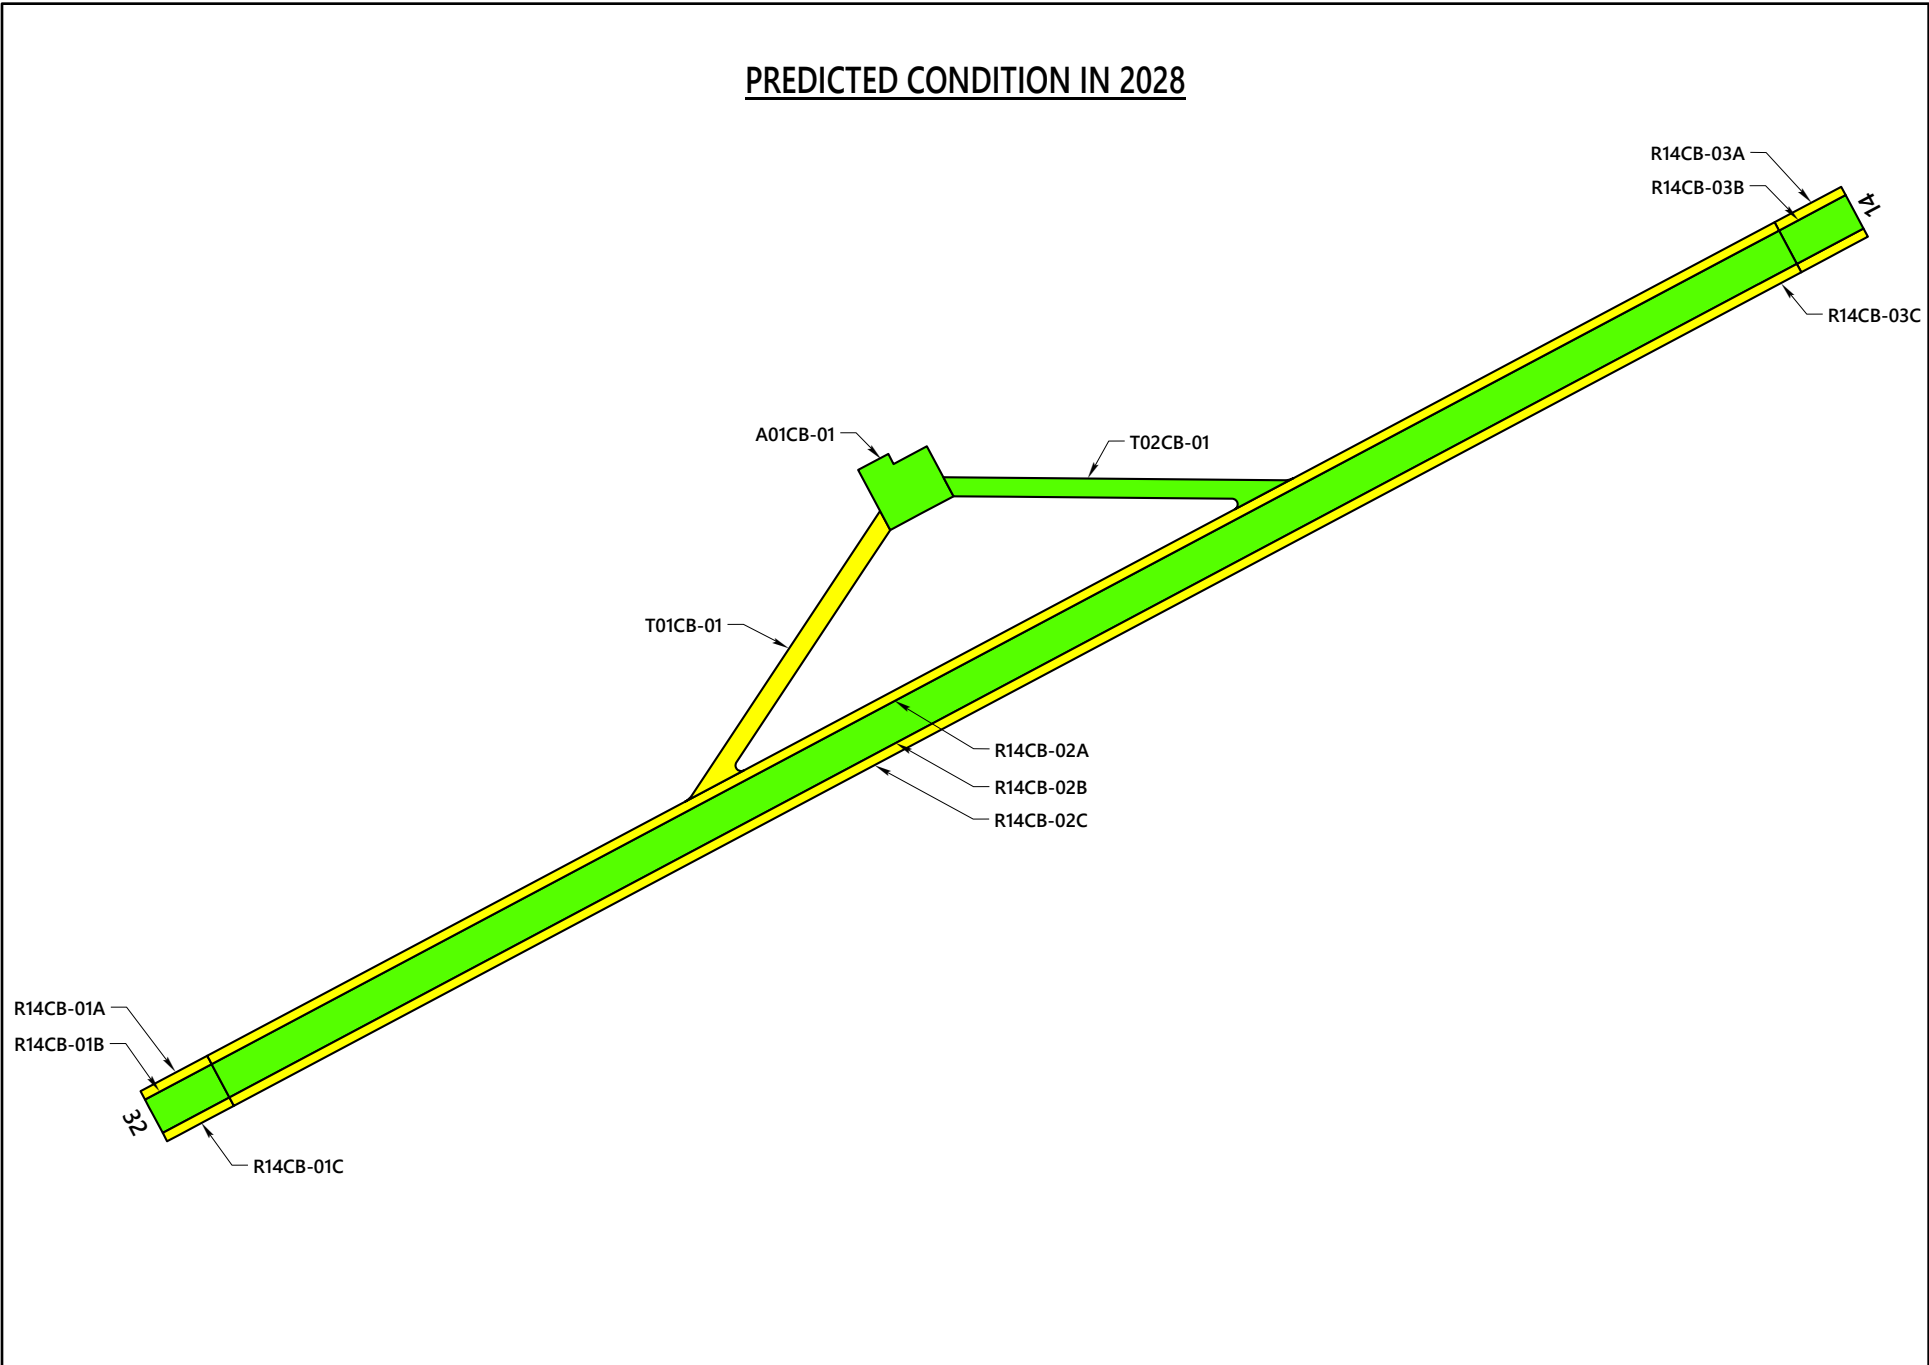
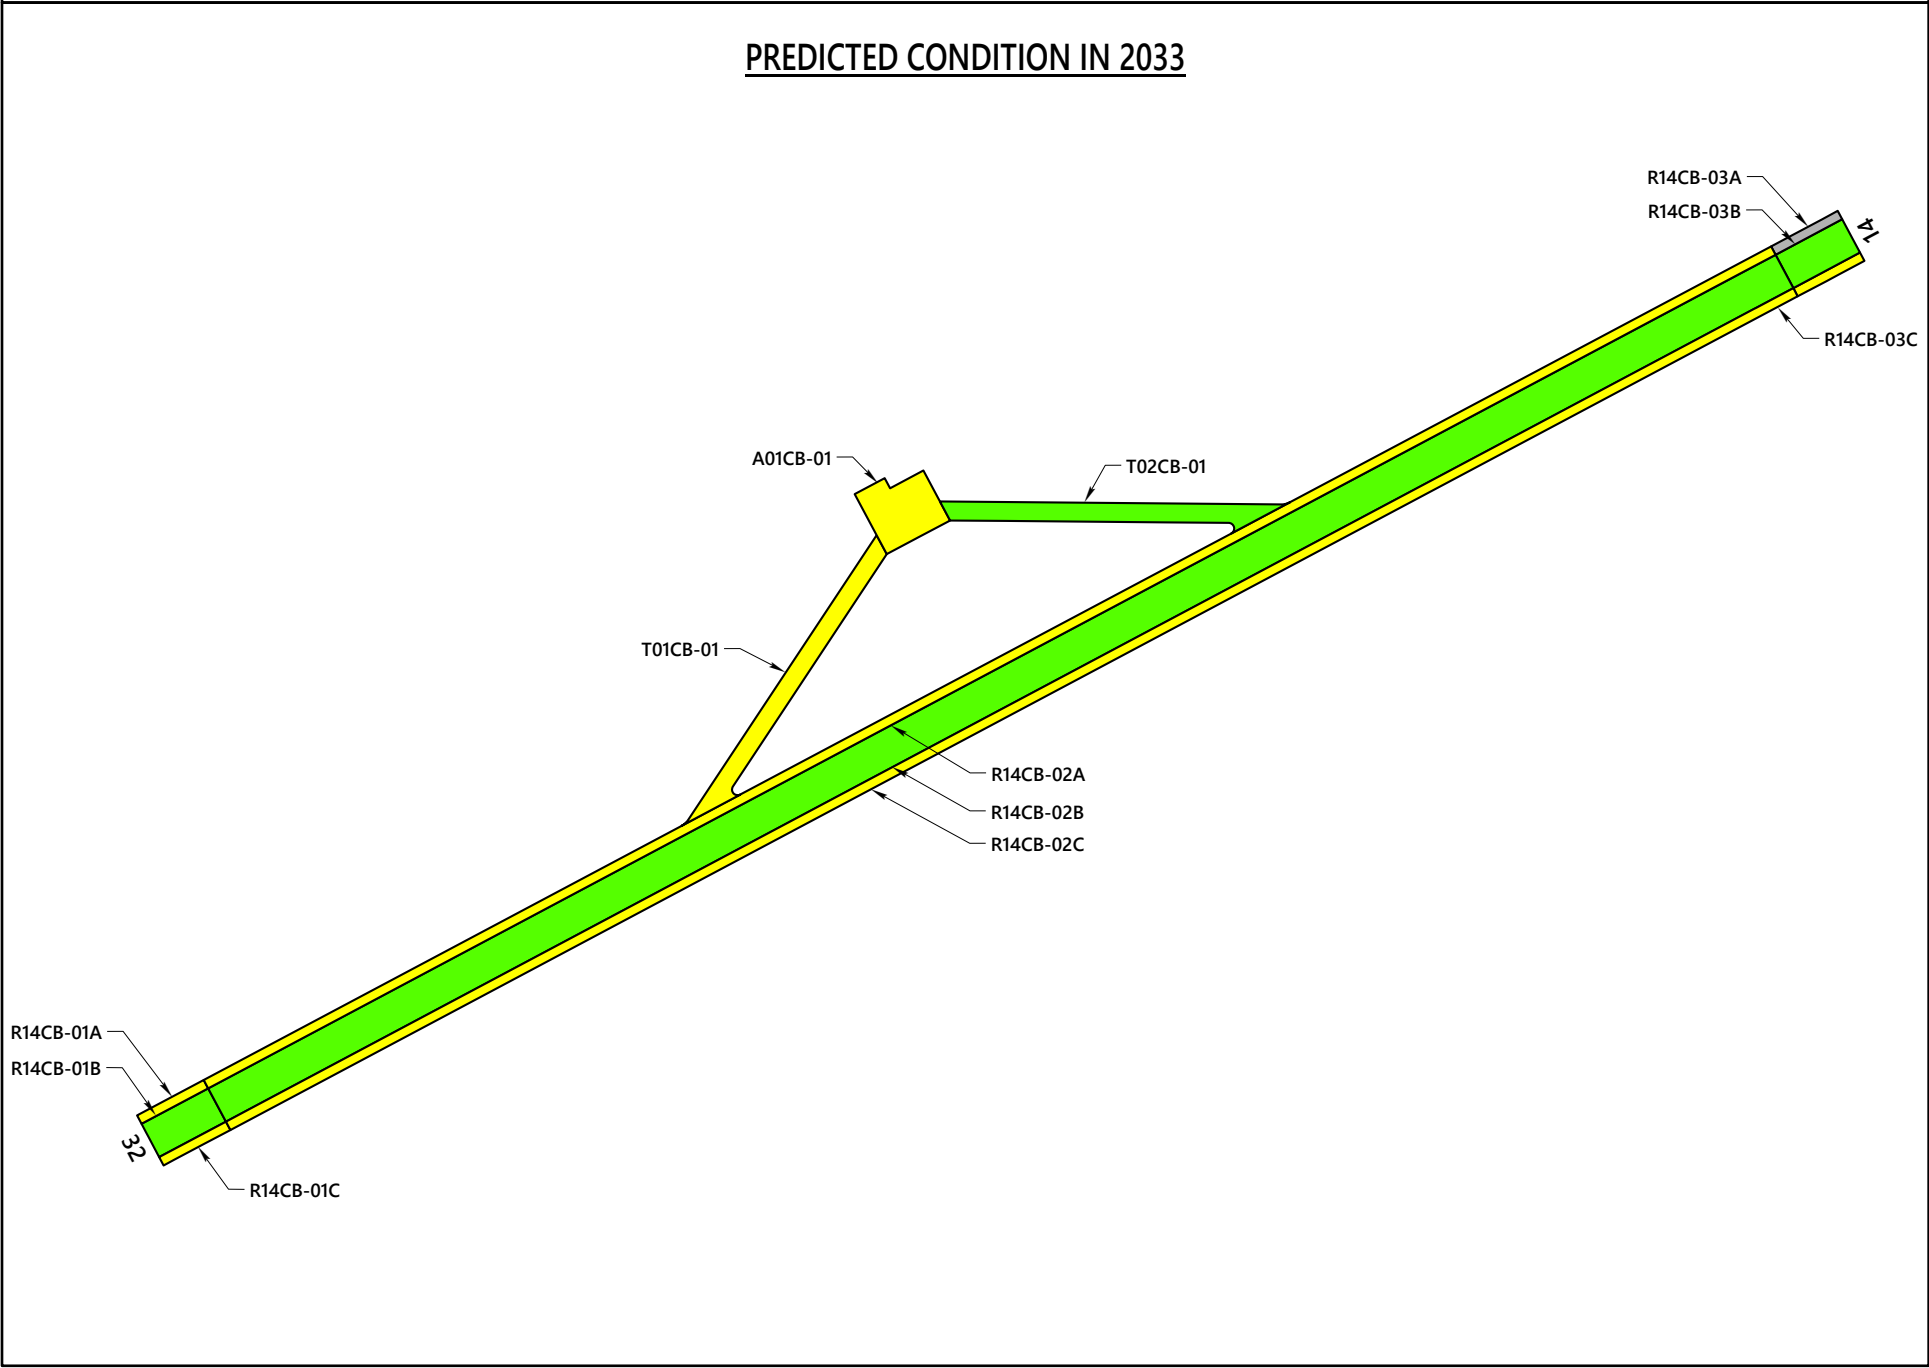
SECTION PCI

Using the condition prediction models discussed above, the projected condition of each pavement section was determined for 5- and 10-year periods. Based on this analysis, we project the PCI to decrease from a current value of 52 to a value of 47 in 2028 and 41 in 2033 if no maintenance or rehabilitation work is performed. The projected pavement condition in 5 years and 10 years for each pavement section at Cape Blanco State Airport is displayed spatially on the Cape Blanco State Airport Future Pavement Condition, Figure 4.1, and listed in Table 1C in Appendix C, along with the past and present PCI values for the pavement network.

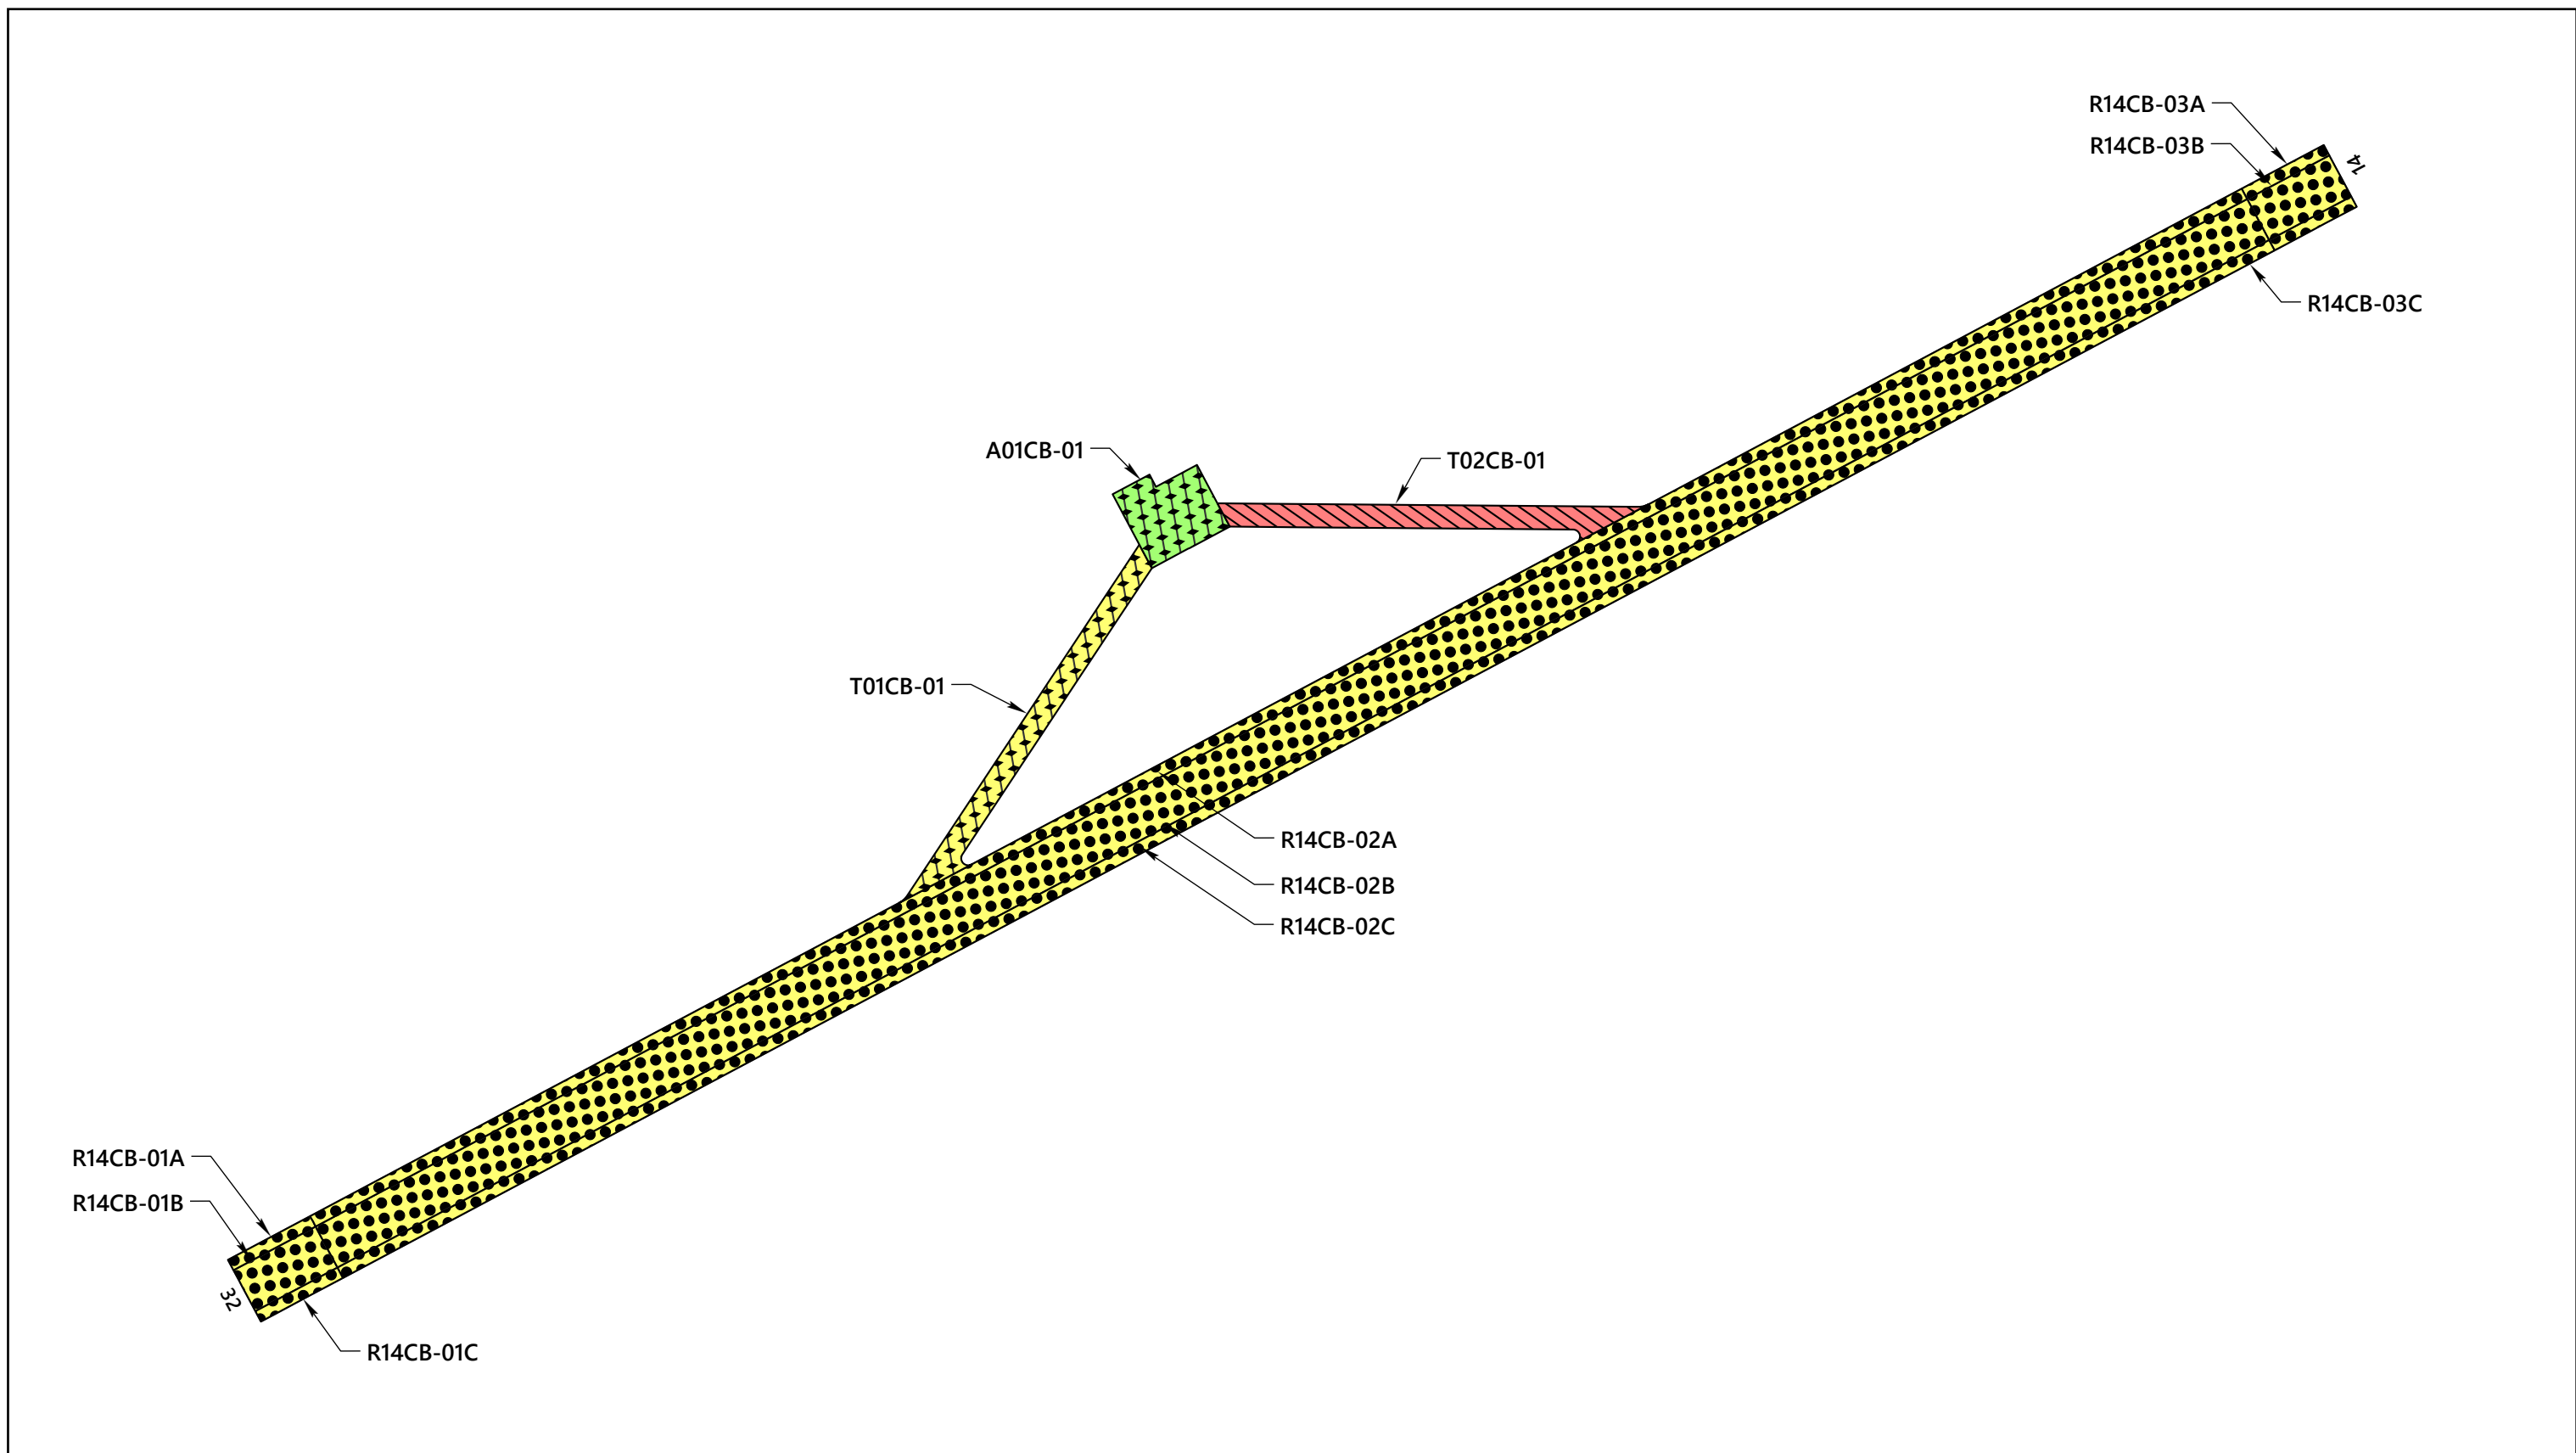
ACTION TIMING		ACTION	
	2024		FOG SEAL
	2025		SLURRY SEAL
	2026	<div style="position: absolute; top: 50%; left: 50%; transform: translate(-50%, -50%); width: 100%; height: 100%; border-top: 1px dashed black; border-bottom: 1px dashed black;"></div>	OVERLAY
	2027		RECONSTRUCTION
	2028		ROUTINE MAINTENANCE
