# **2023 ODAV Pavement Evaluation Program Bandon State Airport**

**Bandon, Oregon**

**December 29, 2023**

**State of Oregon Department of Aviation  
3040 25th Street SE  
Salem, OR 97303-1125**

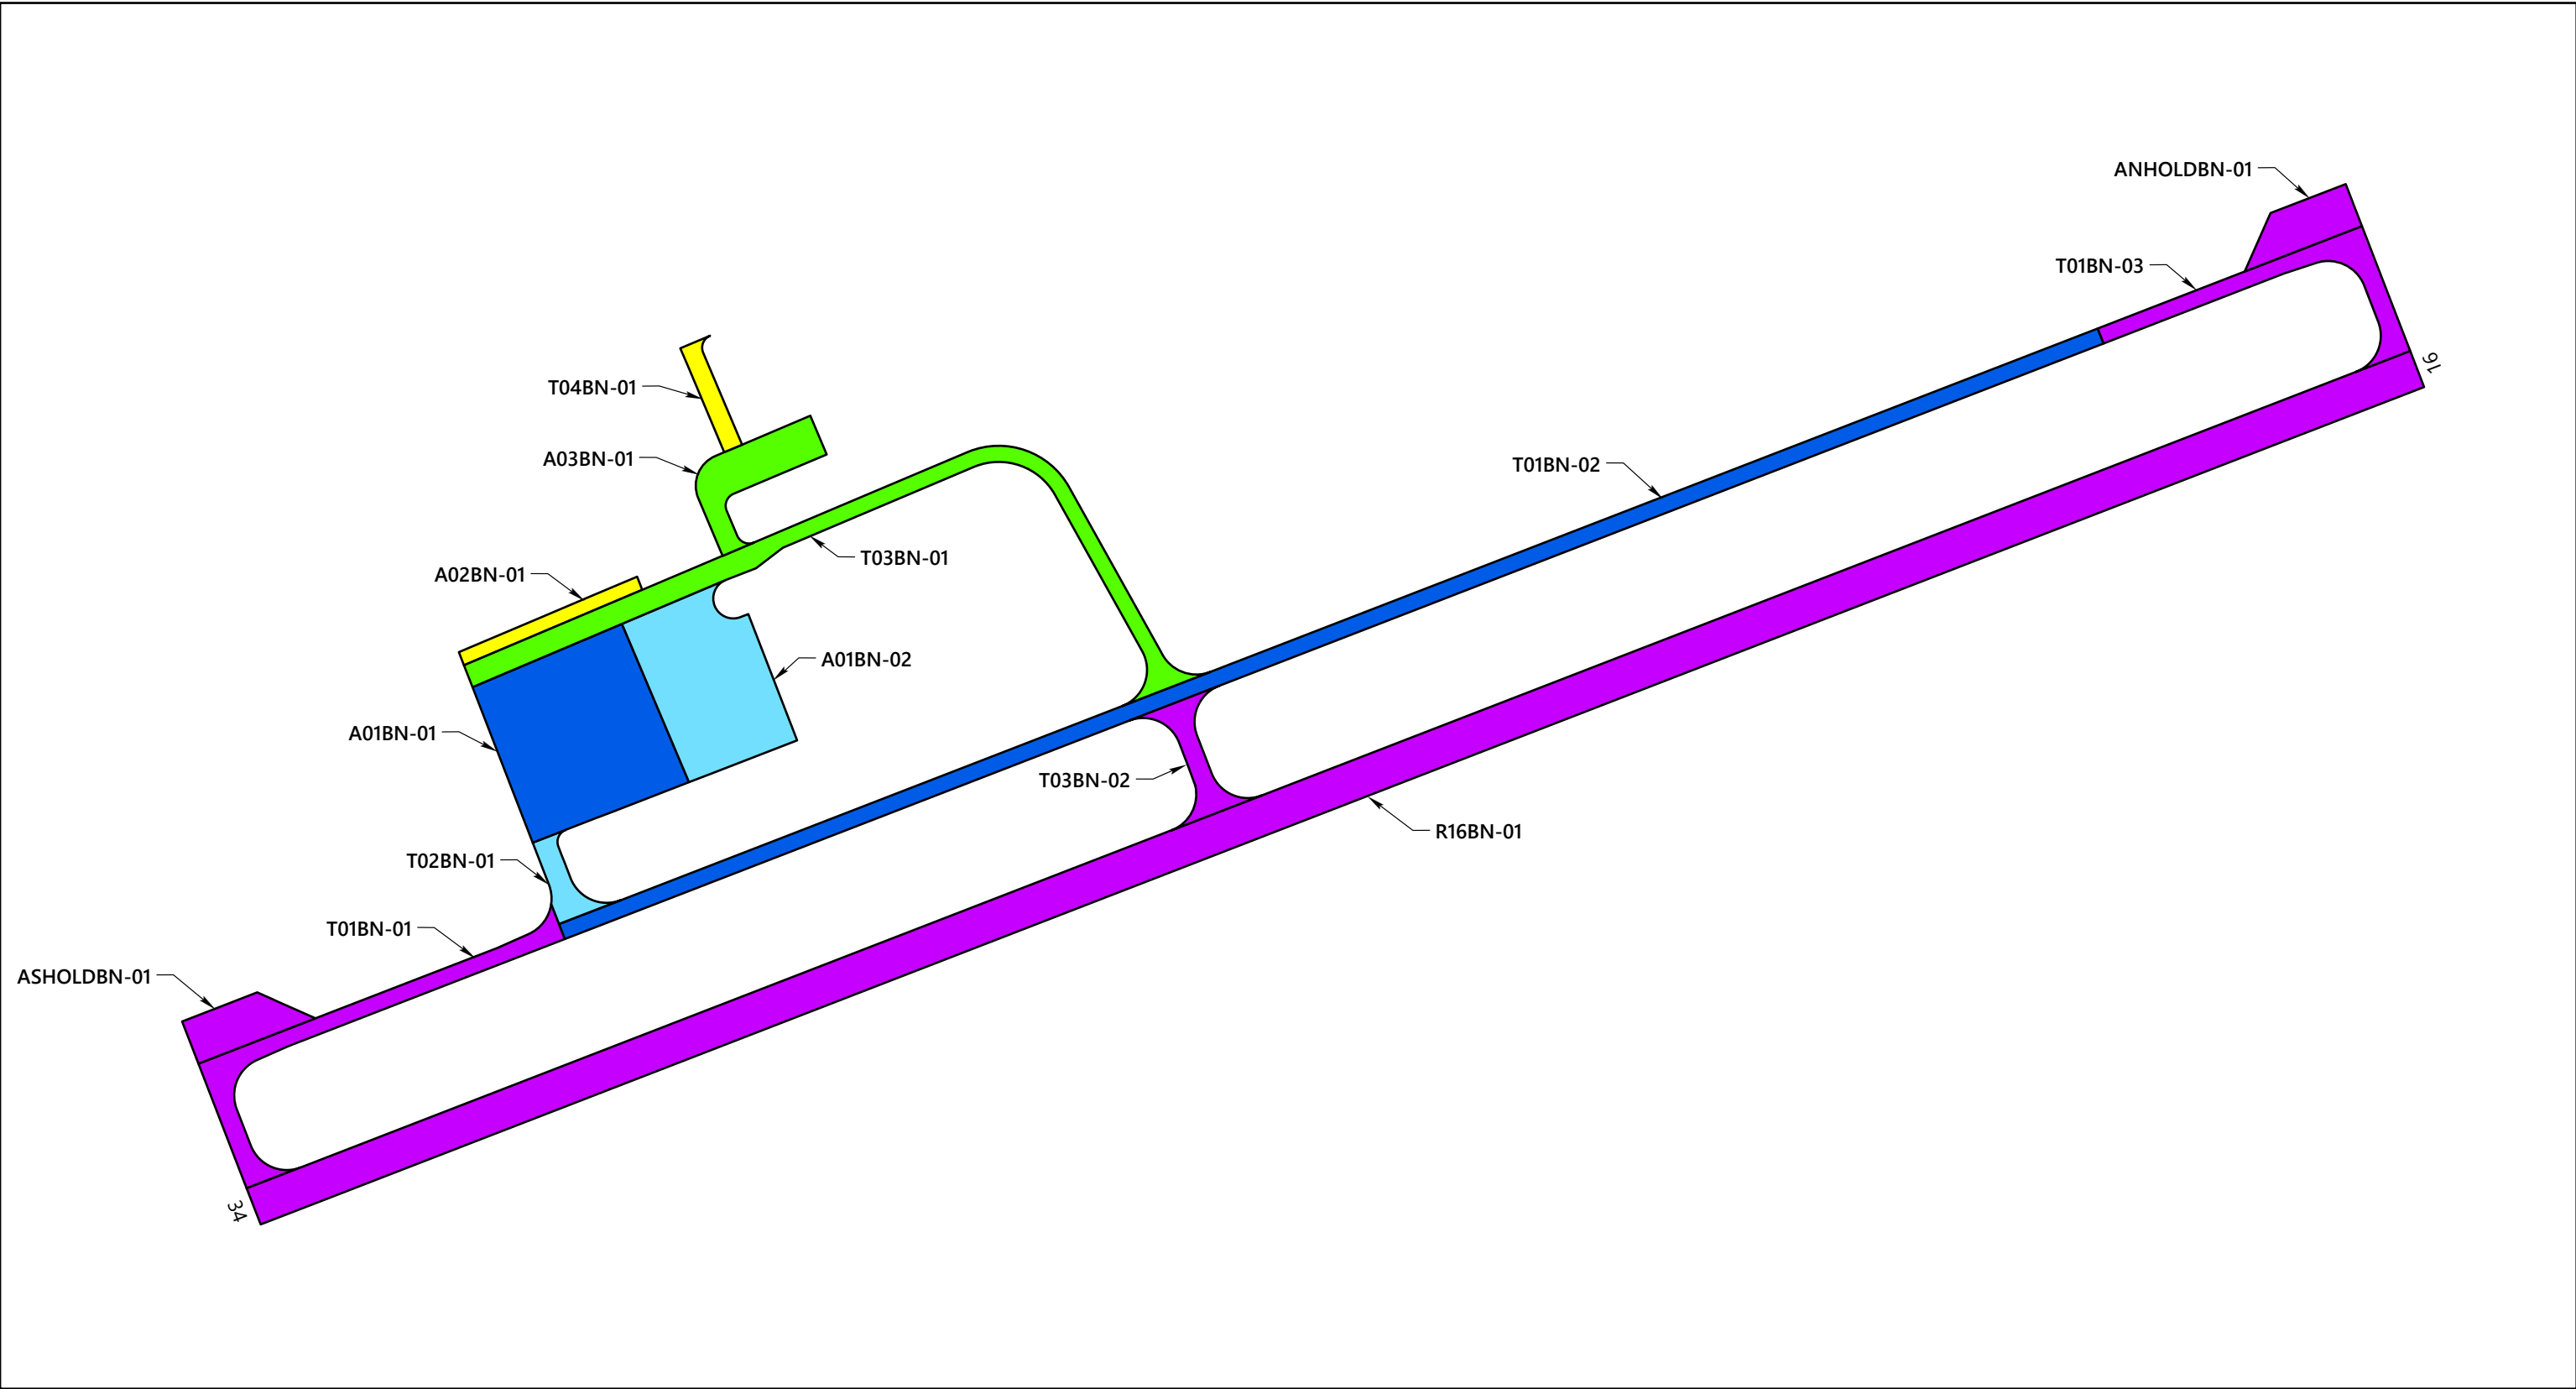
BANDON STATE AIRPORT  
2023 PCI SURVEY RESULTS

The area-weighted average PCI for all airport pavements at Bandon State Airport is approximately 80. The section PCIs ranged from a low of 33 to a high of 98. The primary distresses observed during the inspection were weathering, longitudinal and transverse cracking, fatigue (alligator) cracking, depression, and patching on AC-surfaced pavements. Section PCIs following our pavement survey are displayed below spatially on the Bandon State Airport 2023 PCI Survey Results, Figure 3.1.

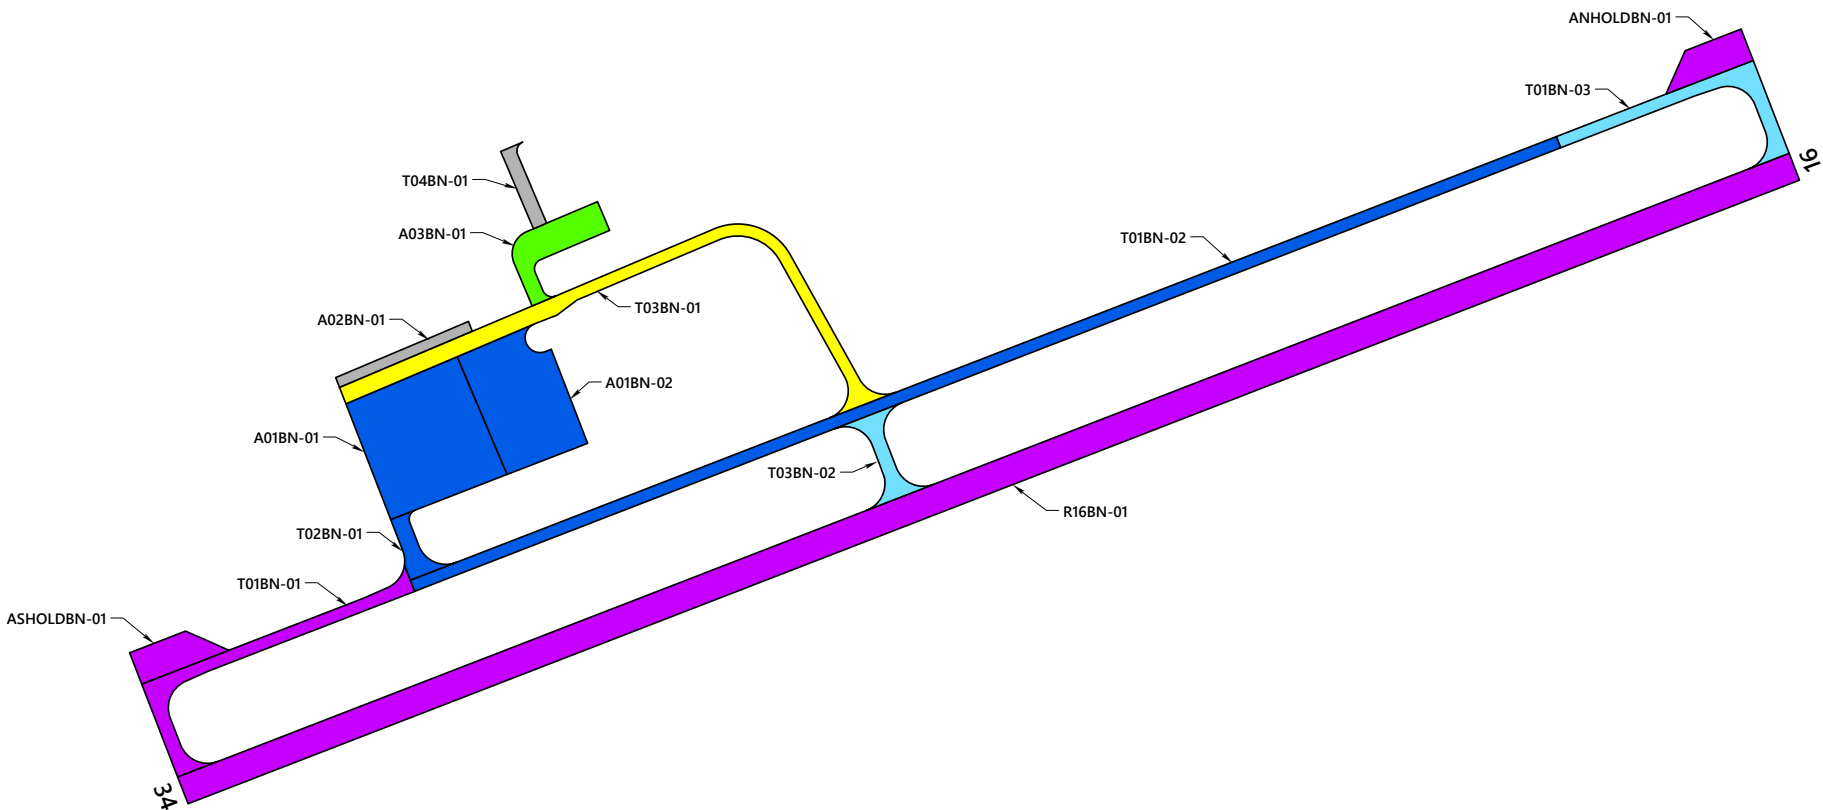
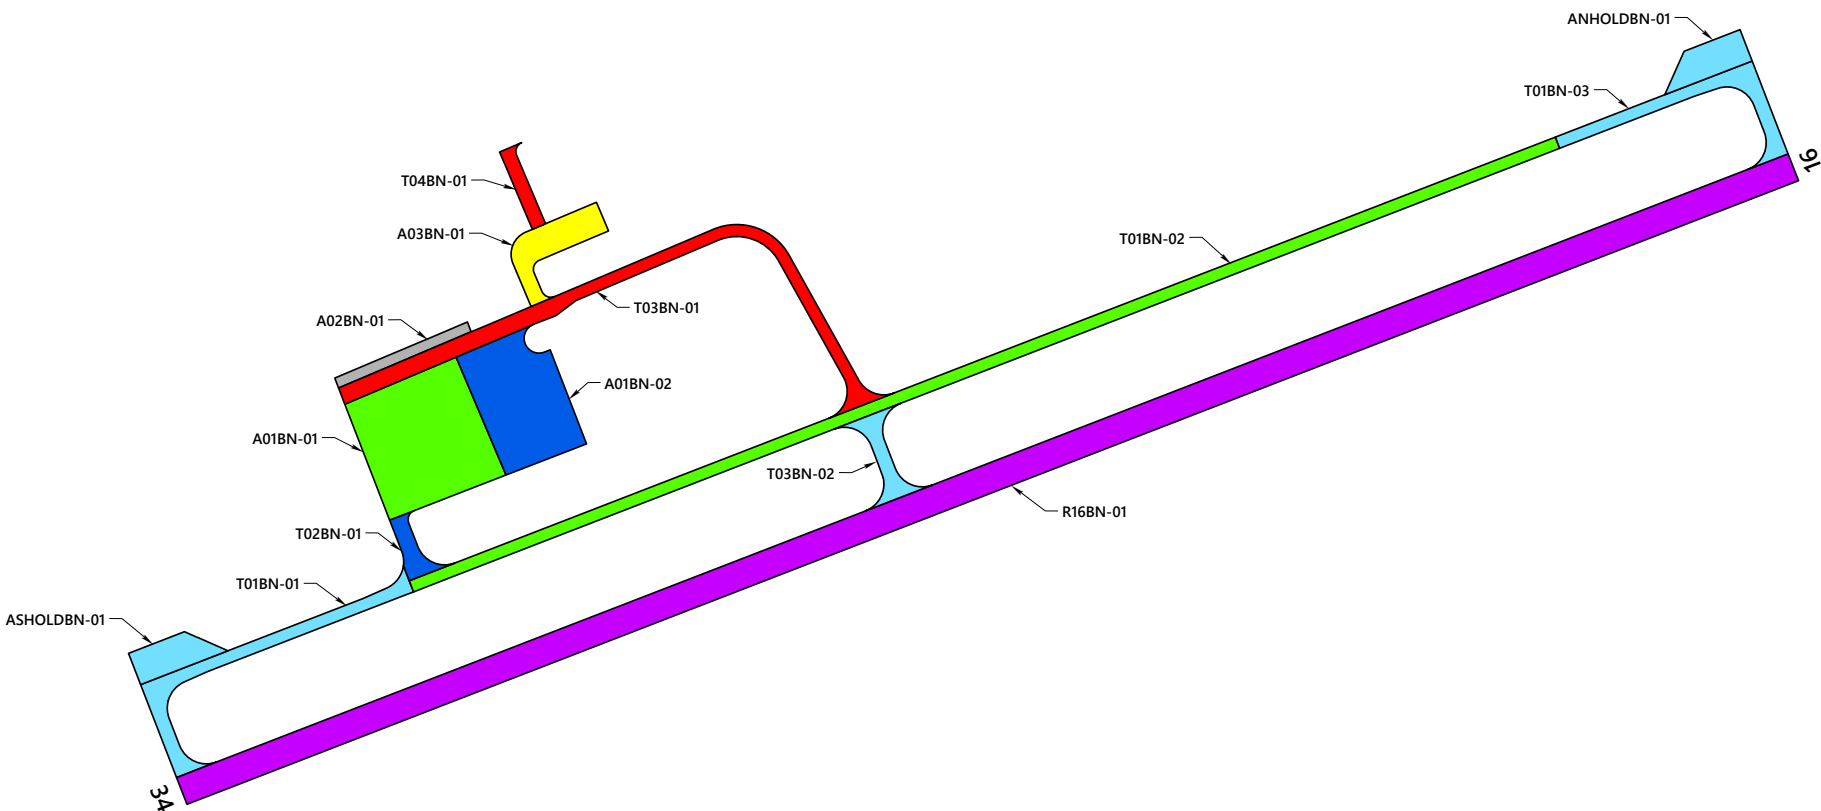
PREDICTED CONDITION IN 2028

Using the condition prediction models discussed above, the projected condition of each pavement section was determined for 5- and 10-year periods. Based on this analysis, we project the PCI to decrease from a current value of 80 to a value of 73 in 2028 and 66 in 2033 if no maintenance or rehabilitation work is performed. The projected pavement condition in 5 years and 10 years for each pavement section at Bandon State Airport is displayed spatially on the Bandon State Airport Future Pavement Condition, Figure 4.1, and listed in Table 1C in Appendix C, along with the past and present PCI values for the pavement network.
