# **2023 ODAV Pavement Evaluation Program Florence Municipal Airport**

Florence, Oregon

**December 29, 2023**

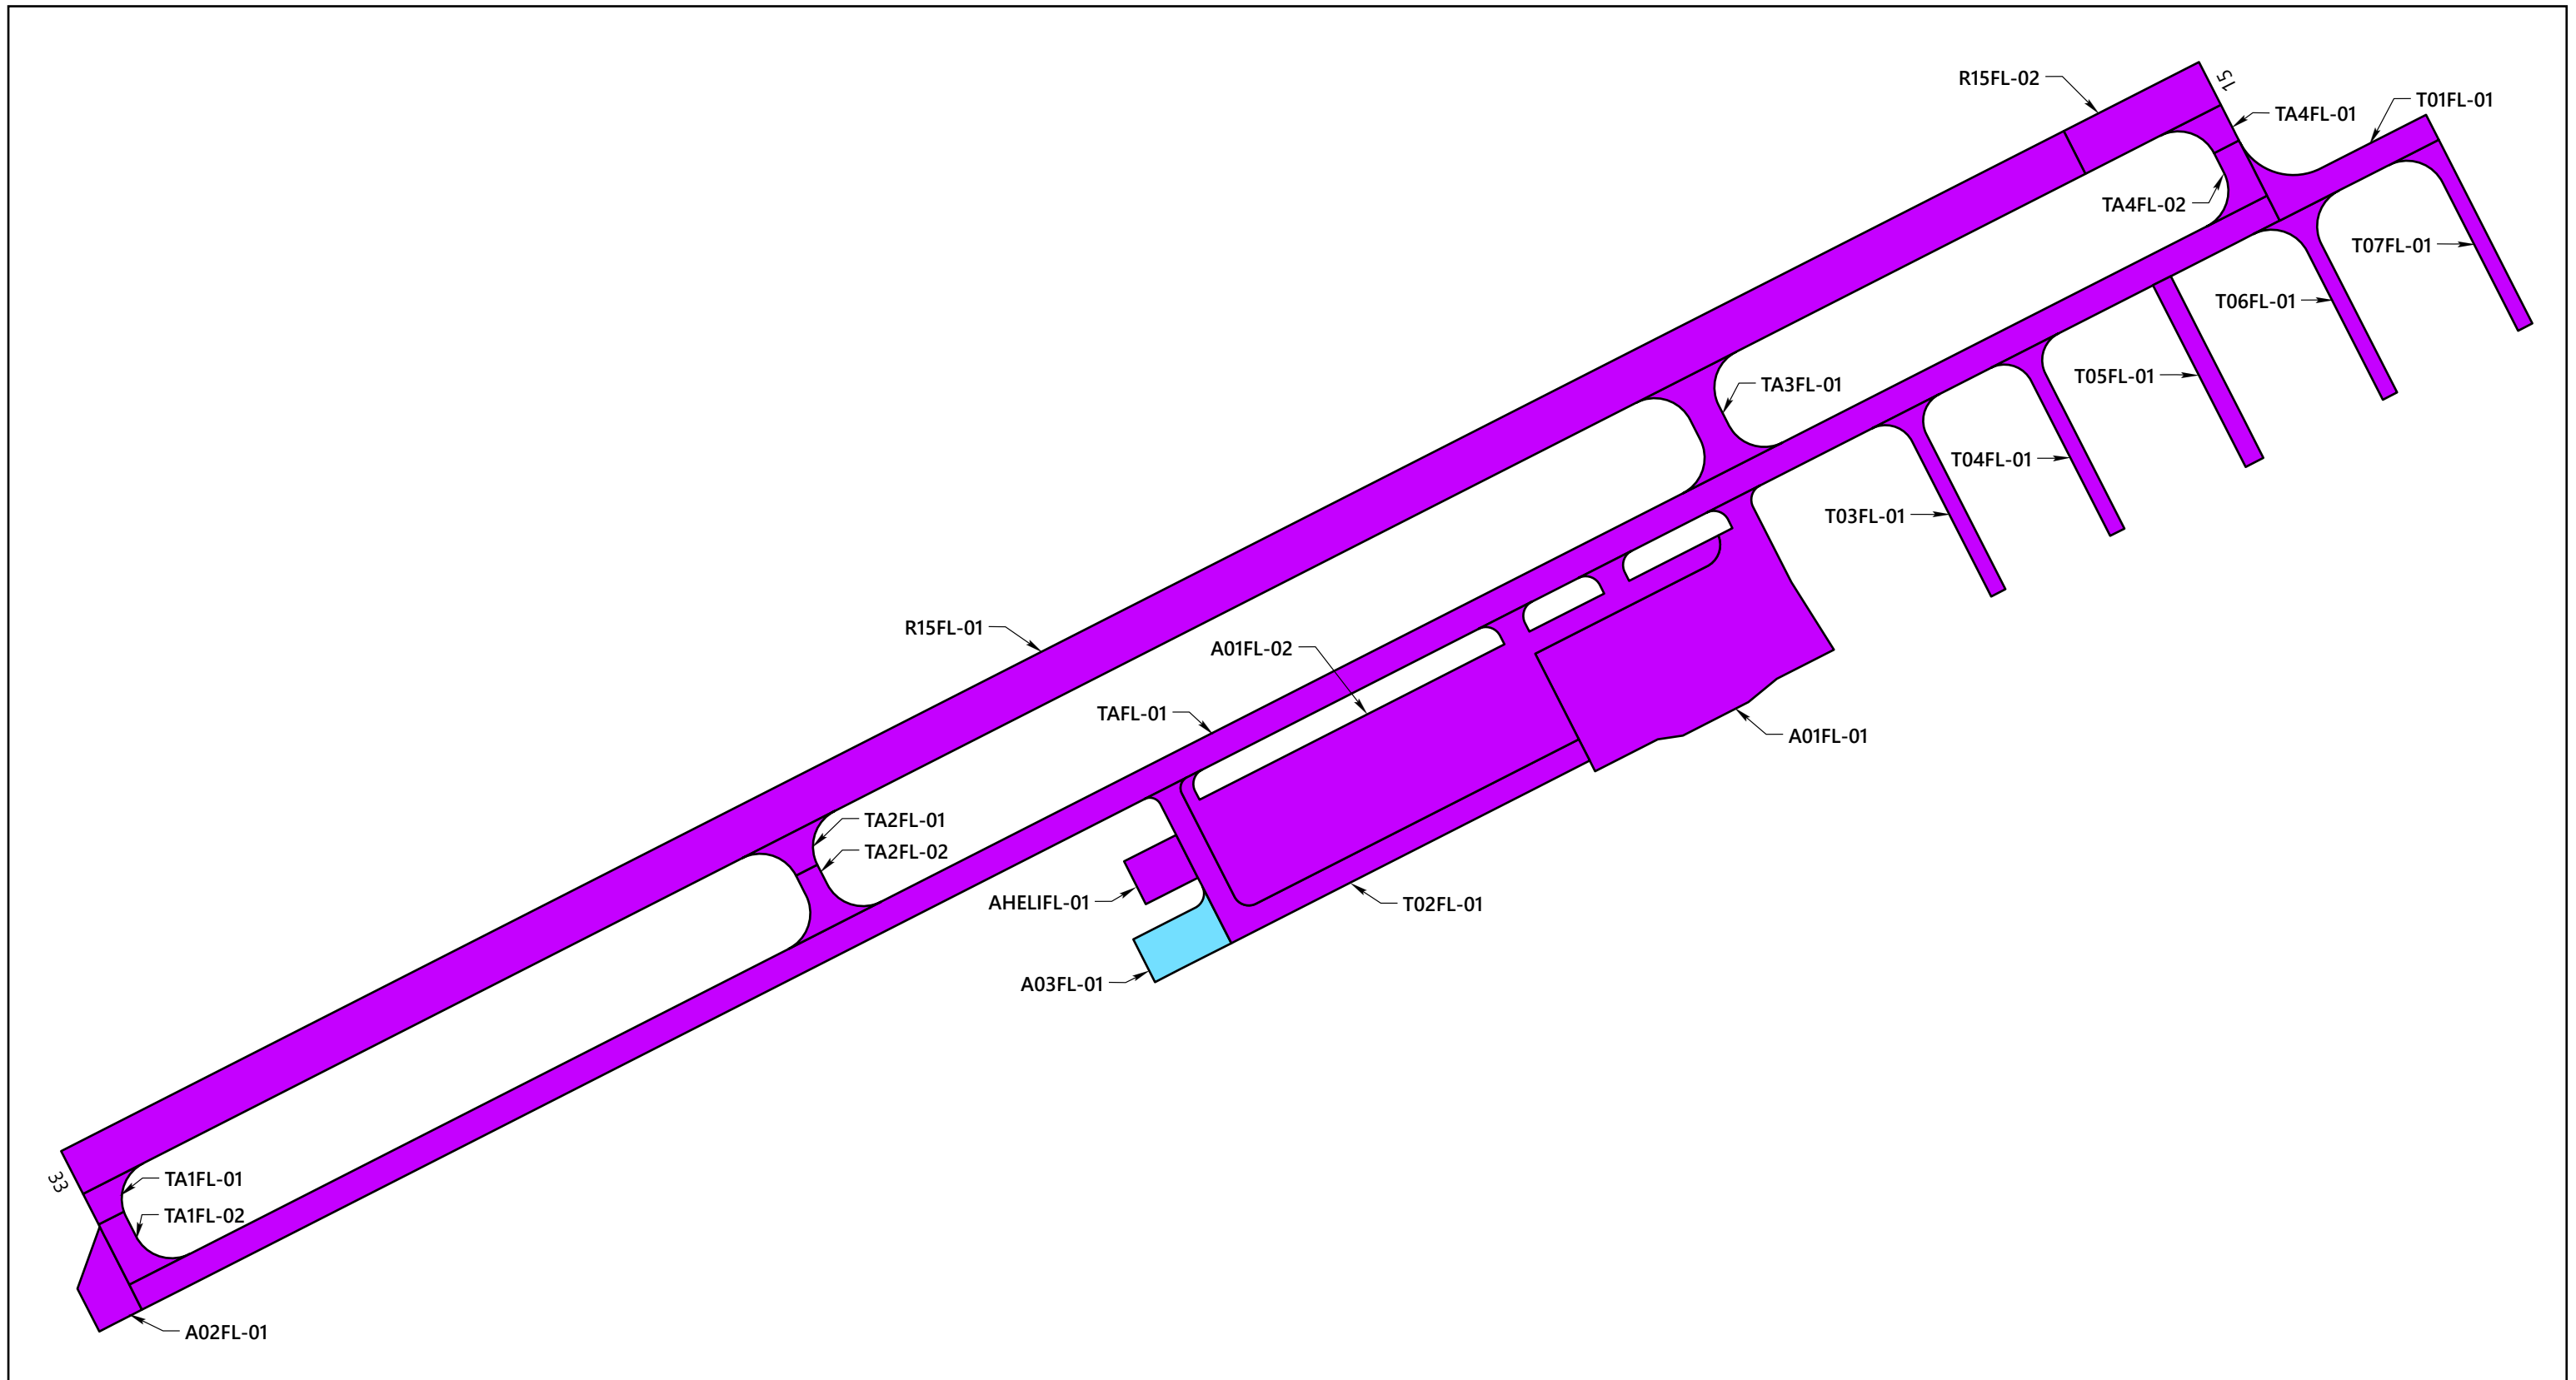
The area-weighted average PCI for all airport pavements at Florence Municipal Airport is approximately 99. The section PCIs ranged from a low of 74 to a high of 100. The primary distresses observed during the inspection were weathering and longitudinal and transverse cracking on AC-surfaced pavements. Section PCIs following our pavement survey are displayed below spatially on the 2023 PCI Survey Results Florence Municipal Airport, Figure 3.1.

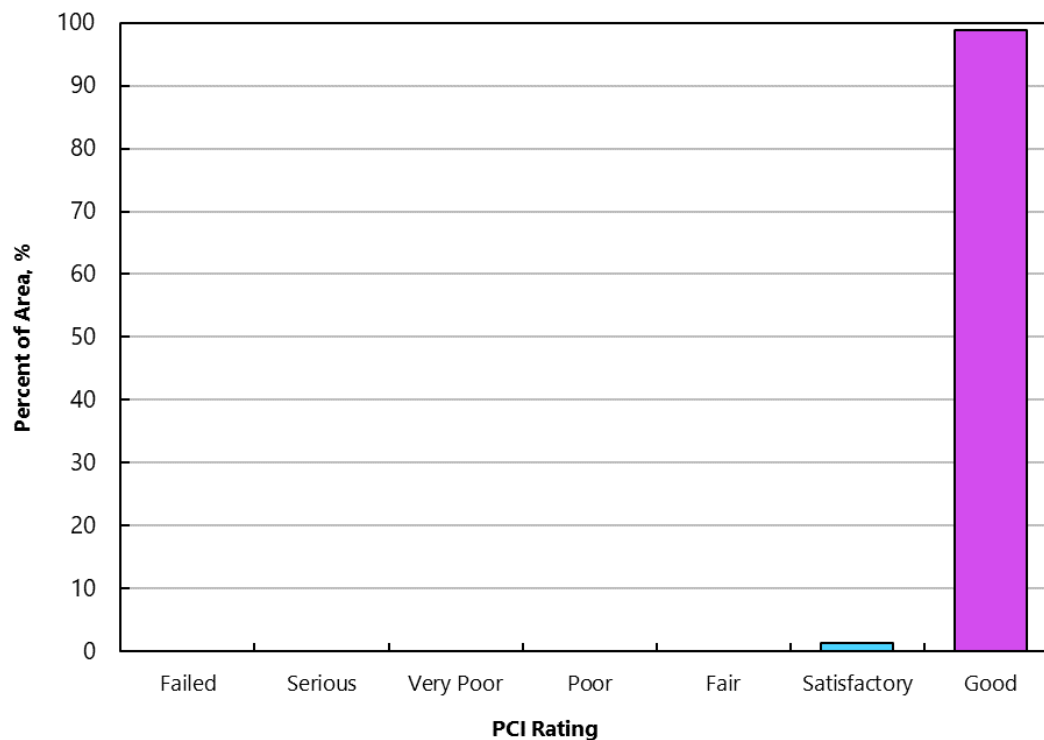
**Figure 3.2: FLORENCE MUNICIPAL AIRPORT PAVEMENT CONDITION RATING BY PERCENT OF AREA**

The condition distribution of the network by percent of total pavement area is provided on the Florence Municipal Airport Pavement Condition Rating by Percent of Area, Figure 3.2. A summary of the pavement condition results by branch and section is included in Tables 2B and 3B of Appendix B, respectively. A comparison between the previous inspection and the 2023 inspection is provided in Table 4B in Appendix B. The re-inspection report that includes inspection details for individual sample units is provided in Table 1E in Appendix E.

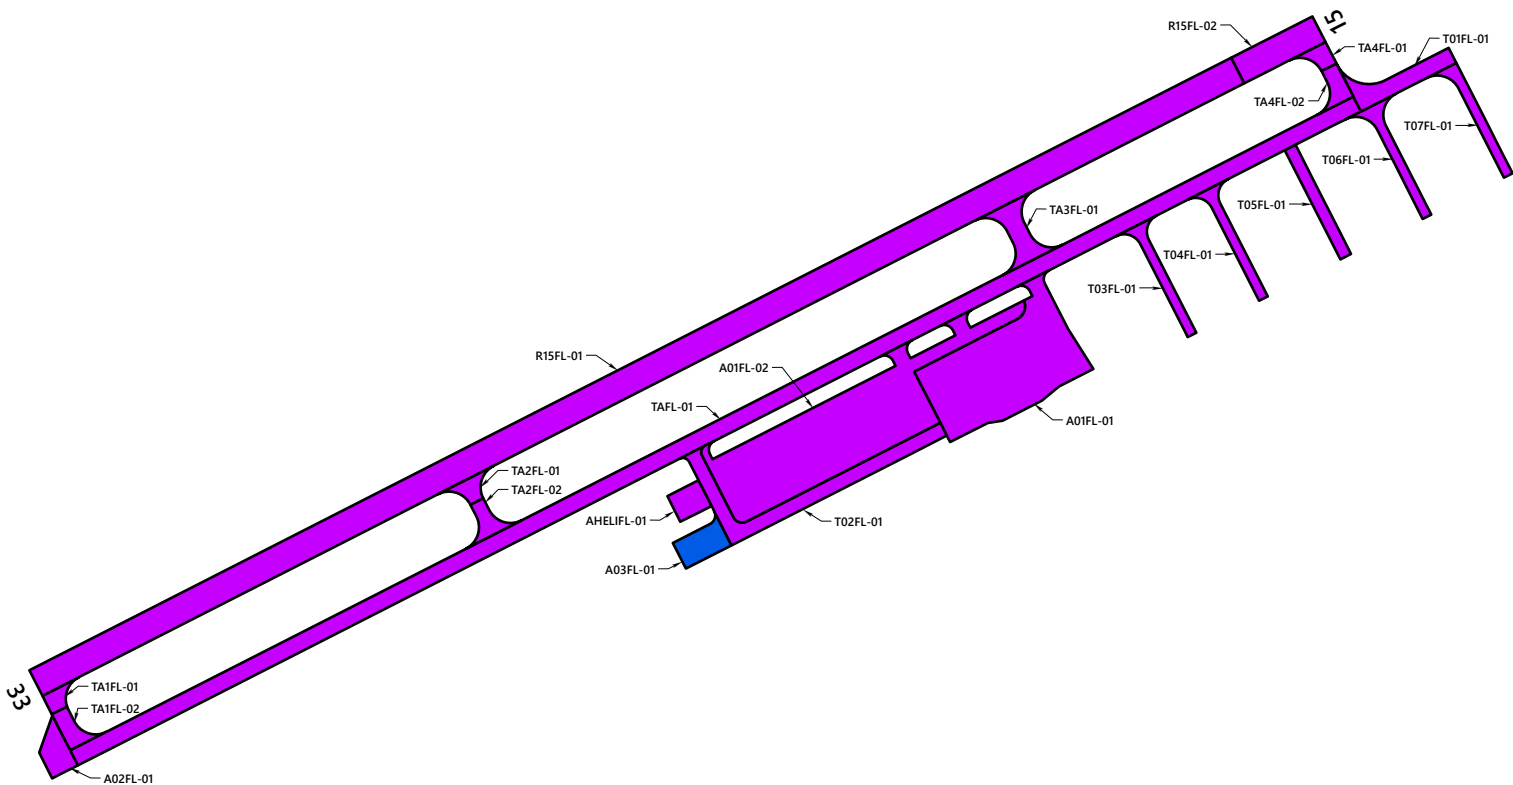
PREDICTED CONDITION IN 2028

Using the condition prediction models discussed above, the projected condition of each pavement section was determined for 5- and 10-year periods. Based on this analysis, we project the PCI to decrease from a current value of 99 to a value of 97 in 2028 and 92 in 2033 if no maintenance or rehabilitation work is performed. The projected pavement condition in 5 years and 10 years for each pavement section at Florence Municipal Airport is displayed spatially on the Future Pavement Condition Florence Municipal Airport, Figure 4.1, and listed in Table 1C in Appendix C, along with the past and present PCI values for the pavement network.
