# **2023 ODAV Pavement Evaluation Program Ken Jernstedt Airfield**

Hood River, Oregon

**December 29, 2023**

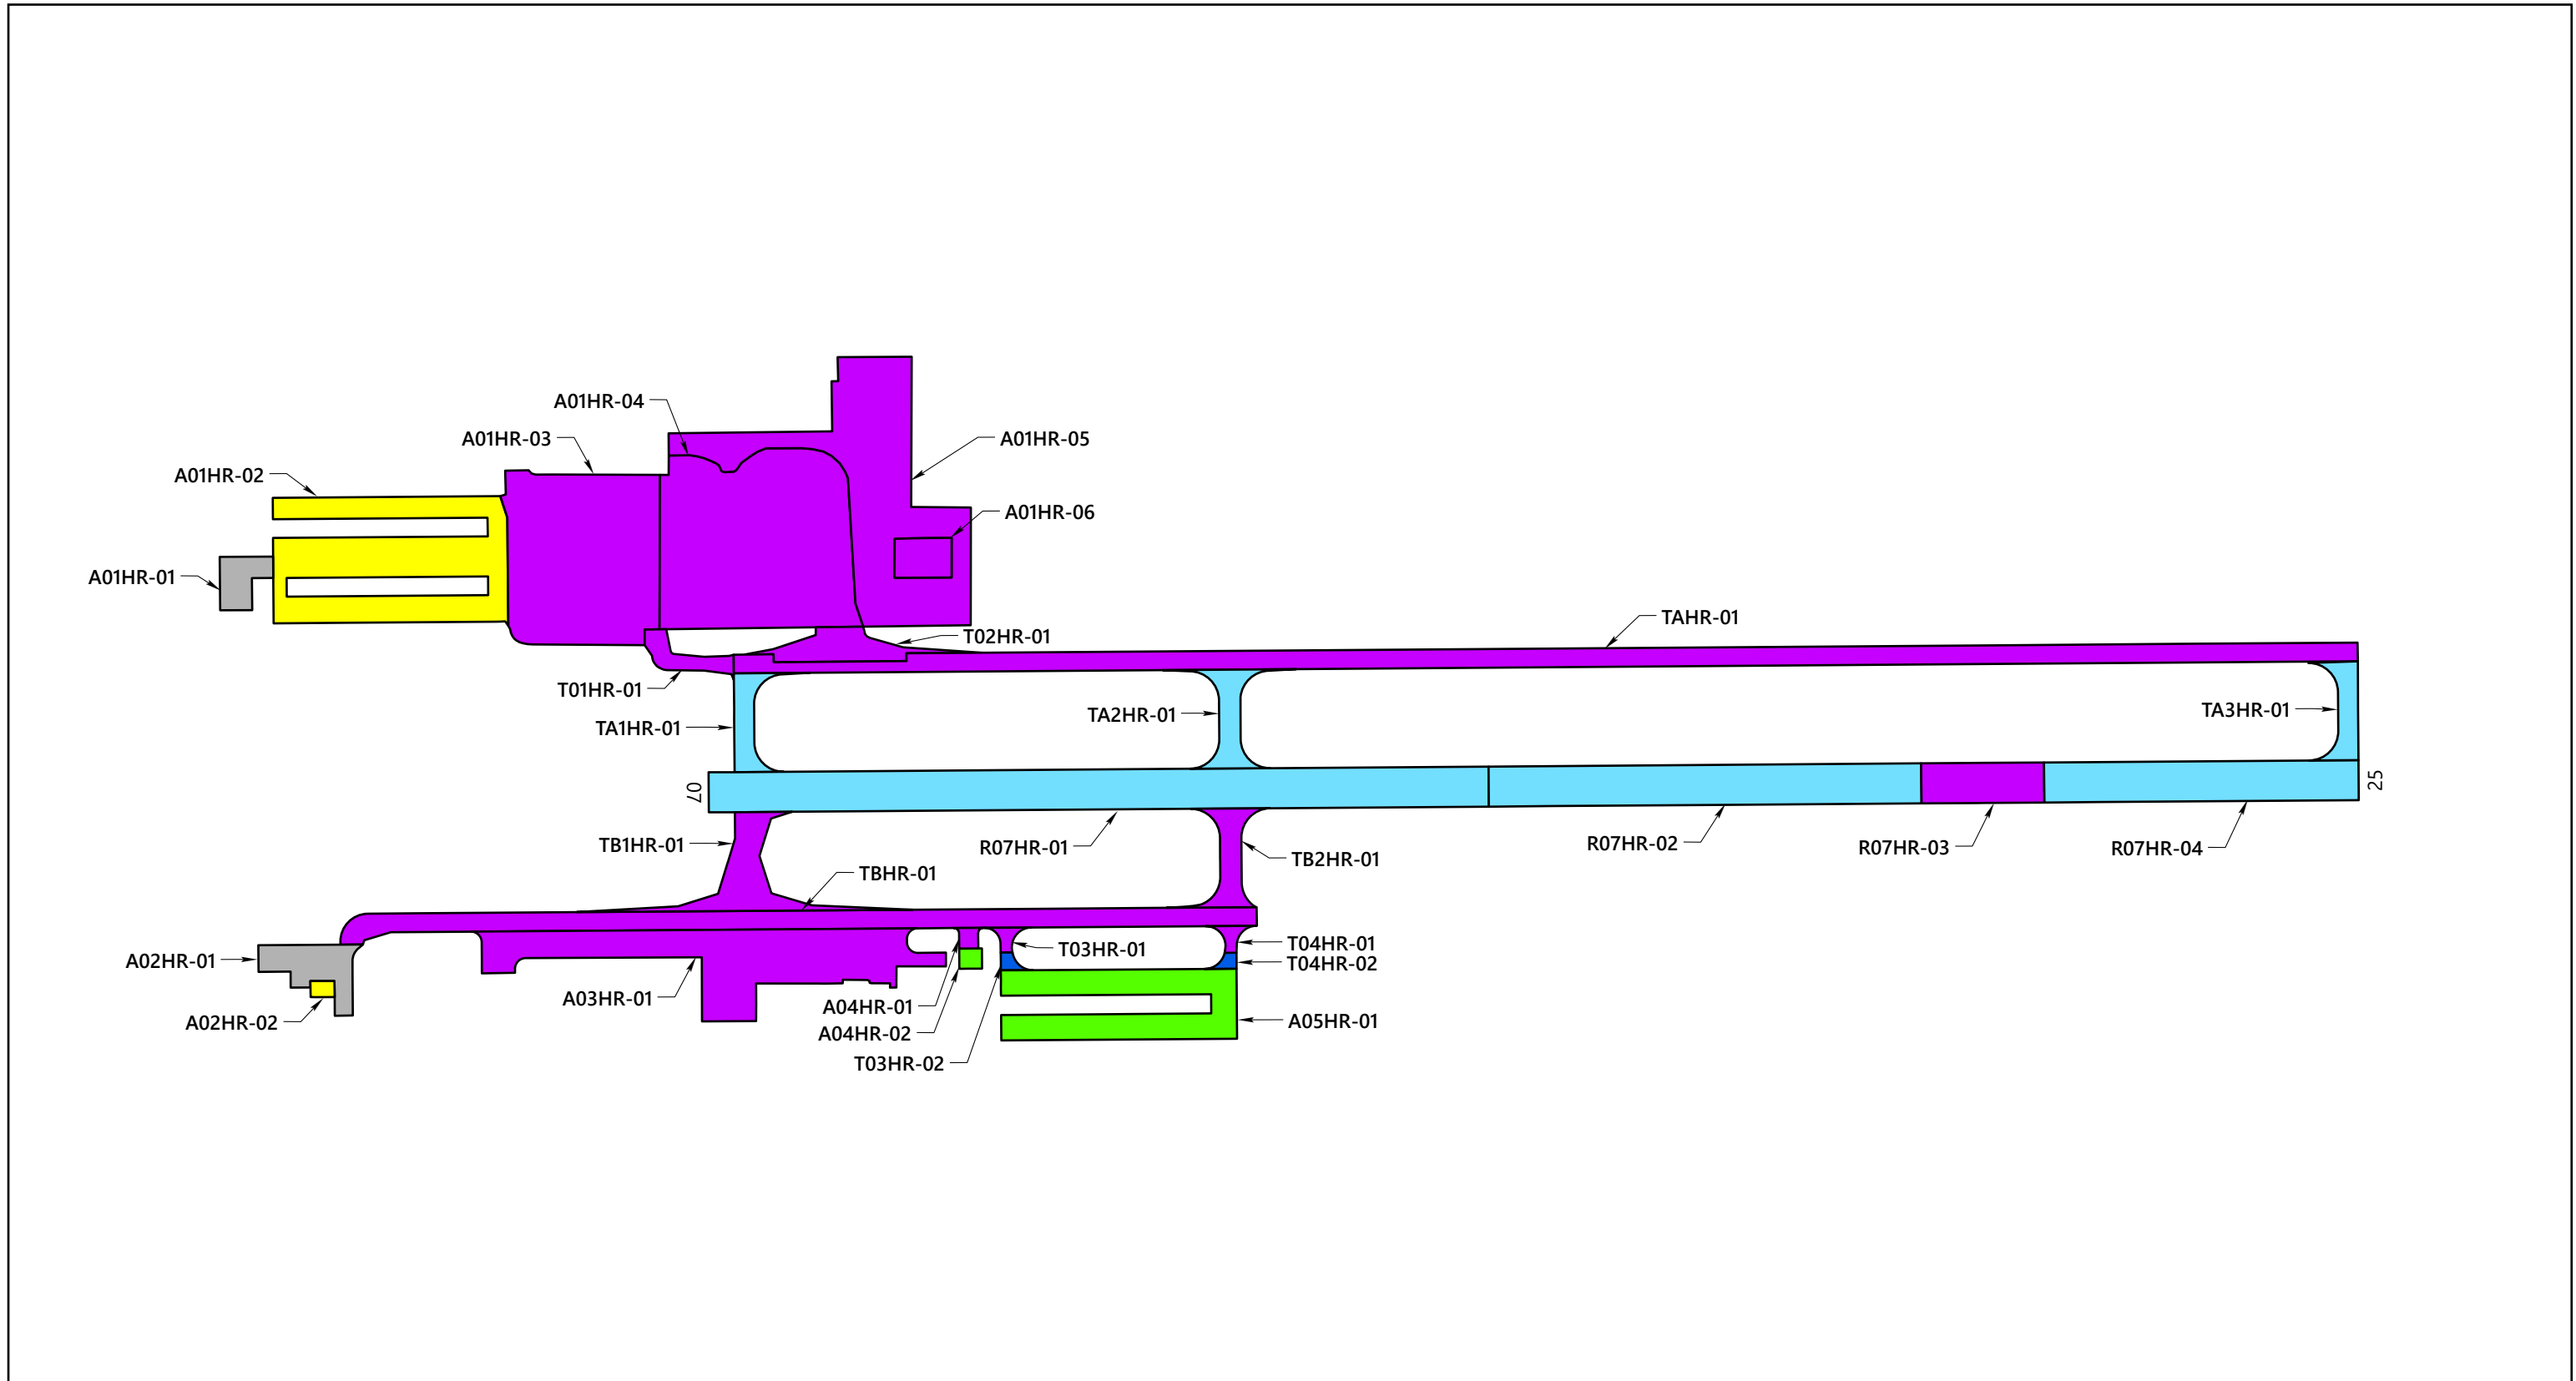
**KEN JERNSTEDT AIRFIELD  
2023 PCI SURVEY RESULTS**

The area-weighted average PCI for all airport pavements at Ken Jernstedt Airfield is approximately 81. The section PCIs ranged from a low of 14 to a high of 94. The primary distresses observed during the inspection were weathering, longitudinal and transverse cracking, fatigue (alligator) cracking, block cracking, and patching on AC-surfaced pavements, and linear cracking, corner spalls, and shattered slabs on PCC pavements. Section PCIs following our pavement survey are displayed below spatially on the Ken Jernstedt Airfield 2023 PCI Survey Results, Figure 3.1.

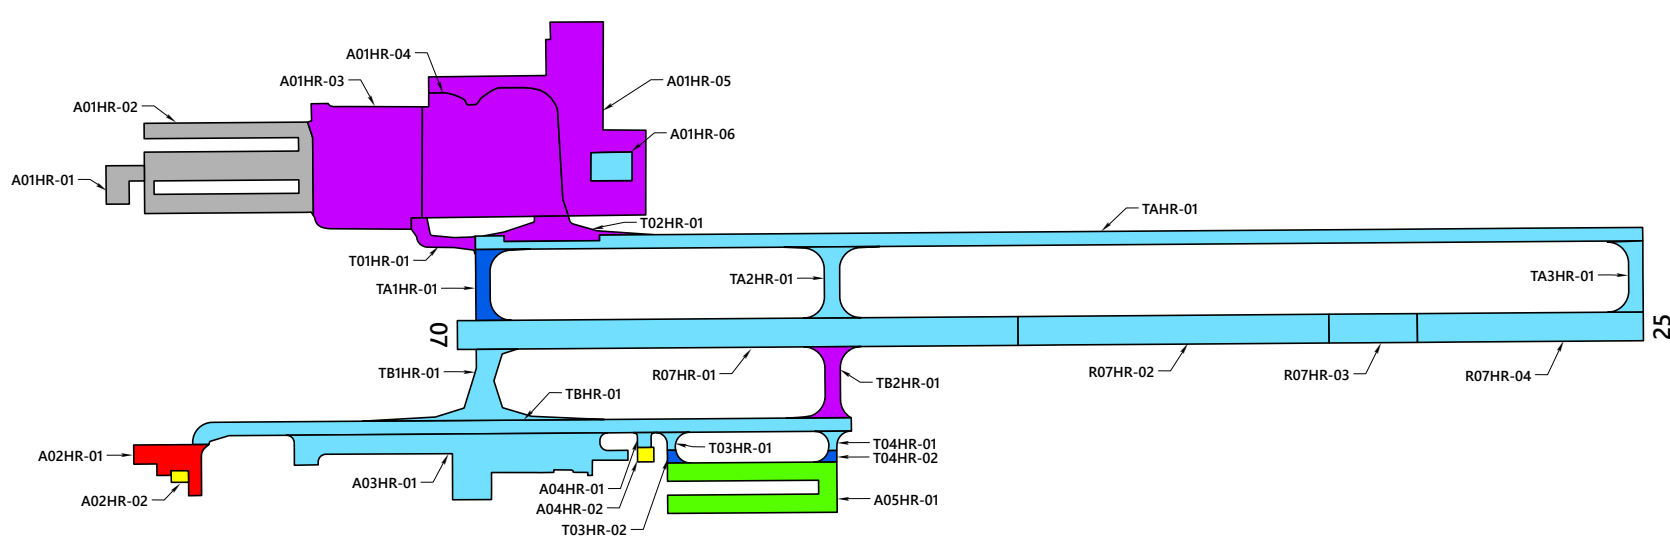
PREDICTED CONDITION IN 2028

Using the condition prediction models discussed above, the projected condition of each pavement section was determined for 5- and 10-year periods. Based on this analysis, we project the PCI to decrease from a current value of 81 to a value of 75 in 2028 and 71 in 2033 if no maintenance or rehabilitation work is performed. The projected pavement condition in 5 years and 10 years for each pavement section at Ken Jernstedt Airfield is displayed spatially on the Ken Jernstedt Airfield Future Pavement Condition, Figure 4.1, and listed in Table 1C in Appendix C, along with the past and present PCI values for the pavement network.
