2023 ODAV Pavement Evaluation Program Mulino State Airport

Mulino, Oregon

December 29, 2023

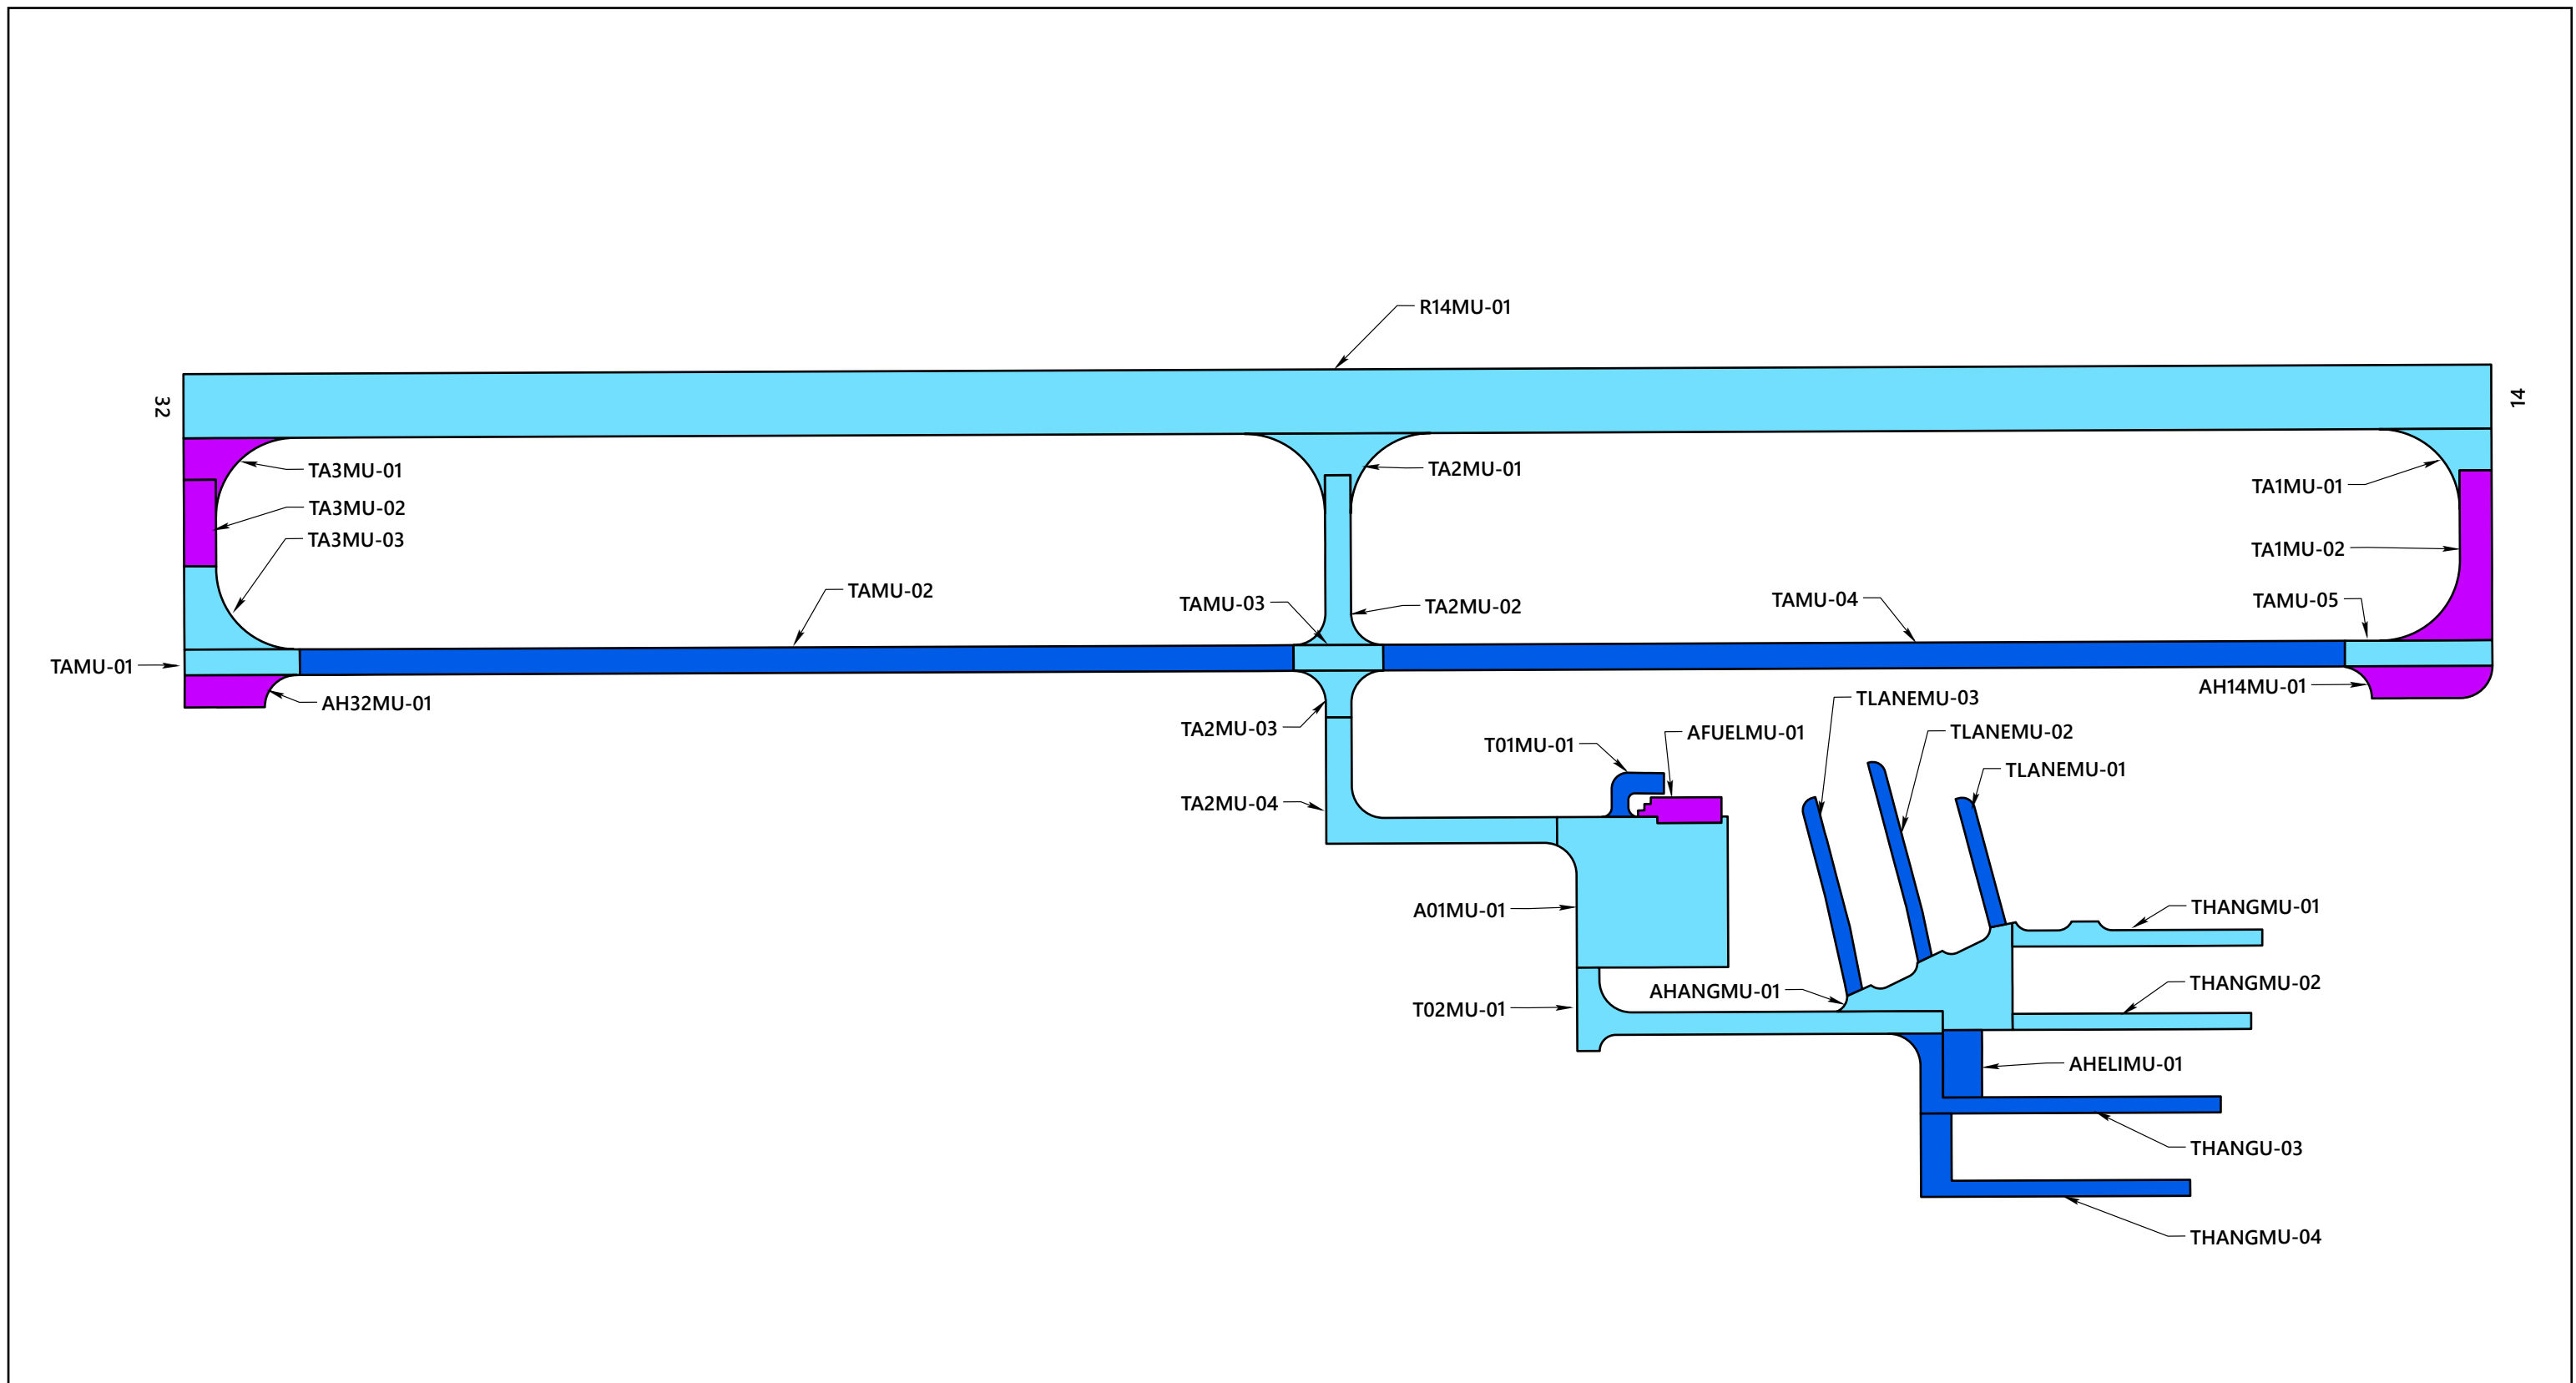
The area-weighted average PCI for all airport pavements at Mulino State Airport is approximately 77. The section PCIs ranged from a low of 62 to a high of 100. The primary distresses observed during the inspection were weathering, longitudinal and transverse, and alligator (fatigue) cracking on AC-surfaced pavements. Section PCIs following our pavement survey are displayed below spatially on the Mulino State Airport 2023 PCI Survey Results, Figure 3.1.

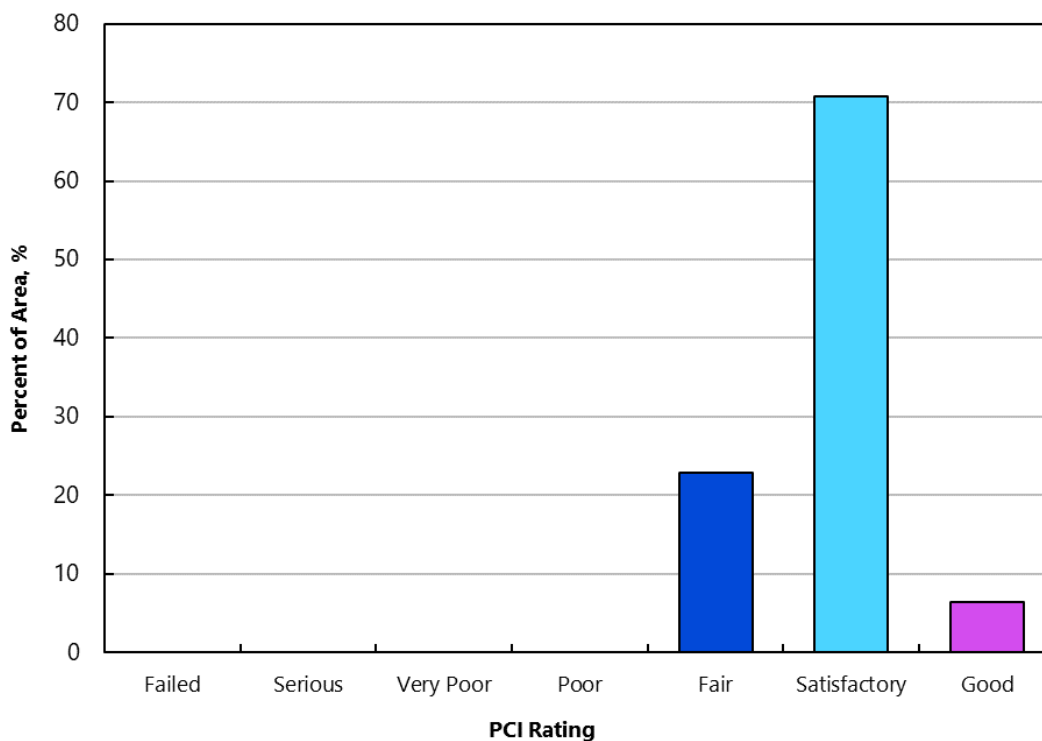
Figure 3.2 – MULINO STATE AIRPORT PAVEMENT CONDITION RATING BY PERCENT OF AREA

The condition distribution of the network by percent of total pavement area is provided on the Mulino State Airport Pavement Condition Rating by Percent of Area, Figure 3.2. A summary of the pavement condition results by branch and section is included in Tables 2B and 3B of Appendix B, respectively. A comparison between the previous inspection and the 2023 inspection is provided in Table 4B in Appendix B. The re-inspection report that includes inspection details for individual sample units is provided in Table 1E in Appendix E.

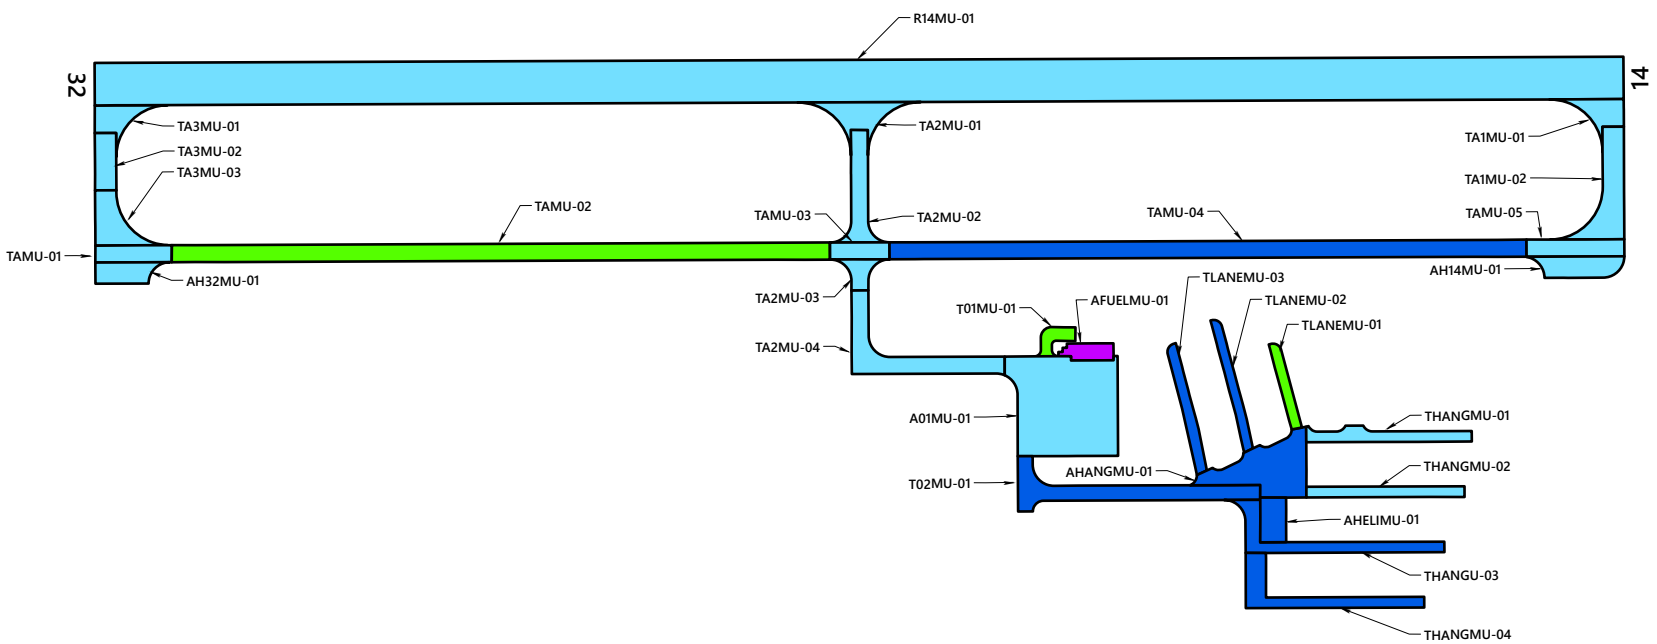
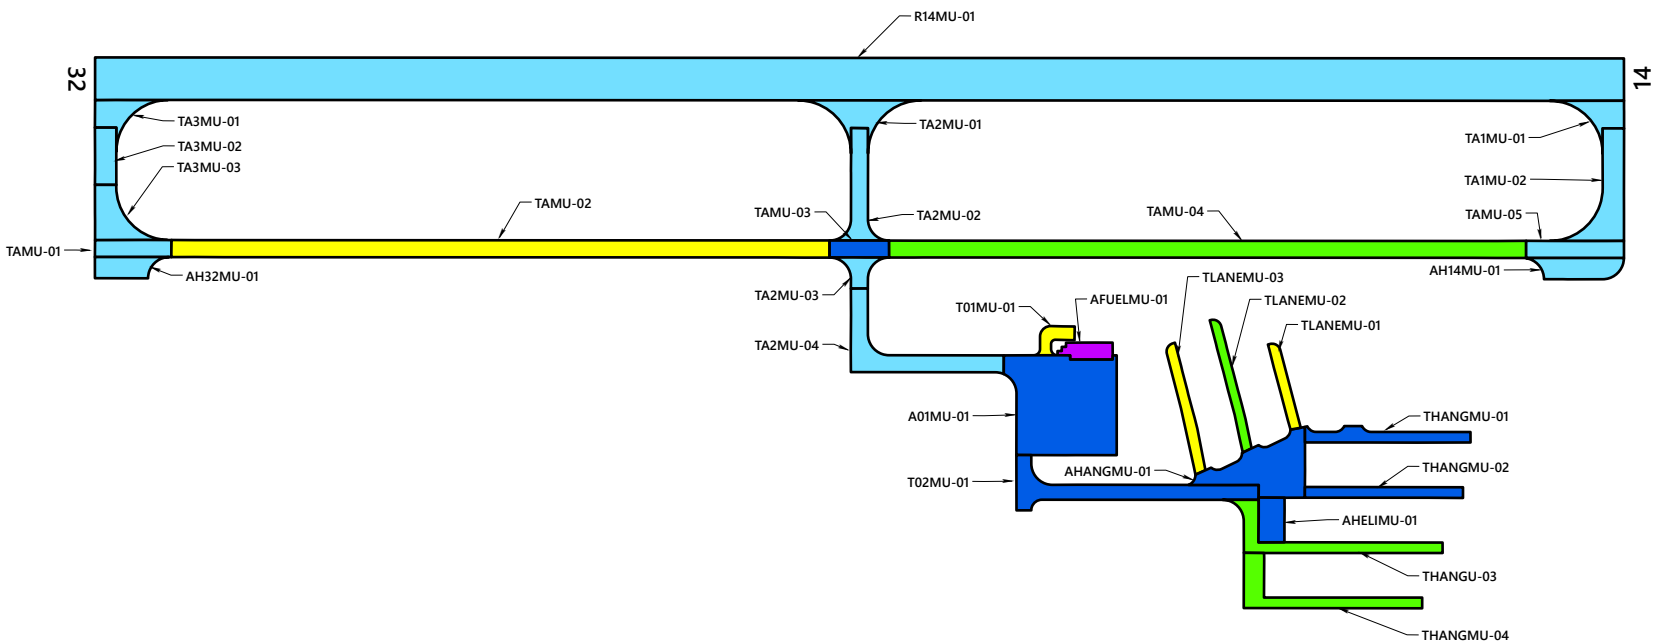
MULINO STATE AIRPORT
FUTURE PAVEMENT CONDITION

Using the condition prediction models discussed above, the projected condition of each pavement section was determined for 5- and 10-year periods. Based on this analysis, we project the PCI to decrease from a current value of 77 to a value of 71 in 2028 and 65 in 2033 if no maintenance or rehabilitation work is performed. The projected pavement condition in 5 years and 10 years for each pavement section at Mulino State Airport is displayed spatially on the Mulino State Airport Future Pavement Condition , Figure 4.1, and listed in Table 1C in Appendix C, along with the past and present PCI values for the pavement network.
