# **2023 ODAV Pavement Evaluation Program Siletz Bay State Airport**

Gleneden Beach, Oregon

**December 29, 2023**

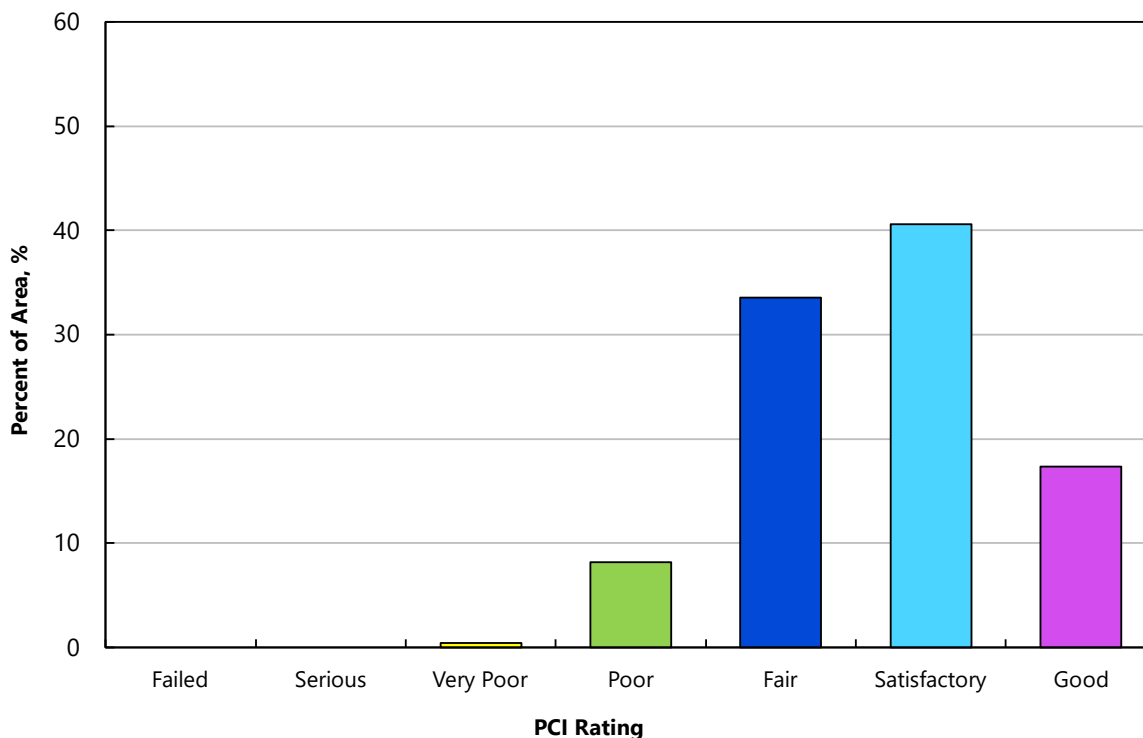
**Figure 3.2: SILETZ BAY STATE AIRPORT PAVEMENT CONDITION RATING BY PERCENT OF AREA**

The condition distribution of the network by percent of total pavement area is provided on the Siletz Bay State Airport Pavement Condition Rating by Percent of Area, Figure 3.2. A summary of the pavement condition results by branch and section are included in Tables 2B and 3B of Appendix B, respectively. A comparison between the previous inspection and the 2023 inspection is provided in Table 4B in Appendix B. The re-inspection report that includes inspection details for individual sample units is provided in Table 1E in Appendix E.

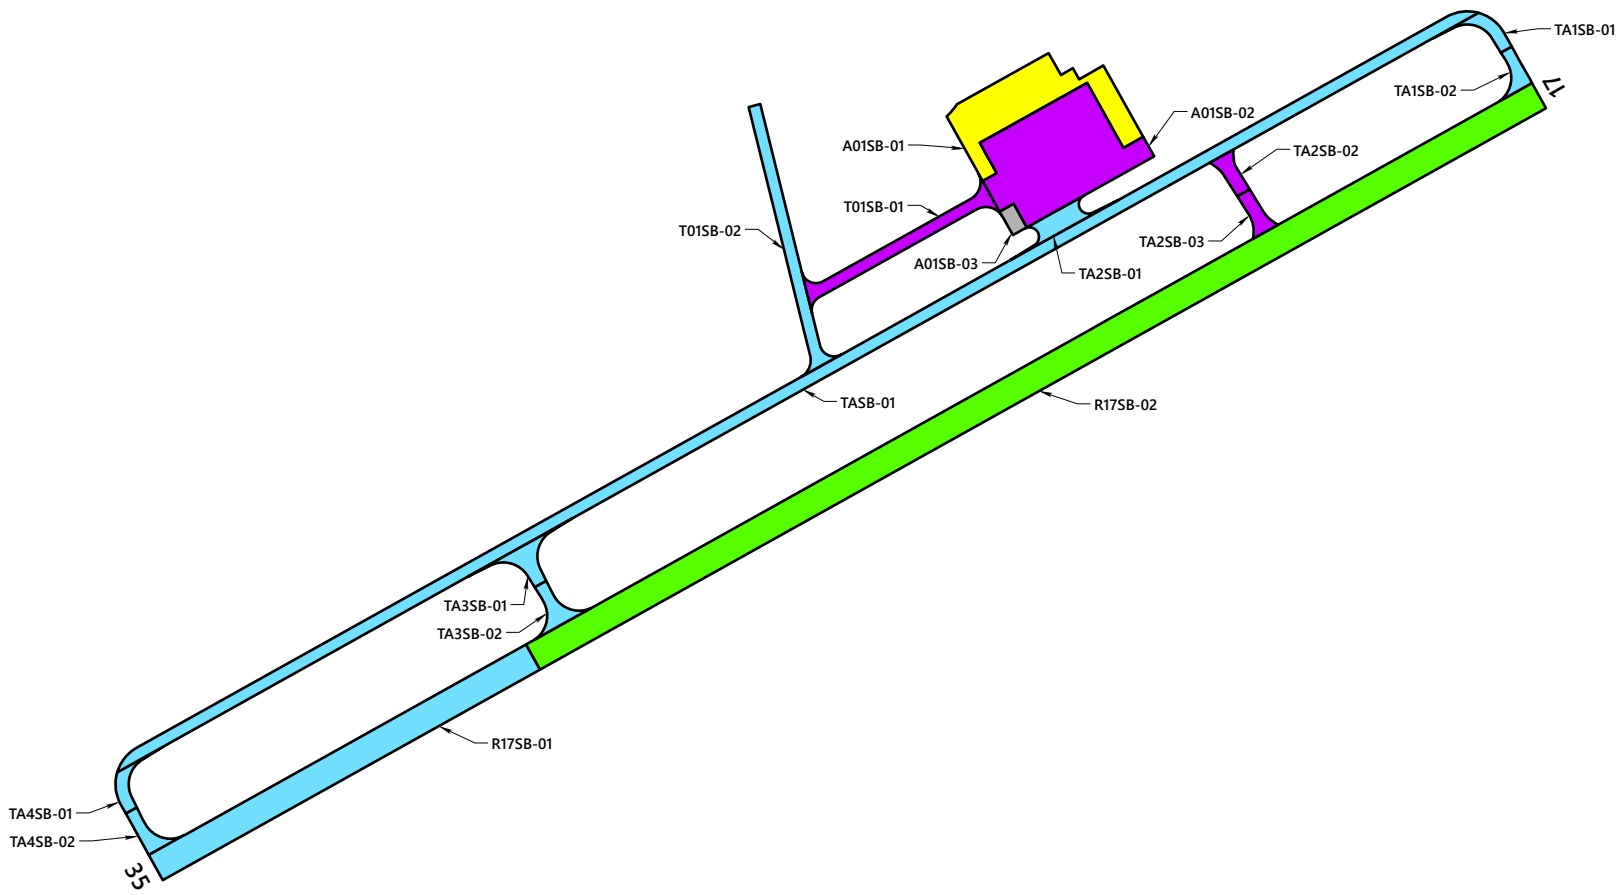
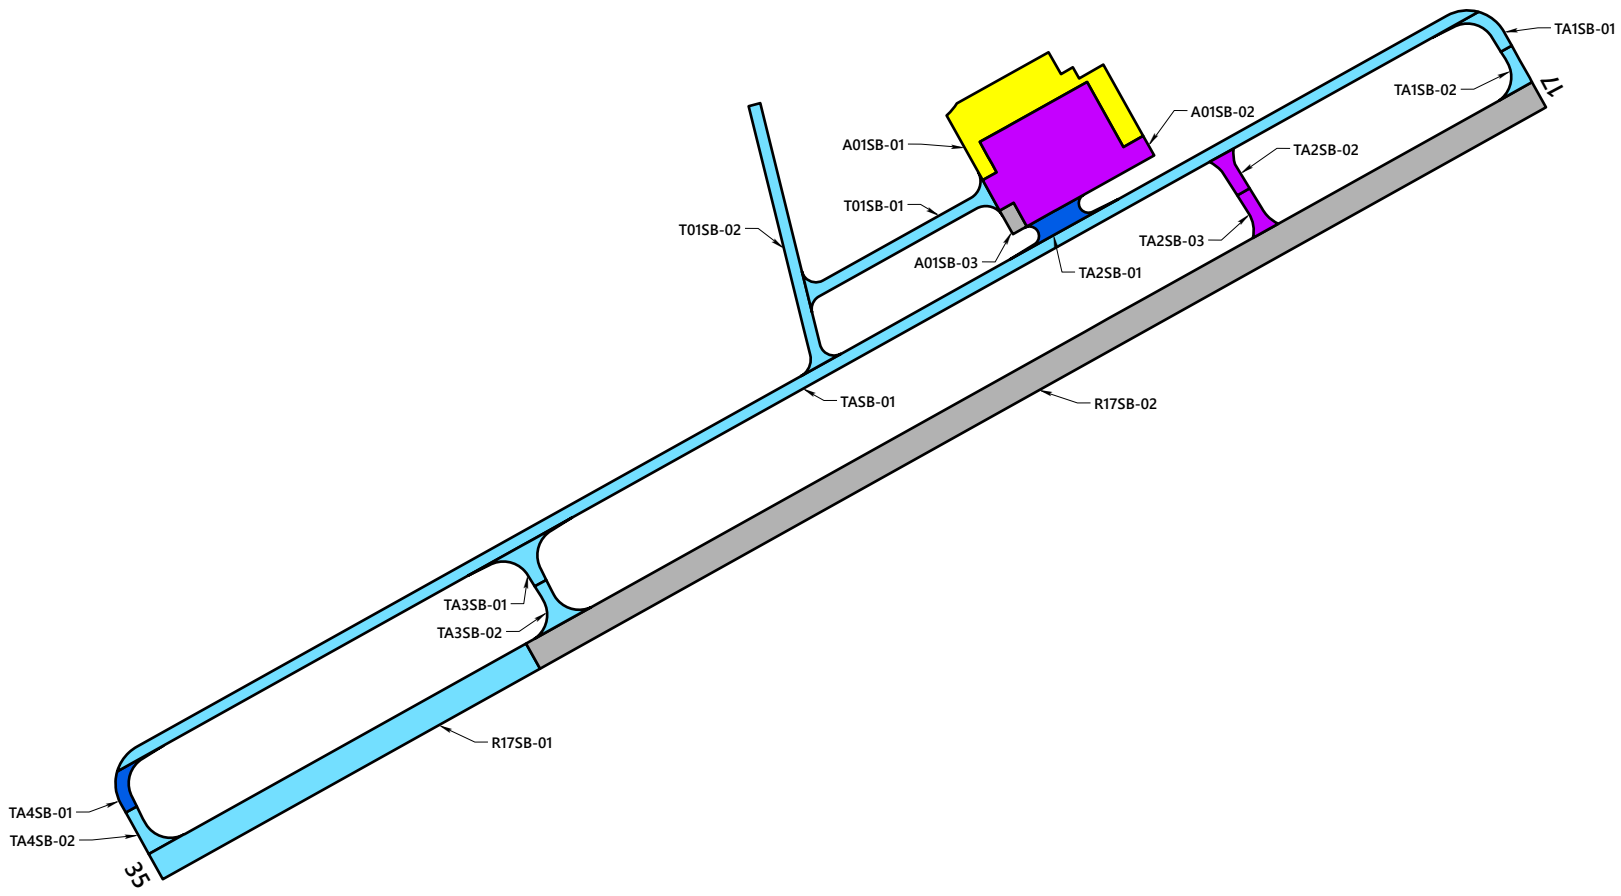
PREDICTED CONDITION IN 2028

Using the condition prediction models discussed above, the projected condition of each pavement section was determined for 5- and 10-year periods. Based on this analysis, we project the PCI to decrease from a current value of 77 to a value of 66 in 2028 and 55 in 2033 if no maintenance or rehabilitation work is performed. The projected pavement condition in 5 years and 10 years for each pavement section at Siletz Bay State Airport is displayed spatially on the Siletz Bay State Airport Future Pavement Condition, Figure 4.1, and listed in Table 1C in Appendix C, along with the past and present PCI values for the pavement network.
