2023 ODAV Pavement Evaluation Program Lenhardt Airpark

Hubbard, Oregon

December 29, 2023

Prepared for

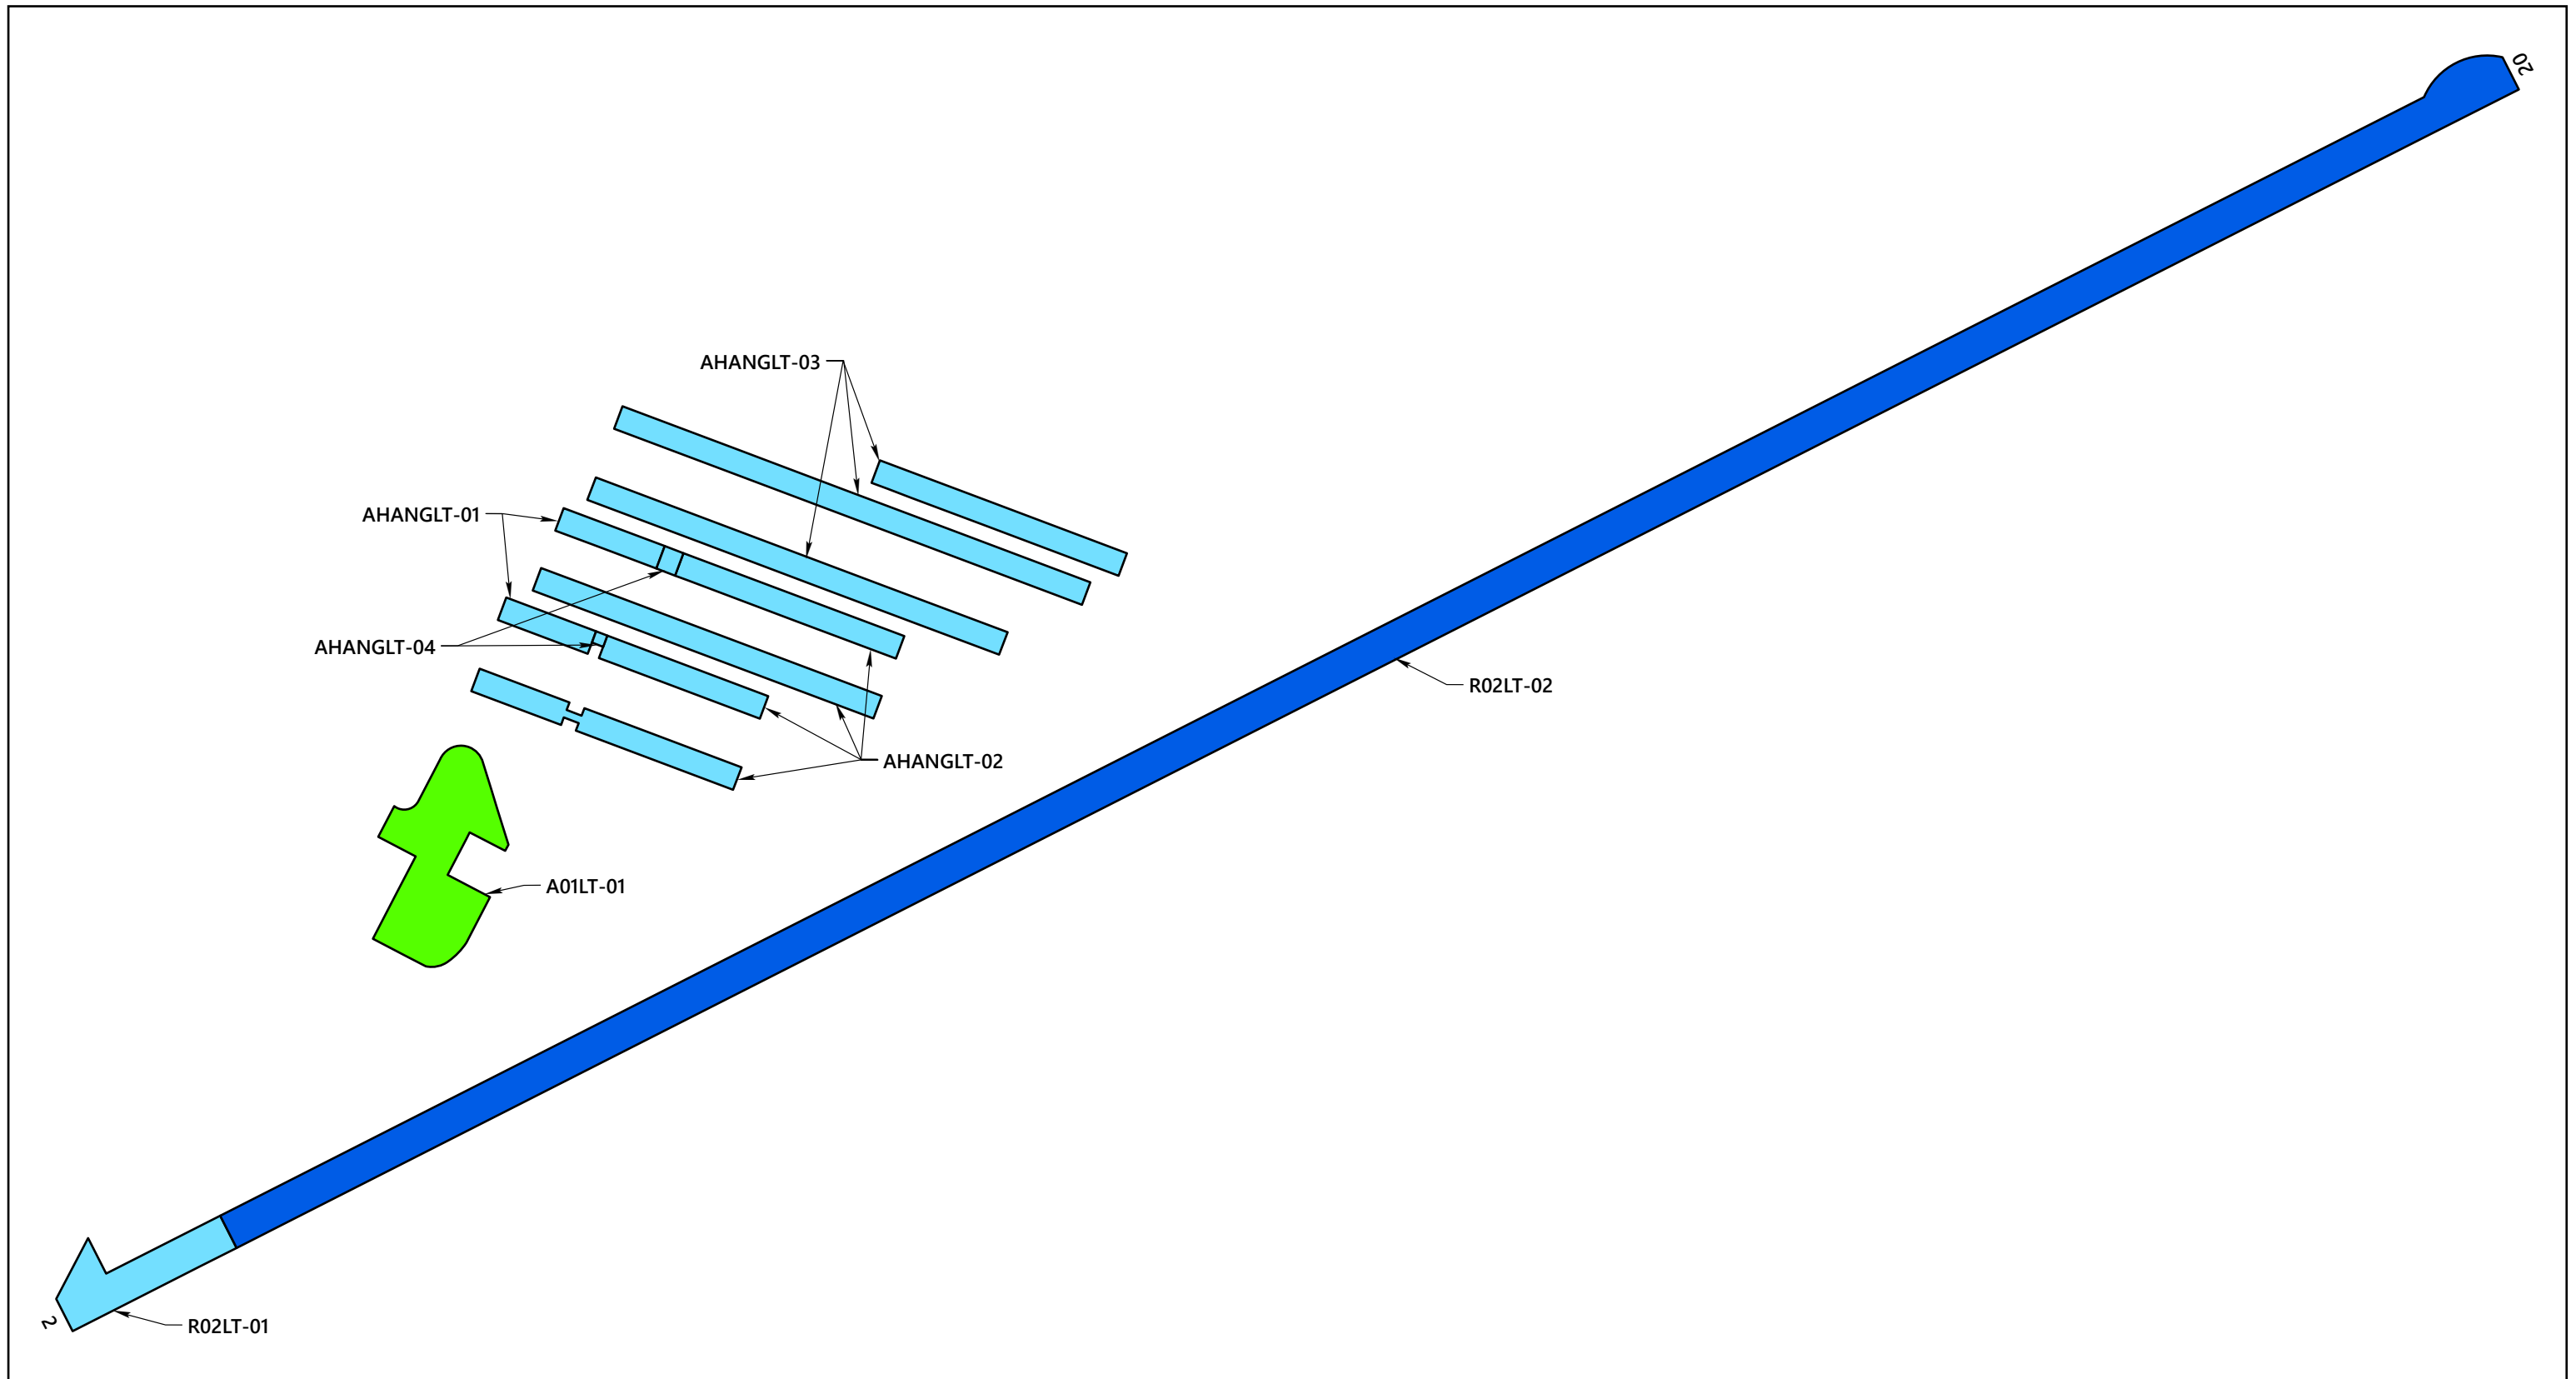
The area-weighted average PCI for all airport pavements at Lenhardt Airpark is approximately 71. The section PCIs ranged from a low of 52 to a high of 82. The primary distresses observed during the inspection were weathering, alligator cracking, longitudinal and transverse cracking, block cracking, and patching on AC-surfaced pavements. Section PCIs following our pavement survey are displayed below spatially on the Lenhardt Airpark 2023 PCI Survey Results, Figure 3.1.

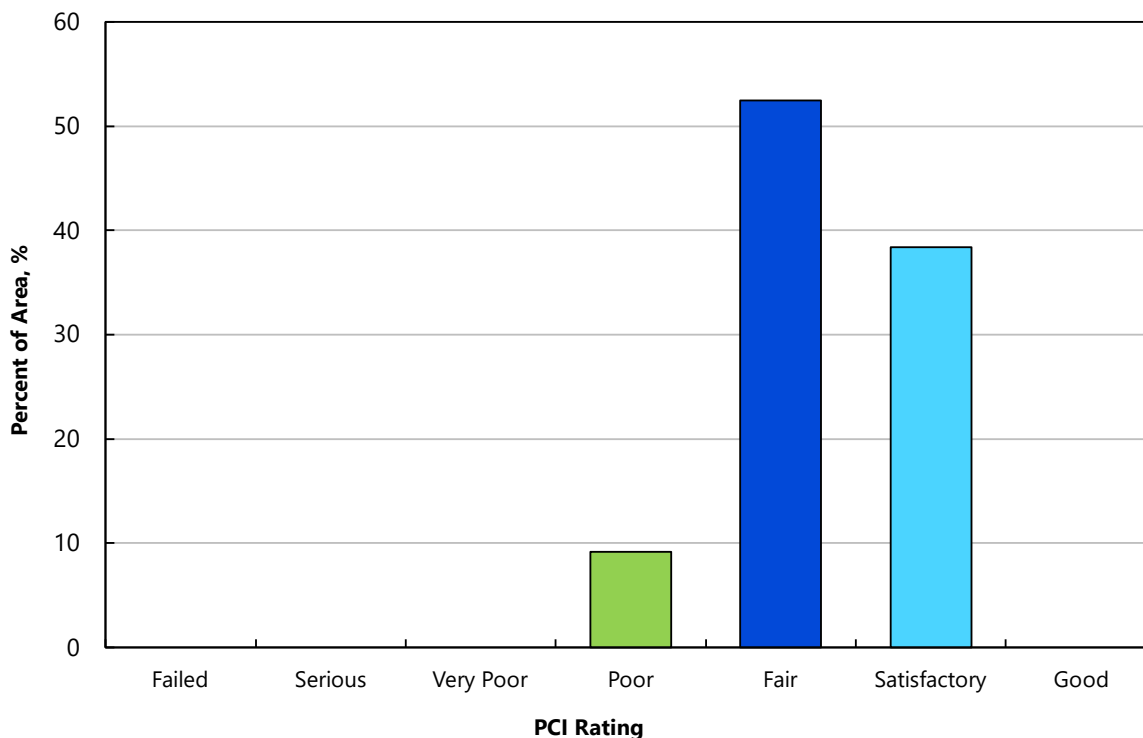
Figure 3.2: LENHARDT AIRPARK PAVEMENT CONDITION RATING BY PERCENT OF AREA

The condition distribution of the network by percent of total pavement area is provided on the Lenhardt Airpark Pavement Condition Rating by Percent of Area, Figure 3.2. A summary of the pavement condition results by branch and section is included in Tables 2B and 3B of Appendix B, respectively. A comparison between the previous inspection and the 2023 inspection is provided in Table 4B in Appendix B. The re-inspection report that includes inspection details for individual sample units is provided in Table 1E in Appendix E.

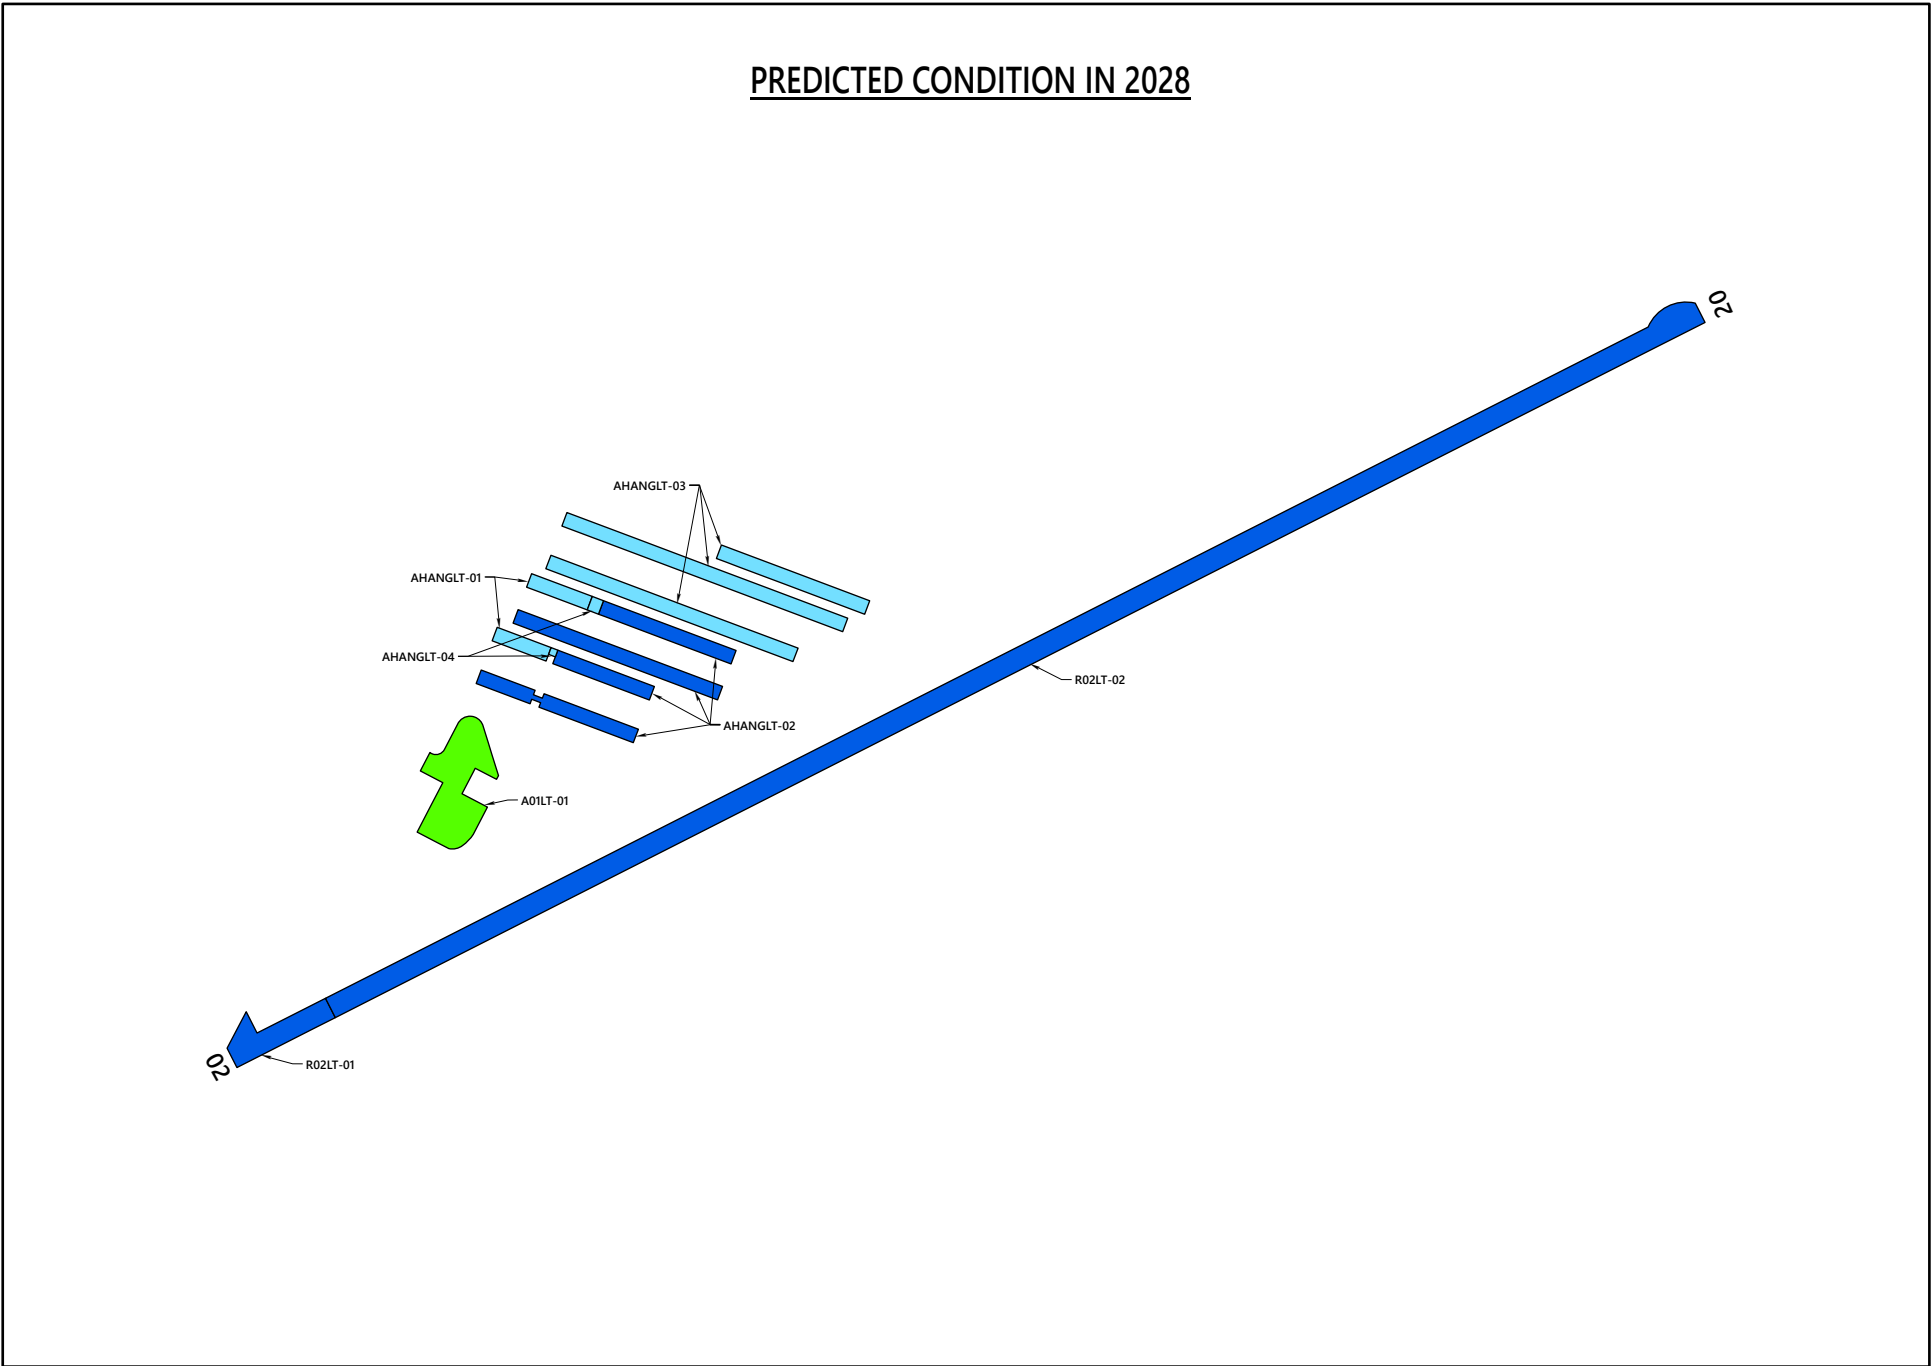
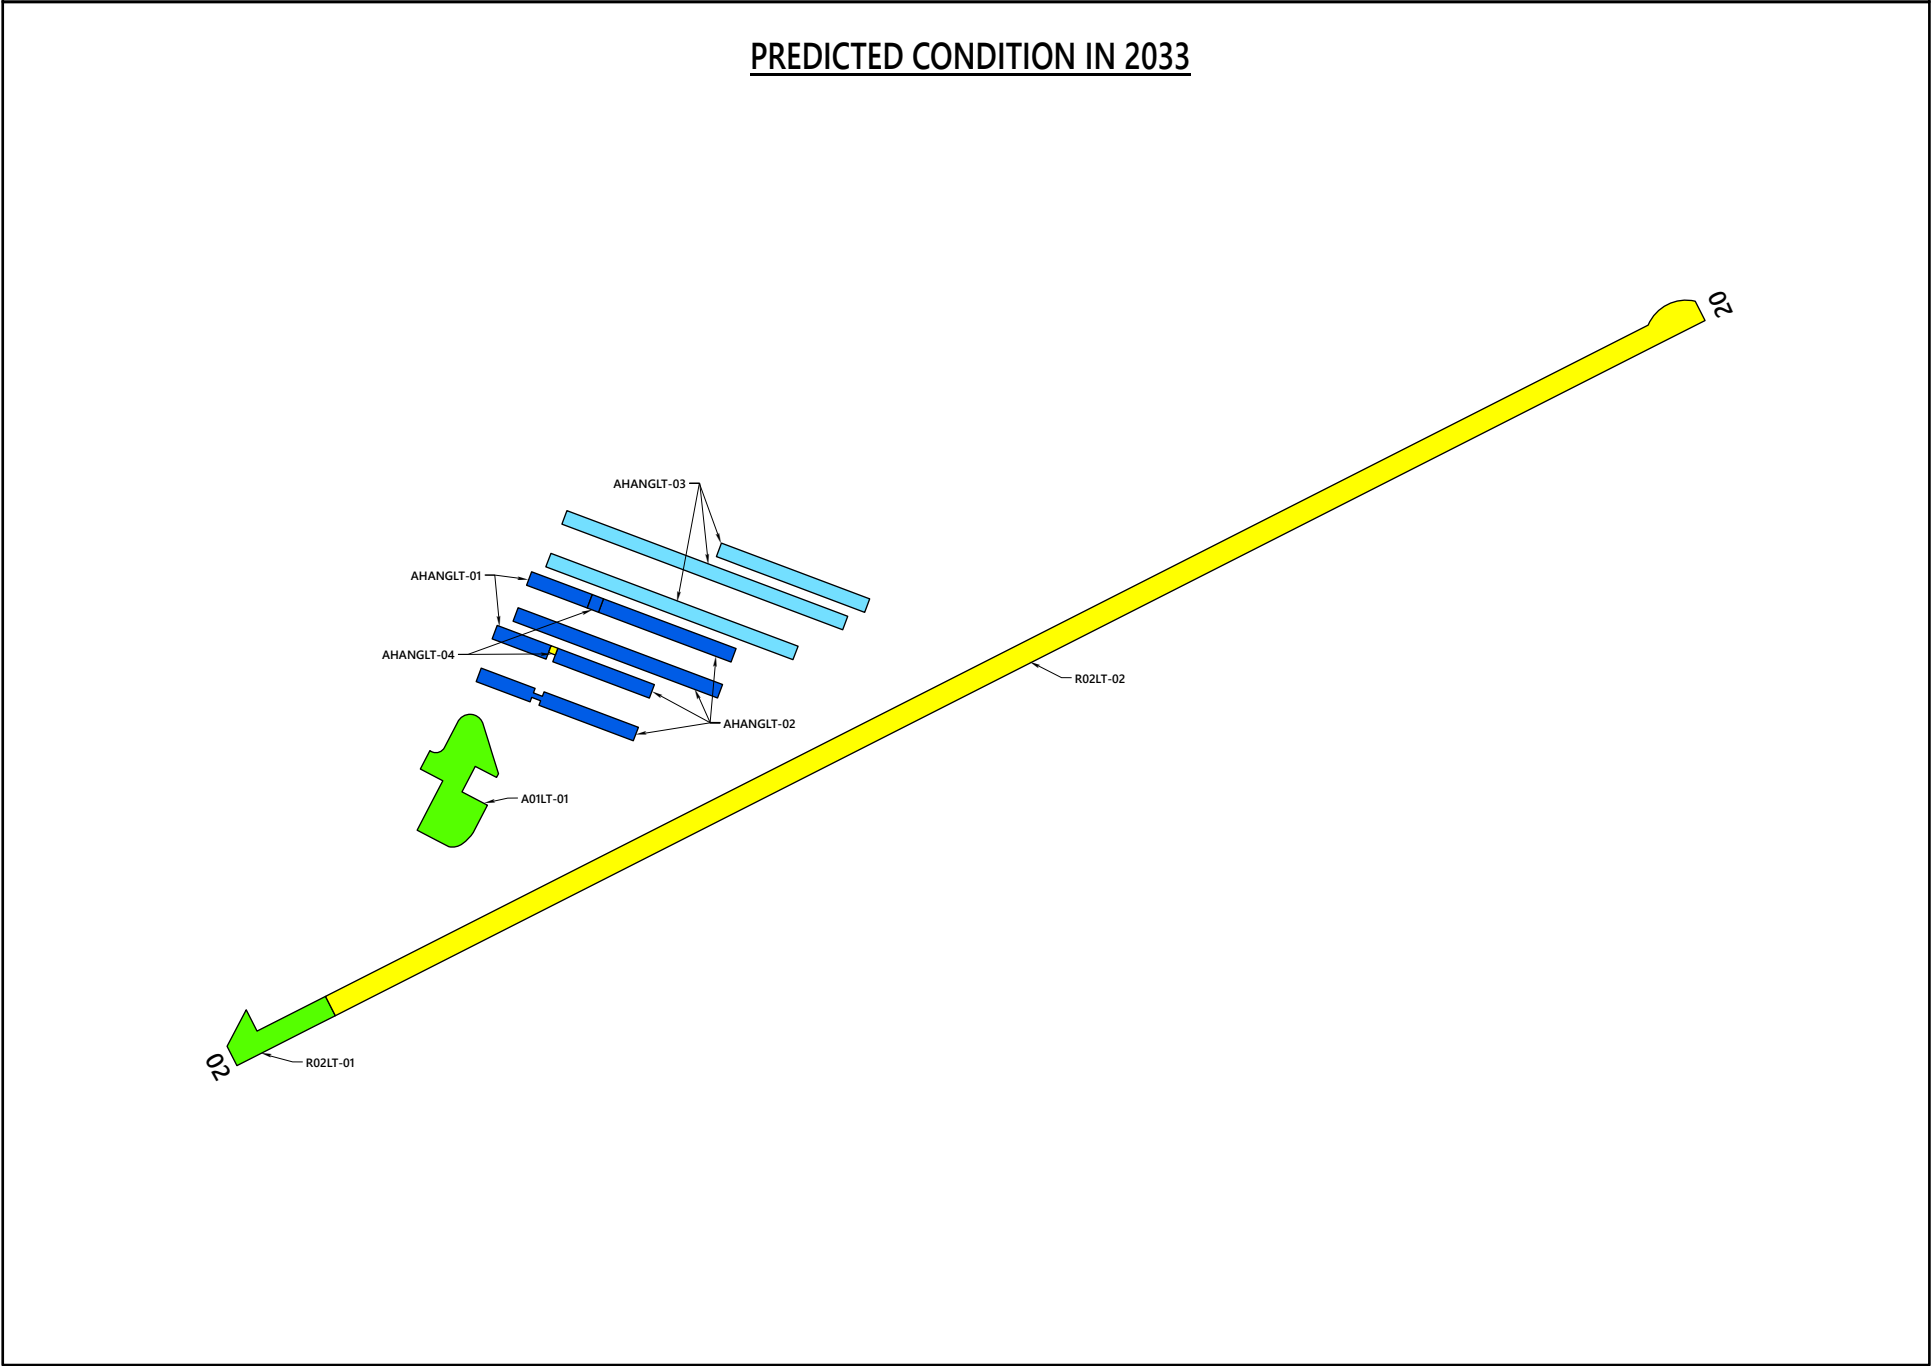
**FUTURE PAVEMENT CONDITION
LENHARDT AIRPARK**

Using the condition prediction models discussed above, the projected condition of each pavement section was determined for 5- and 10-year periods. Based on this analysis, we project the PCI to decrease from a current value of 71 to a value of 61 in 2028 and 45 in 2033 if no maintenance or rehabilitation work is performed. The projected pavement condition in 5 years and 10 years for each pavement section at Lenhardt Airpark is displayed spatially on the Lenhardt Airpark Future Pavement Condition, Figure 4.1, and listed in Table 1C in Appendix C, along with the past and present PCI values for the pavement network.
