2023 ODAV Pavement Evaluation Program Nehalem Bay State Airport

Manzanita, Oregon

December 29, 2023

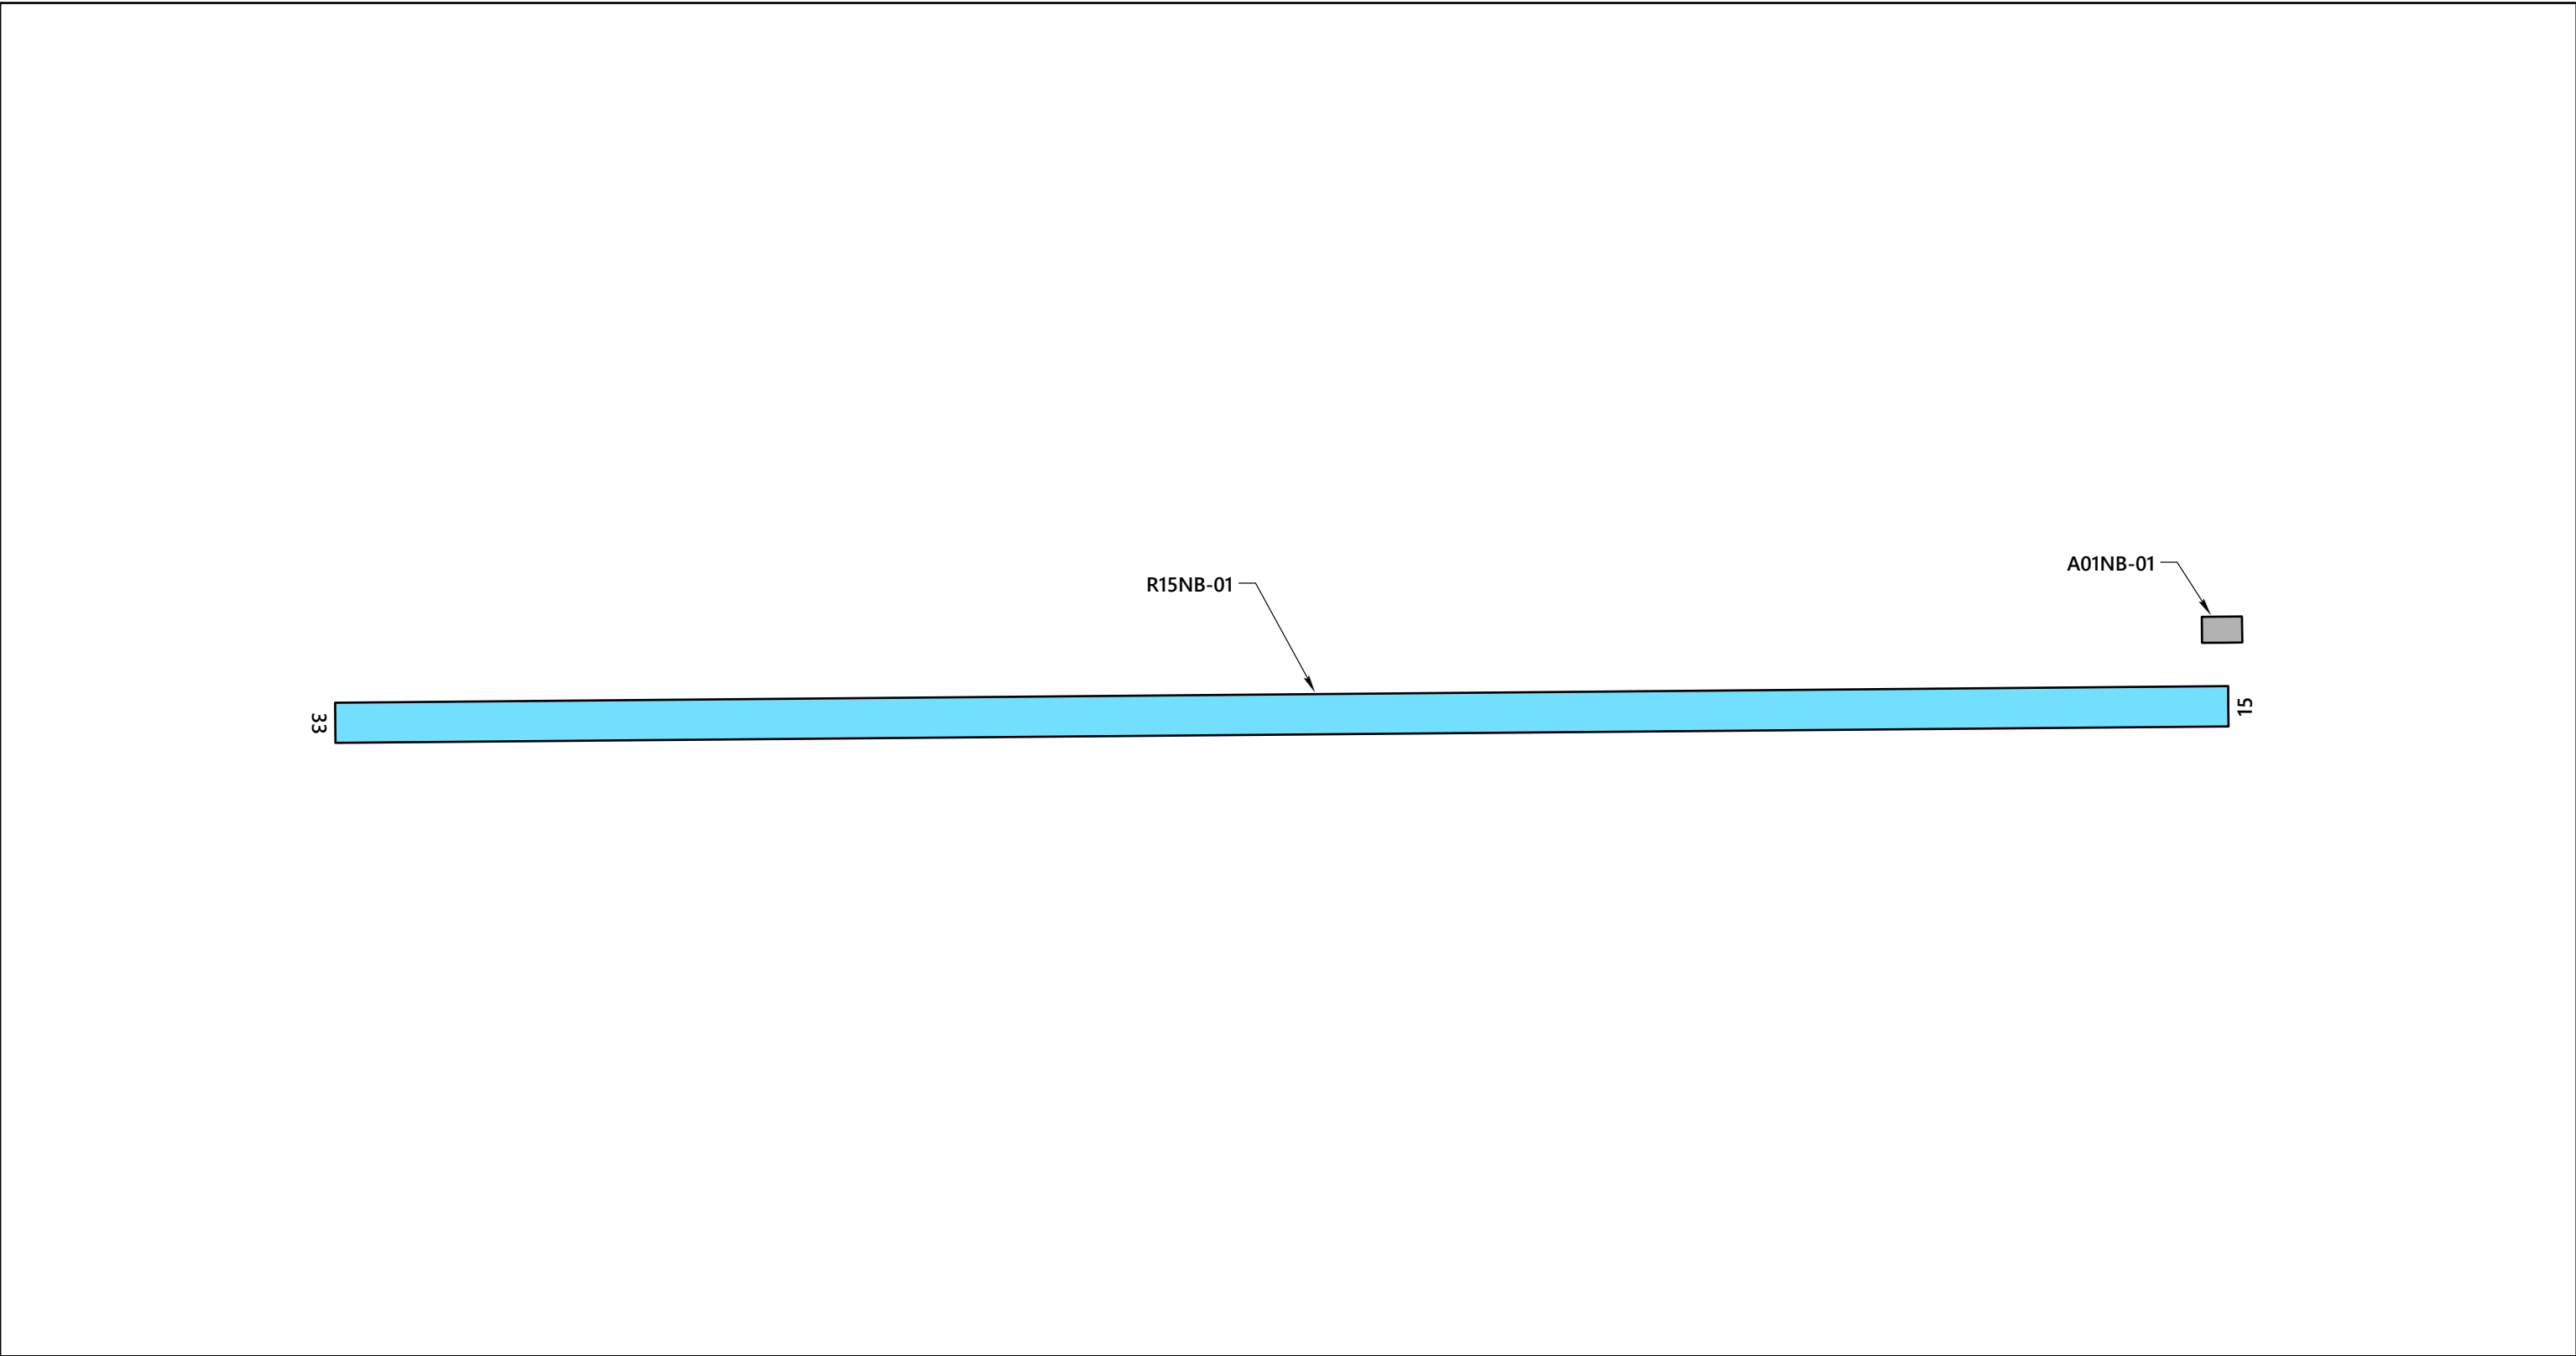
NEHALEM BAY STATE AIRPORT
2023 PCI SURVEY RESULTS

The area-weighted average PCI for all airport pavements at Nehalem Bay State Airport is approximately 75. The section PCIs ranged from a low of 25 to a high of 76. The primary distresses observed during the inspection were weathering, longitudinal and transverse cracking, block cracking, alligator cracking, and patching. Section PCIs following our pavement survey are displayed below spatially on the Nehalem Bay State Airport 2023 PCI Survey Results, Figure 3.1.
