2023 ODAV Pavement Evaluation Program Sportsman Airpark

Newberg, Oregon

December 29, 2023

State of Oregon Department of Aviation
3040 25th Street SE
Salem, OR 97303-1125

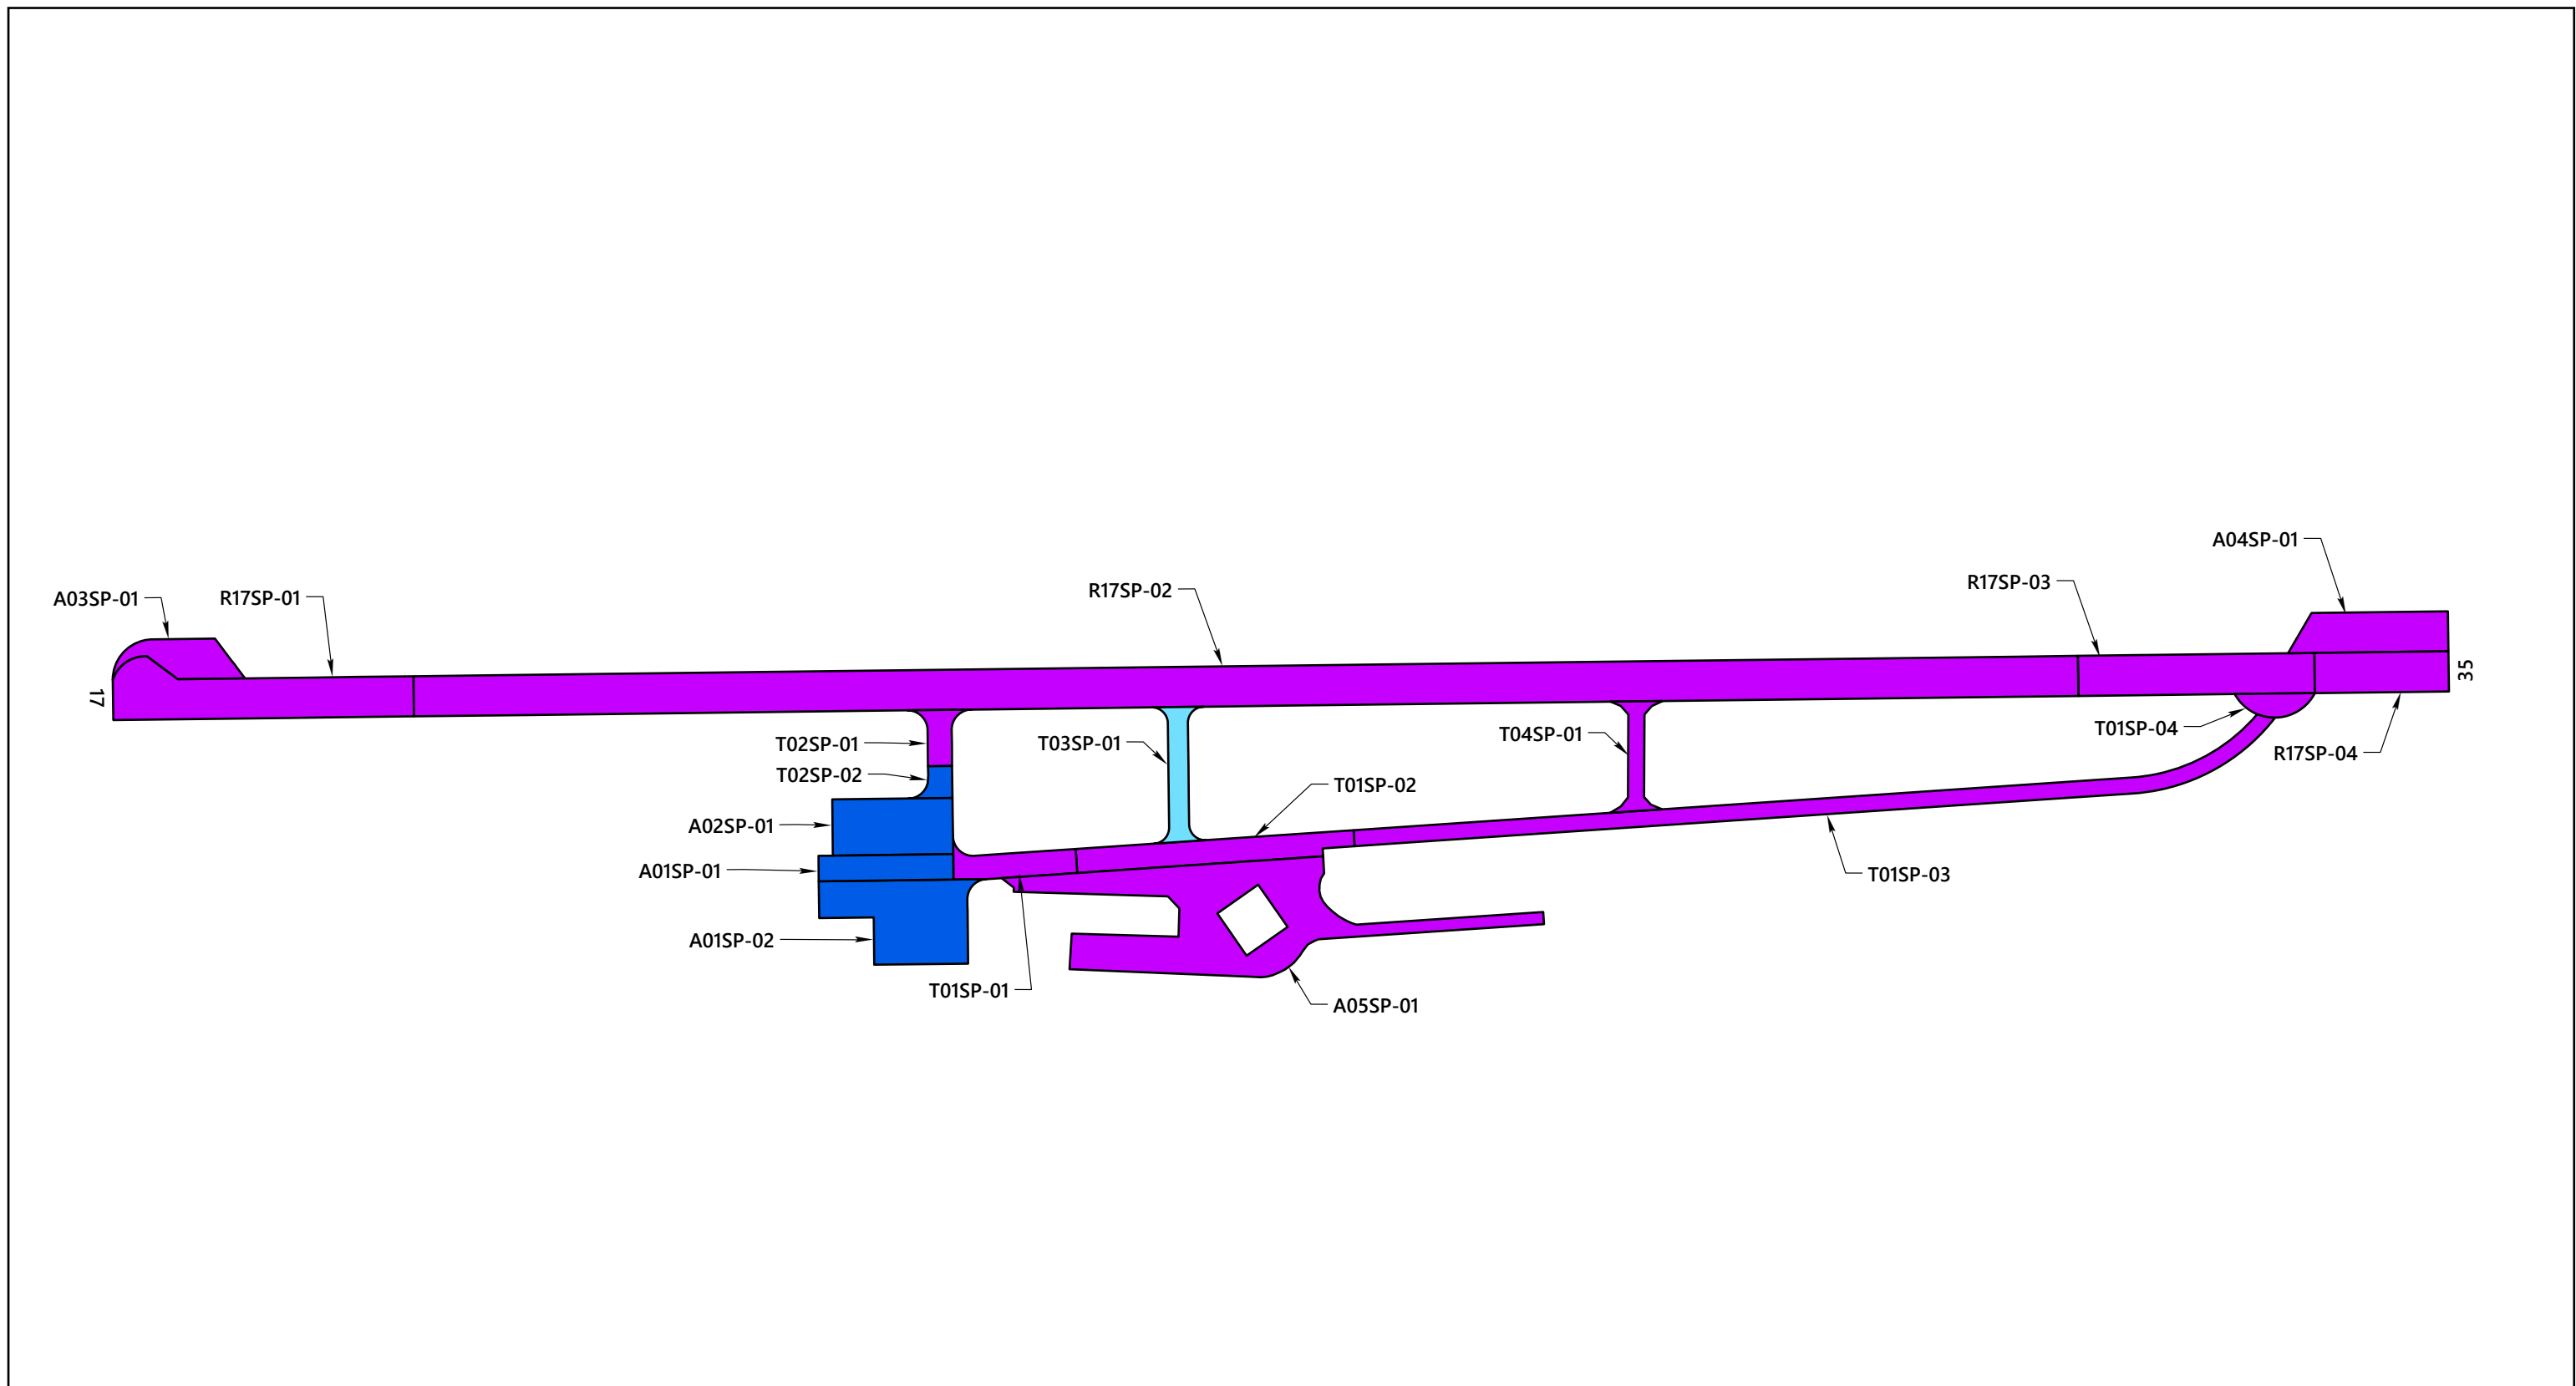
The area-weighted average PCI for all airport pavements at Sportsman Airpark is approximately 96. The section PCIs ranged from a low of 69 to a high of 100. The primary distresses observed during the inspection were weathering, longitudinal and transverse cracking and fatigue (alligator) cracking. Section PCIs following our pavement survey are displayed below spatially on the Sportsman Airpark 2023 PCI Survey Results, Figure 3.1.

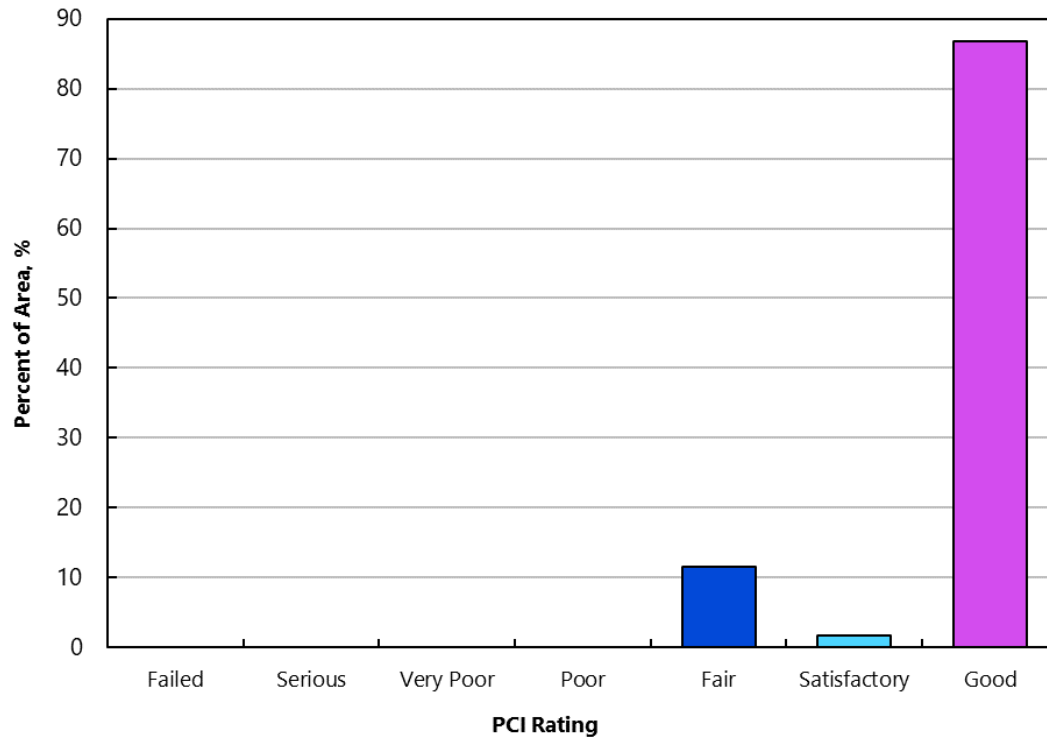
Figure 3.2: SPORTSMAN AIRPARK PAVEMENT CONDITION RATING BY PERCENT OF AREA

The condition distribution of the network by percent of total pavement area is provided on the Sportsman Airpark Pavement Condition Rating by Percent of Area, Figure 3.2. A summary of the pavement condition results by branch and section is included in Tables 2B and 3B of Appendix B, respectively. A comparison between the previous inspection and the 2023 inspection is provided in Table 4B in Appendix B. The re-inspection report that includes inspection details for individual sample units is provided in Table 1E in Appendix E.

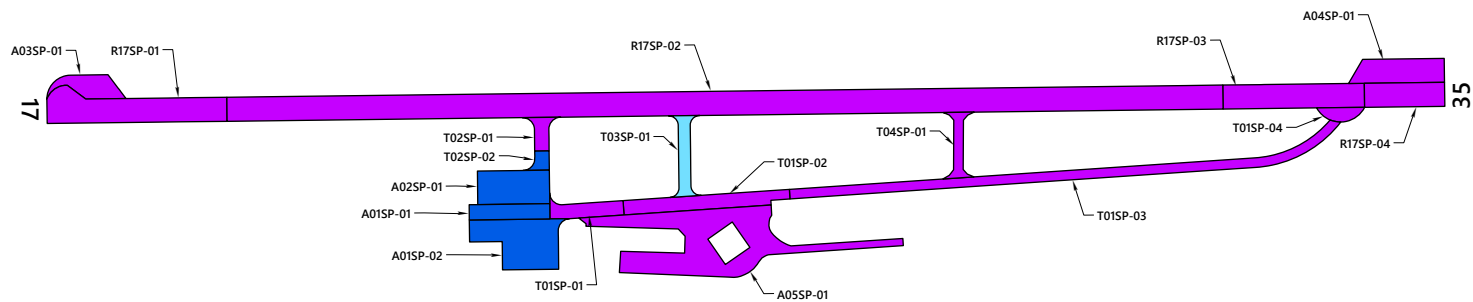
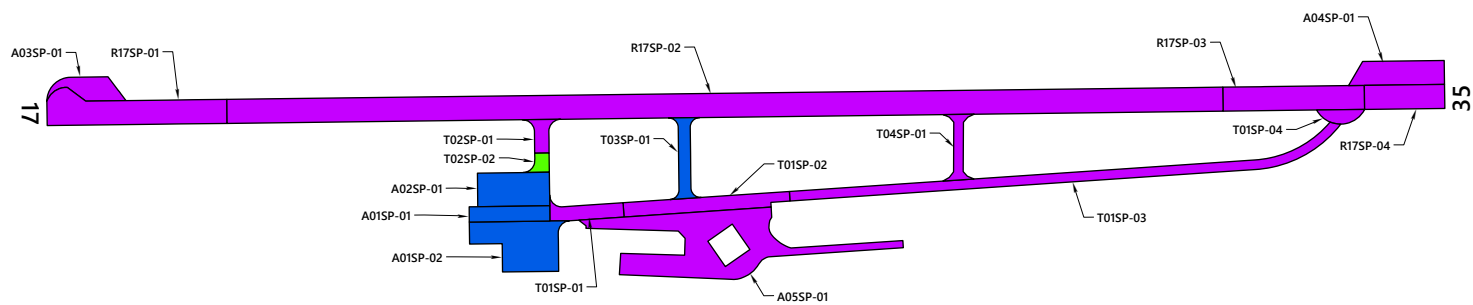
Using the condition prediction models discussed above, the projected condition of each pavement section was determined for 5- and 10-year periods. Based on this analysis, we project the PCI to decrease from a current value of 96 to a value of 91 in 2028 and 86 in 2033 if no maintenance or rehabilitation work is performed. The projected pavement condition in 5 years and 10 years for each pavement section at Sportsman Airpark is displayed spatially on the Sportsman Airpark Future Pavement Condition, Figure 4.1, and listed in Table 1C in Appendix C, along with the past and present PCI values for the pavement network.
