2023 ODAV Pavement Evaluation Program Toledo State Airport

Toledo, Oregon

December 29, 2023

State of Oregon Department of Aviation
3040 25th Street SE
Salem, OR 97303-1125

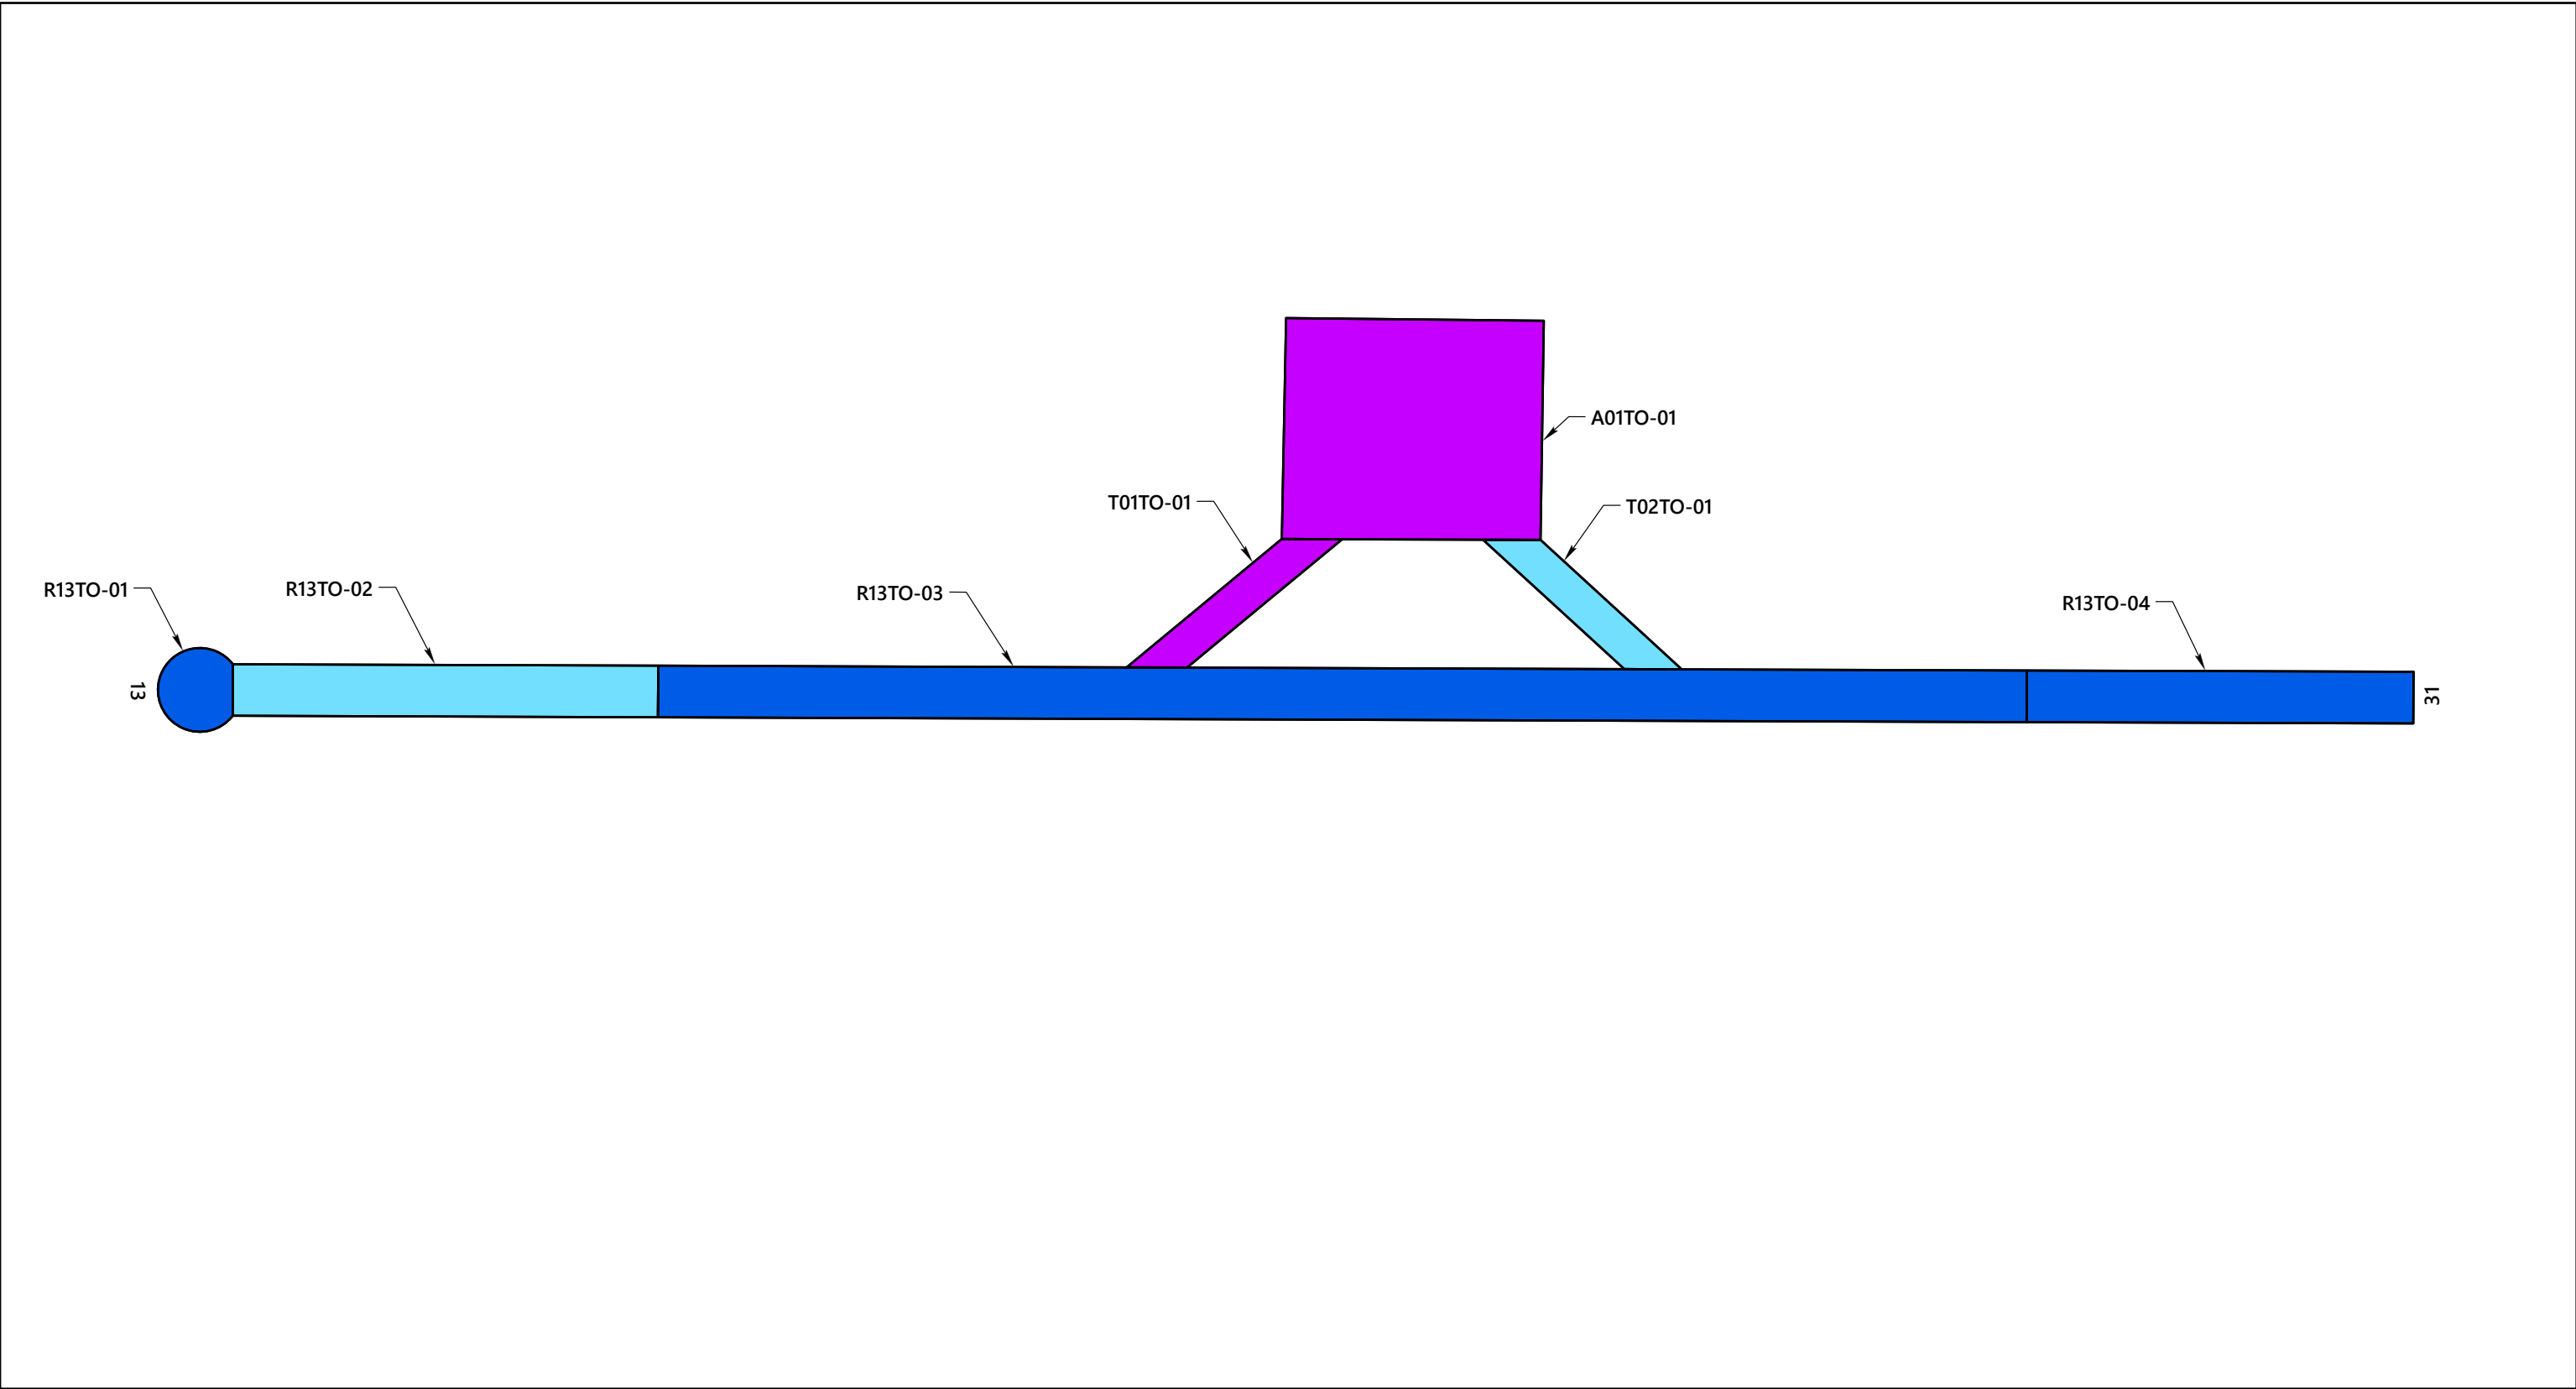
The area-weighted average PCI for all airport pavements at Toledo State Airport is approximately 80. The section PCIs ranged from a low of 63 to a high of 100. The primary distresses observed during the inspection were weathering, longitudinal and transverse cracking, and fatigue (alligator) cracking on AC-surfaced pavements. Section PCIs following our pavement survey are displayed below spatially on the Toledo State Airport 2023 PCI Survey Results, Figure 3.1.

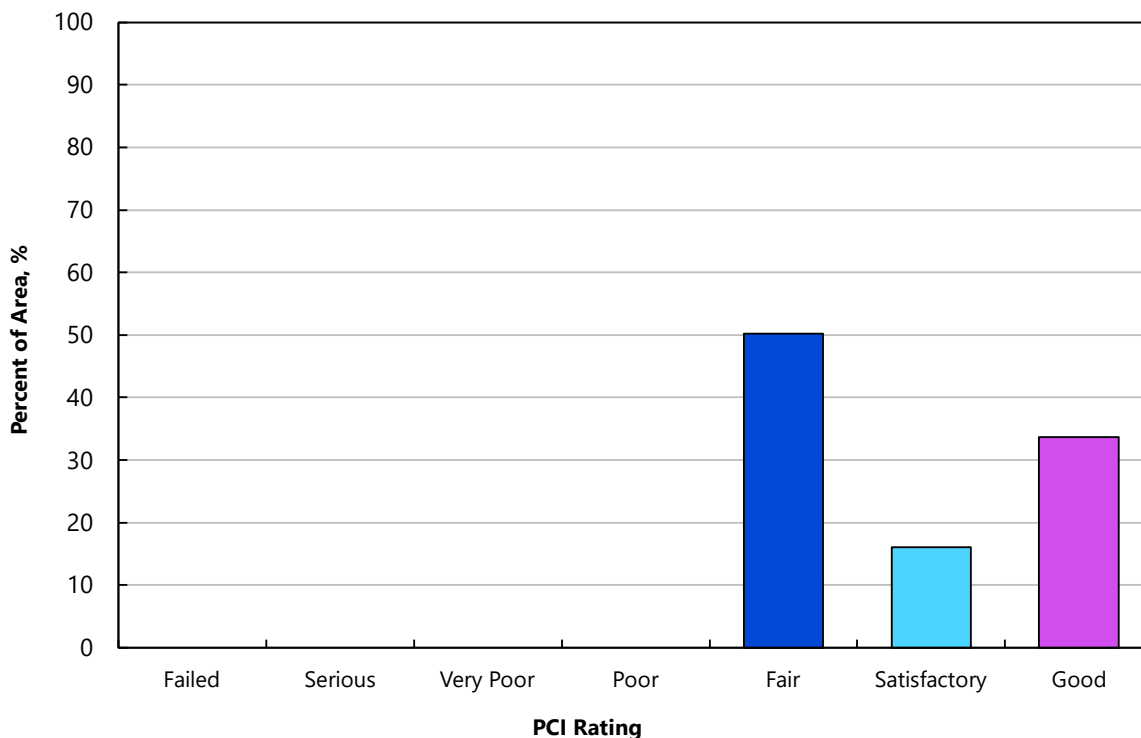
Figure 3.2: TOLEDO STATE AIRPORT PAVEMENT CONDITION RATING BY PERCENT OF AREA

The condition distribution of the network by percent of total pavement area is provided on the Toledo State Airport Pavement Condition Rating by Percent of Area, Figure 3.2. A summary of the pavement condition results by branch and section is included in Tables 2B and 3B of Appendix B, respectively. A comparison between the previous inspection and the 2023 inspection is provided in Table 4B in Appendix B. The re-inspection report that includes inspection details for individual sample units is provided in Table 1E in Appendix E.

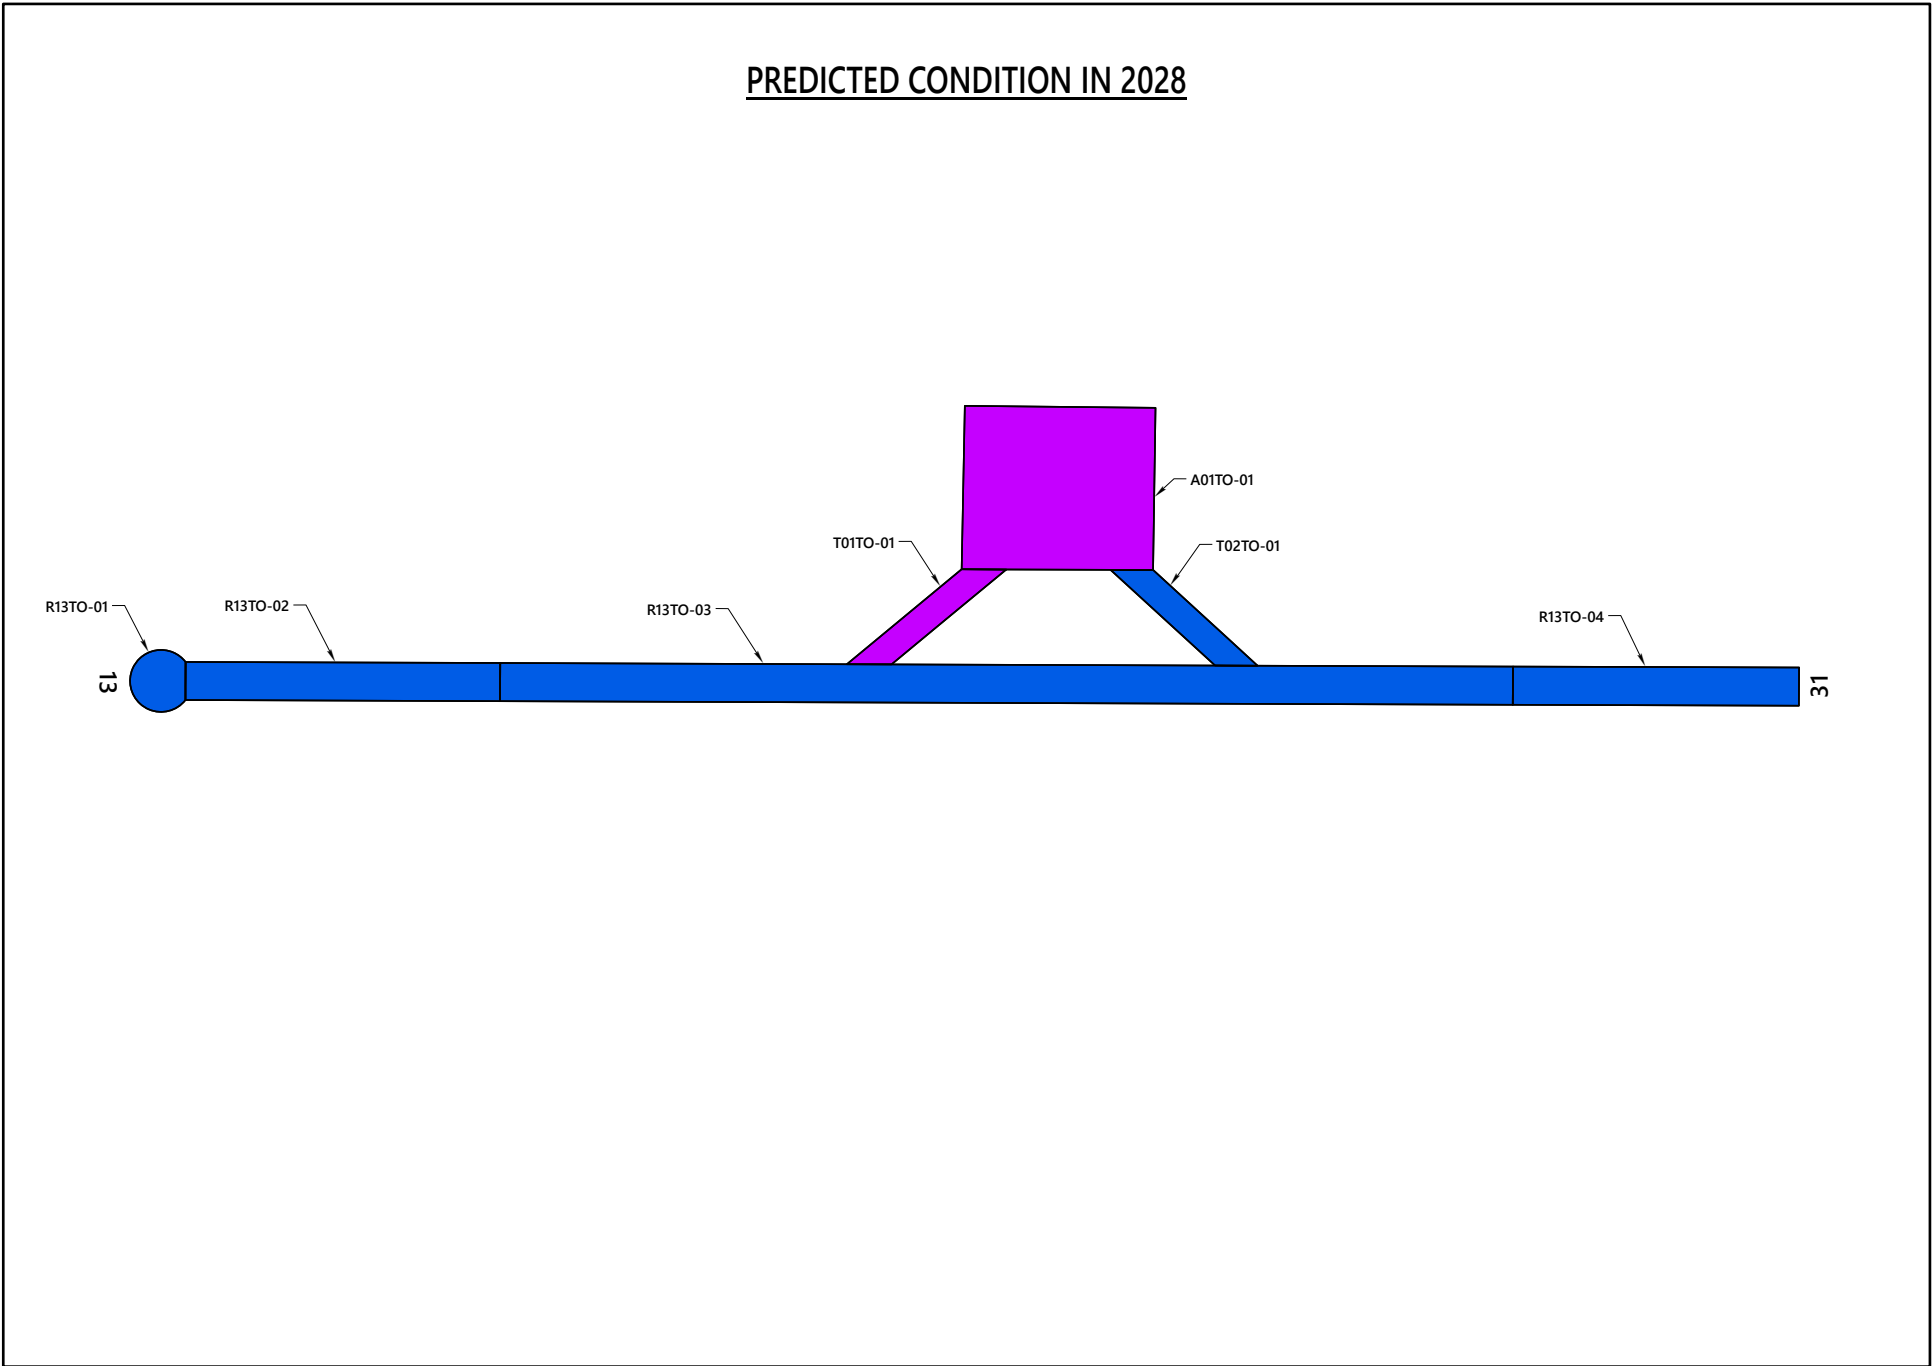
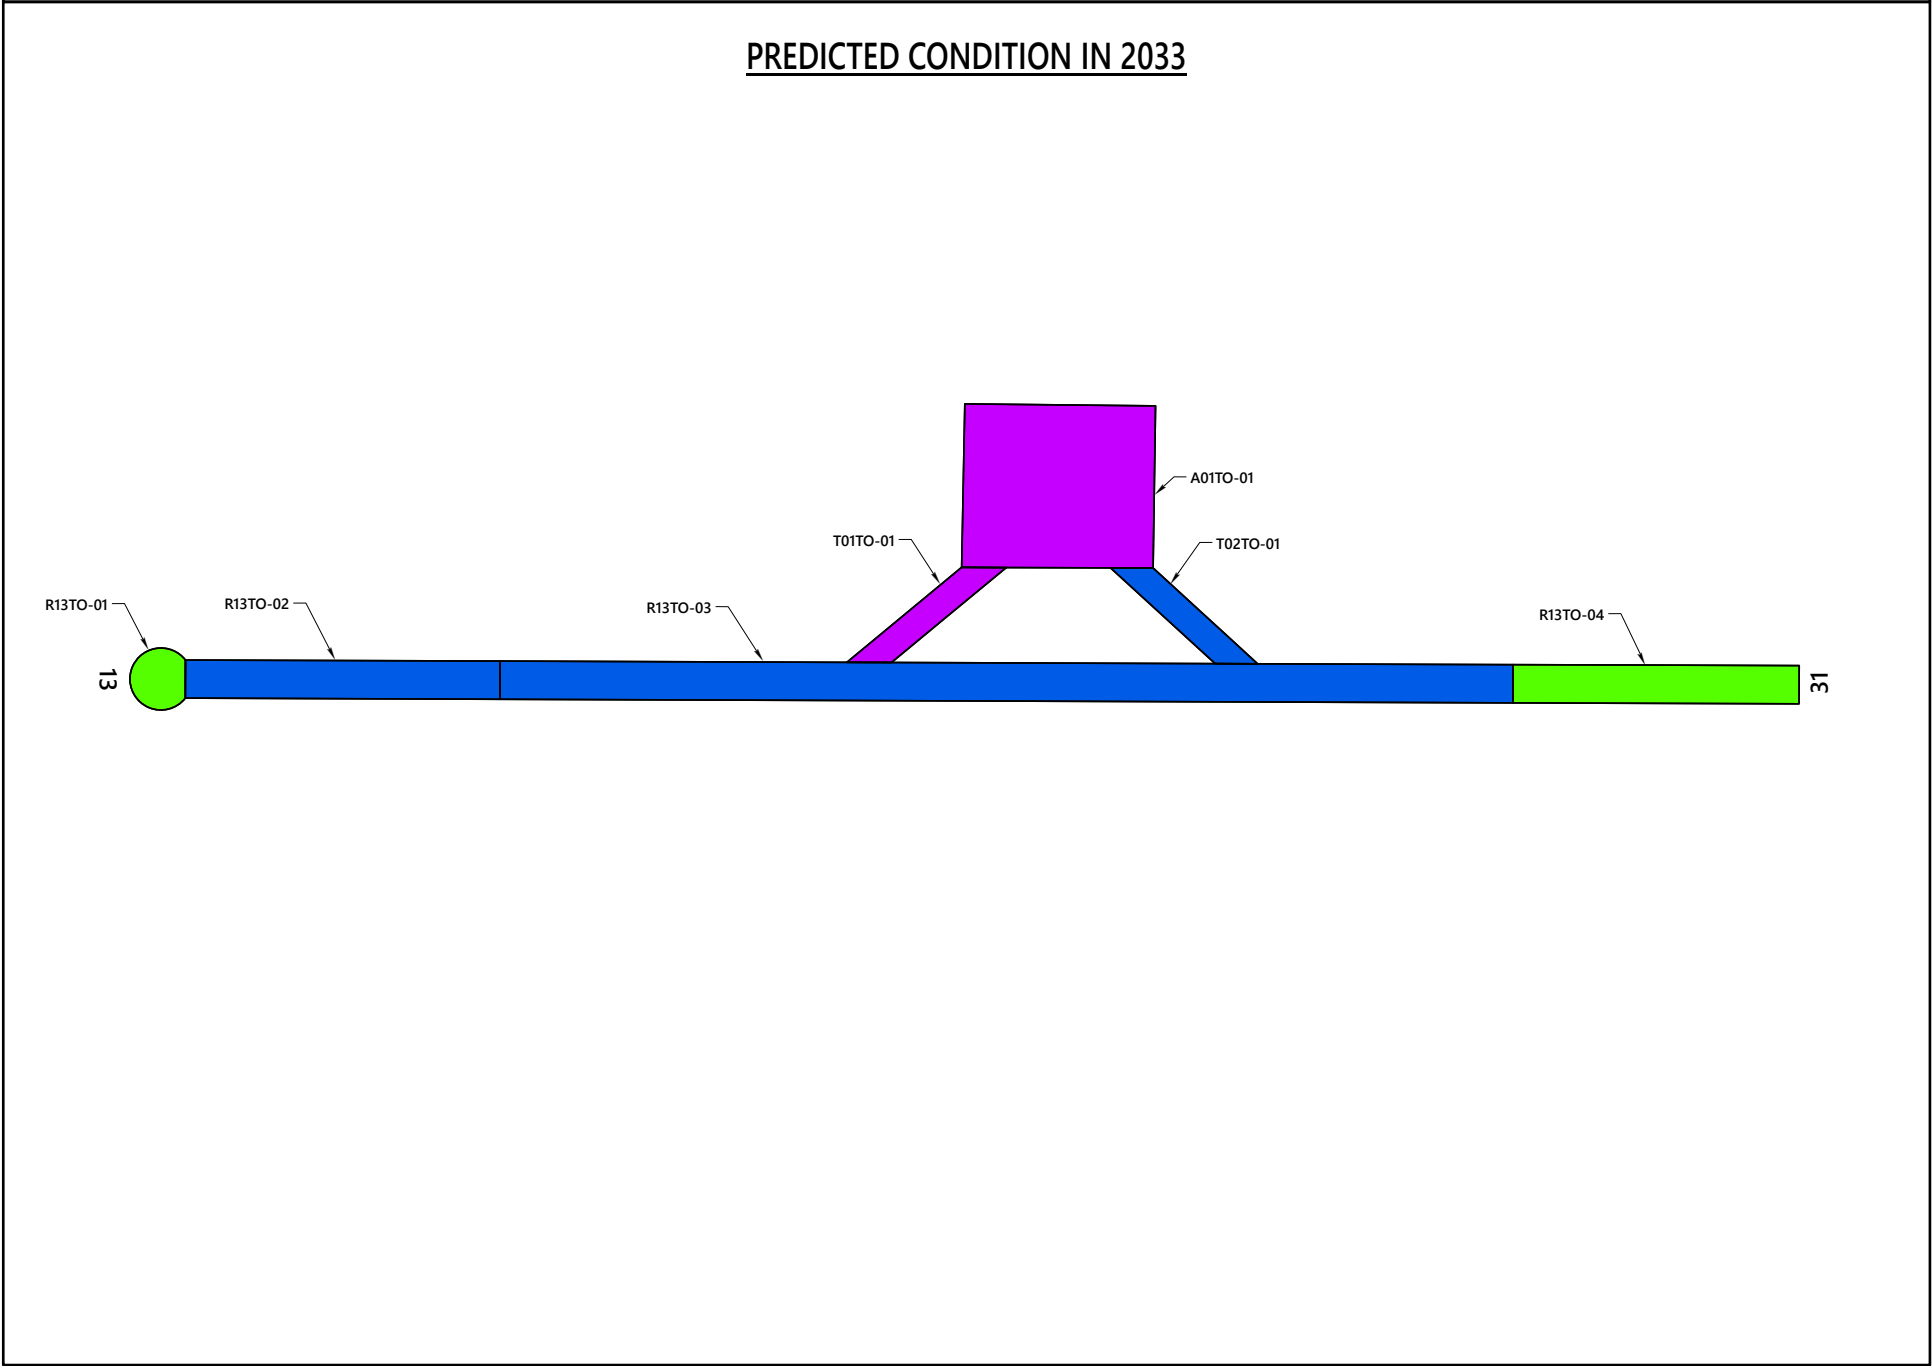
**FUTURE PAVEMENT CONDITION
TOLEDO STATE AIRPORT**

Using the condition prediction models discussed above, the projected condition of each pavement section was determined for 5- and 10-year periods. Based on this analysis, we project the PCI to decrease from a current value of 80 to a value of 75 in 2028 and 70 in 2033 if no maintenance or rehabilitation work is performed. The projected pavement condition in 5 years and 10 years for each pavement section at Toledo State Airport is displayed spatially on the Toledo State Airport Future Pavement Condition, Figure 4.1, and listed in Table 1C in Appendix C, along with the past and present PCI values for the pavement network.
