# **2023 ODAV Pavement Evaluation Program Valley View Airport**

Estacada, Oregon

**December 29, 2023**

State of Oregon Department of Aviation  
3040 25th Street SE  
Salem, OR 97303-1125

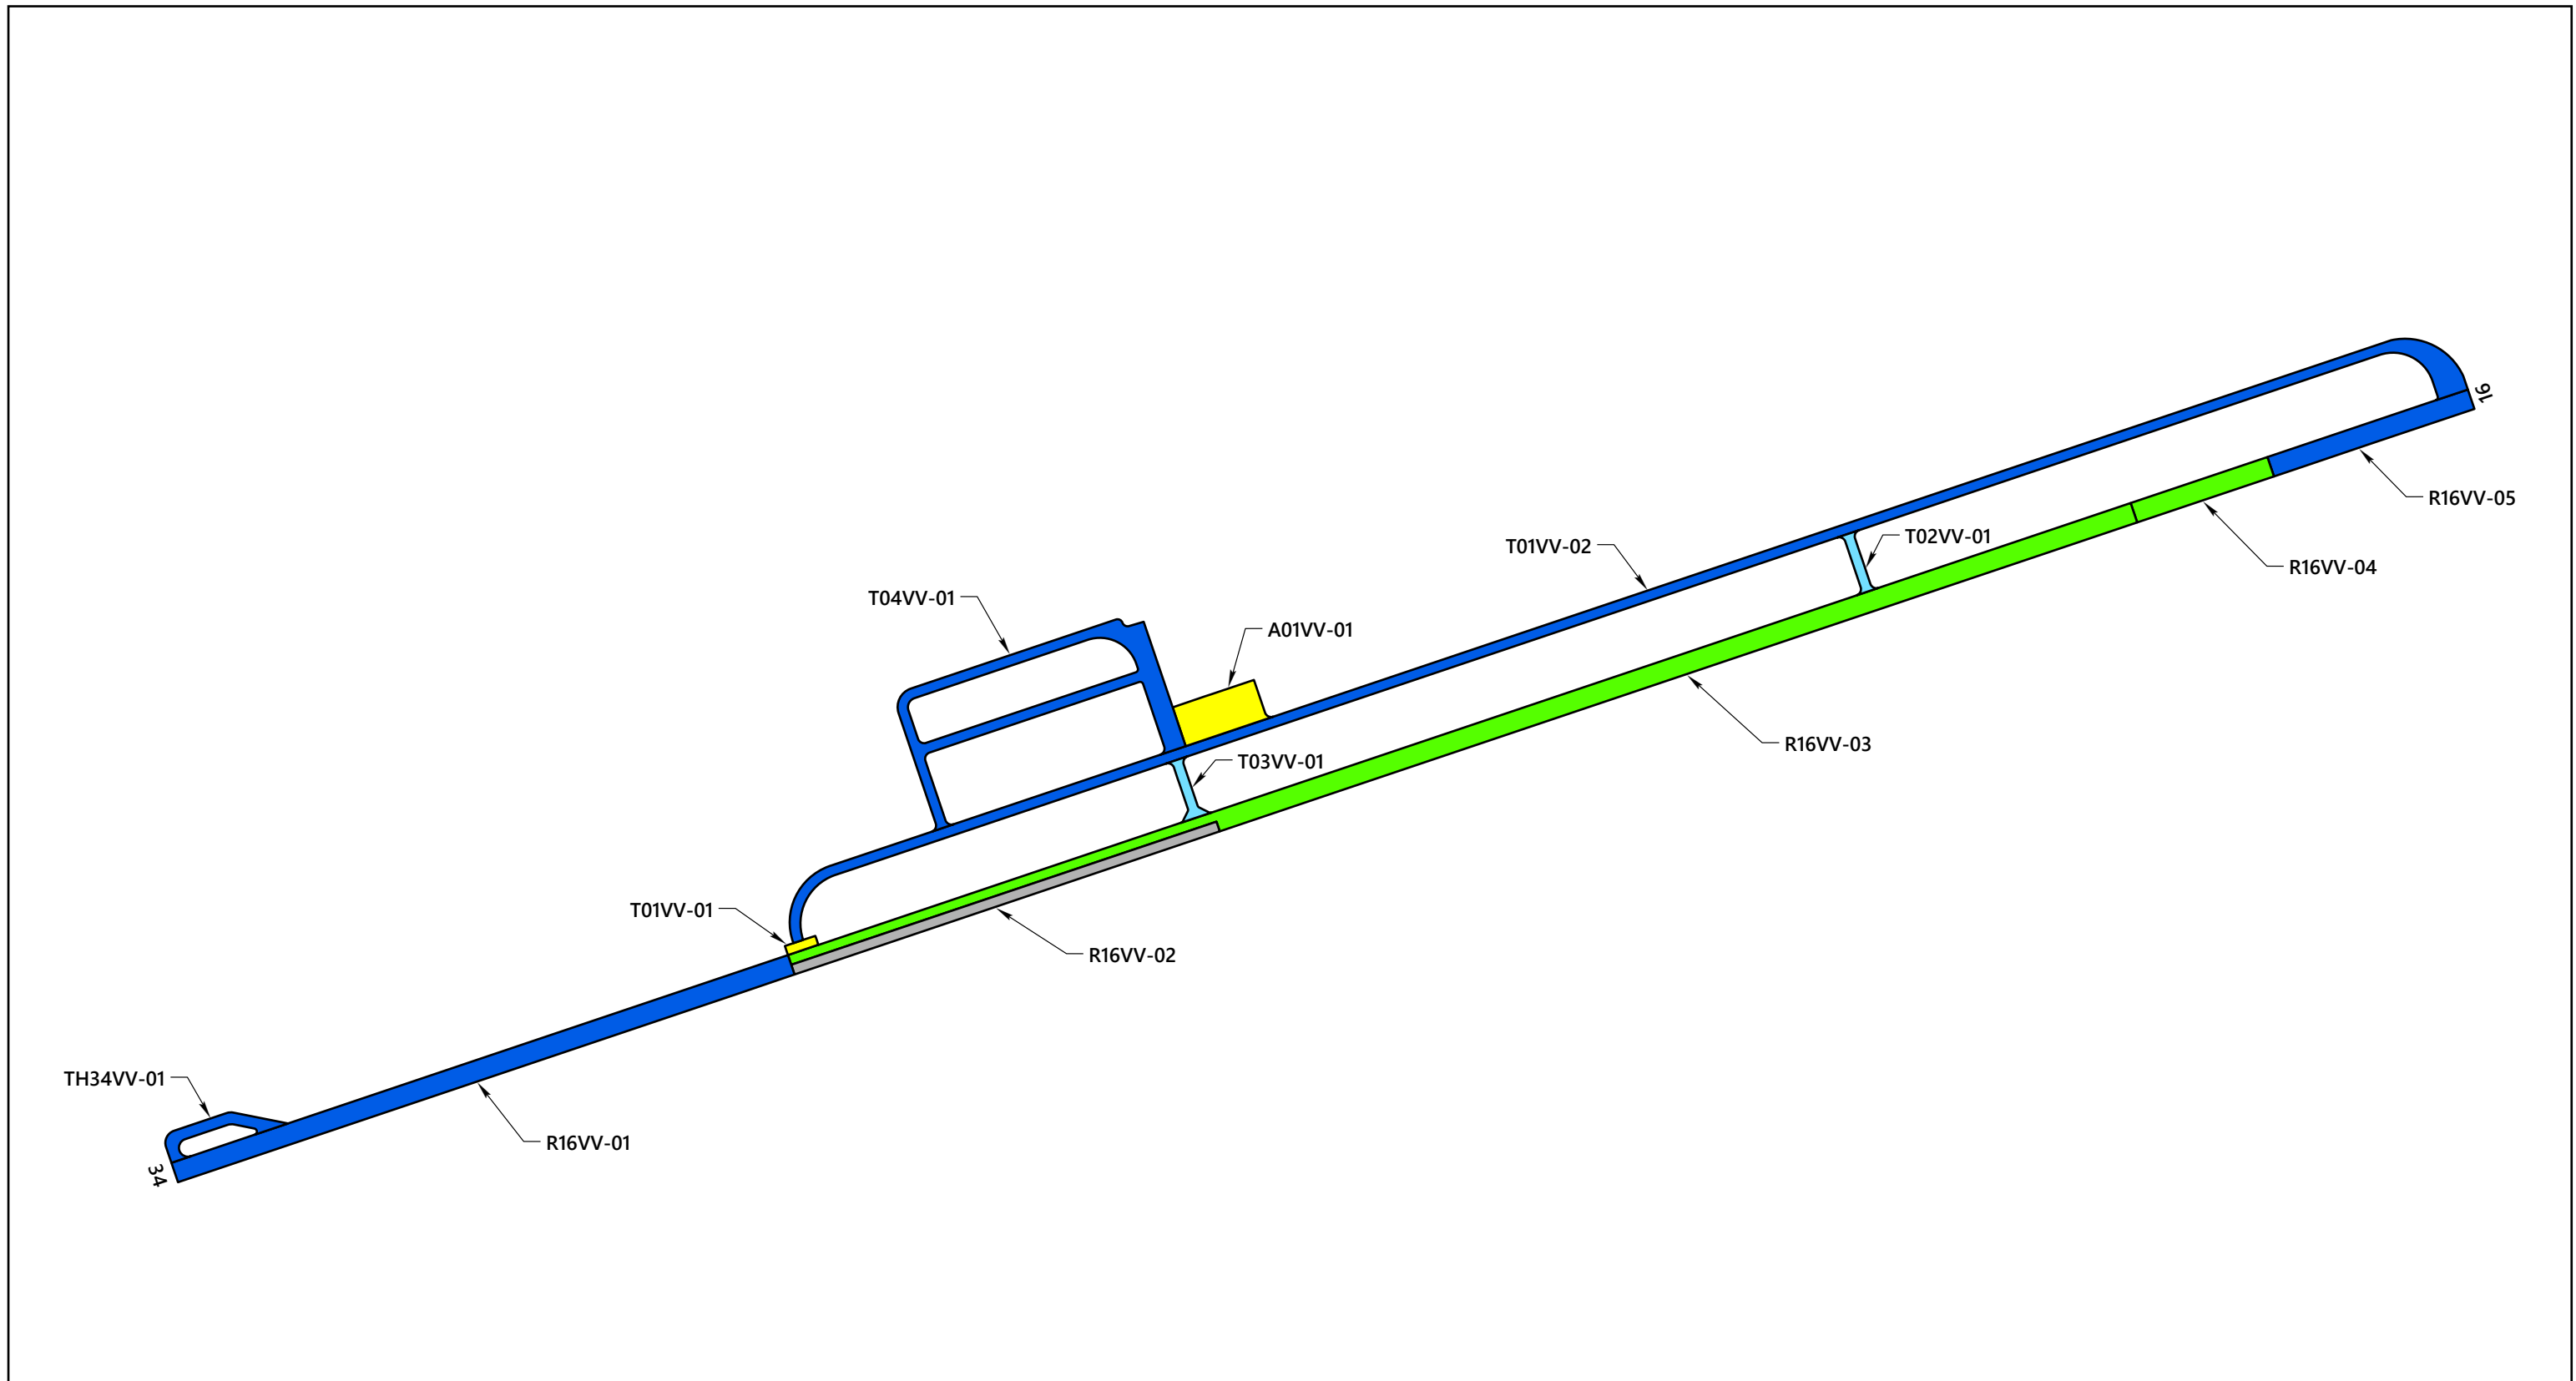
The area-weighted average PCI for all airport pavements at Valley View Airport is approximately 58. The section PCIs ranged from a low of 20 to a high of 75. The primary distresses observed during the inspection were weathering, longitudinal and transverse cracking, fatigue (alligator) cracking, block cracking, raveling, and patching on AC-surfaced pavements. Section PCIs following our pavement survey are displayed below spatially on the Valley View Airport 2023 PCI Survey Results, Figure 3.1.

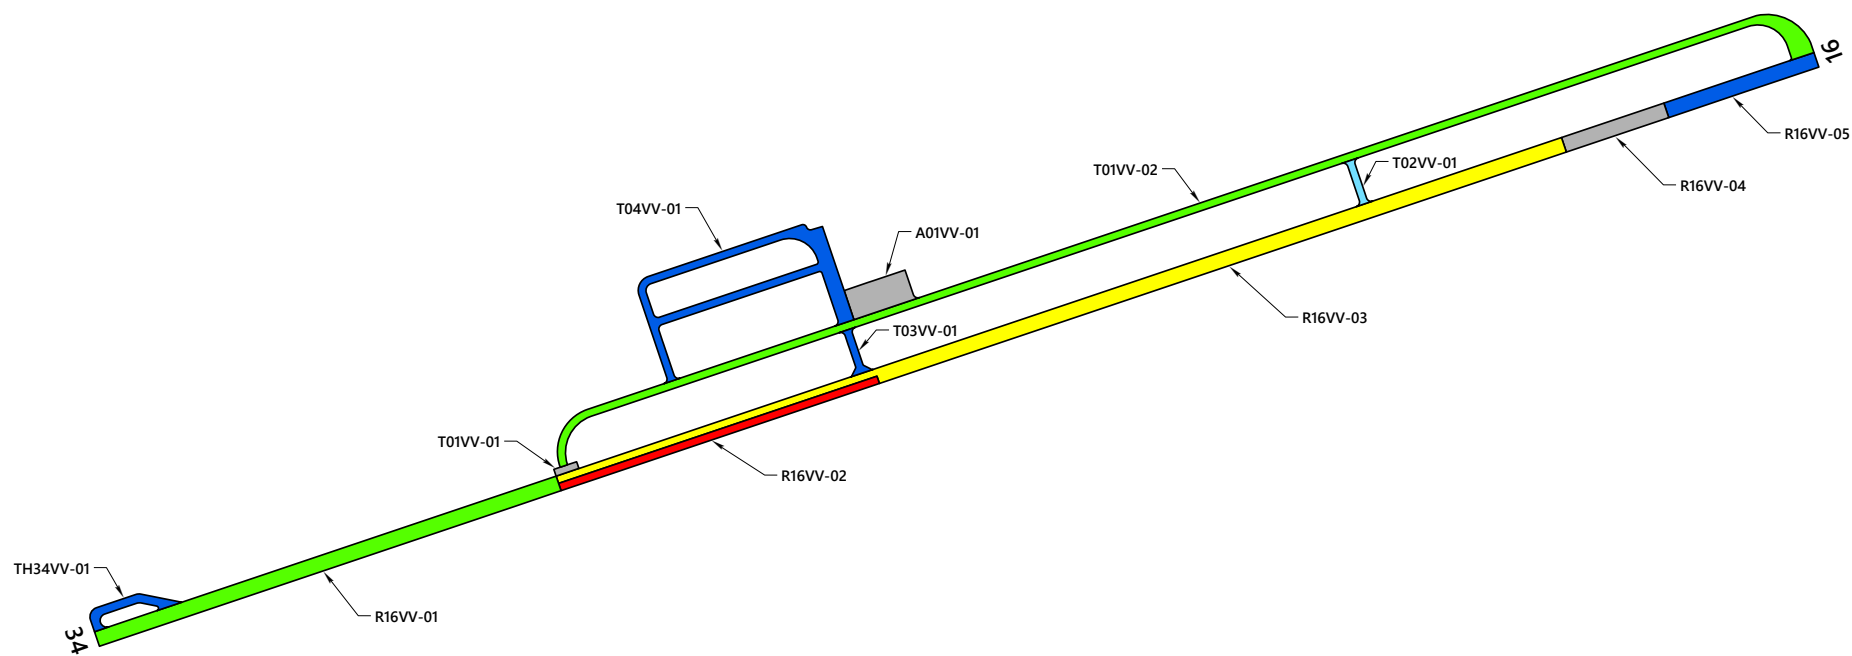
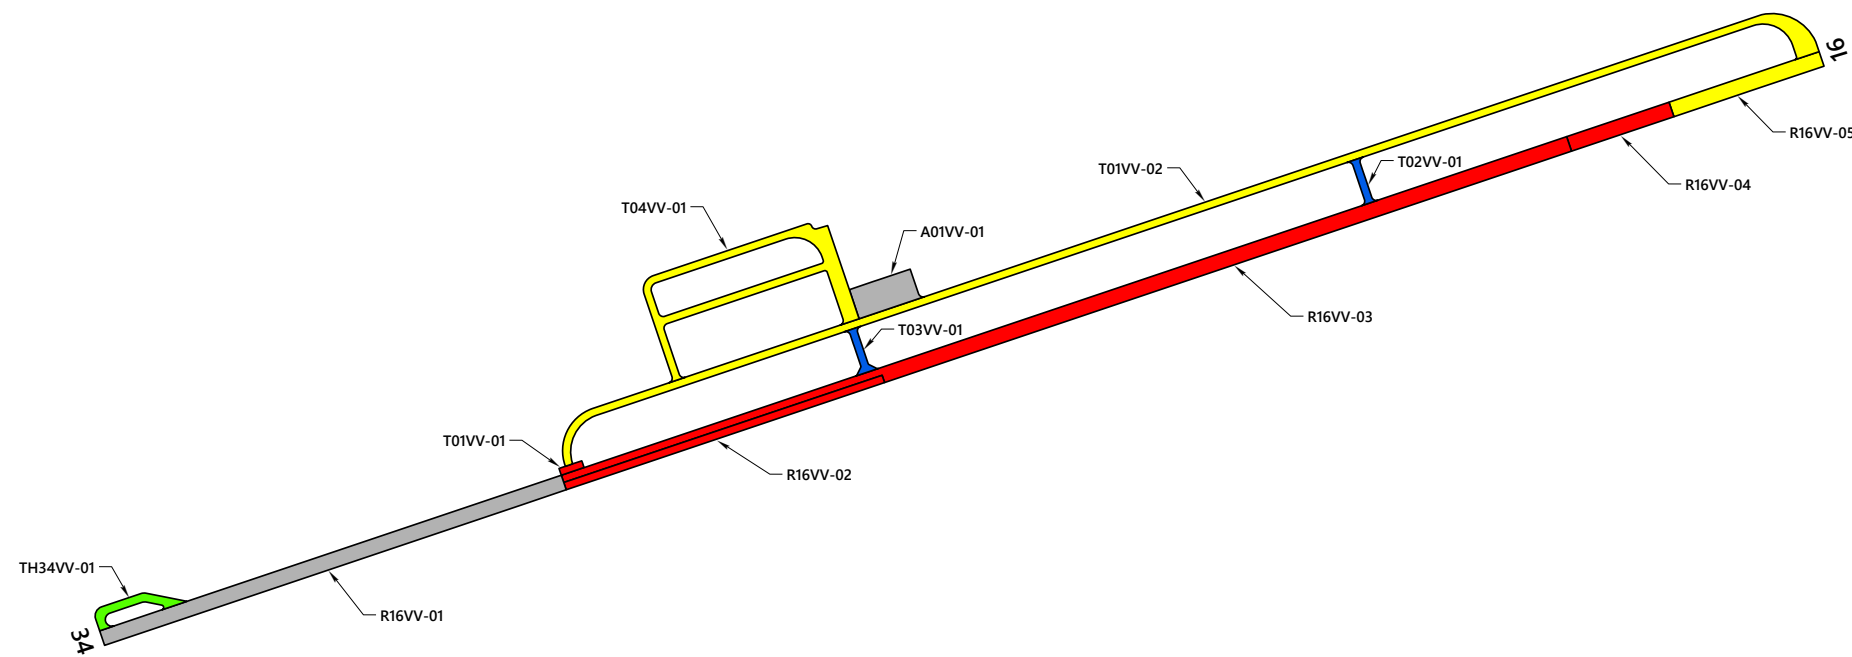
Using the condition prediction models discussed above, the projected condition of each pavement section was determined for 5- and 10-year periods. Based on this analysis, we project the PCI to decrease from a current value of 58 to a value of 41 in 2028 and 21 in 2033 if no maintenance or rehabilitation work is performed. The projected pavement condition in 5 years and 10 years for each pavement section at Valley View Airport is displayed spatially on the Valley View Airport Future Pavement Condition, Figure 4.1, and listed in Table 1C in Appendix C, along with the past and present PCI values for the pavement network.
