2024 ODAV Pavement Evaluation Program Illinois Valley Airport

Cave Junction, Oregon

February 12, 2025

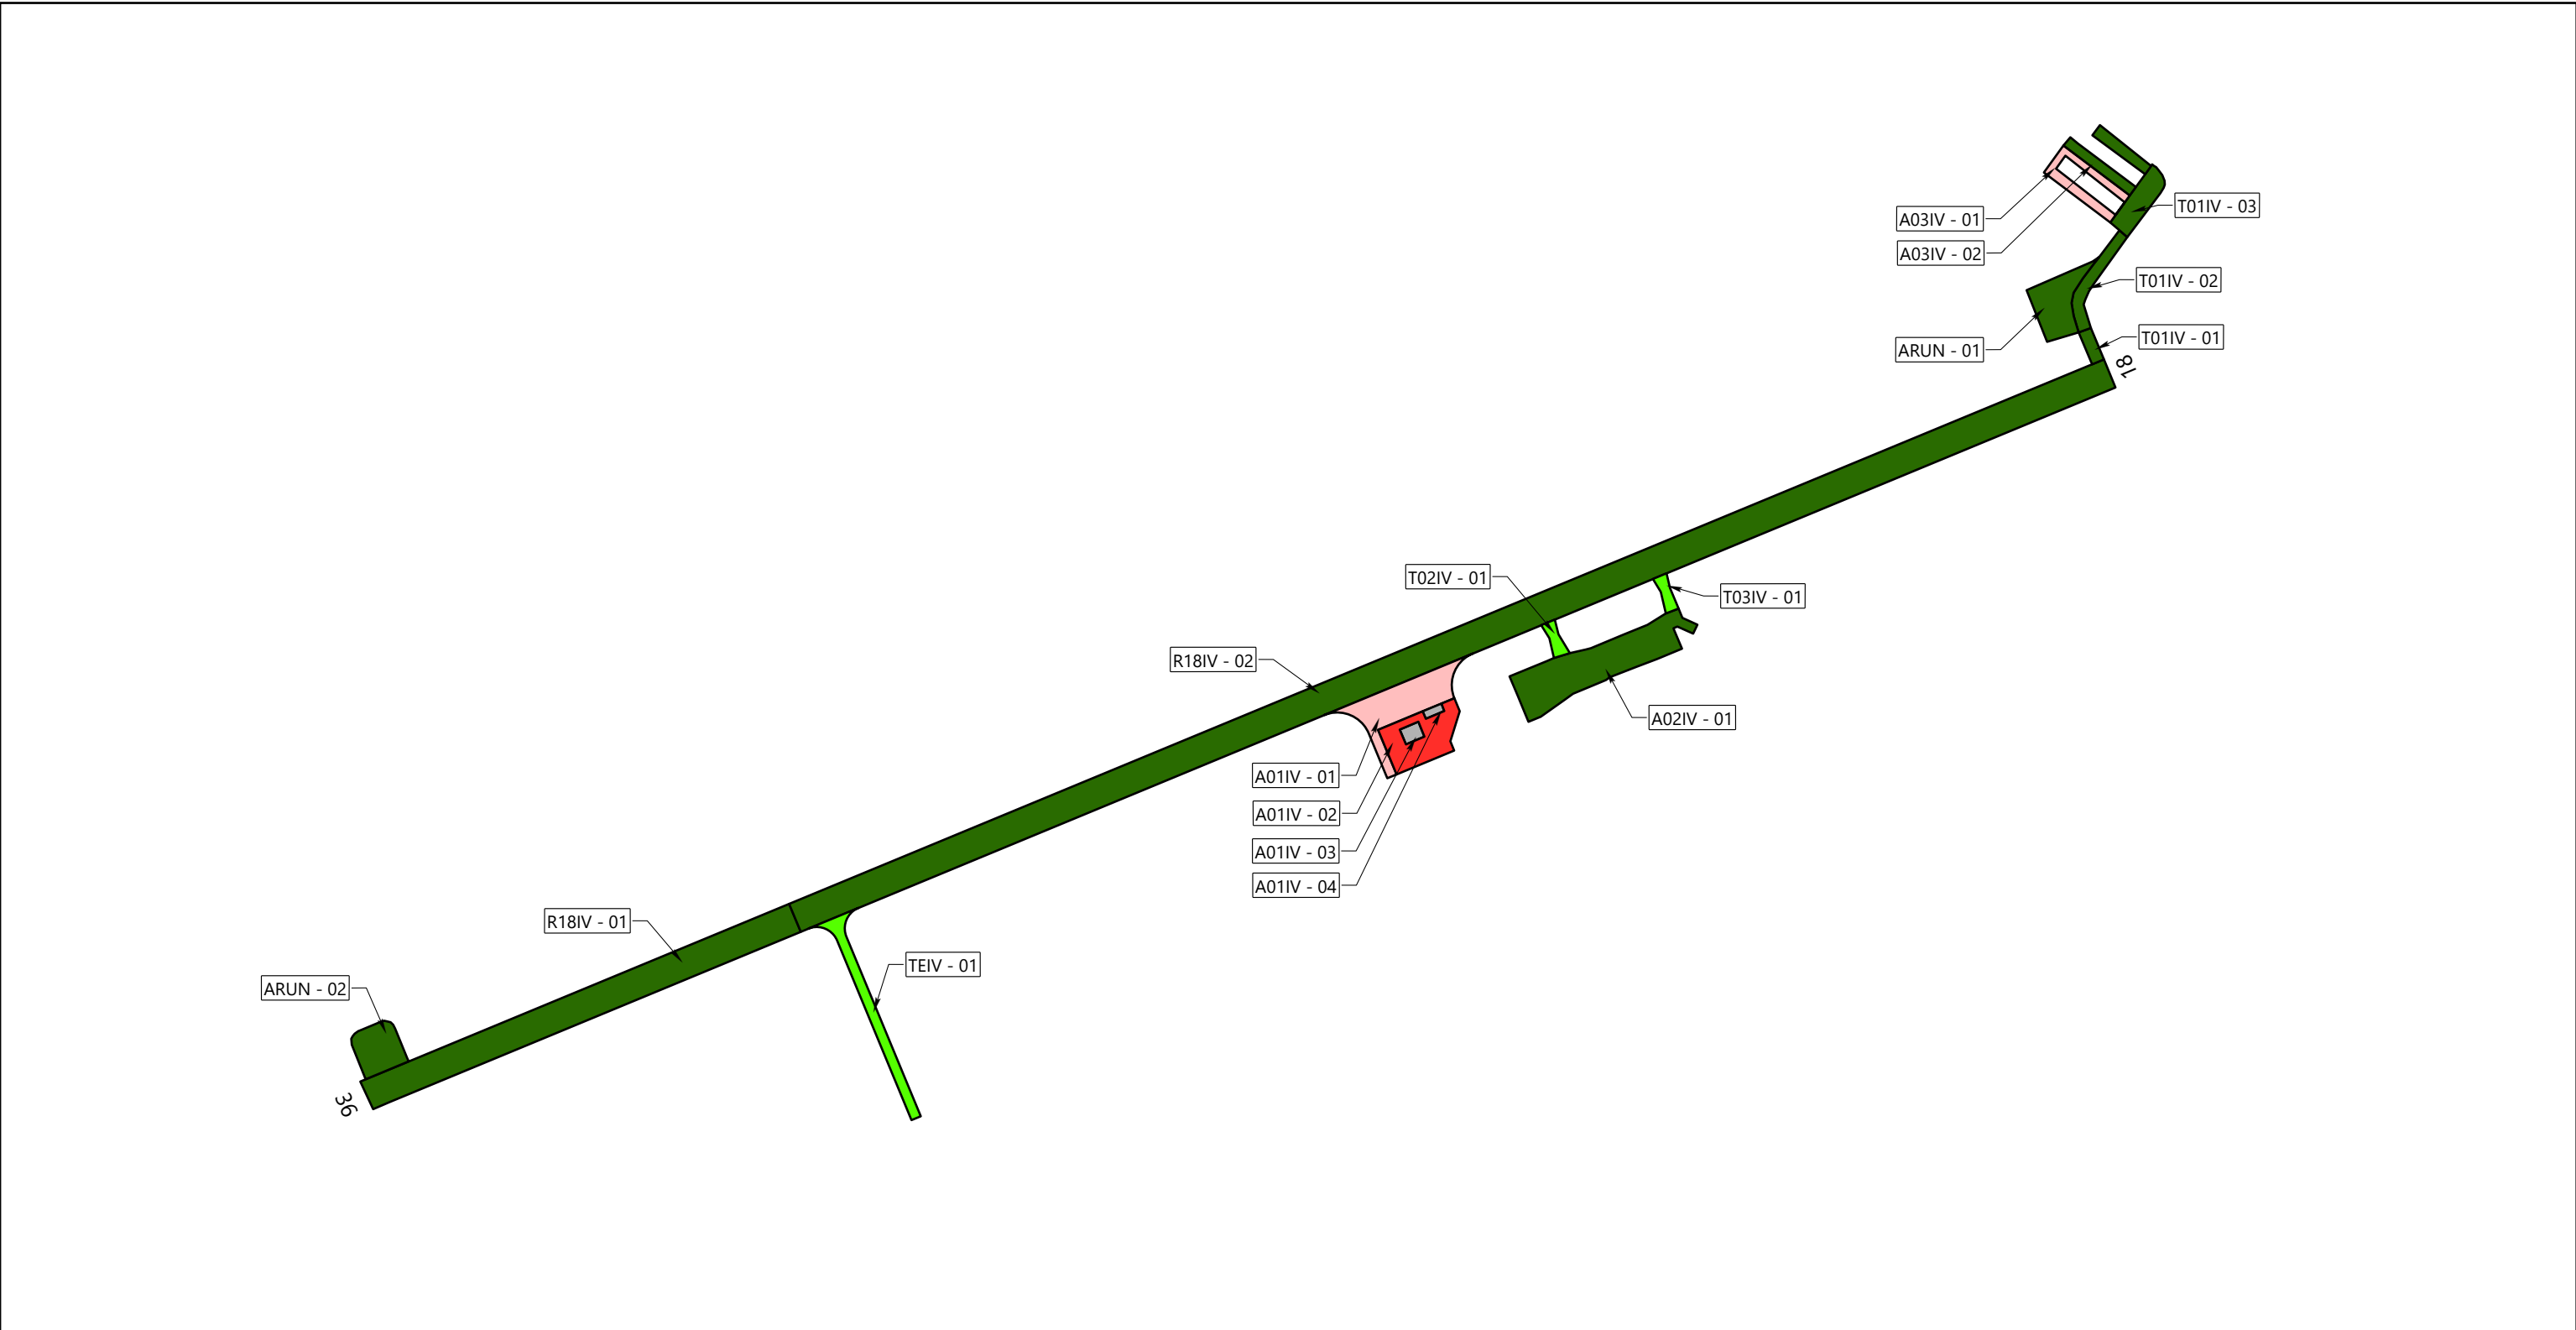
**ILLINOIS VALLEY AIRPORT
2024 PCI SURVEY RESULTS**

The area-weighted average PCI for all airport pavements at Illinois Valley Airport is approximately 86. The section PCIs ranged from a low of 0 to a high of 94. The primary distresses observed during the inspection were weathering, longitudinal and transverse cracking, fatigue (alligator) cracking, block cracking, and depression on AC-surfaced pavements and patching, shattered slabs, and faulting on PCC surfaced pavements. Section PCIs following our pavement survey are displayed below spatially on the Illinois Valley Airport 2024 PCI Survey Results, Figure 3.1.
