# **2024 ODAV Pavement Evaluation Program Oakridge State Airport**

Oakridge, Oregon

February 12, 2025

Prepared for  
State of Oregon Department of Aviation  
3040 25th Street SE  
Salem, OR 97303-1125

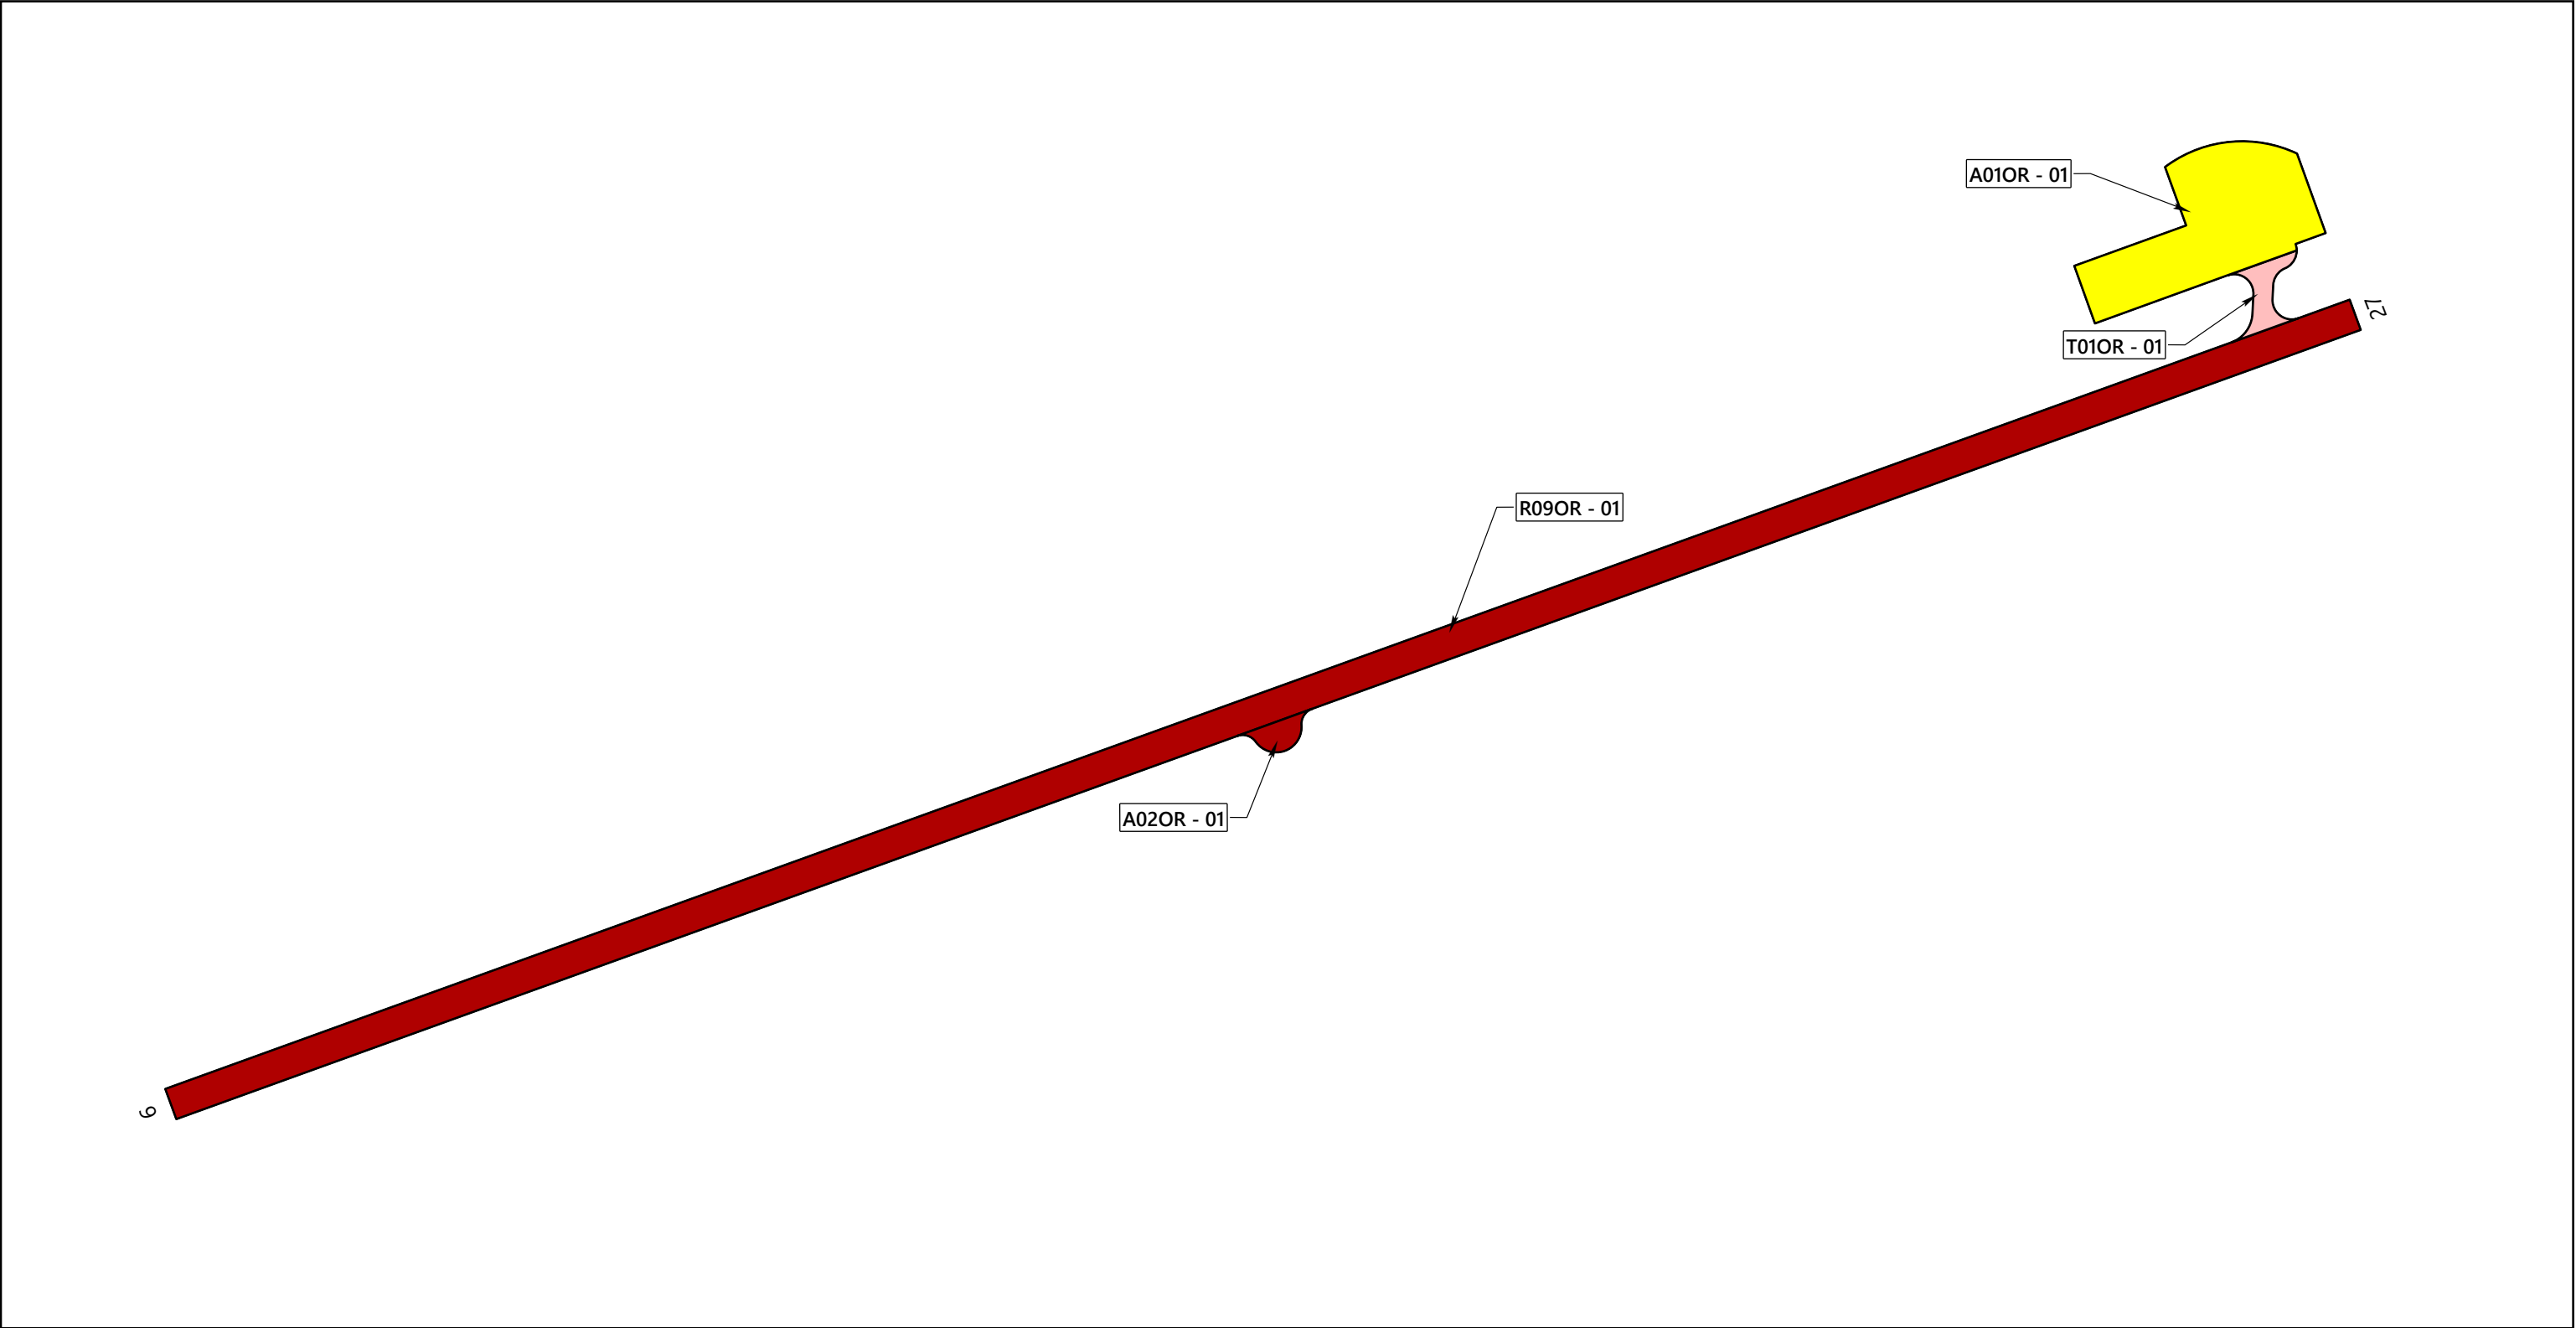
OAKRIDGE STATE AIRPORT  
2024 PCI SURVEY RESULTS

The area-weighted average PCI for all airport pavements at Oakridge State Airport is approximately 35. The section PCIs ranged from a low of 18 to a high of 67. The primary distresses observed during the inspection were weathering, longitudinal and transverse cracking, fatigue (alligator) cracking, block cracking, raveling, and patching on AC-surfaced pavements. Section PCIs following our pavement survey are displayed below spatially on the Oakridge State Airport 2024 PCI Survey Results, Figure 3.1, below.

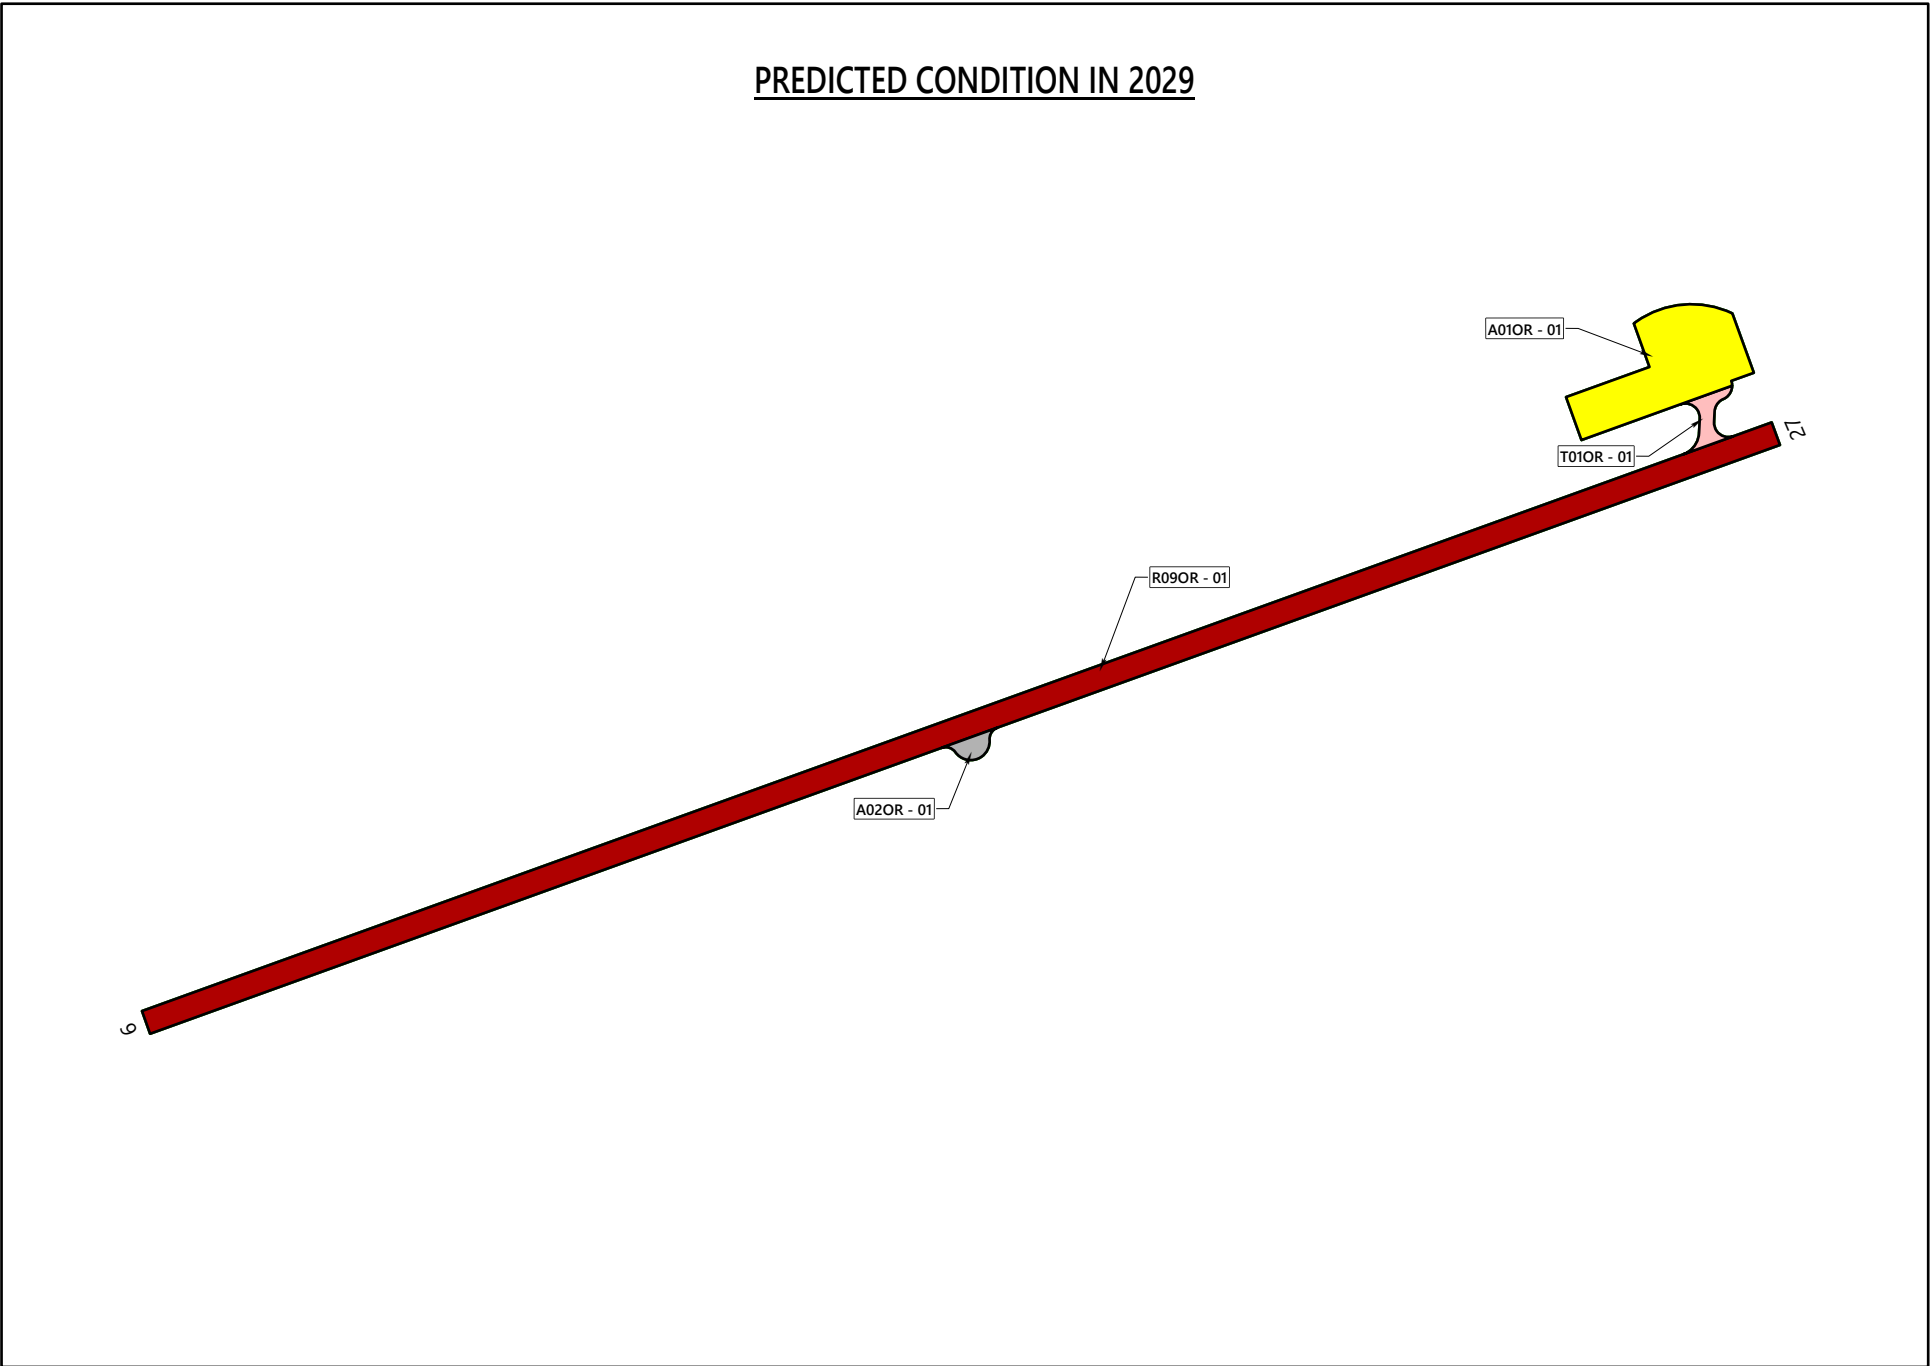
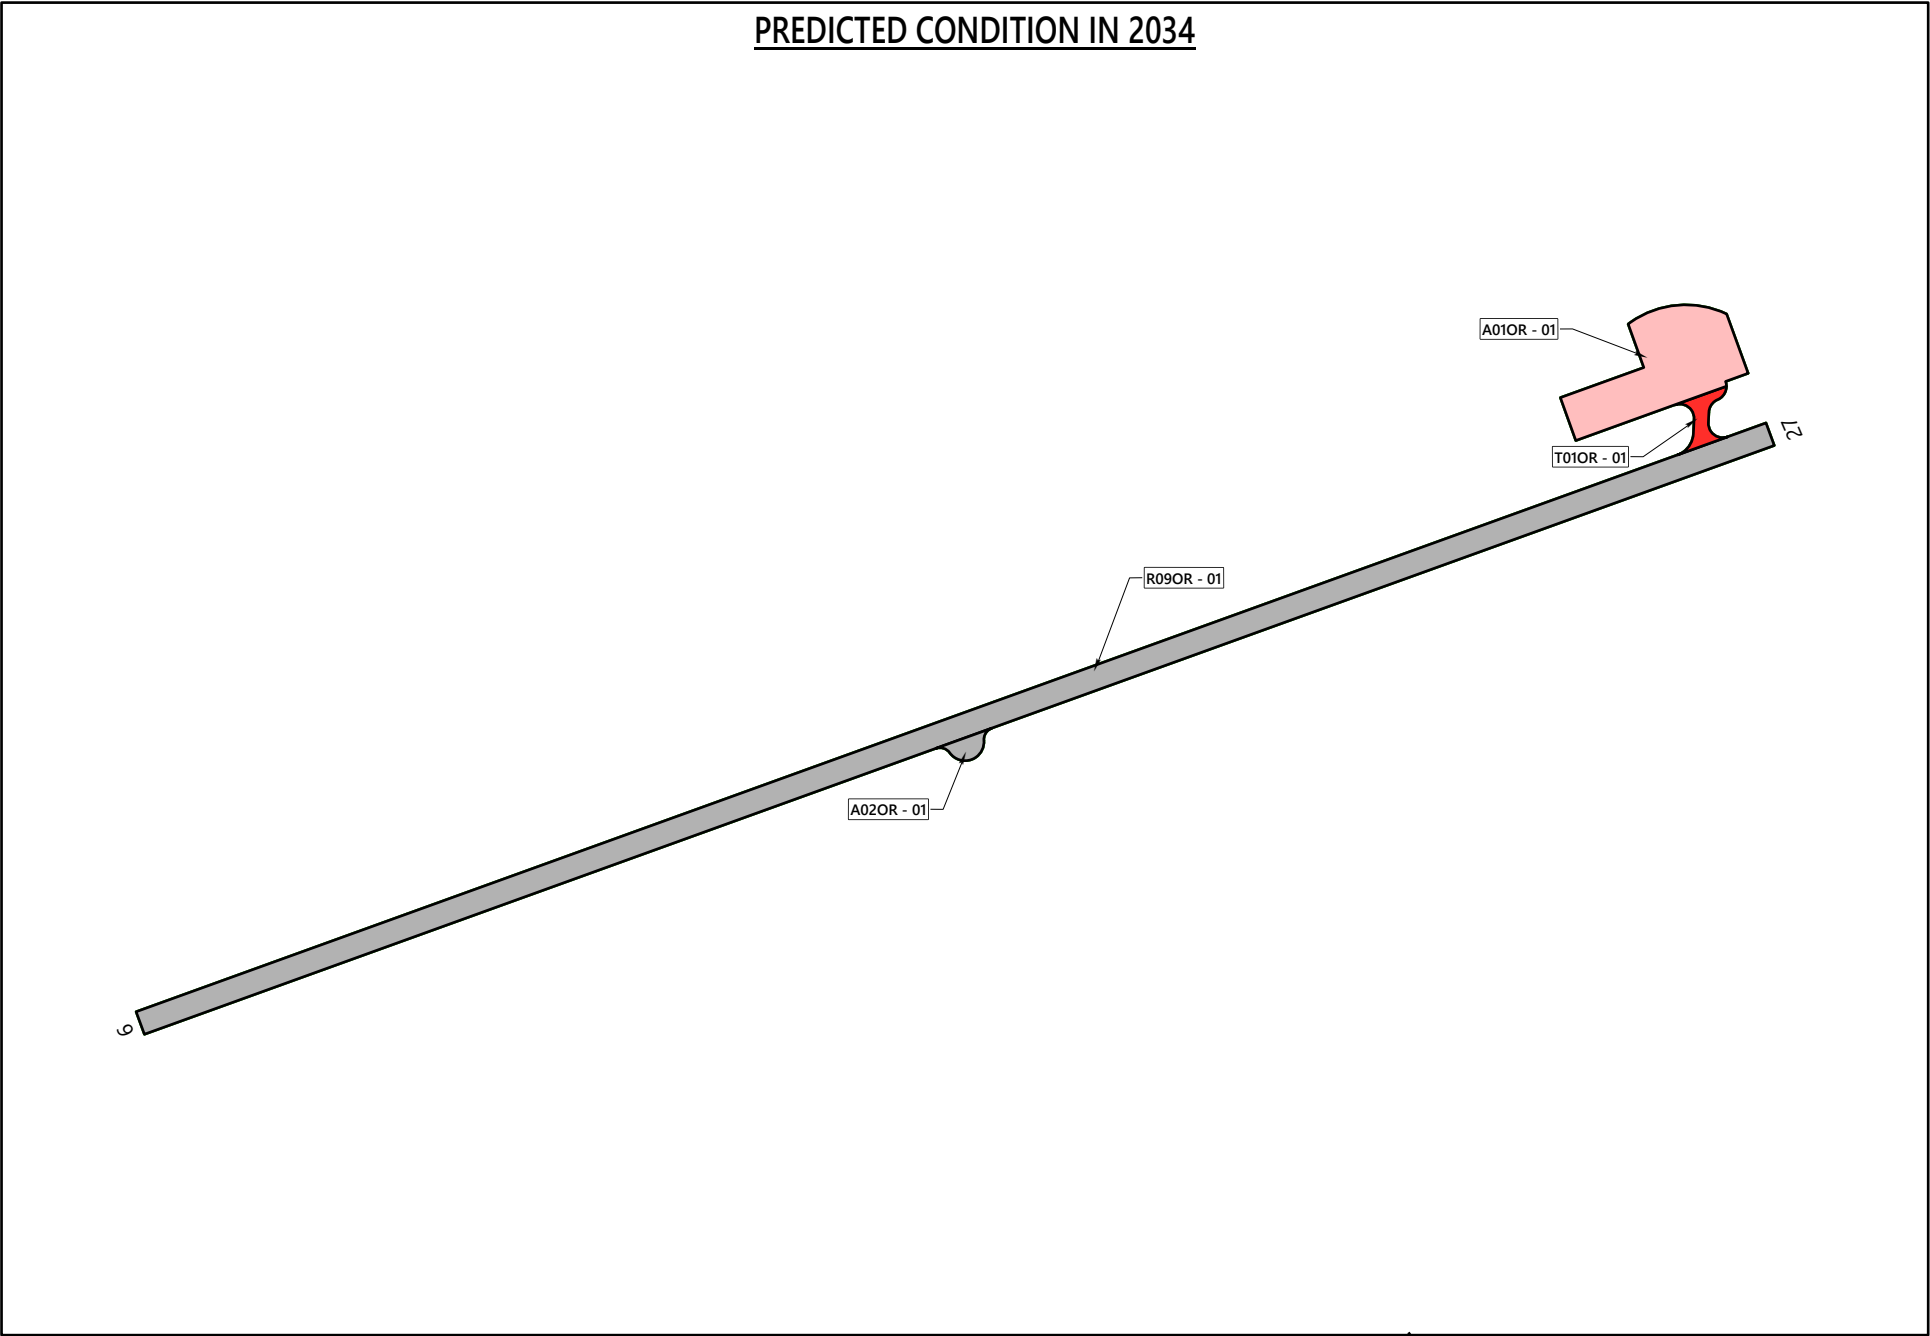
**OAKRIDGE STATE AIRPORT  
FUTURE PAVEMENT CONDITION**

Using the condition prediction models discussed above, the projected condition of each pavement section was determined for five- and 10-year periods. Based on this analysis, we project the PCI will decrease from its current value of 35 to a value of 26 in 2029 and a value of 18 in 2034 if no maintenance or rehabilitation work is performed. The projected pavement condition in five years and 10 years for each pavement section at Oakridge State Airport is displayed spatially on the Oakridge State Airport Future Pavement Condition, Figure 4.1, and listed in Table 1C in Appendix C, along with the past and present PCI values for the pavement network.
